Identifying the Origin of Sliver Defects in Rolled Aluminum Sheets

Fahad Bokhari, Trey Eads, Hassan Khan, and Matt Leavitt

This work is sponsored by Logan Aluminum, Russellville, KY.

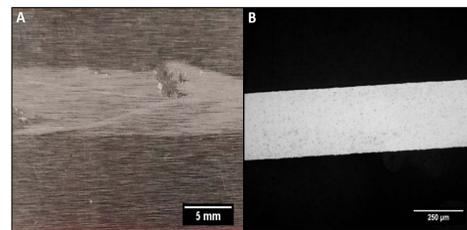
Production slivers in samples provided by Logan Aluminum were classified as either Smeared (Fig. 4A) or Ruptured Surface (Fig. 5A) Slivers. No distinct compositional or metallographic differences between the smeared surface sliver and the sheet suggests the defect is caused by mechanical damage, whereas a distinct boundary divides the ruptured surface sliver from the sheet. Slivers responsible for failure during drawing (Fig. 1) share topographical characteristics such as striations with ruptured surface slivers.

Figure 4: (A) smeared sliver on surface. No sign of sliver is found in cross section (B), suggesting it being a surface discoloration.

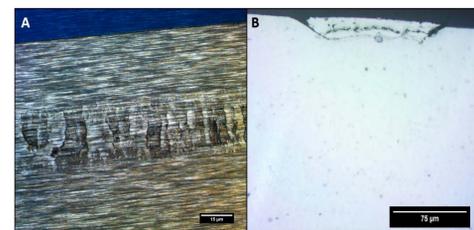
Figure 5: Example of ruptured surface sliver (A) on surface and (B) in cross section. Lack of composition difference between sliver and bulk metal suggests the defect is caused by mechanical damage.

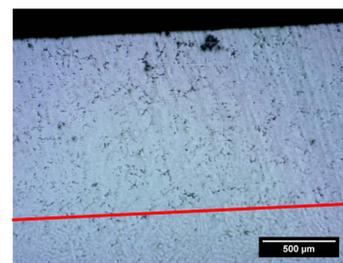
Composition profiles were measured from the surface into the bulk ingot to characterize the exudation and depleted layer depths and to compare these depths to Logan's scalp depth. The solute enrichment measured 1.1 ± 0.3 mm for 5182, and contained up to 2.5 times the nominal Mg content of the alloy's (4.5wt%). Due to the lower Mg content of 3104 (1wt%), no significant composition variation near the surface was found. The 5182 exudation layer was found to have a higher hardness (Fig. 8), due to higher solute content, leading to a decrease in ductility. This results in edge cracks and a potential source of debris on the unscalped sides of the ingot.

Figure 6: A thick exudation layer in 5182 above the red line, while a dendritic structure is seen below.

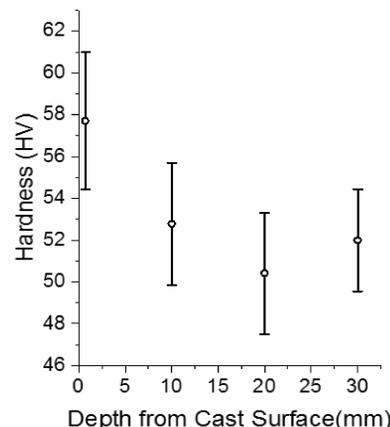
Figure 8: Vickers hardness measurements of the 5182 alloy. Hardness of the exudation layer is about 10% higher than in the bulk (subsurface).

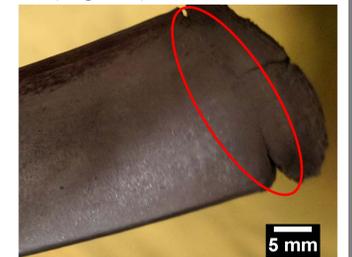
The control, scored, and fine debris samples displayed no slivering. Coarse debris caused a sliver attached at one end. A light-colored scar, Fig. 9, formed if coarse debris fell off during rolling. The exudation layer at the head of the transverse sample began to crack and separate (Fig. 10).

Figure 10: Separation of rolled exudation layer from bulk sample.

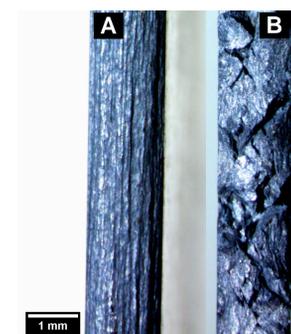
Transverse sample defects were constrained to the exudation layer, implying solute enrichment results in defect susceptibility. To confirm this effect, a larger sample was rolled with the exudation layer as one side (edge) and a scalped edge as the other. This sample allowed direct comparison of the effect of ingot side scalping. Shown in Fig. 11, the scalped edge remained smooth and did not crack while the unscalped edge was heavily cracked. The damage on the unscalped side was the same as is seen on edge trim of production sheet (Fig. 12).

Figure 11: (A) relatively smooth scalped edge (B) extensive cracking on unscalped edge.

Since compositional differences appear to not be the source of slivers, scalping of rolling surfaces should be limited to removing the exudation layer and obtaining a level rolling surface. To reduce mechanical damage and mitigate edge cracking, a potential source of debris, scalping sides before hot rolling is recommended, as it will remove the harder and less ductile exudation layer.

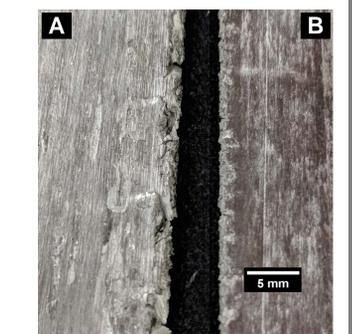
Figure 12: (A) 5182 edge trim from Logan Aluminum compared to (B) the unscalped edge of the transverse sample.
