Edge cracking and edge delamination are phenomena that occur during rolling of 5182 aluminum and cause significant losses for Logan Aluminum. This study investigated the causes of these phenomena as well as ways to minimize or eliminate their occurrence and severity. Simulated rolling experiments, metallography, and material property testing on material at different stages throughout the rolling process showed that edge cracking can be reduced by reducing the reduction speed while rolling.

This work is sponsored by Logan Aluminum, Russellville, KY

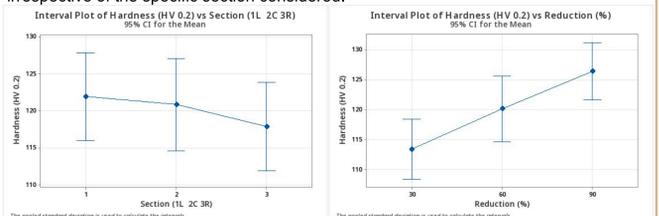
Hardness

The analysis of hardness across different sections reveals a consistent pattern: there is no significant difference in hardness values between the sections themselves. However, there is a notable trend when examining the relationship between hardness and the percentage of reduction. The data visualized in the graphs below indicates that as the percentage of reduction increases, so does the hardness of the material, irrespective of the specific section considered.

For a reduction of 30%, the average hardness measured was 113.44 HV, with a standard deviation of 8.33 HV, and the 95% confidence interval ranged from 108.44 HV to 118.44 HV. When the reduction percentage doubled to 60%, the mean hardness increased to 120.19 HV, accompanied by a slightly tighter standard deviation of 7.25 HV, and a 95% confidence interval stretching from 114.71 HV to 125.67 HV. The most substantial increase was observed at a 90% reduction, where the average hardness further escalated to 126.45 HV, despite a slightly larger standard deviation of 9.47 HV, with the confidence interval lying between 121.64 HV and 131.25 HV.

This pattern is observed in the graphs above, clearly illustrating the direct relationship between the degree of reduction and the resultant hardness of the material across all sections. The graph underscores the consistent increase in hardness with higher percentages of reduction, confirming the observed trend in the numerical data.
