Abstract: Surface cracks in an ASTM A1011 Nb-HSLA hollow steel beam produced via thin-slab casting were characterized to determine their origin and propagation behavior. Optical microscopy (OM), scanning electron microscopy (SEM), and energy-dispersive X-ray spectroscopy (EDS) revealed intergranular cracking associated with subsurface oxidation. Oxygen enrichment was observed along crack surfaces, while no significant enrichment of copper or other elements typically associated with hot shortness were found. The results suggest that oxide-decorated microcracks formed during high-temperature processing in the bending/straightening region of the caster and subsequently reopened during downstream deformation.

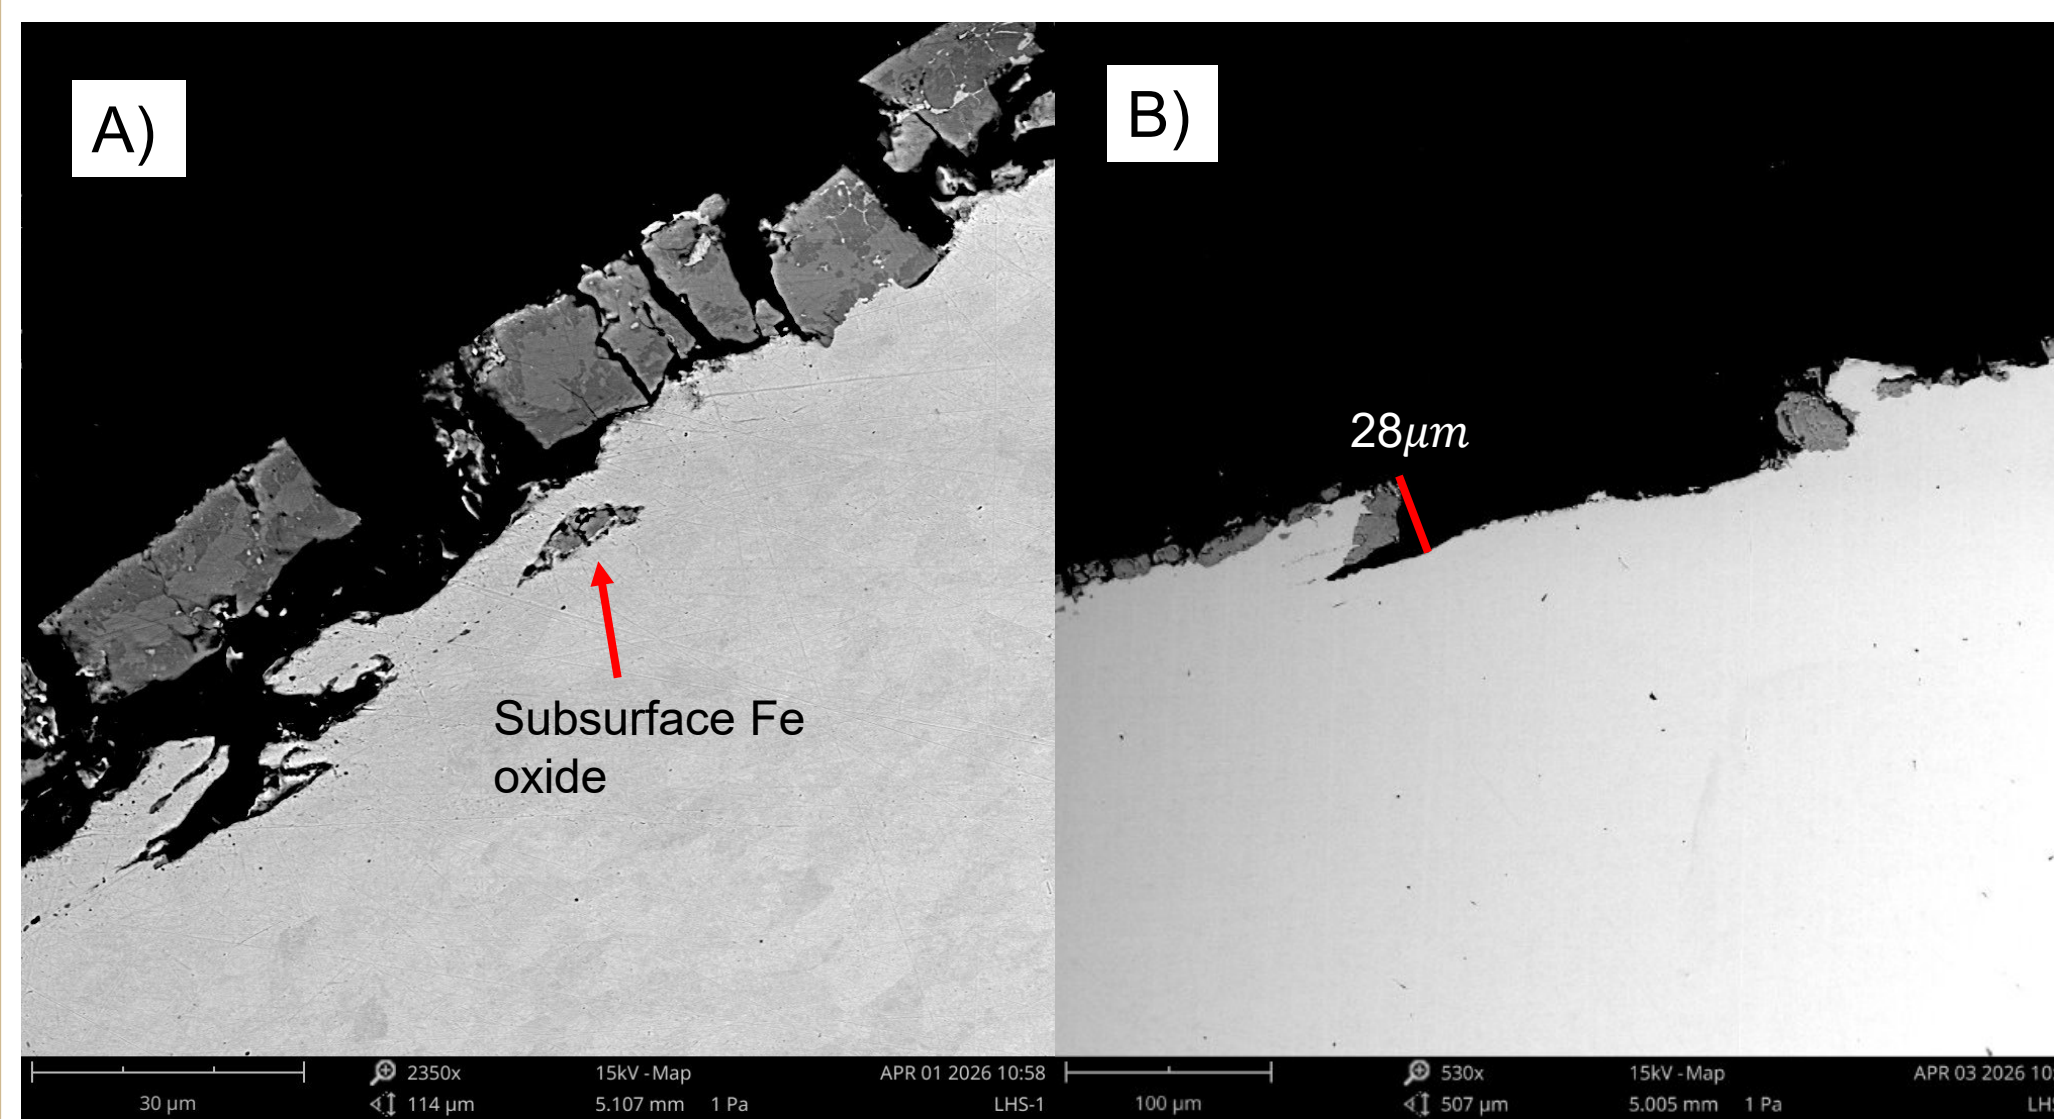
- Subsurface precipitates and oxidation were observed near cracks in the samples exhibiting cracking.

Figure 2. SEM images of the cross-sectional corner region: A) large subsurface oxide, B) crack length annotated for clarity.

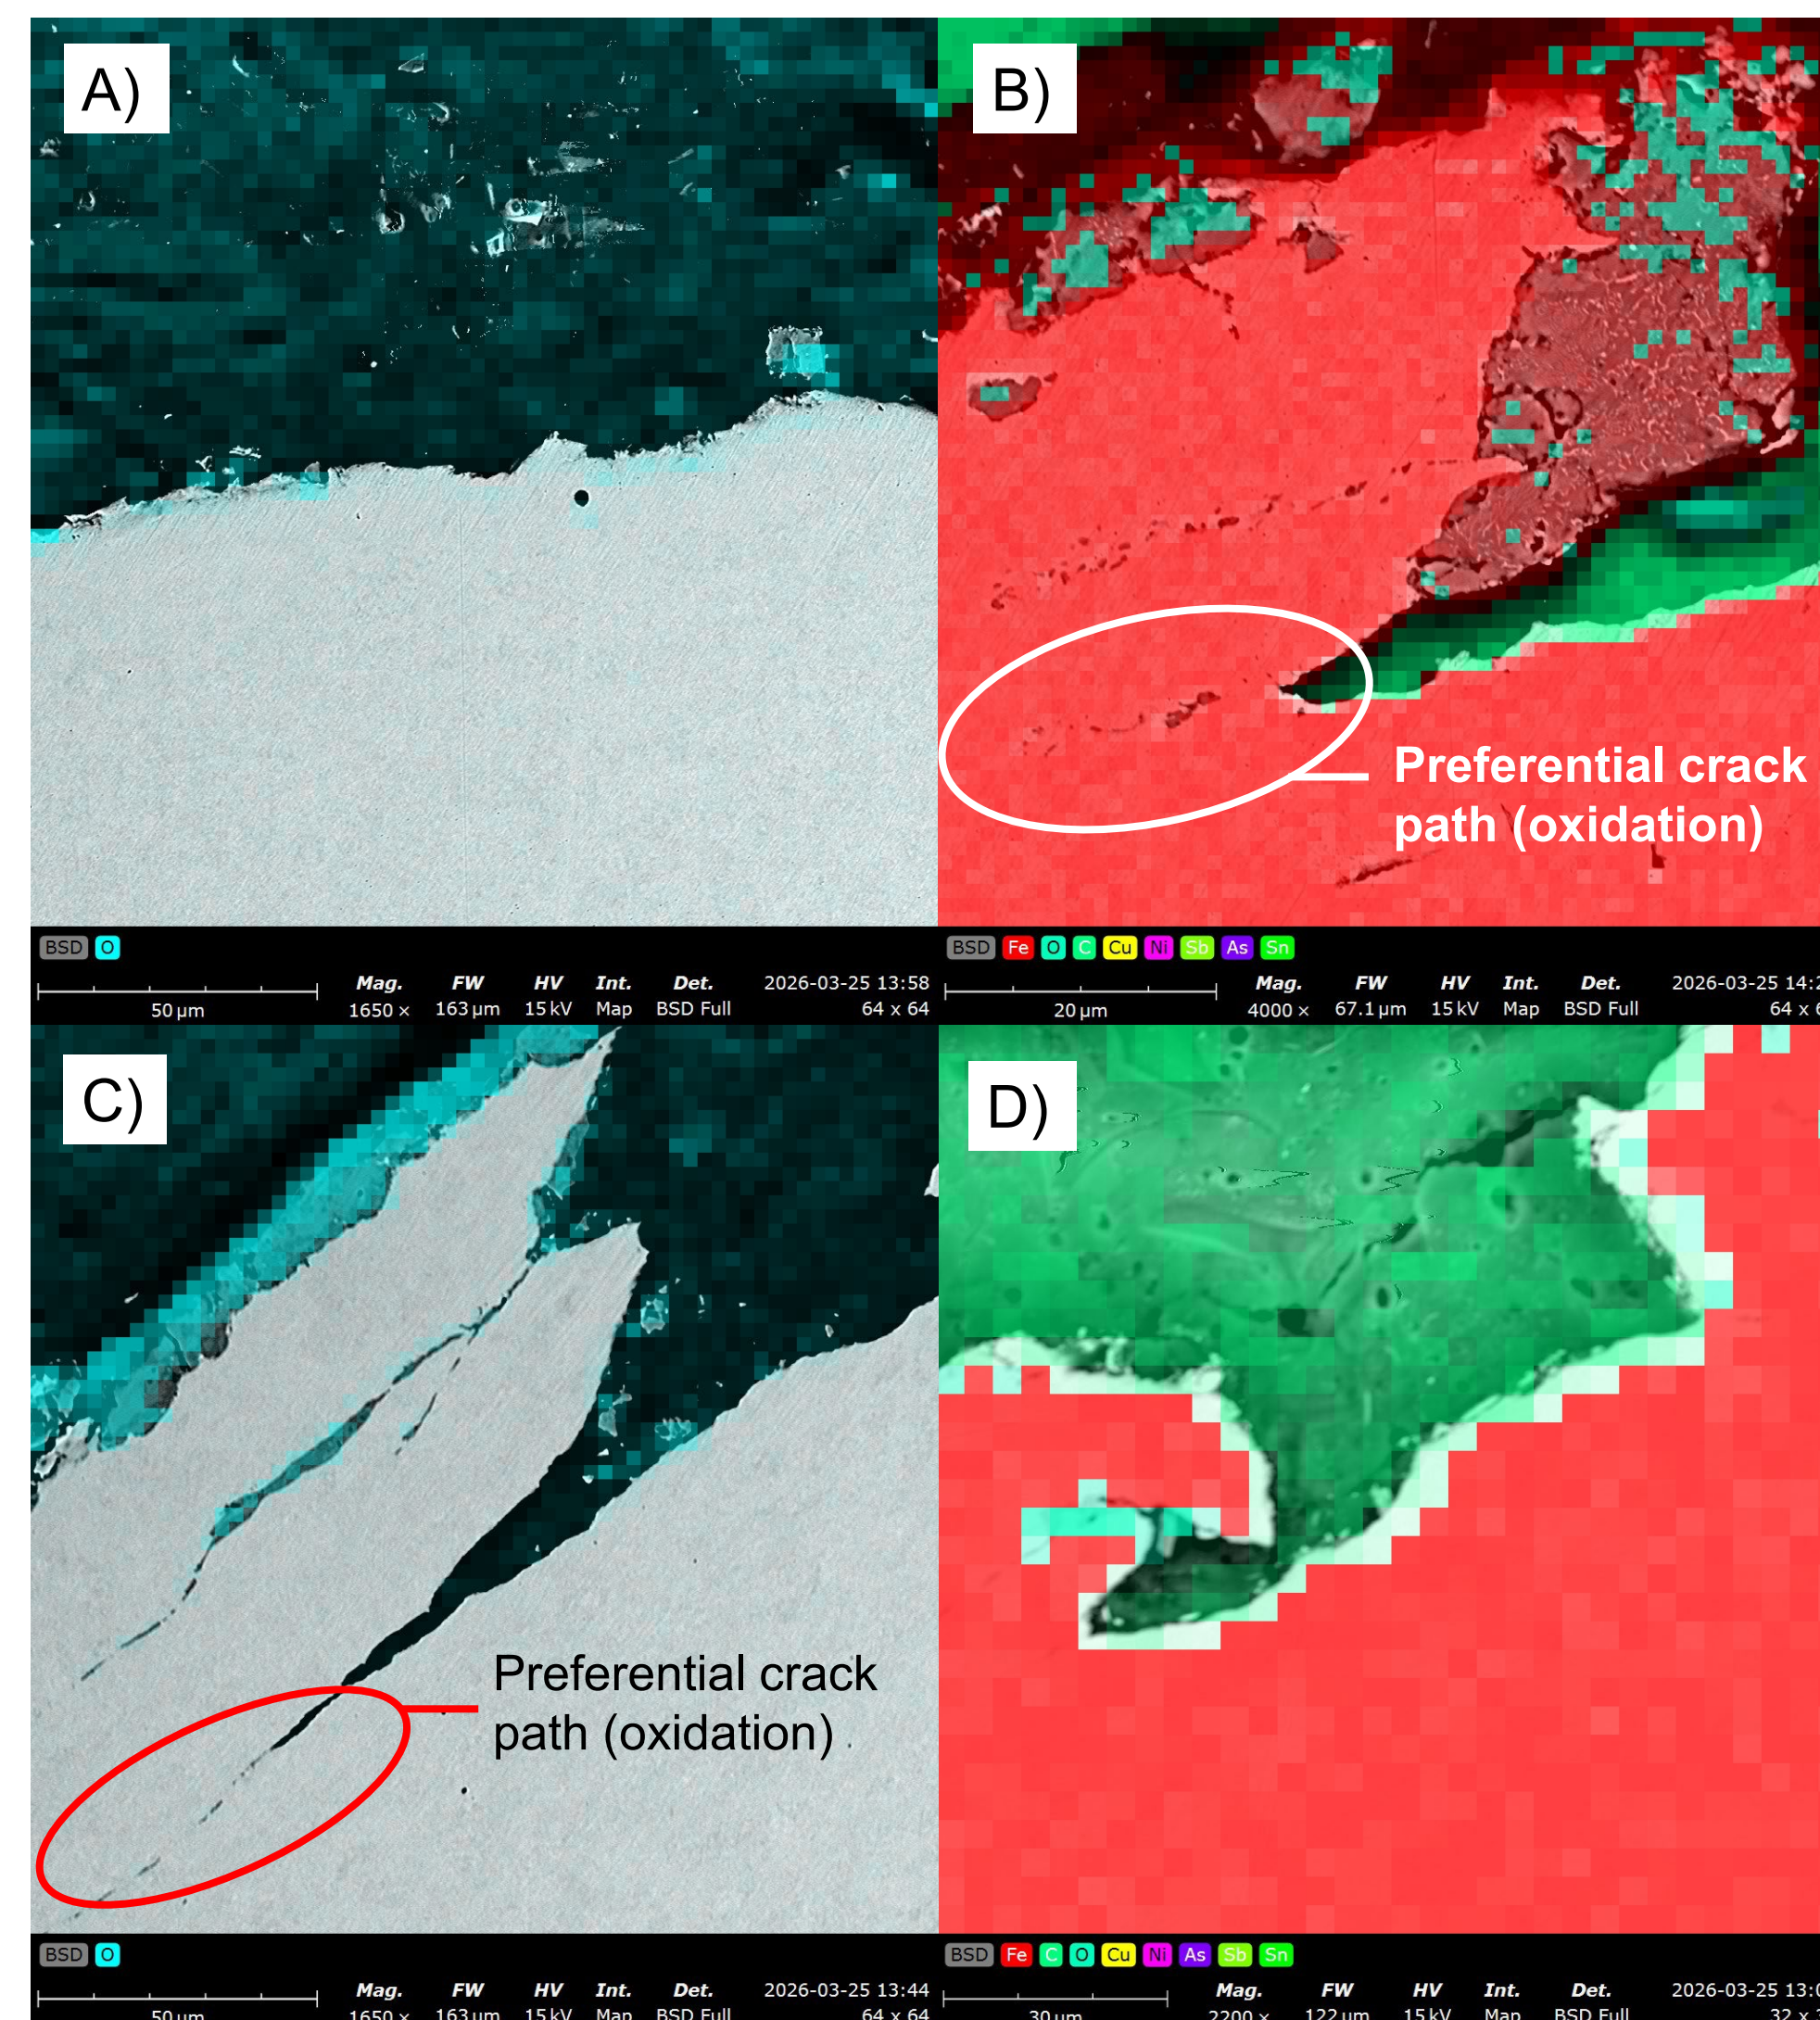
Figure 3. EDS of oxidized cracks: A) Control sample, B) Sample exhibiting subsurface oxidation displaying tramp elements, C) Sample exhibiting subsurface oxidation, D) Sample exhibiting subsurface oxidation showing tramp elements

- Figure 3A) an oxygen mask is overlaid in blue, only surface oxidation is present, no subsurface oxidation is observed
- Figure 3B) oxidation can be observed leading away from the crack laterally. Aluminum Oxide precipitates and oxidation formed below the crack
- Figure 3C) an oxygen mask is overlaid in blue, oxidation can be seen at the surface, in the crack, as well as below the surface of the crack.
- Figure 3D) a mask of tramp elements is overlaid, minor oxidation path can be observed

During downstream deformation, **cracks reopened and propagated along oxidized grain boundaries**, consistent with subsurface oxidation observed along the crack paths in Figures 3B and 3C.

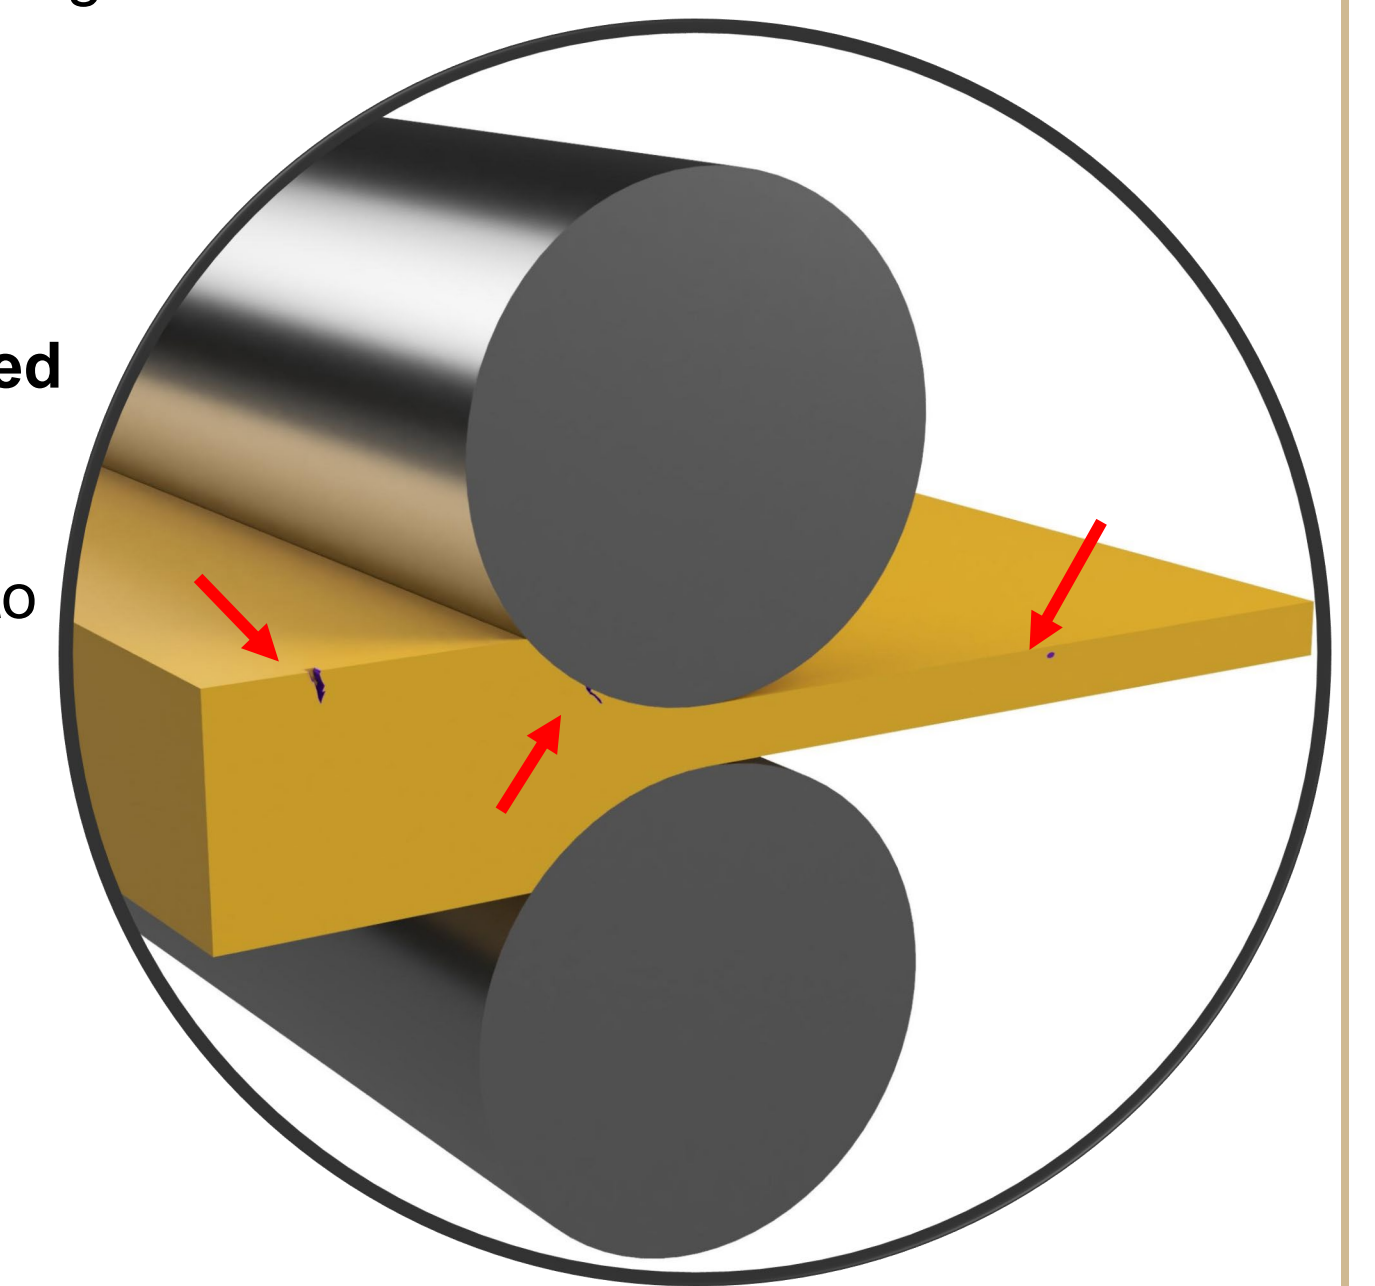
These observations suggested an alternative cracking mechanism. **Microcracks likely formed after casting, during bending and straightening.** Exposed to a high temperature environment, the cracks oxidized, and were subsequently rolled and 'trapped' subsurface, as seen in Figure 4.

Figure 4. Three-dimensional model of how oxide-decorated microcracks form
