First insertion failure of Dual In-line Memory Modules (DIMMs) is a detrimental, industry-wide issue. Potential causes of failure were investigated by analyzing DIMM pins and server sockets with Atomic Force Microscopy (AFM), Scanning Electron Microscopy (SEM), Energy Dispersive X-ray Spectroscopy (EDS), and Optical Microscopy. DIMMs were inserted into servers to test for failures. After testing, contamination was determined to be the most likely failure cause.

Cisco Systems, Santa Clara, CA

Project Description

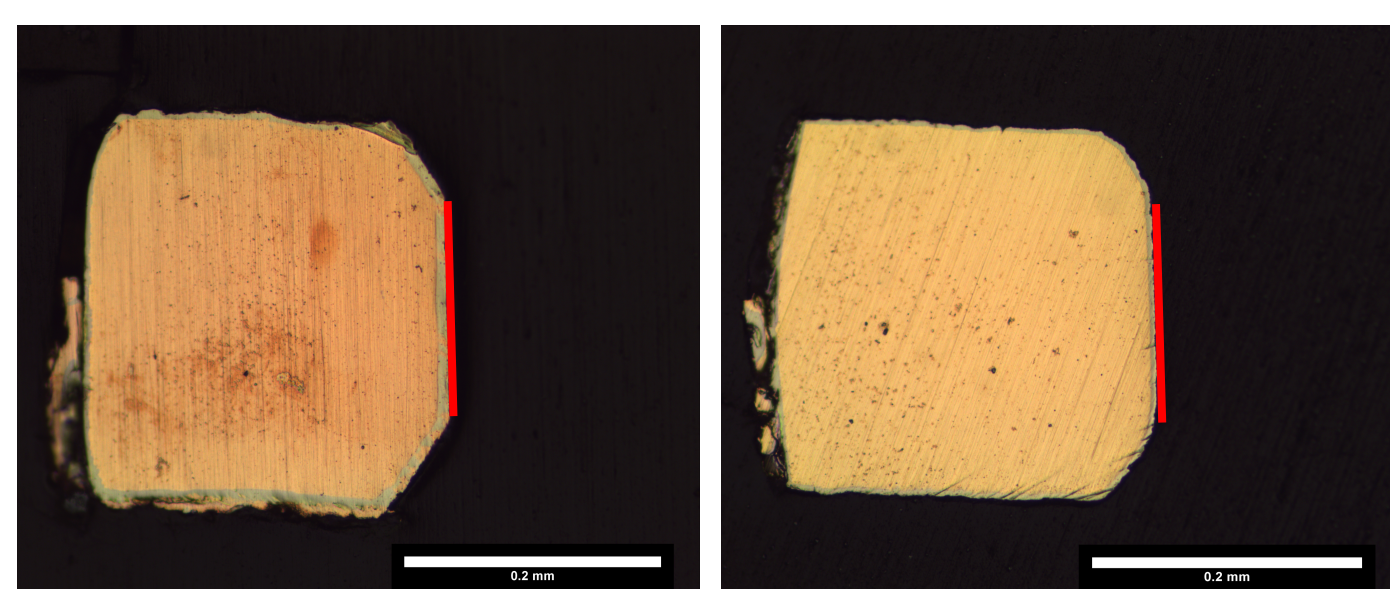
Contact geometry was investigated by comparing cross section images. Supplier 1 uses a sharper angle; no other obvious differences observed. The contact area of Supplier 1 is 6% narrower than Supplier 2.

Cross sections of the springs; Left is from Supplier 1 and right is from Supplier 2. Red line indicates contact area.

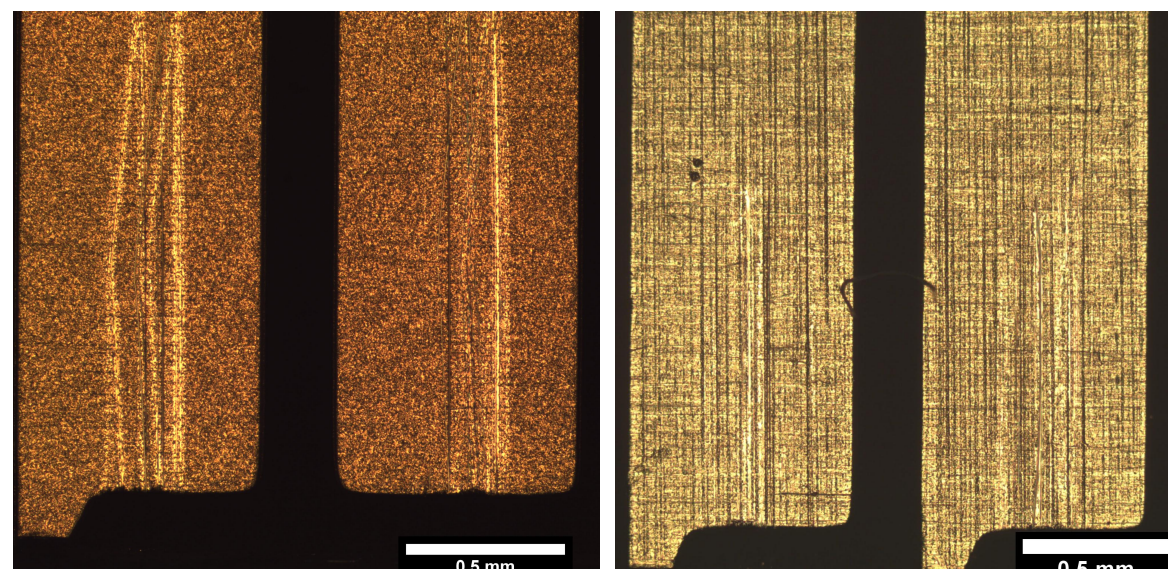
Left: Wipe marks on pins from supplier A
Right: Wipe marks on pins from supplier B

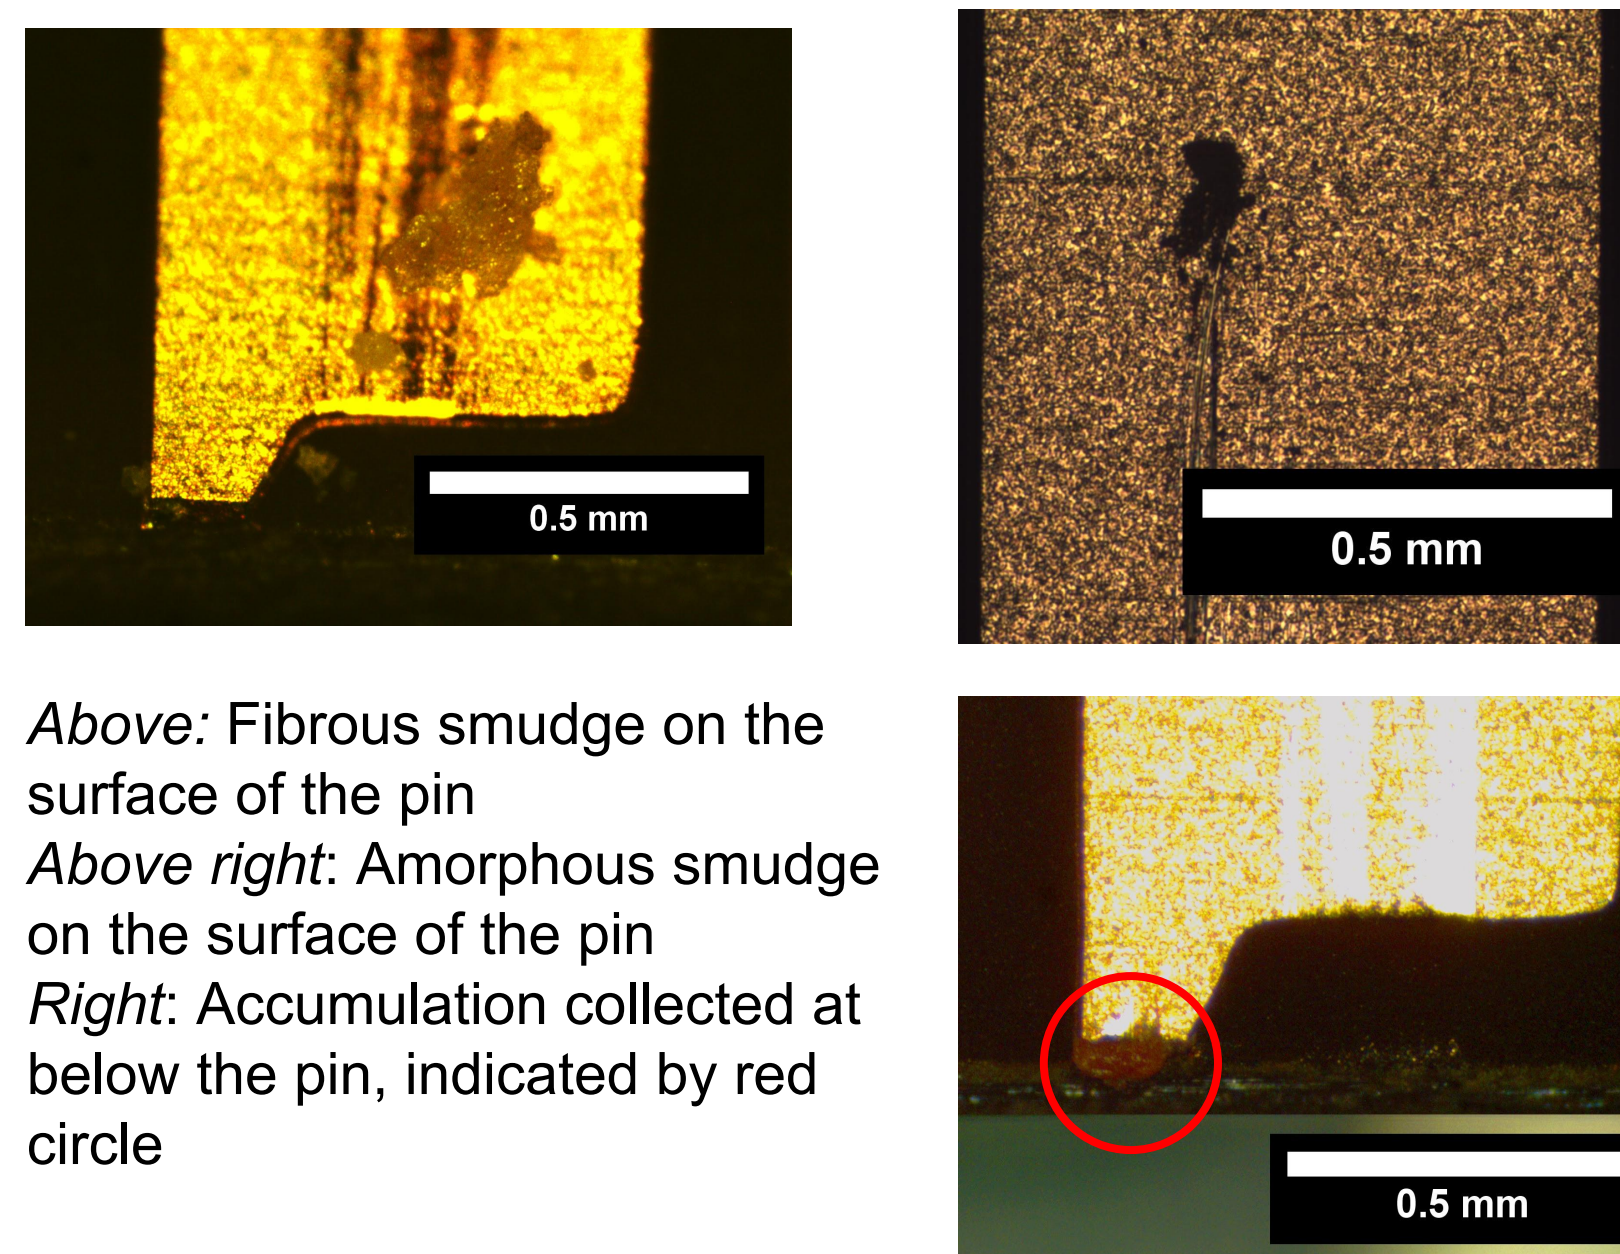
10 DIMMs were thoroughly analyzed, with the remaining 240 briefly scanned. Three abnormalities were discovered:

- Fibrous smudges
- Amorphous smudges
- Accumulation on the bottom of pins

Accumulation occurred on up to 40% of the pins of some DIMMs. Smudges appeared less frequently, only one or two on occasional DIMMs.

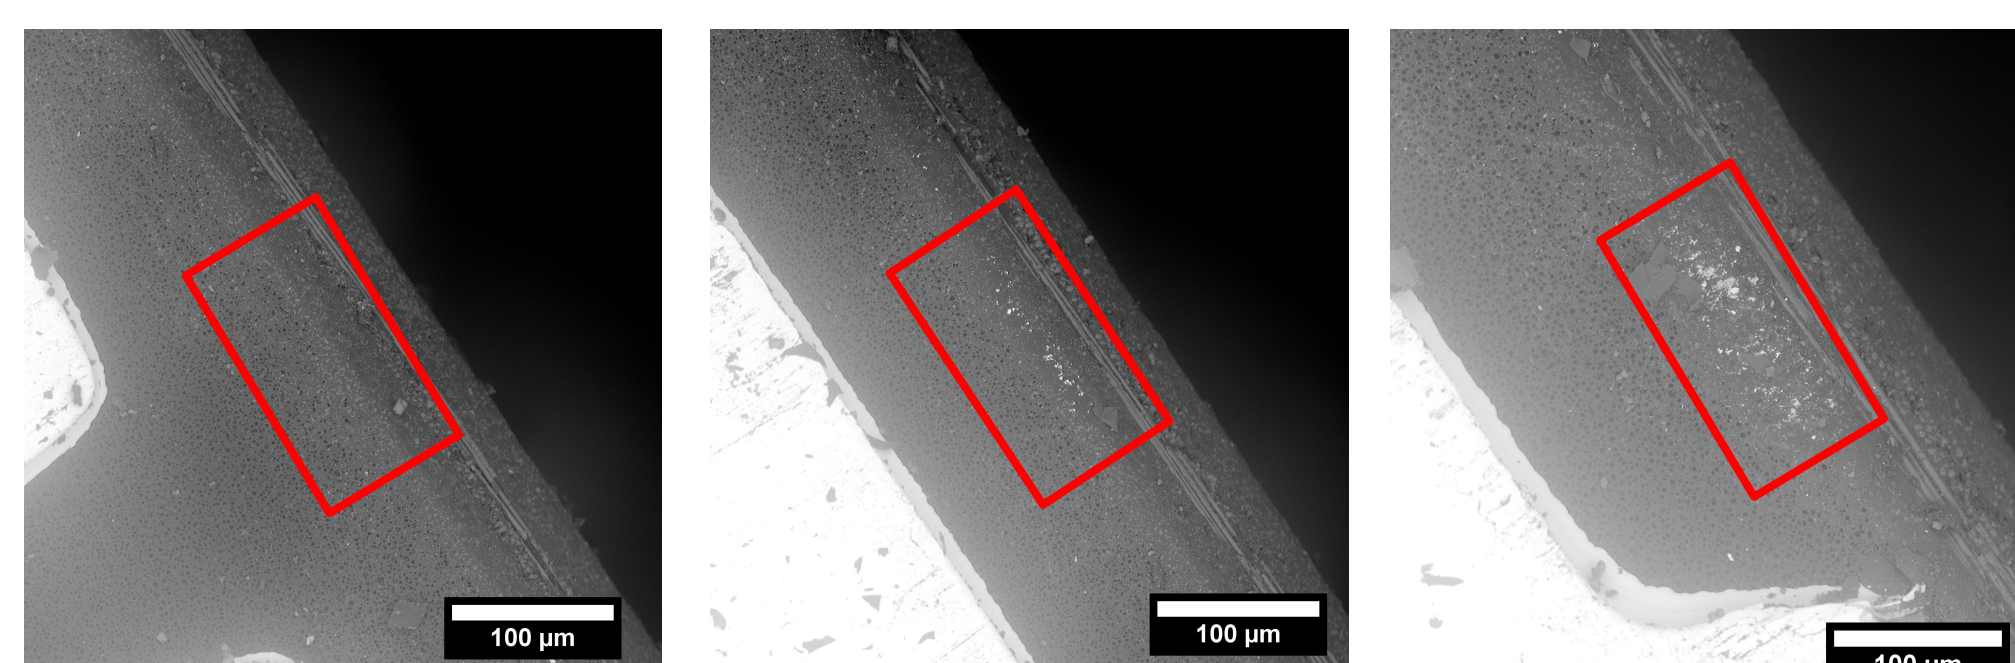
Optical Microscopy revealed changes to the board below the pins during insertion. SEM was used to further investigate their origin. The size and location of these board features indicate that the source is the socket springs.

Left: No feature on edge of board below the pin
Middle: Minor feature on board with some gold particles
Bottom: Major features on board with large amount of gold particles

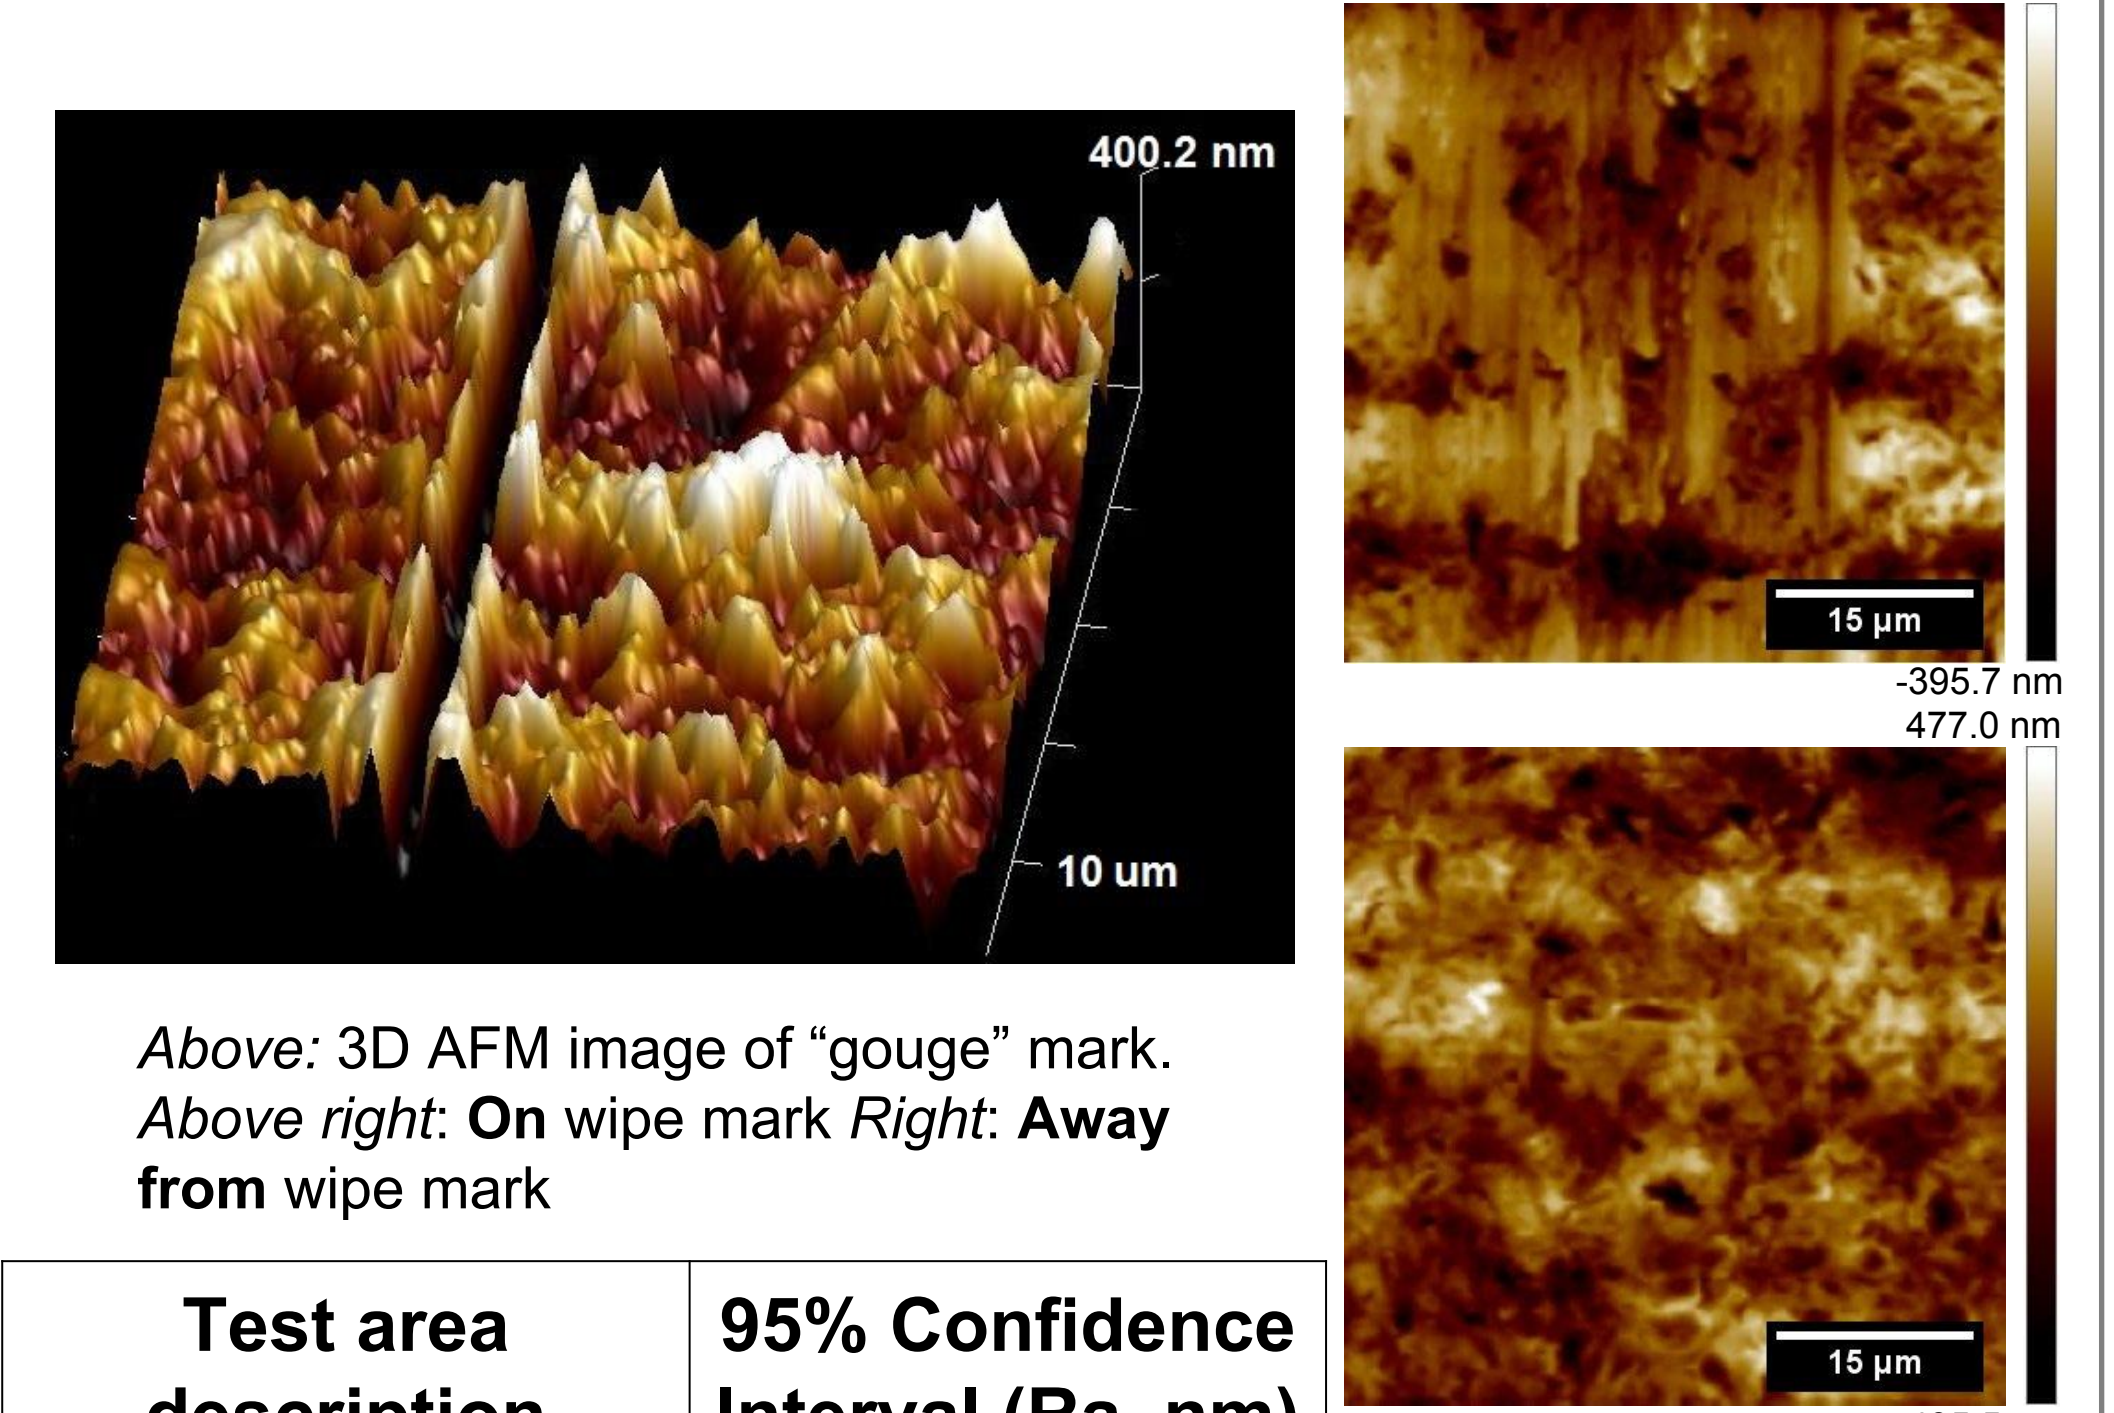
Test area description	95% Confidence Interval (Ra, nm)
Away from Wipe mark	91.7 to 97.3
On Wipe Mark	89.8 to 103.4
Failed DIMM	91.1 to 96.5
Supplier B away from wipe mark	143.0 to 170.6

Left: AFM Roughness (Ra) results (equation below). All values are in nm and from Supplier A DIMMs unless indicated otherwise.

The roughness analysis indicated no significant difference in Ra on and away from wipe mark areas, indicating that the morphology of these areas is not a large influence on failure.

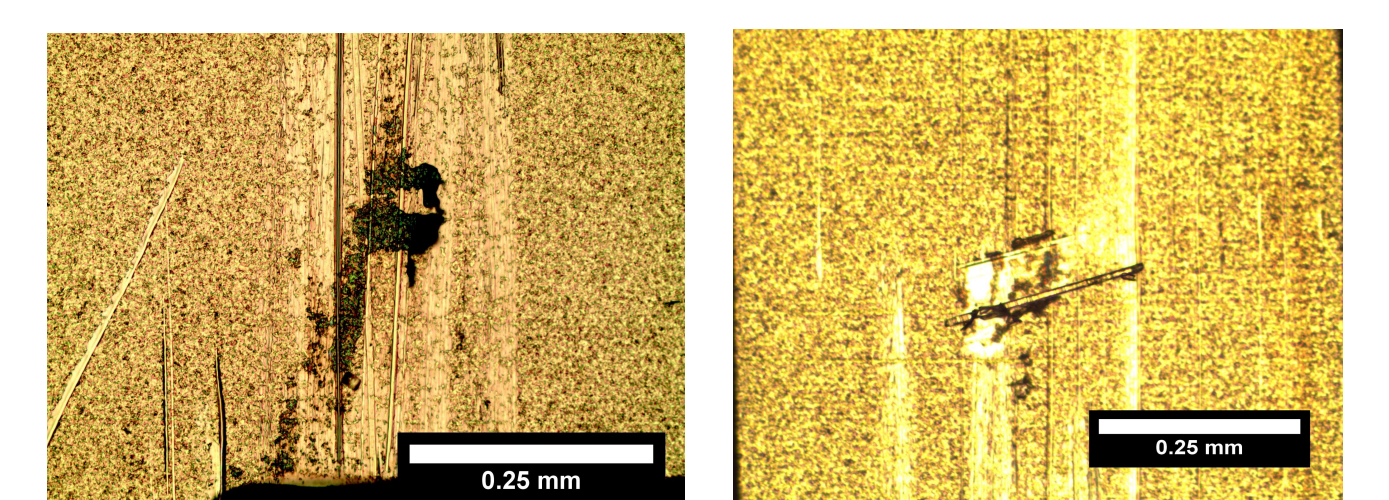
Contamination is the most likely cause of failure.

- ☐ Amorphous smudge (A/1) - Failed on first insertion
- ☐ Fibrous smudge (A/2) - Failed on third insertion

Left: Amorphous smudge found on failed DIMM (A/2)
Right: Fibers found on failed DIMM (A/1)

- These smudges were not present prior to insertion
- Both these foreign materials occur in the area where the spring makes contact with the pin
- Their presence indicates that the failure is due to a physical blockage of the electrical contact.
- Failure after multiple insertions indicates that failures due to contamination interfering with the electric connection

After concluding that contamination from smudges is the most probable cause of failure, we recommend investigating this further with a larger scale experiment. Cleaning the pins or sockets may improve insertion results and reduce failure rate.
