The purpose of this project was to develop a materials failure analysis protocol to identify the root causes of failure in high power battery packs tested at the BIC under accelerated conditions. Plausible mechanisms were identified through examination of electrical measurements taken during charge/discharge cycling and post-test materials characterization. A combined analysis suggests that high charging rates can lead to degradation of the electrolyte which reduces battery lifetime.

This work was sponsored by the Battery Innovation Center.

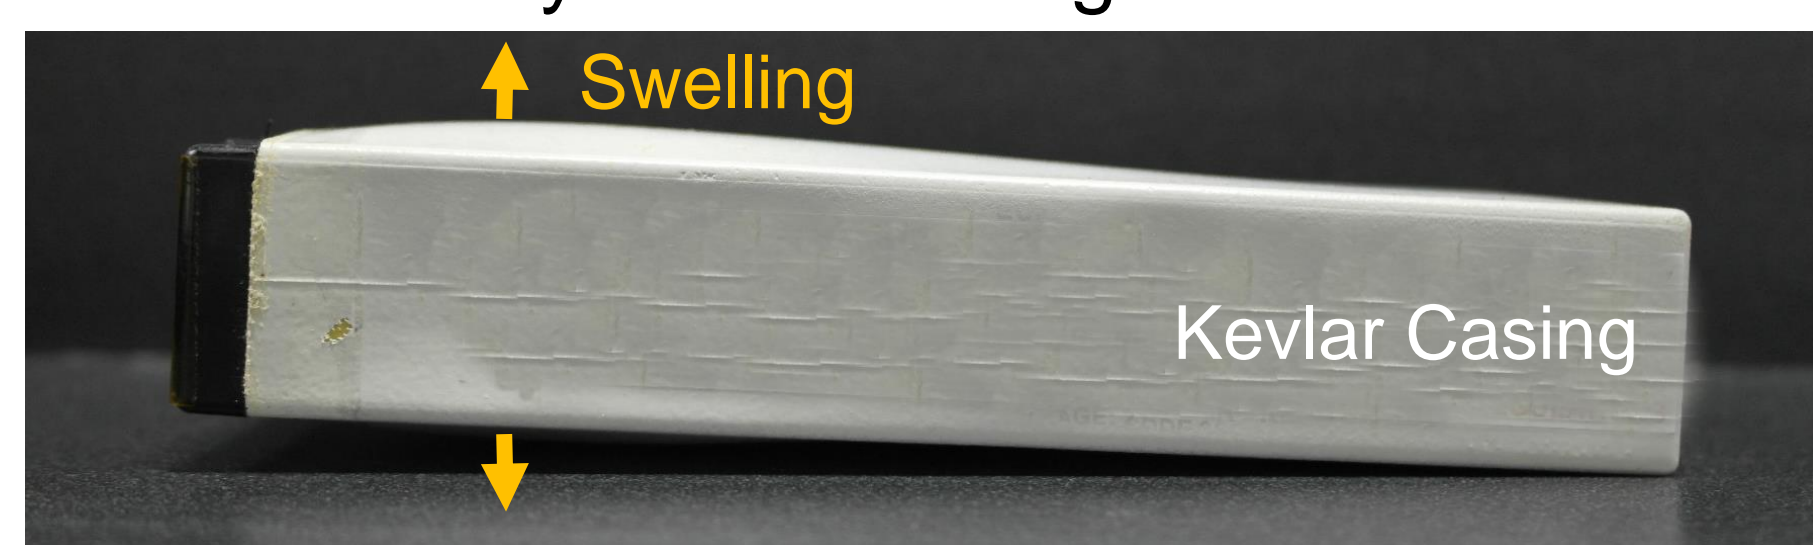
Photograph of swollen battery pack

A customer of the BIC reported swelling of their high-power battery packs during field use. Battery swelling presents considerable danger: the evolved gases inside the battery are often flammable and can be easily ignited.

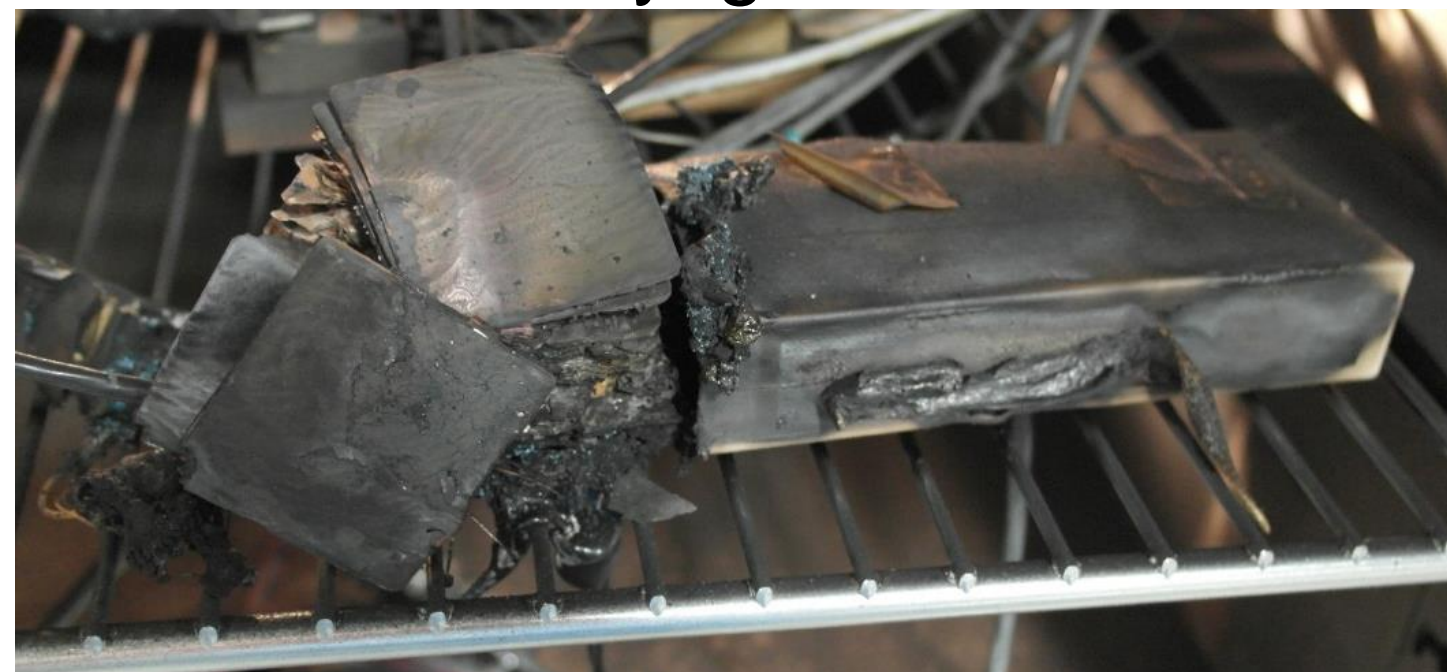
Photograph of a battery pack after a “thermal event”, where it is expected that a spark caused by a short circuit ignited the battery electrolyte.

It is expected that a spark cause by a short circuit in Pack B caused the electrolyte to ignite.

The charge rate for the battery packs should be decreased, and the minimum discharge voltages of each of the cell pairs should be periodically measured. Battery packs that consistently show discharge voltages below 2.8 V should be replaced. Finally, active cooling of the batteries during charging is recommended.

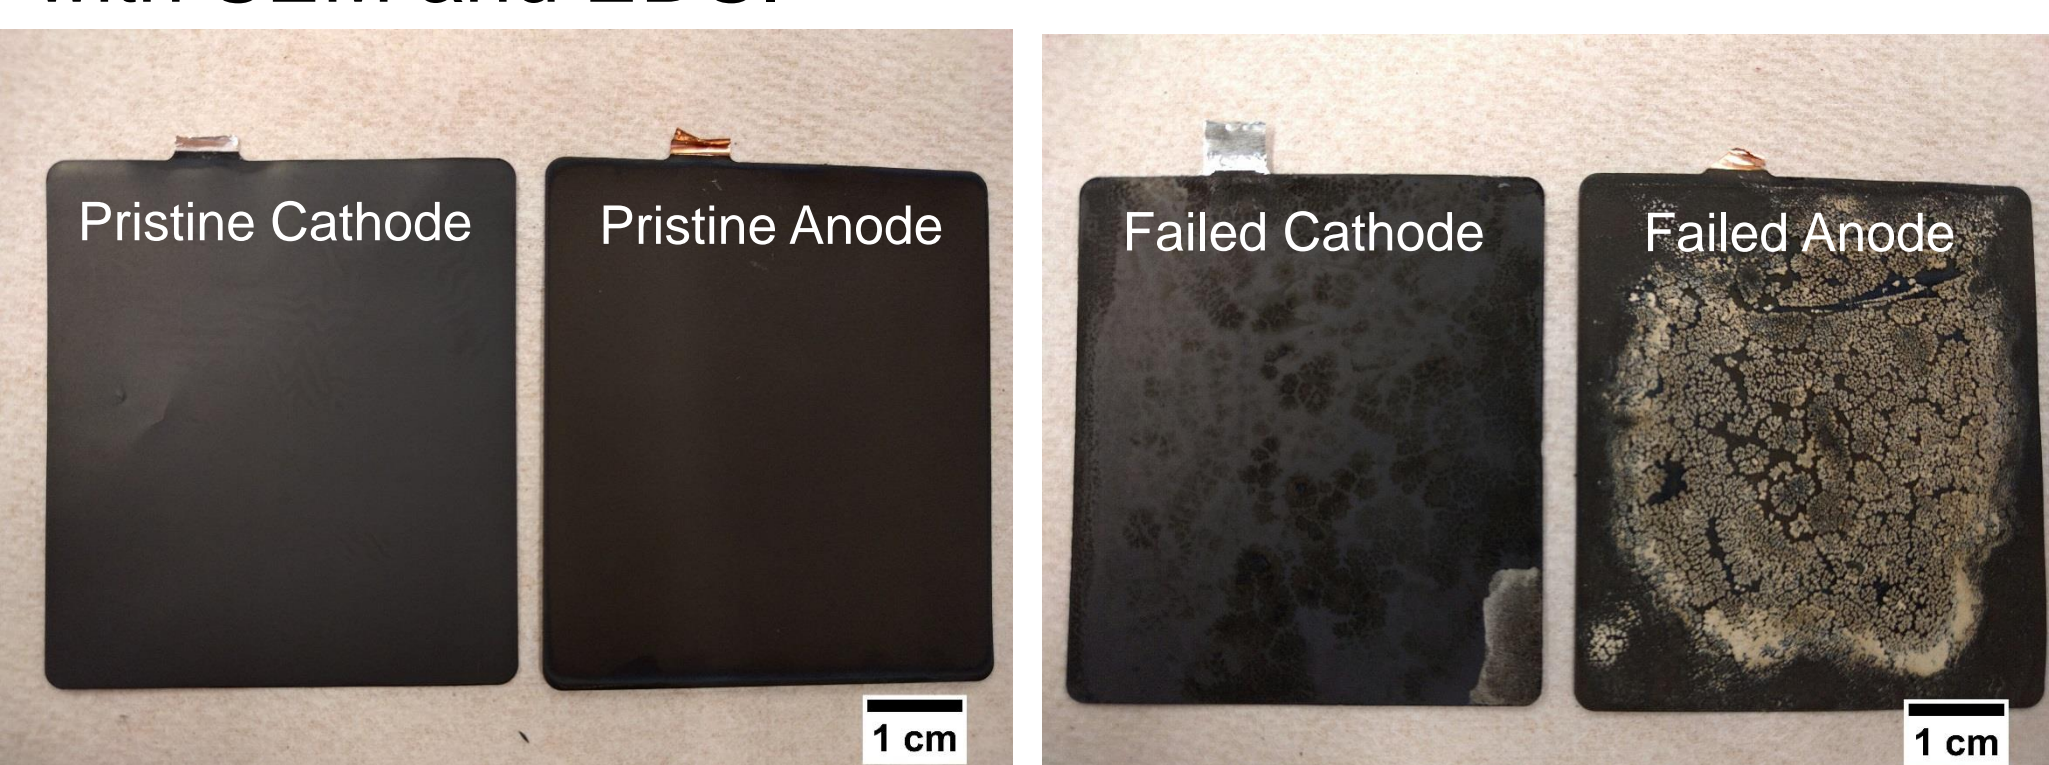
Photographs of pristine and failed electrodes. The failed electrodes were taken from a battery that was visibly swollen

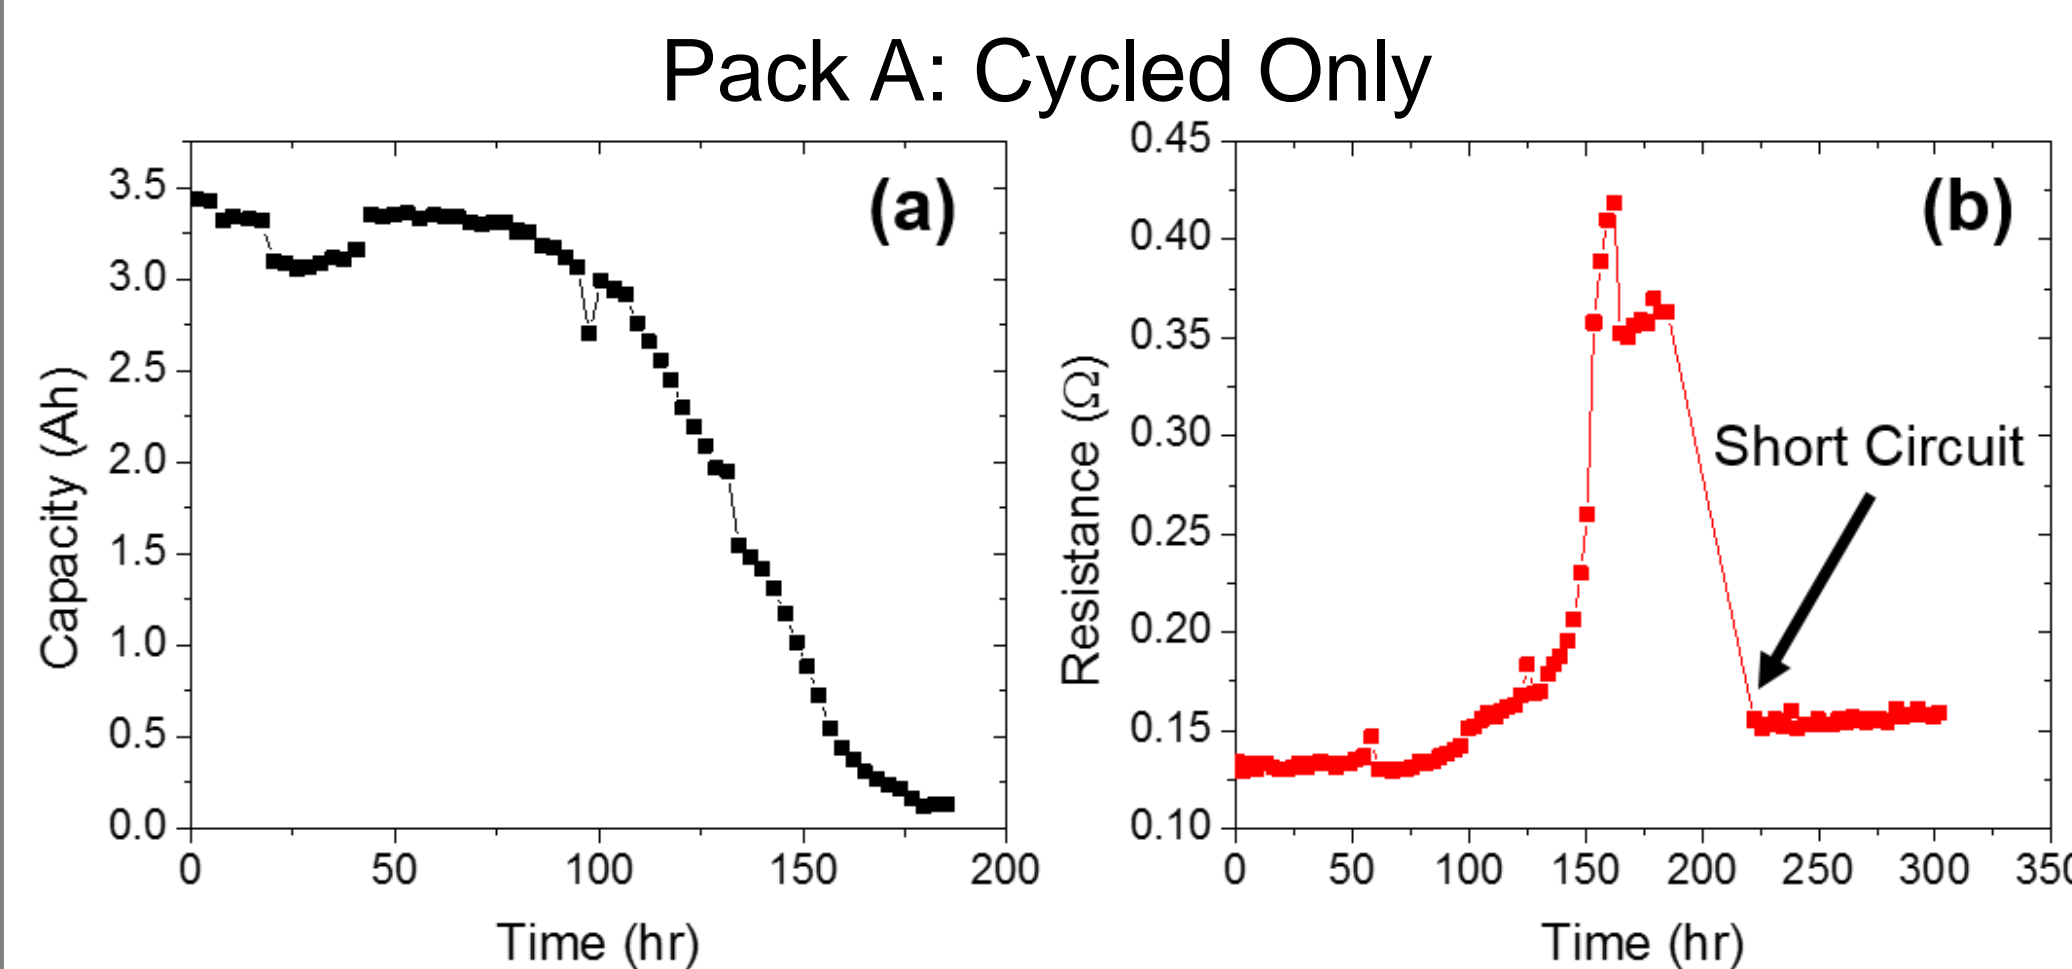
(a) Capacity fade and (b) corresponding resistance increase for a swollen battery pack. As the capacity decreased to zero, the resistance reached a peak before dropping due to a short circuit. Lithium dendrites are a common cause of short circuits in Li-ion batteries.

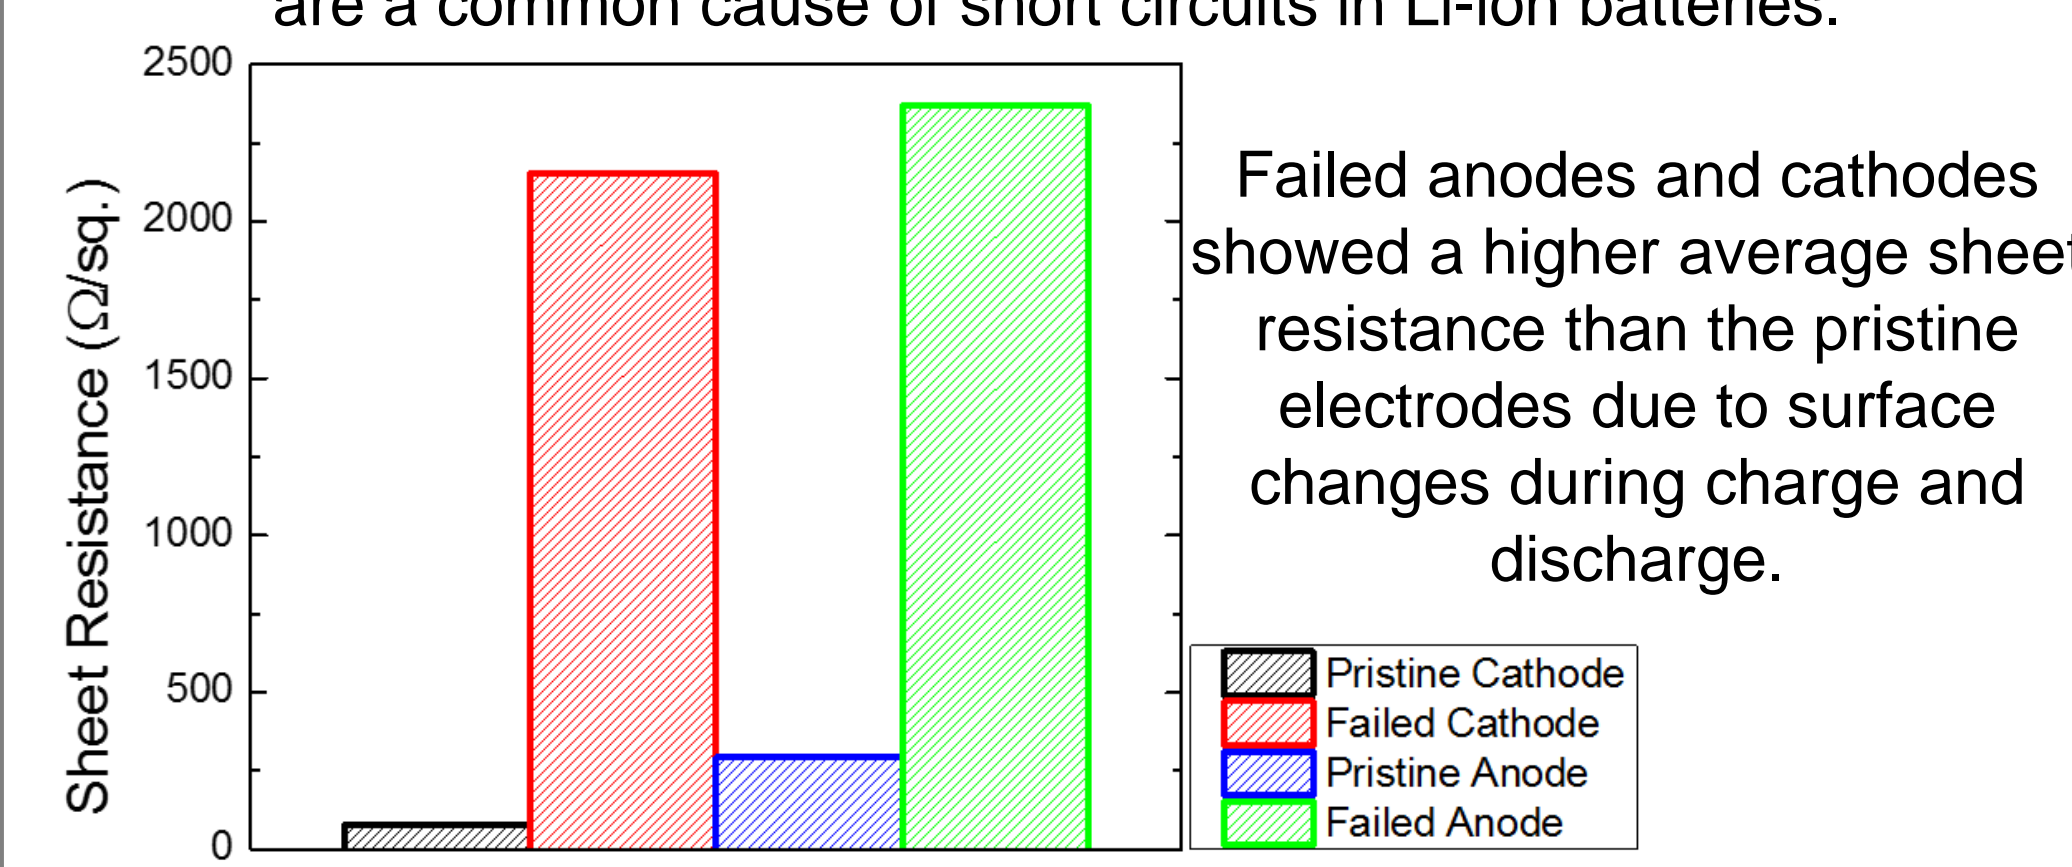
Failed anodes and cathodes showed a higher average sheet resistance than the pristine electrodes due to surface changes during charge and discharge.

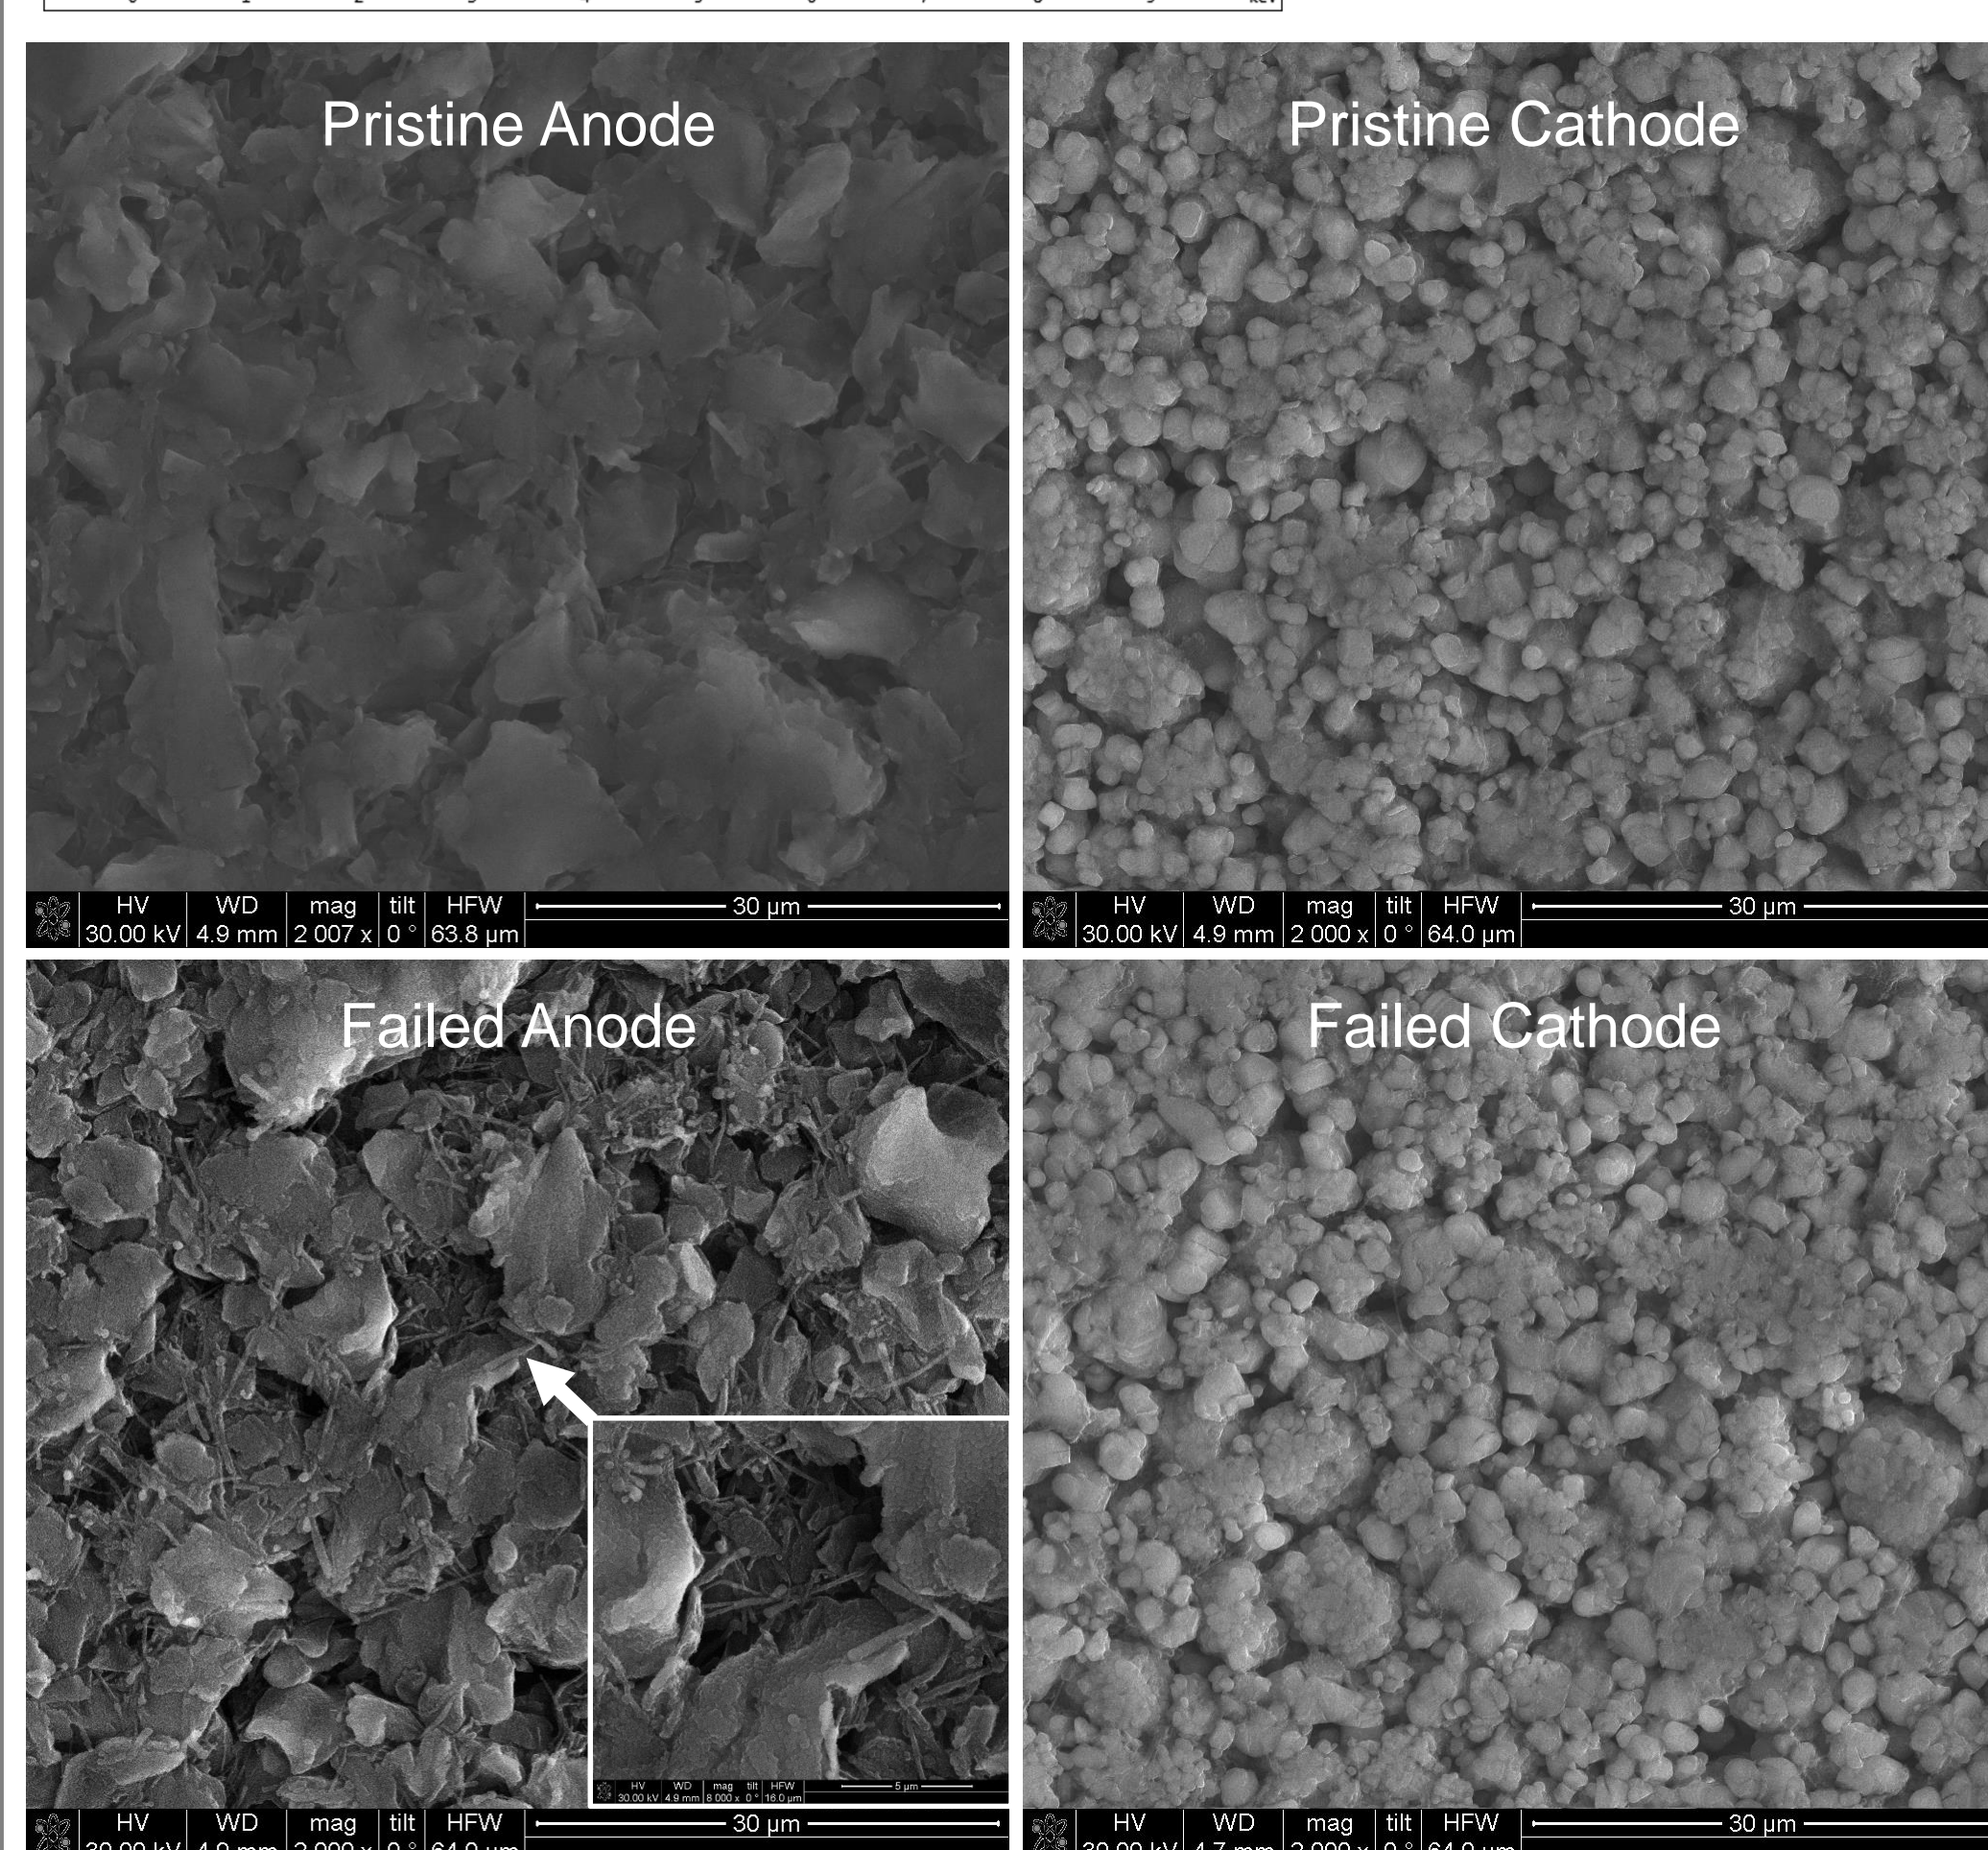
Comparison of failed and pristine battery electrodes. No notable difference existed between the failed and pristine cathodes, but the failed anodes exhibited needle-like particles, possibly lithium dendrites.

SEM and EDS results suggest that gradual battery failure is related to **electrolyte degradation** and/or **lithium dendrite growth** [1].

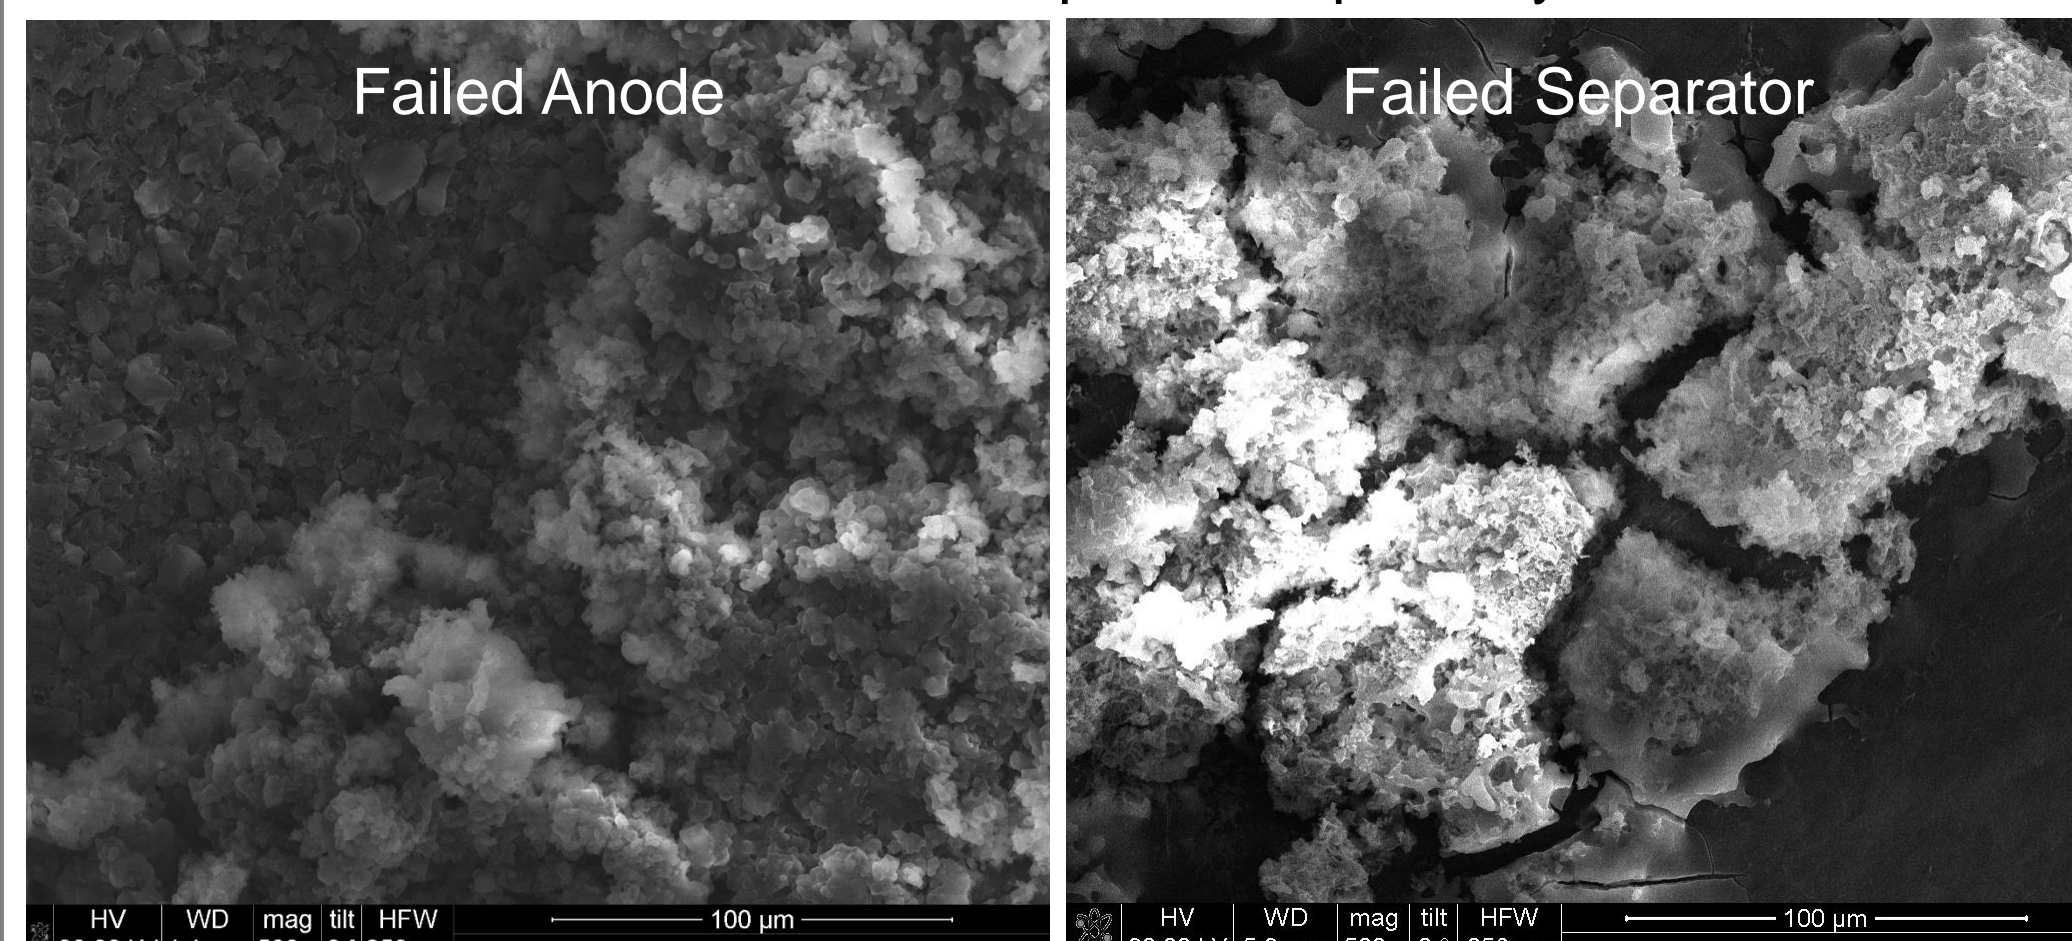
Failed anode and separator material contained clusters of oxide particles. EDS identified oxygen, fluorine, and phosphorous as the main components of these particles.

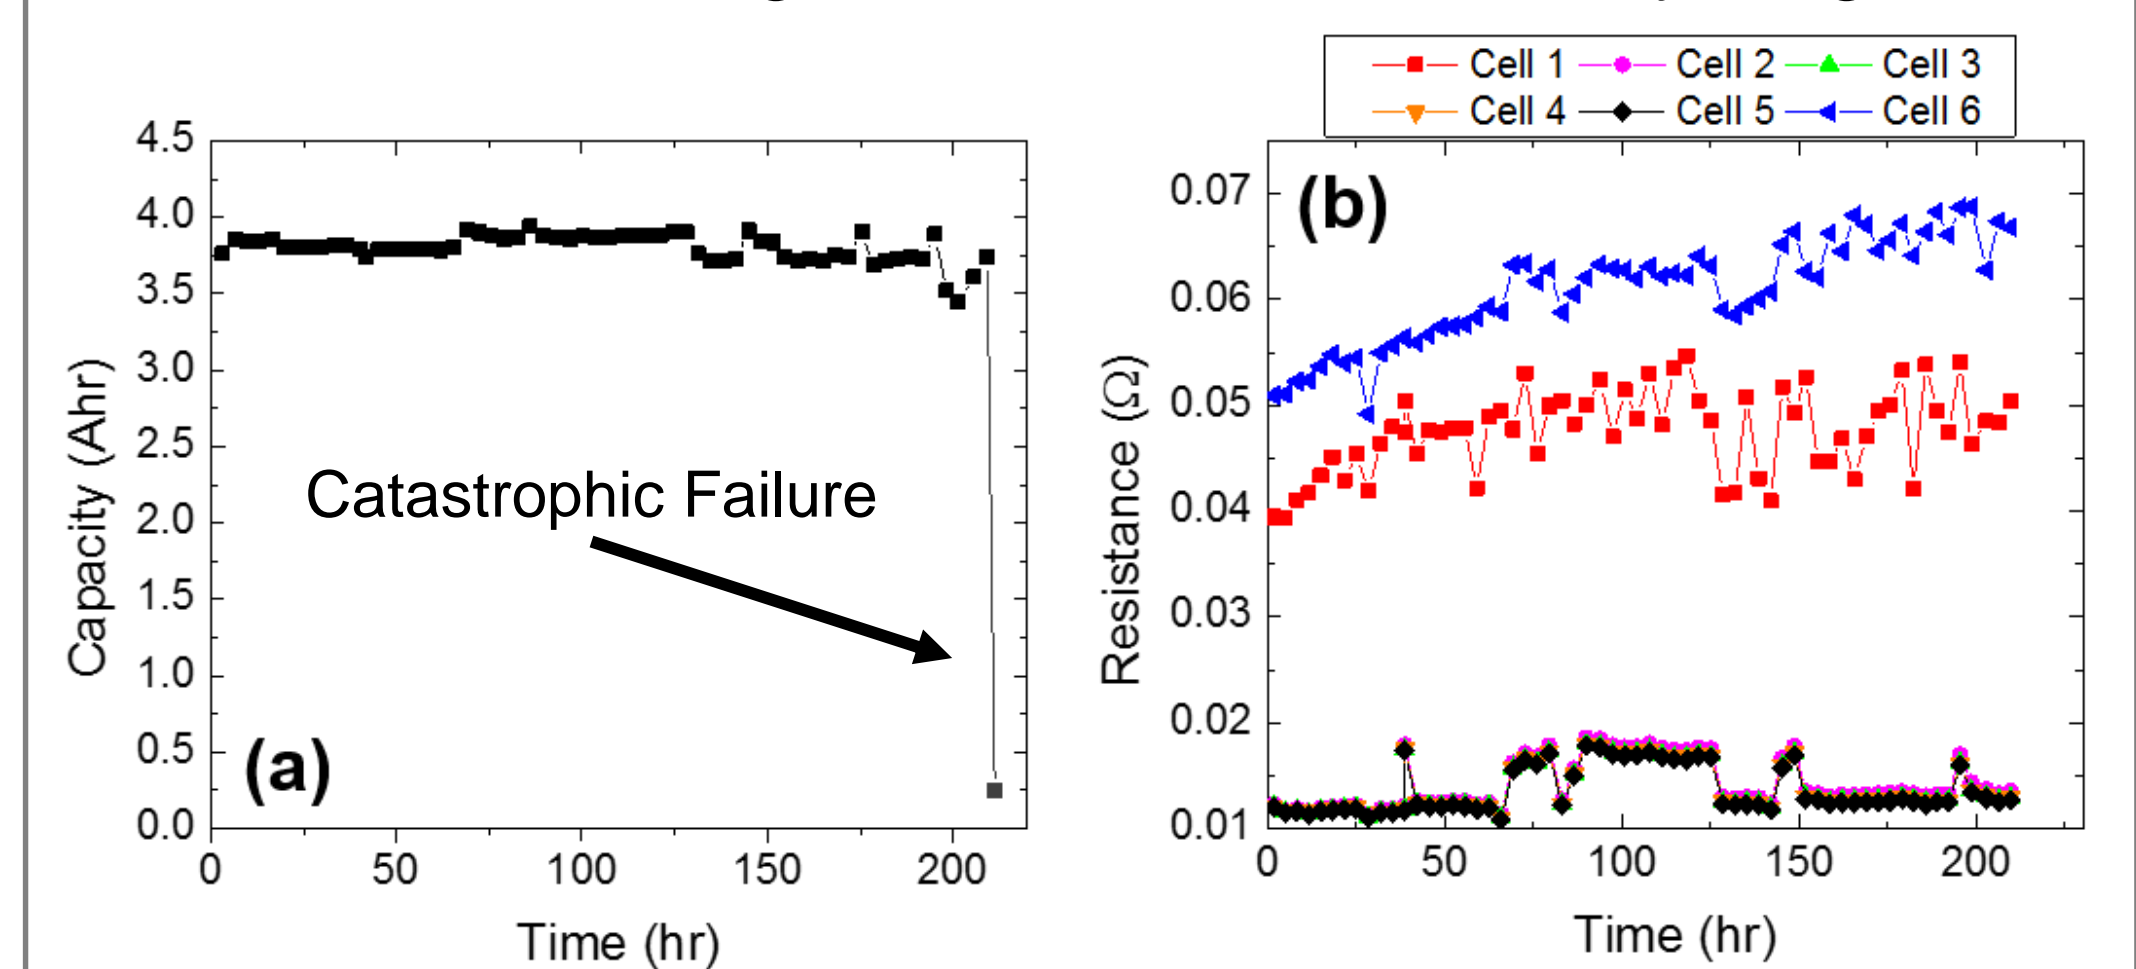
Pack B: Aged 6 Months Prior to Cycling

(a) Battery capacity and (b) corresponding resistance increase for a battery pack aged at 100% state of charge for six months before being cycled. Unlike the swollen pack, this battery did not show capacity fade or a dramatic increase in resistance.

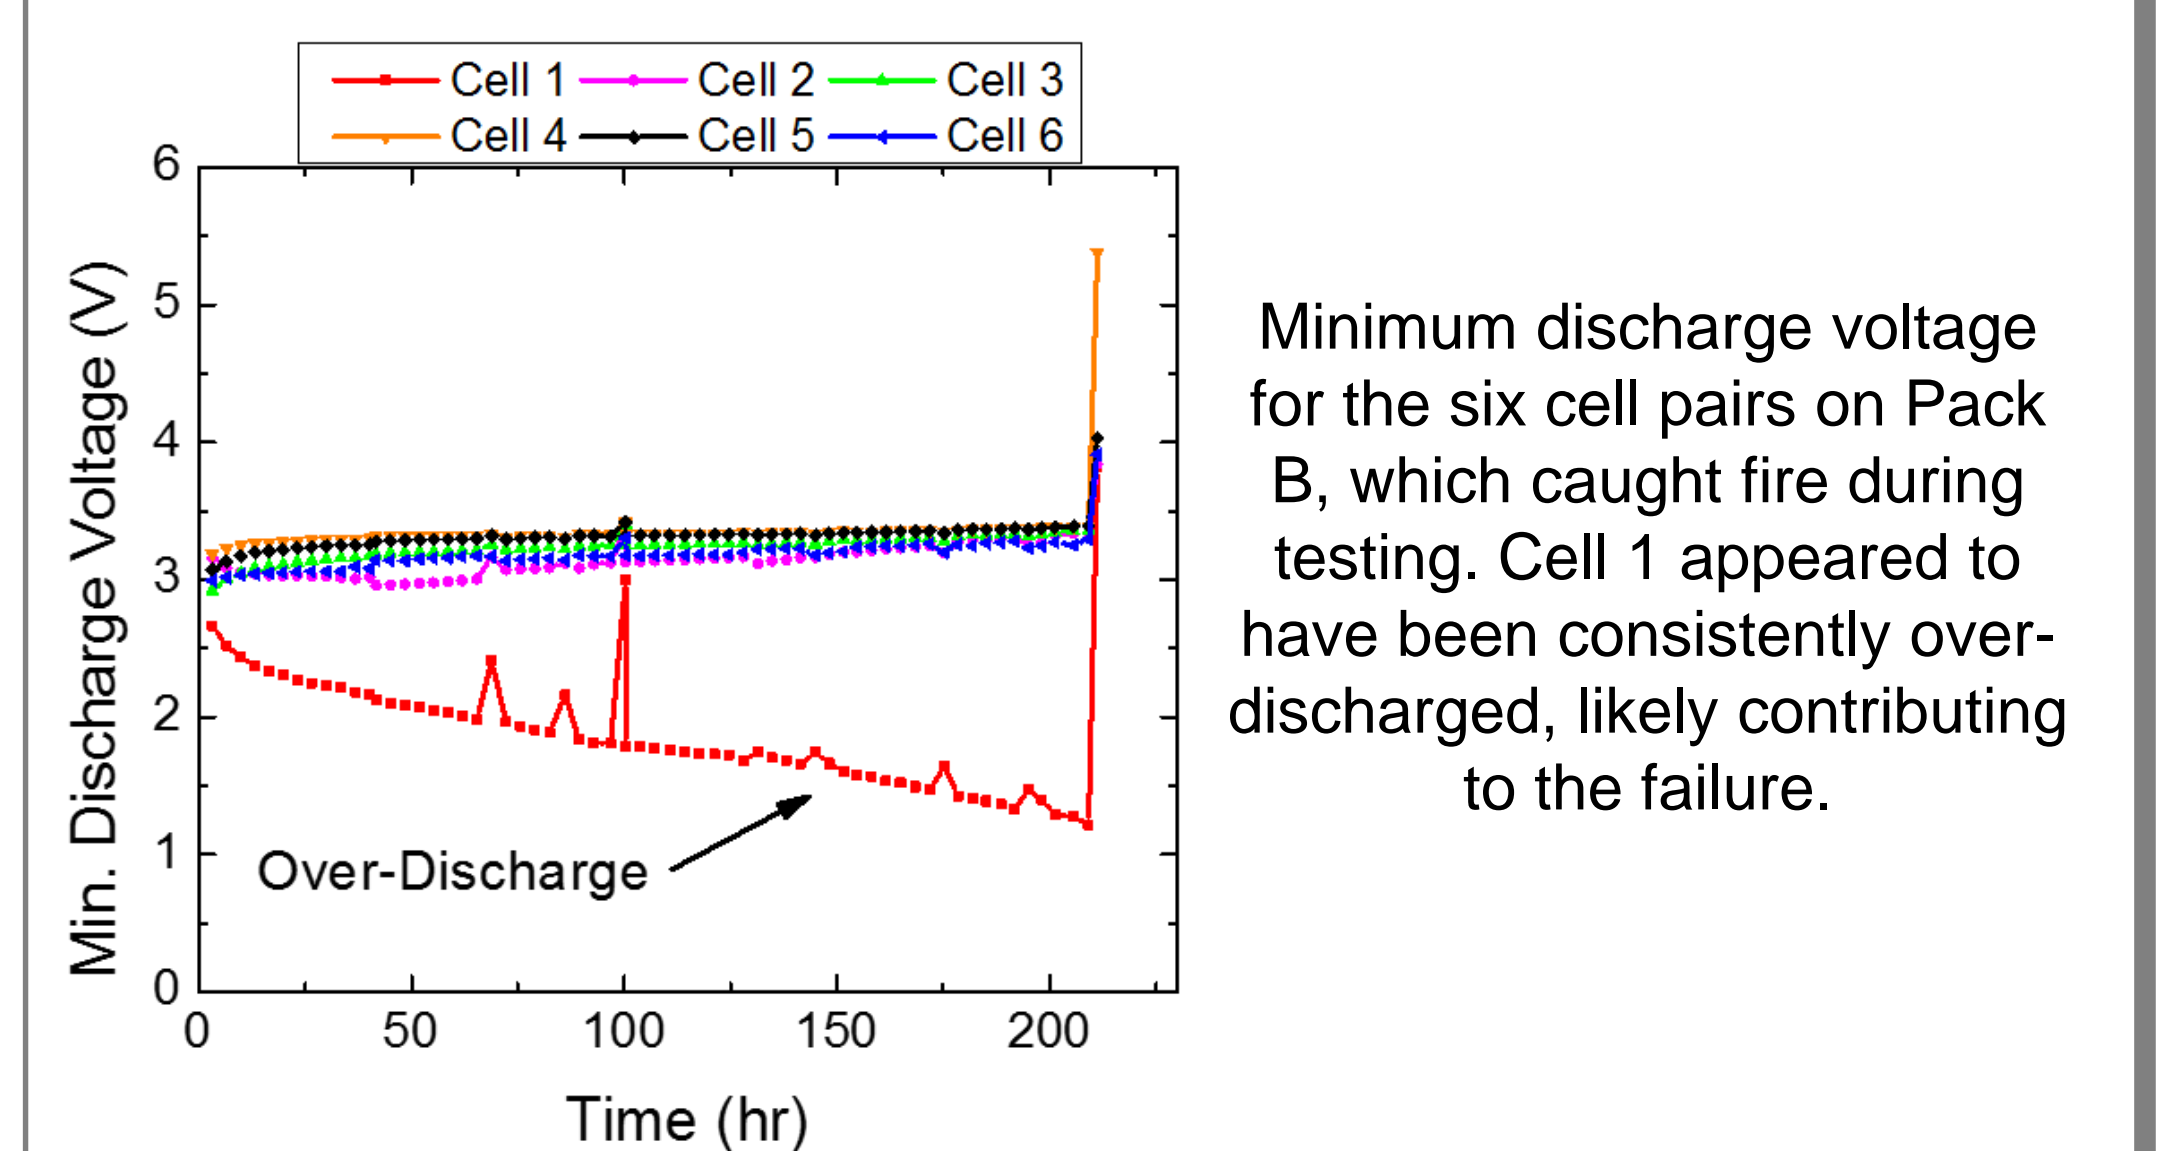
Minimum discharge voltage for the six cell pairs on Pack B, which caught fire during testing. Cell 1 appeared to have been consistently over-discharged, likely contributing to the failure.

Over-discharge of a battery (discharge below 2.8 V) can cause **dissolution of the copper current collector** at the anode. As the battery is recharged, the dissolved copper can precipitate out of the electrolyte and aggregate into deposits, possibly **short-circuiting the battery** [2].

The charge profile imposes a current of 2.5 A on each pouch battery, which is about **30% higher than the maximum charge current recommended by the manufacturer**. Moreover, the charge takes place at an elevated temperature, which accelerates battery degradation. This was likely to be a factor in the failures of both Pack A and Pack B.

The duration and temperature at which Pack B was aged before being cycled also exceeded the manufacturer’s recommendation, possibly contributing to the sudden failure of the pack.
