The formation of non-transformation products and grinder burn on heat-treated steel gears is a serious problem for John Deere. These defects reduce hardness, residual compressive stresses and fatigue life, increasing scrap costs. John Deere has suggested shot peening as a possible way to restore mechanical properties. Shot peening induces compressive residual stress into the gears, potentially undoing the damage caused by grinder burn. Residual stress, metallography and microhardness measurements were conducted on gear samples provided by John Deere in order to recommend whether or not John Deere should pursue the shot peening approach.

This work is sponsored by John Deere, Waterloo, IA

## Project Background

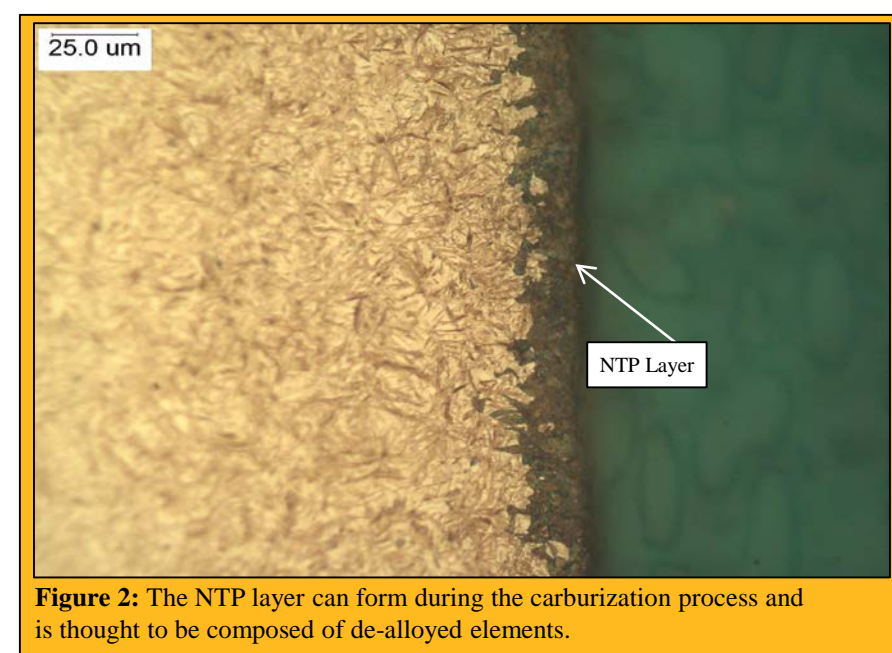
Figure 2: The NTP layer can form during the carburization process and is thought to be composed of de-alloyed elements.

During the carburization heat treatment process, softer non-transformation products (NTP) are sometimes formed on the gear surface. This NTP layer is thought to result from de-alloying during carburization. If any NTP affected zone measures deeper than 25  $\mu\text{m}$ , the part is scrapped.

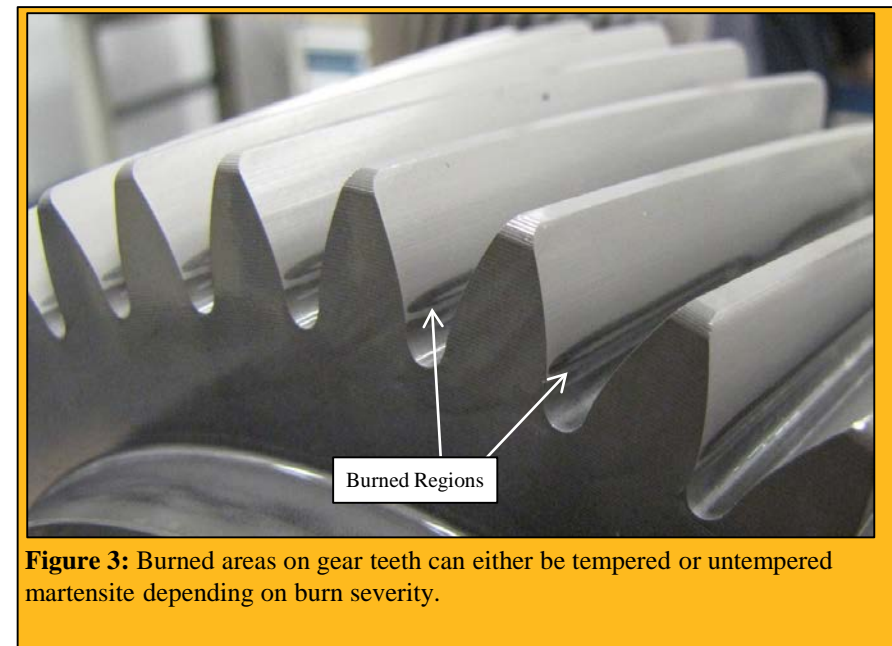
Figure 3: Burned areas on gear teeth can either be tempered or untempered martensite depending on burn severity.

Grinder burn occurs during finish grinding and can over-temper or re-harden the surface, depending on severity. This results in an inhomogeneous surface with hard and soft spots, making the tooth vulnerable to failure in bending.

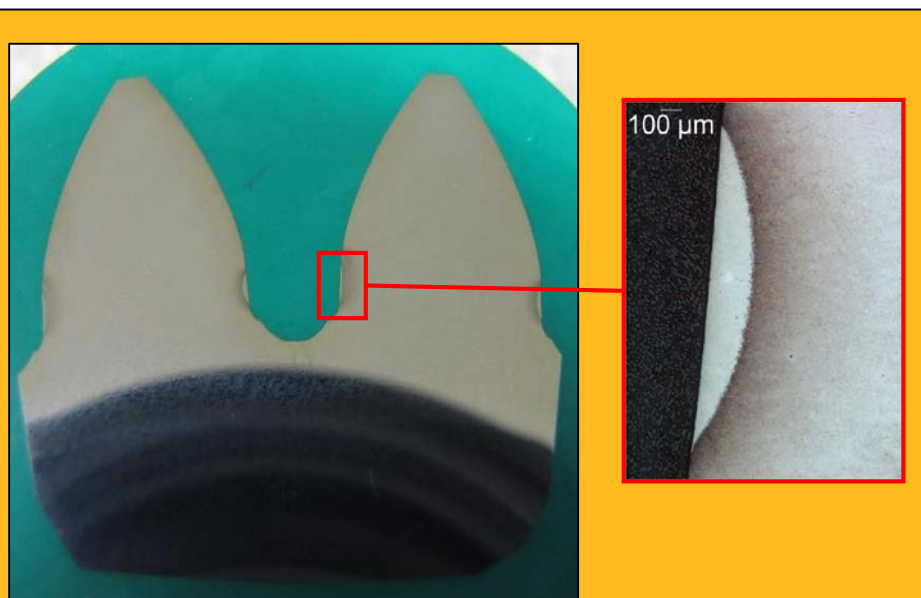
Figure 4: This cross section shows a burned location near the root of a gear tooth. Notice how the burn penetrates past the tooth surface.

Burned areas are detected using an acid bathing process and present themselves as black streaks. The darker that a streak comes through, the more intense is the burn. John Deere uses a gradient scale to pass or reject burned gears.

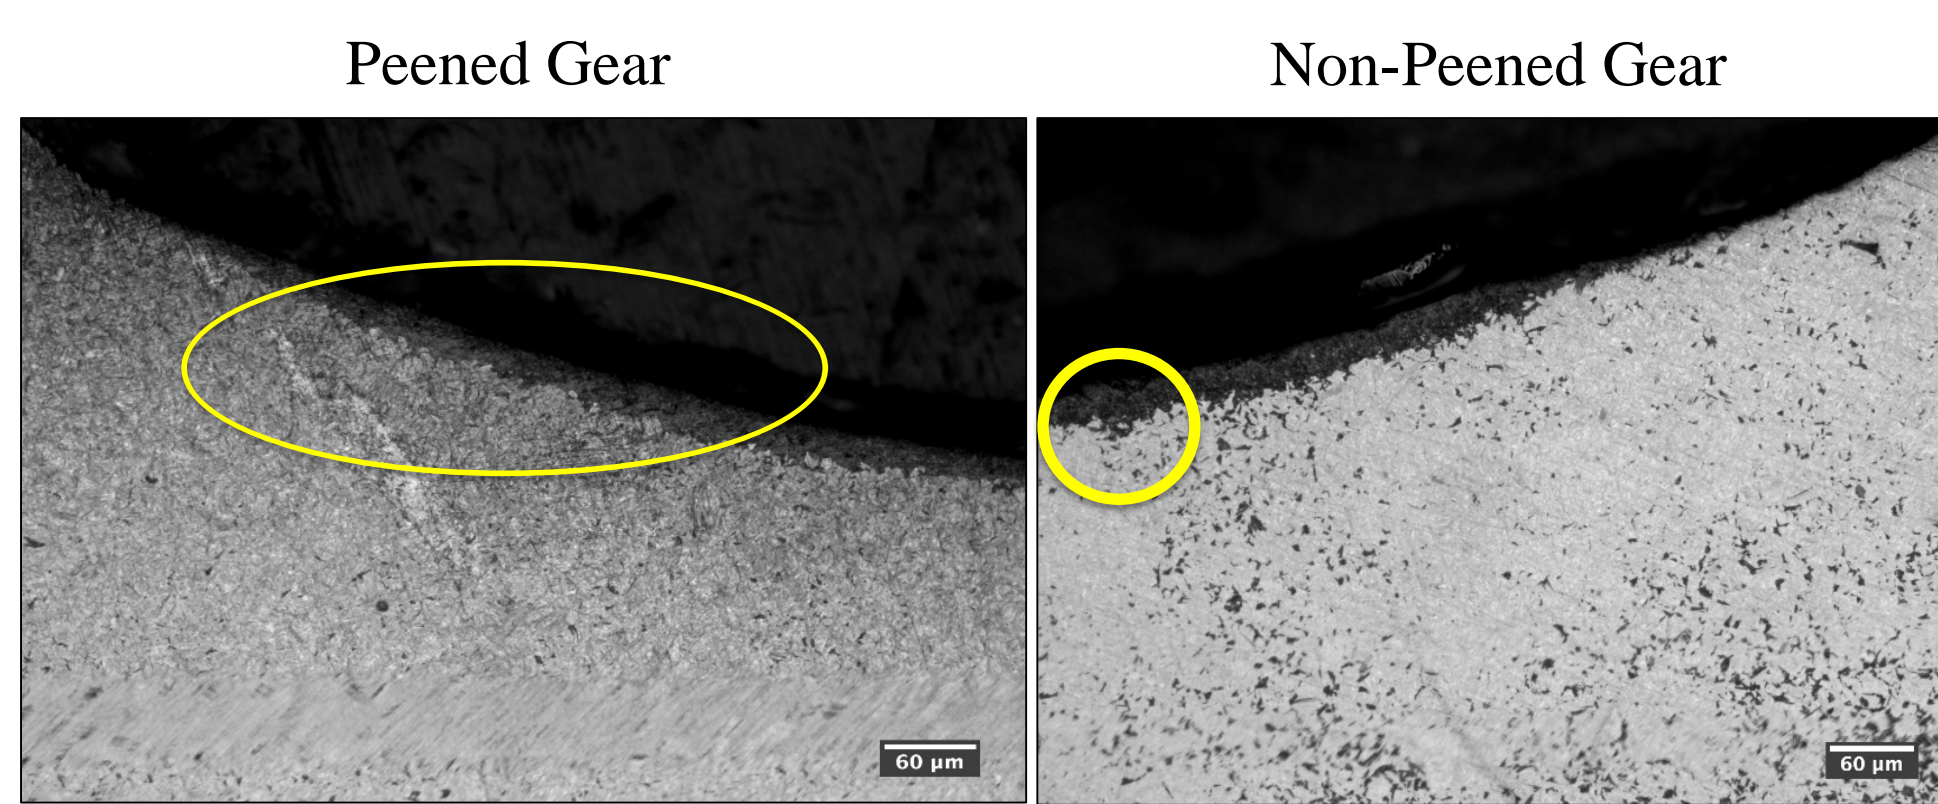
Optical microscopy and residual stress and hardness measurements were performed on a set of shot peened and non-shot peened poor microstructure gears. As shown in Fig. 8, the greatest amount of NTP was found near the 30 degree offset location (Fig. 7).

Figure 8: Optical microscope images of a poor microstructure peened and non-peened gear teeth near the 30 degree offset location. The yellow circles indicate where the maximum NTP layer was found. The thicknesses were measured to be 34  $\mu\text{m}$  and 42  $\mu\text{m}$  respectively.

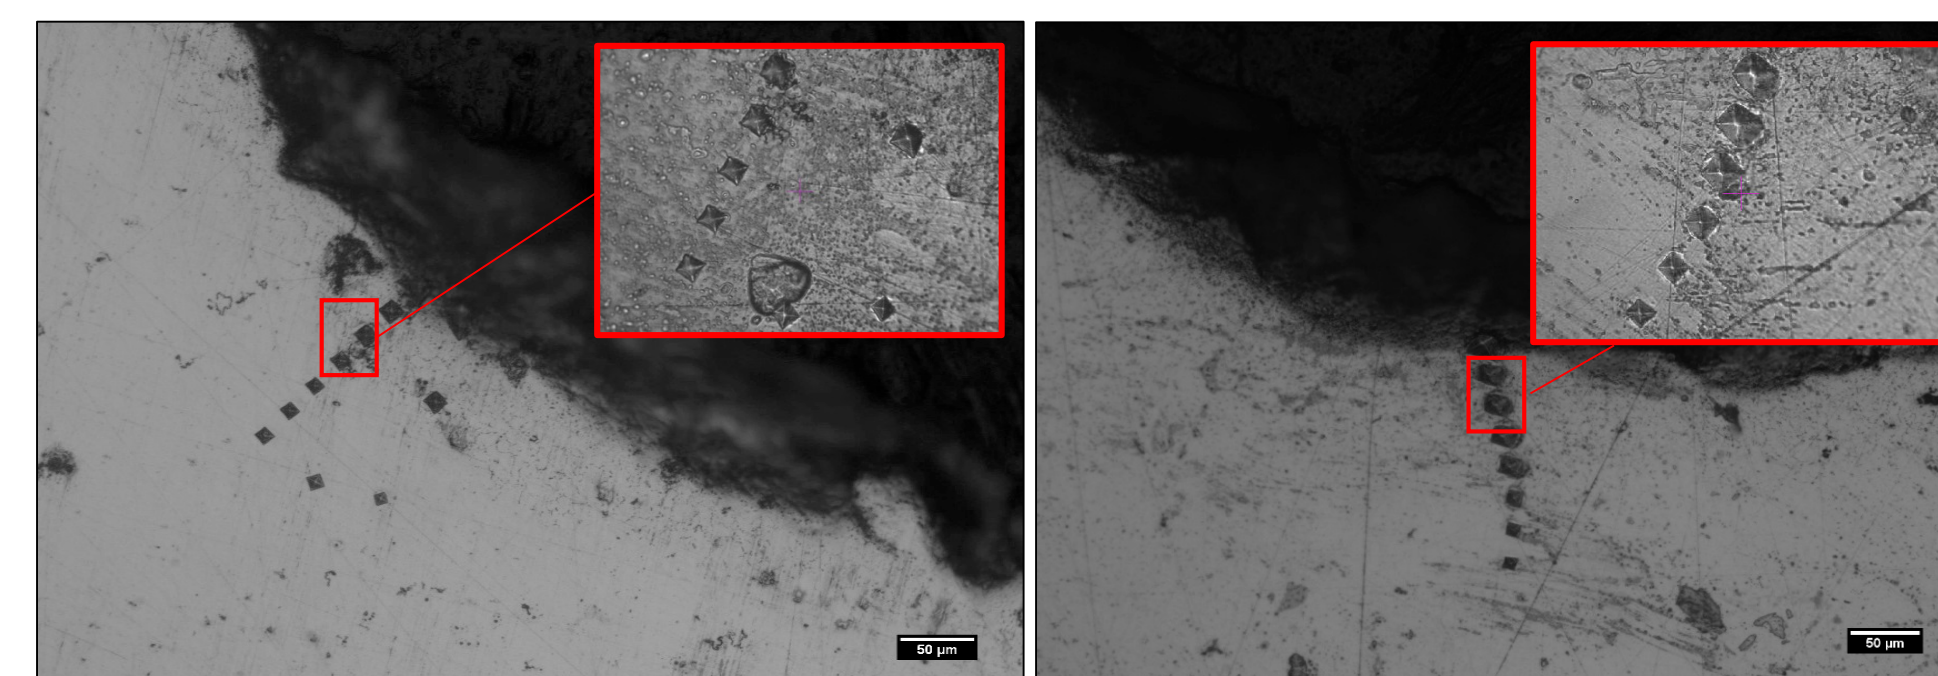
Figure 9: Optical microscope images of Vickers hardness indentations on a poor microstructure shot peened and non-shot peened gear teeth near the 30 degree offset location. The close up view highlights the poor microstructure area.

In Figure 11, the hardness profile had unexpected data points. For non-peened data, the hardness jumped from 21 HRC to 35 HRC at depths of 25  $\mu\text{m}$  and 50  $\mu\text{m}$ . This is much lower than expected. In Figure 9b we can see that there is a poor microstructure layer between the NTP layer and martensitic layer. The location of this soft layer is around 50-150  $\mu\text{m}$  below surface. The application of shot peening did not improve the microstructure in this region but it improved the hardness by 10-20 HRC.

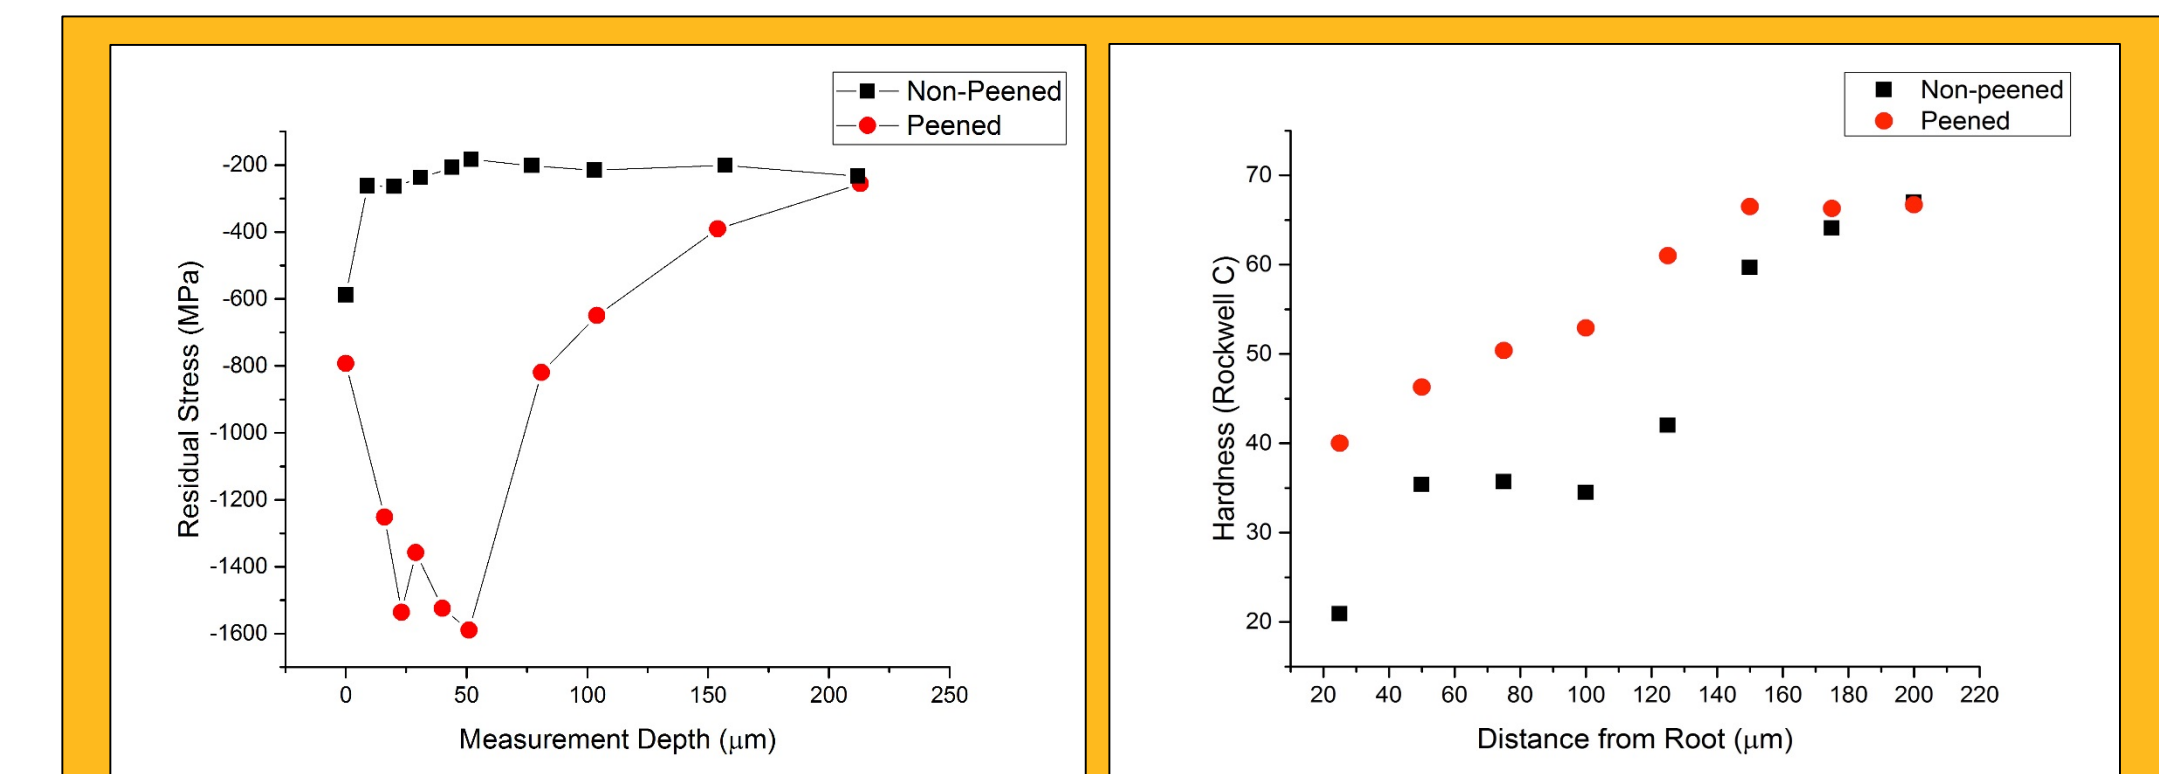
Application of shot peening was able to improve the internal stress state and recover some of its hardness lost due to NTP layer formation at the surface. The application of shot peening introduced up to 1400 MPa of compressive residual stress into the surface of the gear. The effect of shot peening on residual stress and hardness decreases as depth increases, and is negligible beyond a depth of 220  $\mu\text{m}$ .

Figure 10: Residual stress vs. depth to surface profile for peened and non-peened poor microstructure gears near 30 degree offset location.

Our team recommends that John Deere further pursue shot peening as a countermeasure to offset the negative effects of excessive surface NTP and grinder burn. Additionally, we suggest more testing to be done to establish a correlation between residual stress recovery and a non-destructive testing method such as Barkhausen Noise.

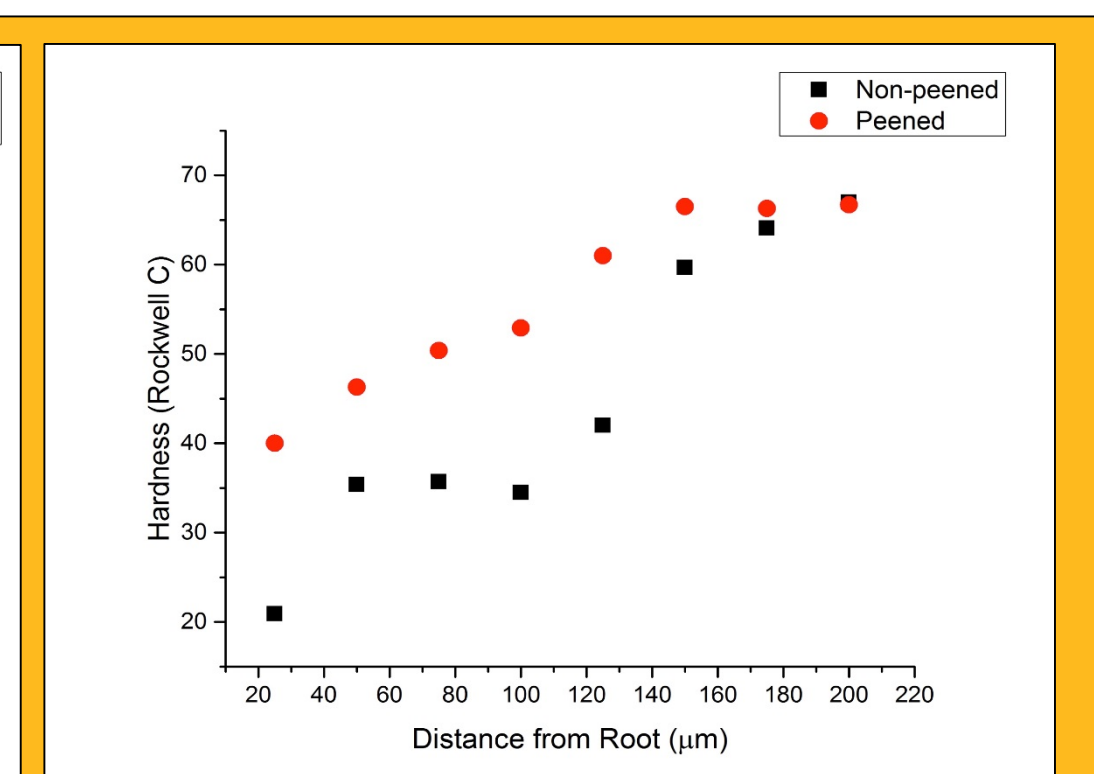
Figure 11: Hardness vs. distance to root profile for peened and non-peened poor microstructure gears near 30 degree offset location.

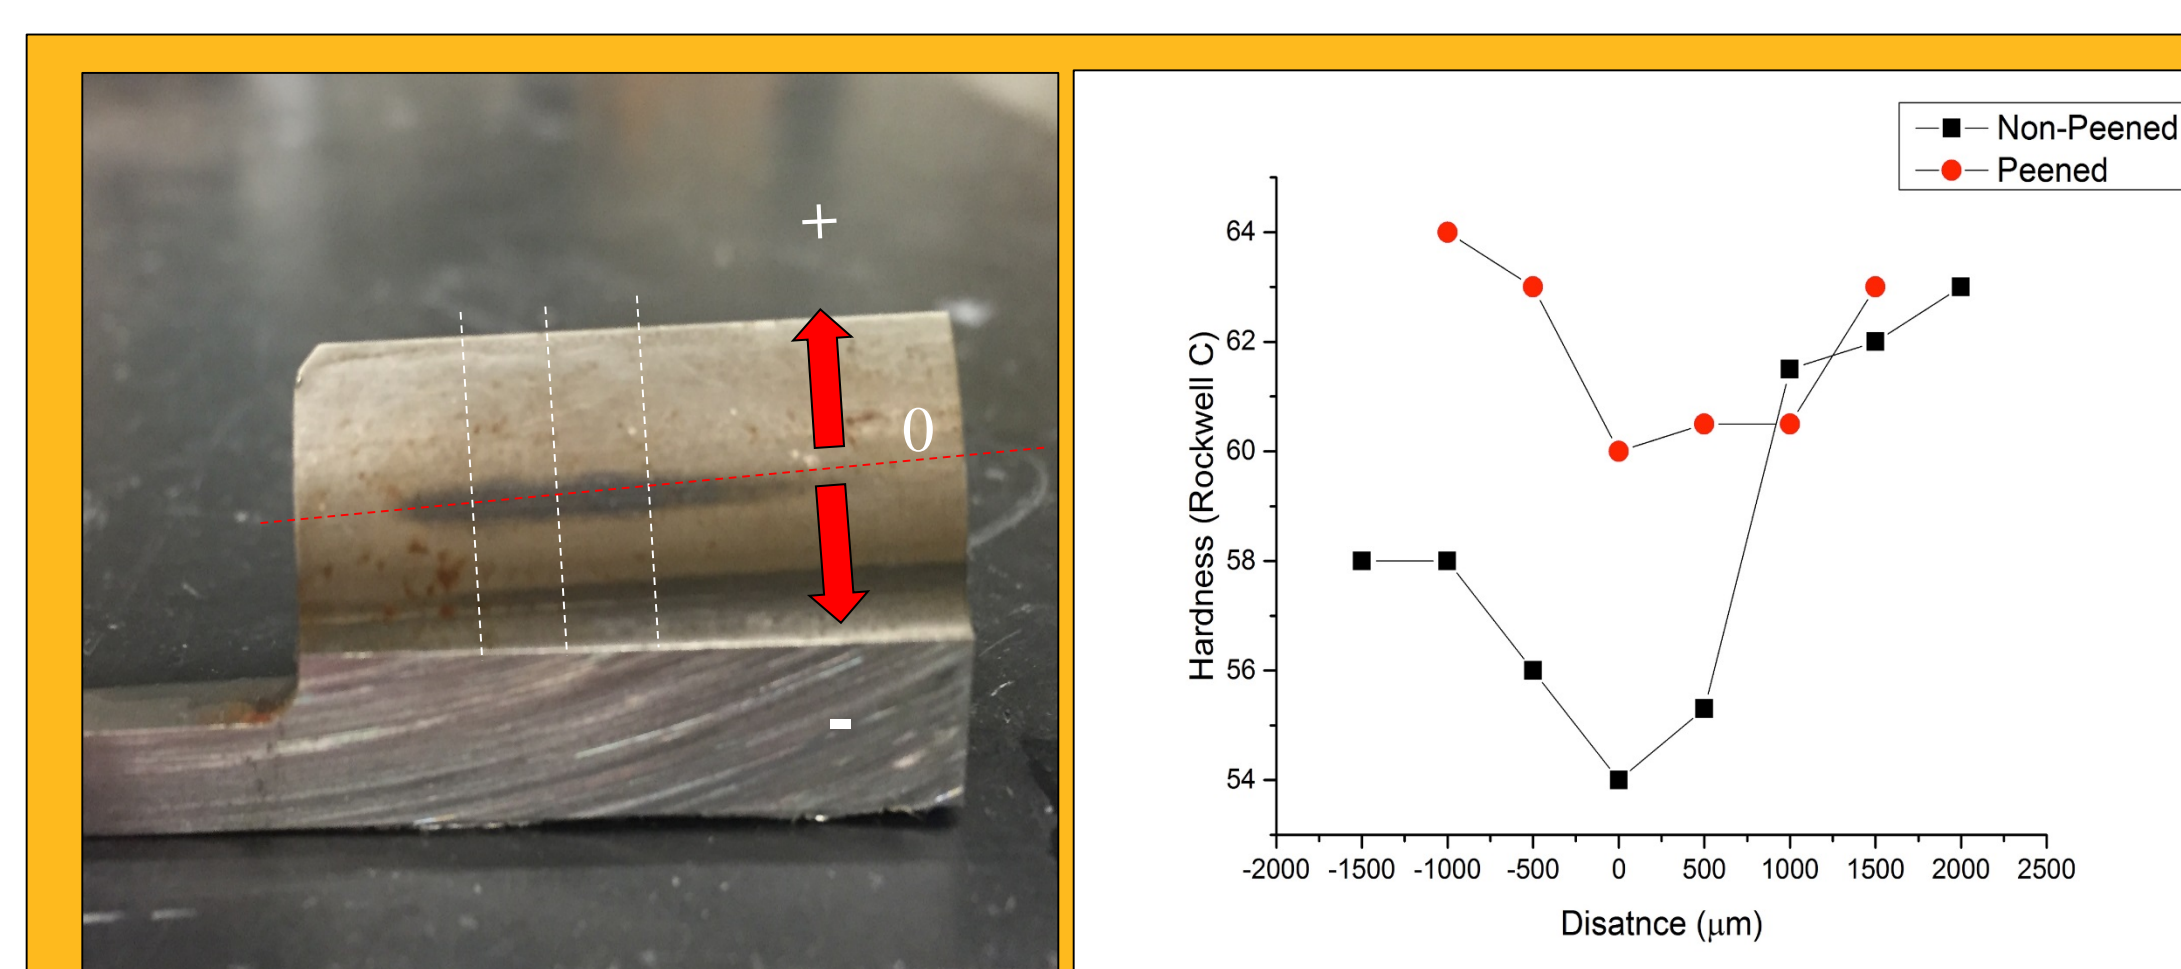
A severe grinder burn region was selected by visual inspection and measurements were taken along the burned area. The average surface hardness of a shot peened tooth was shown to be higher than a non-shot peened. Figure 13 shows a clear surface hardness difference between shot peened and non-shot peened teeth. The greatest post-peen hardness difference presented itself in the burned zone. This shows that shot peening cannot fully recover lost surface hardness in the grinder burn region.

Figure 12: Sectioned grinder burn gear with white dashed lines indicating Vickers hardness test locations. White lines are spaced in increments of 3mm.

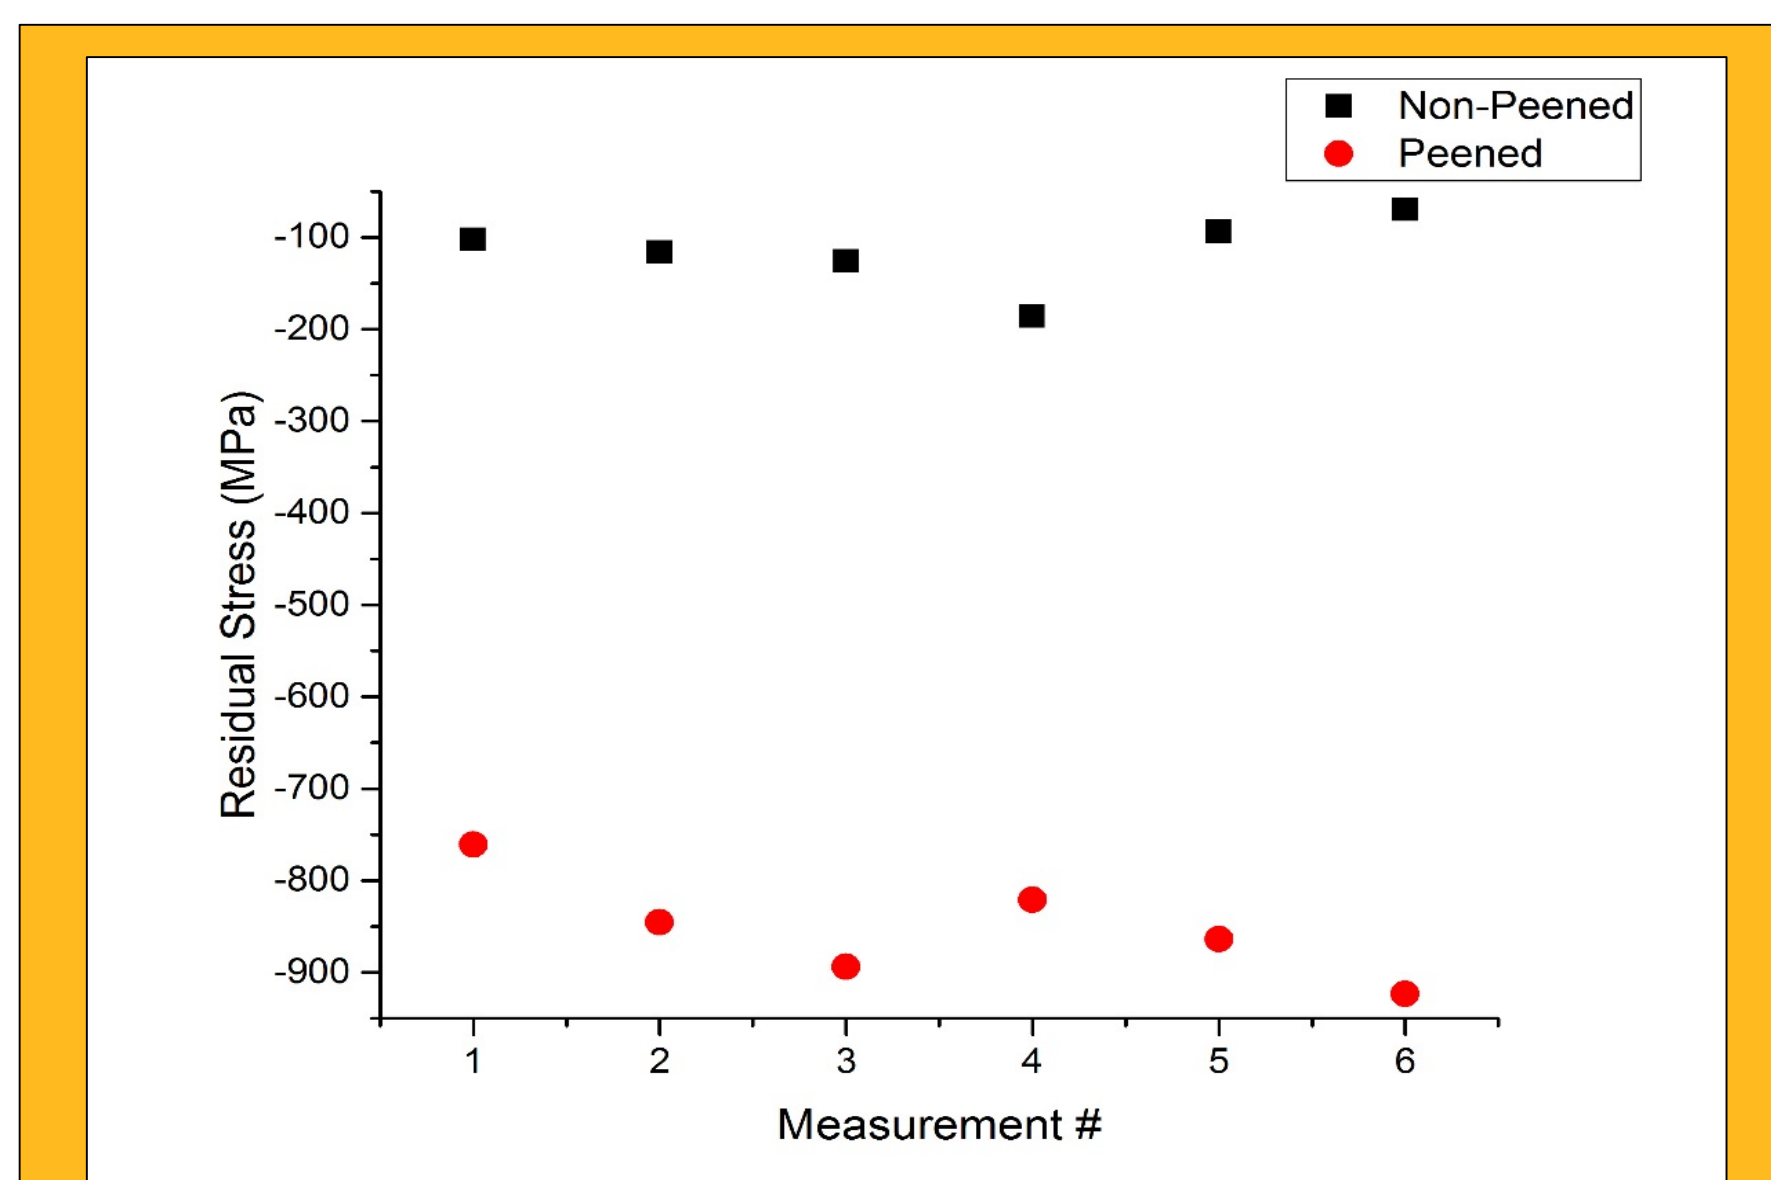
After grinder burn, it was expected to see high tensile stress in non-shot peened and compressive stress in shot peened. In Fig. 14, the non-shot peened part still has lower compressive stress. Surface residual stress of the shot peened part shows significantly higher residual stress compared to non-shot peened. It shows application of shot peening was able to recover a large amount of lost compressive residual stress on the grinder burn surface.

Figure 14: XRD residual stress measurement on 30 degree offset horizontally on the surface of grinder burned shot peened and non-shot peened.

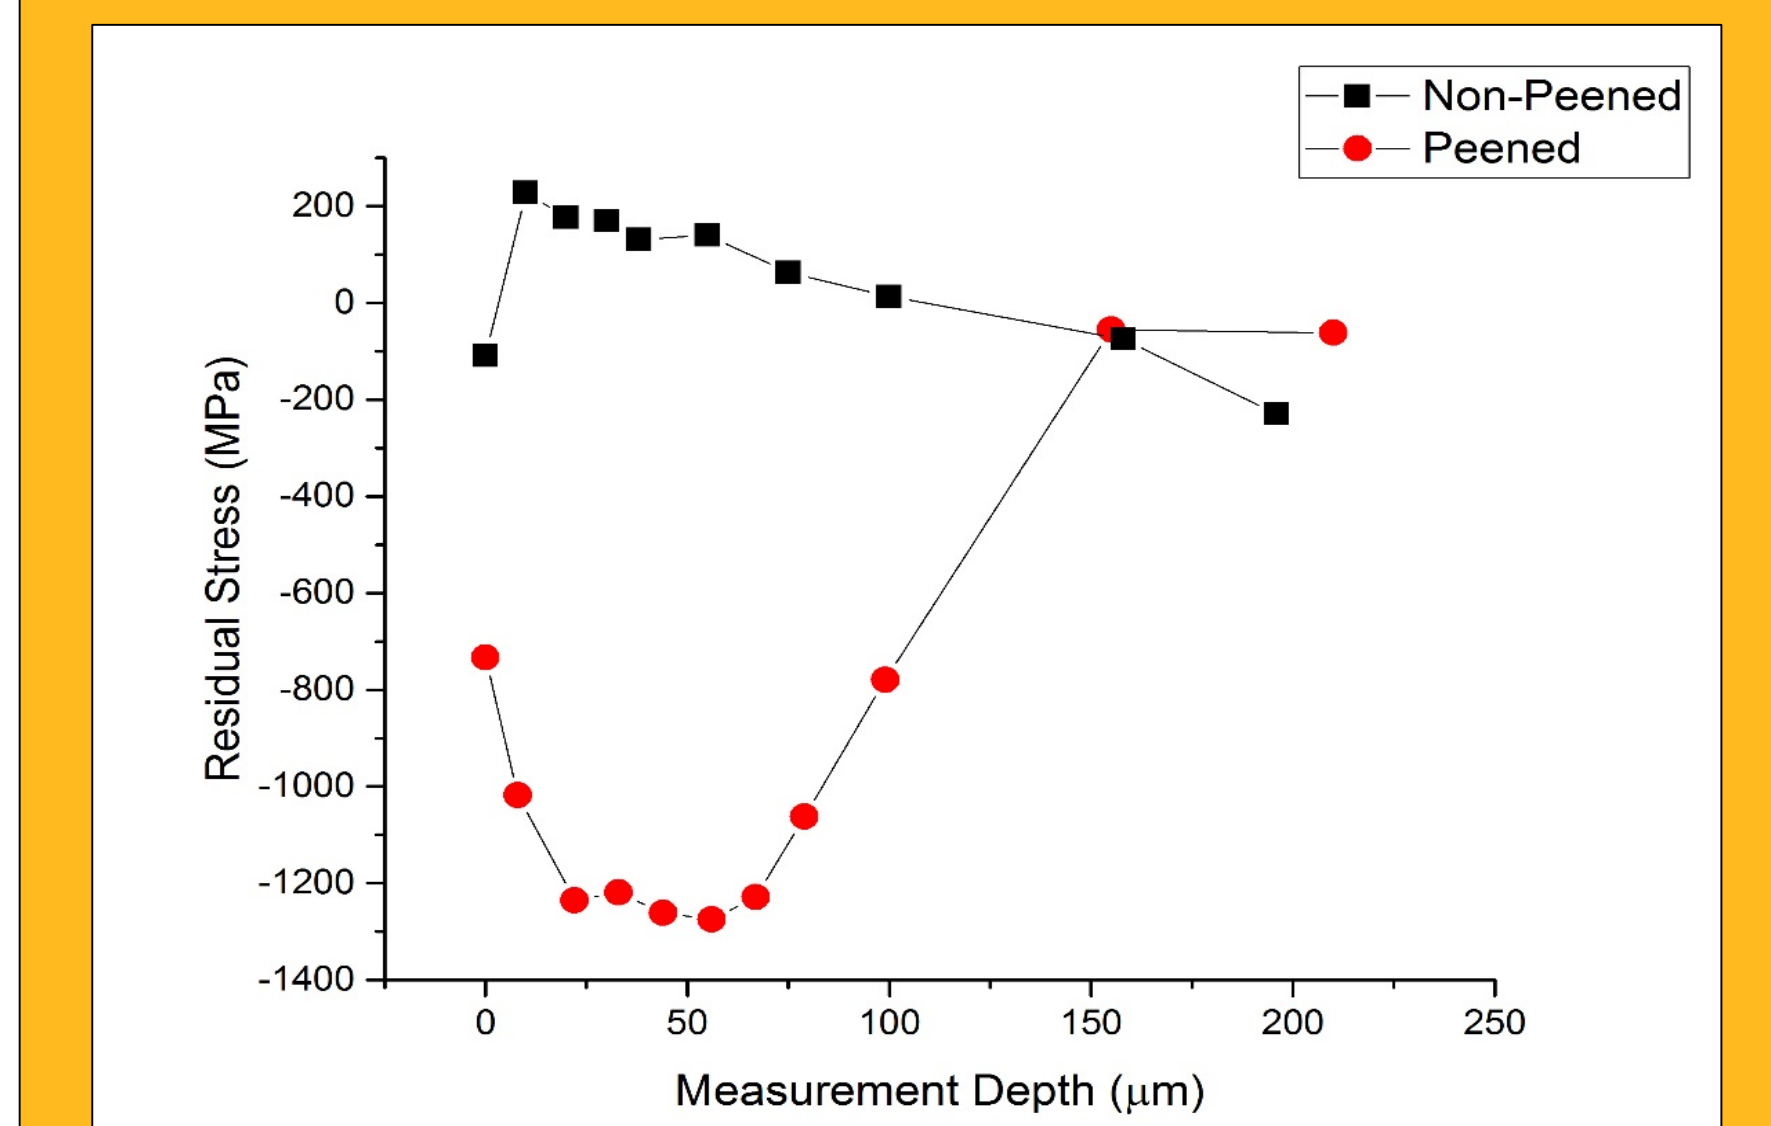
Non-peened grinder burn shows that it lost significant residual stress after being burned but it still keeps lower compressive stress and does not go up to tensile stress. Residual stress profiles (Fig. 15) show development of tensile stress near surface after grinder burn. It shows how the application of shot peening is able to recover the residual stress lost from burning.

Figure 15: XRD residual depth profile on the 30 degree offset on the surface of grinder burned shot peened and non-shot peened.
