NFPA 660 & A Dust Hazard Analysis Case Study

Process Safety Engineer
Fauske and Associates

Wood Pellet Explosion Case Study

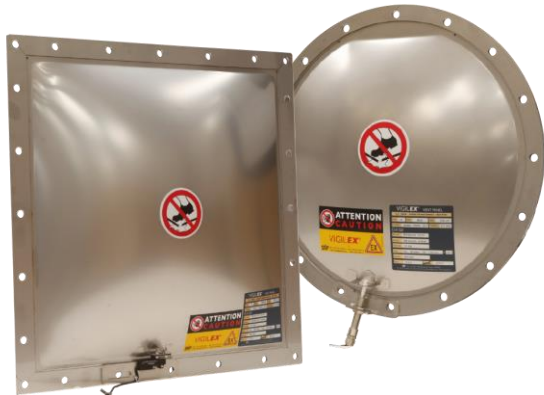
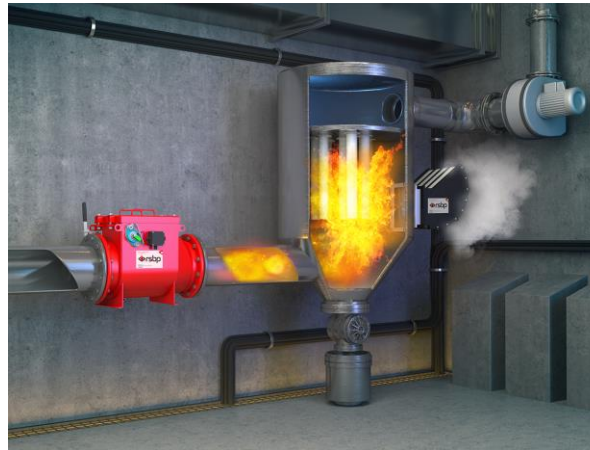
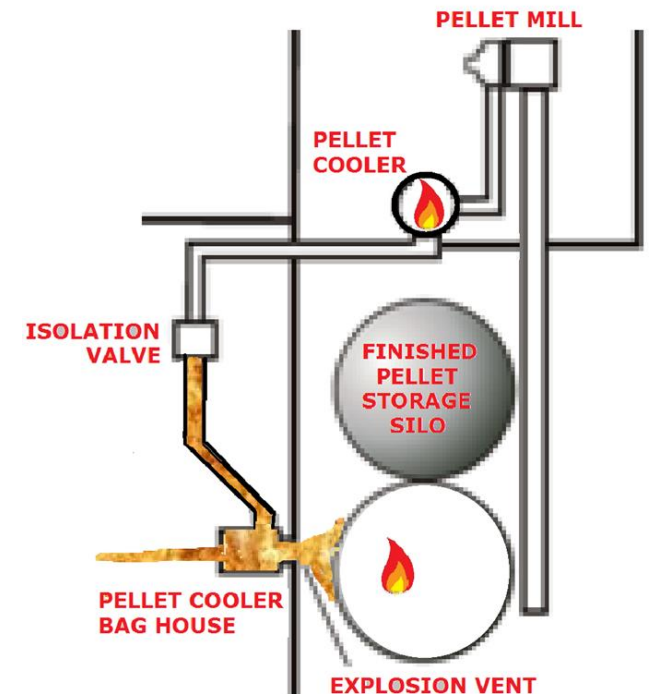
Safeguards In Place

- Explosion vent panel on pellet cooler bag house
 - Short (6 ft) ducting to the exterior of the building
- Isolation valve between pellet cooler bag house and cooler
- Effective housekeeping in Hammer Mill Building
 - No exposed combustibles

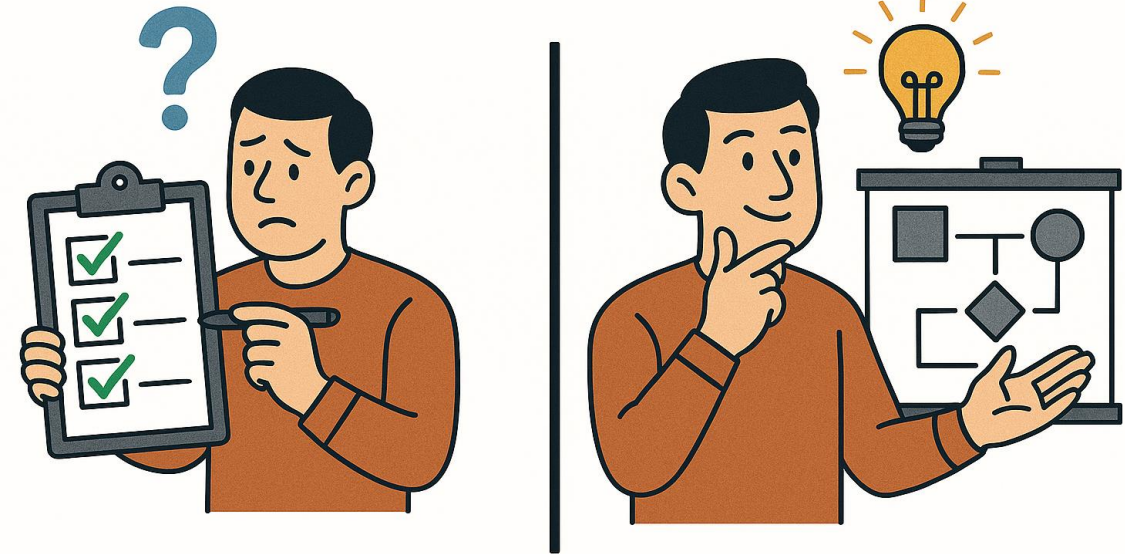
Shortfalls

- Protection Failures
 - Inaccurately sized explosion vents
 - OSHA data vs Test data
 - Destruction of doors
 - Lack of reinforced ductwork
 - Inappropriately directed explosion vents
 - Lack of explosion venting on silos
- Lack of Combustible Dust Management Programs
 - No written management of change (MoC) program
 - No written housekeeping program
 - No written preventative maintenance (PM) program
- Insufficient electrical Area Classification
