Review of failure trends in the US natural gas pipeline industry: An in-depth analysis of transmission and distribution system incidents

Christian P. Vetter, Laura A. Kuebel, Divya Natarajan, Ray A. Mentzer*

Purdue Process Safety and Assurance Center, Davidson Department of Chemical Engineering, Purdue University, West Lafayette, IN, United States

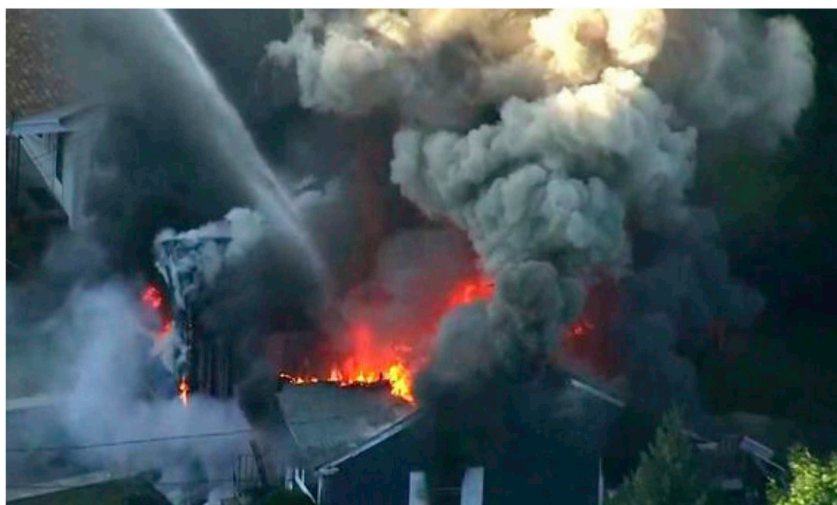
Fig. 14. Home on fire following natural gas distribution pipeline leak in Boston, September 13, 2018 (New York Times, 2018):

D - September 13th, 2018, Boston, Massachusetts. On September 13, 2018, a natural gas distribution pipeline ruptured 25 miles north of Boston, which spurred dozens of explosions and fires, as shown in Fig. 14. This ultimately affected three communities nearby where fires were ignited in 60–80 homes. This resulted in one fatality, dozens of injuries and the evacuation of nearly 8,000 people from the surrounding area. In addition, nearly 18,000 homes and businesses were left stranded without power (CNBC News, 2018). Preliminary investigations claim the cause to be the over-pressurization of the gas lines. However, the complete incident investigation is yet to be completed by PHMSA and other authorities to identify the primary root cause(s). The gas pipelines are owned by Columbia Gas of Massachusetts (Lee & Soraghan, 2018).

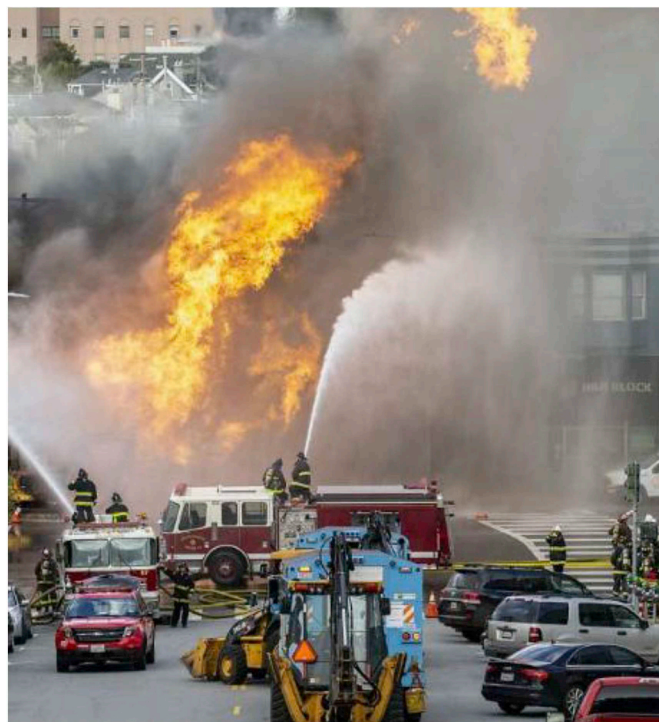
At 6:11 p.m. on September 9, 2010 in San Bruno, CA, a 28-foot section of carbon steel pipe erupted from the ground. The section of pipe, owned and operated by Pacific Gas & Electric (PG&E), landed nearly 100 feet from the blast's epicenter (Repanich, 2011). The explosion led to eight deaths, 51 injuries, nearly 40 houses destroyed, and ~\$600 MM in damages (Wald, 2011). Almost immediately after the rupture occurred, escaping gas ignited, creating an inferno, as shown in Fig. 15. According to a report by the NTSB, the 30-inch diameter pipe had numerous flaws in its welds (National Transportation Safety Board, 2010). The section of pipe that failed, originally welded in 1956, did not meet generally accepted quality control and welding standards in effect.

The rupture was a result of over pressurization of the segment of pipe (Line 132) due to a series of issues within the PG&E Milpitas Terminal. An uninterruptible power supply had been undergoing

Fig. 15. Fire in San Bruno, CA following transmission line release, September 9, 2010 (San Francisco Chronicle, 2010):

maintenance at the facility when an open circuit resulted in a local control panel unexpectedly losing power. As a result, a series of valves were fully opened, and Line 132 was over pressurized. Monitor valves were in place to prevent over pressurization within the mains from occurring. However, the monitor valves were displayed as closed after a series of erroneous signals were sent to the supervisory control and data acquisition (SCADA) unit due to the resulting outage. Subsequently, the gas ignited and exploded following over pressurization of the line segment.
