6th Purdue Geotechnical Society
Workshop – April 18, 2008

***Fast-Track Emergency
Replacement of Collapsed Sewer
by Tunneling in Miocene Clay***

David Chapman
Lachel Felice & Associates, Inc.
Morristown, NJ

Battery Park Sewer – Richmond, VA

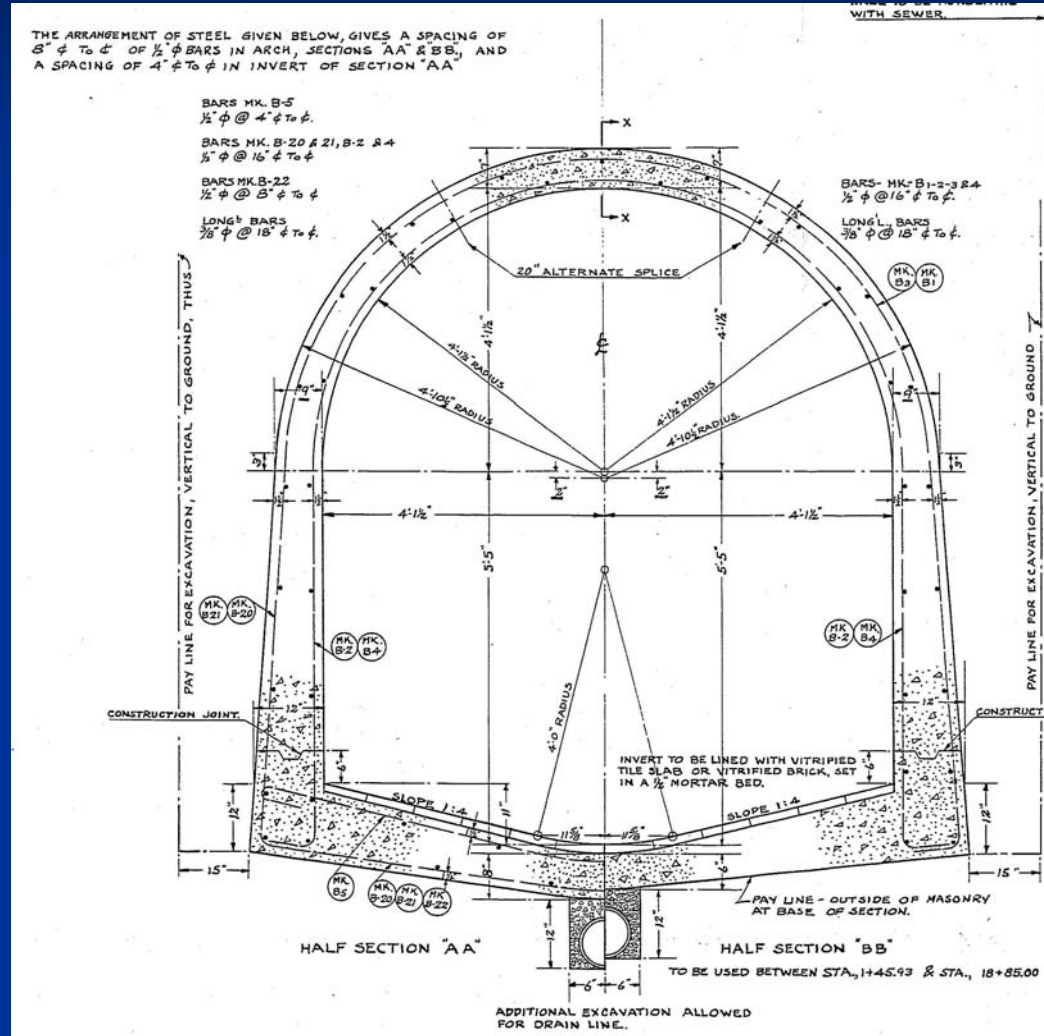
Original Arch Sewer/Changes

- 8'-3" wide x 9'-6" Concrete Arch Trunk Sewer built circa 1924 – crown only 9" thick – only slightly buried
- Beginning 1940's – up to additional 100 feet of landfill - Municipal Solid Waste (MSW)

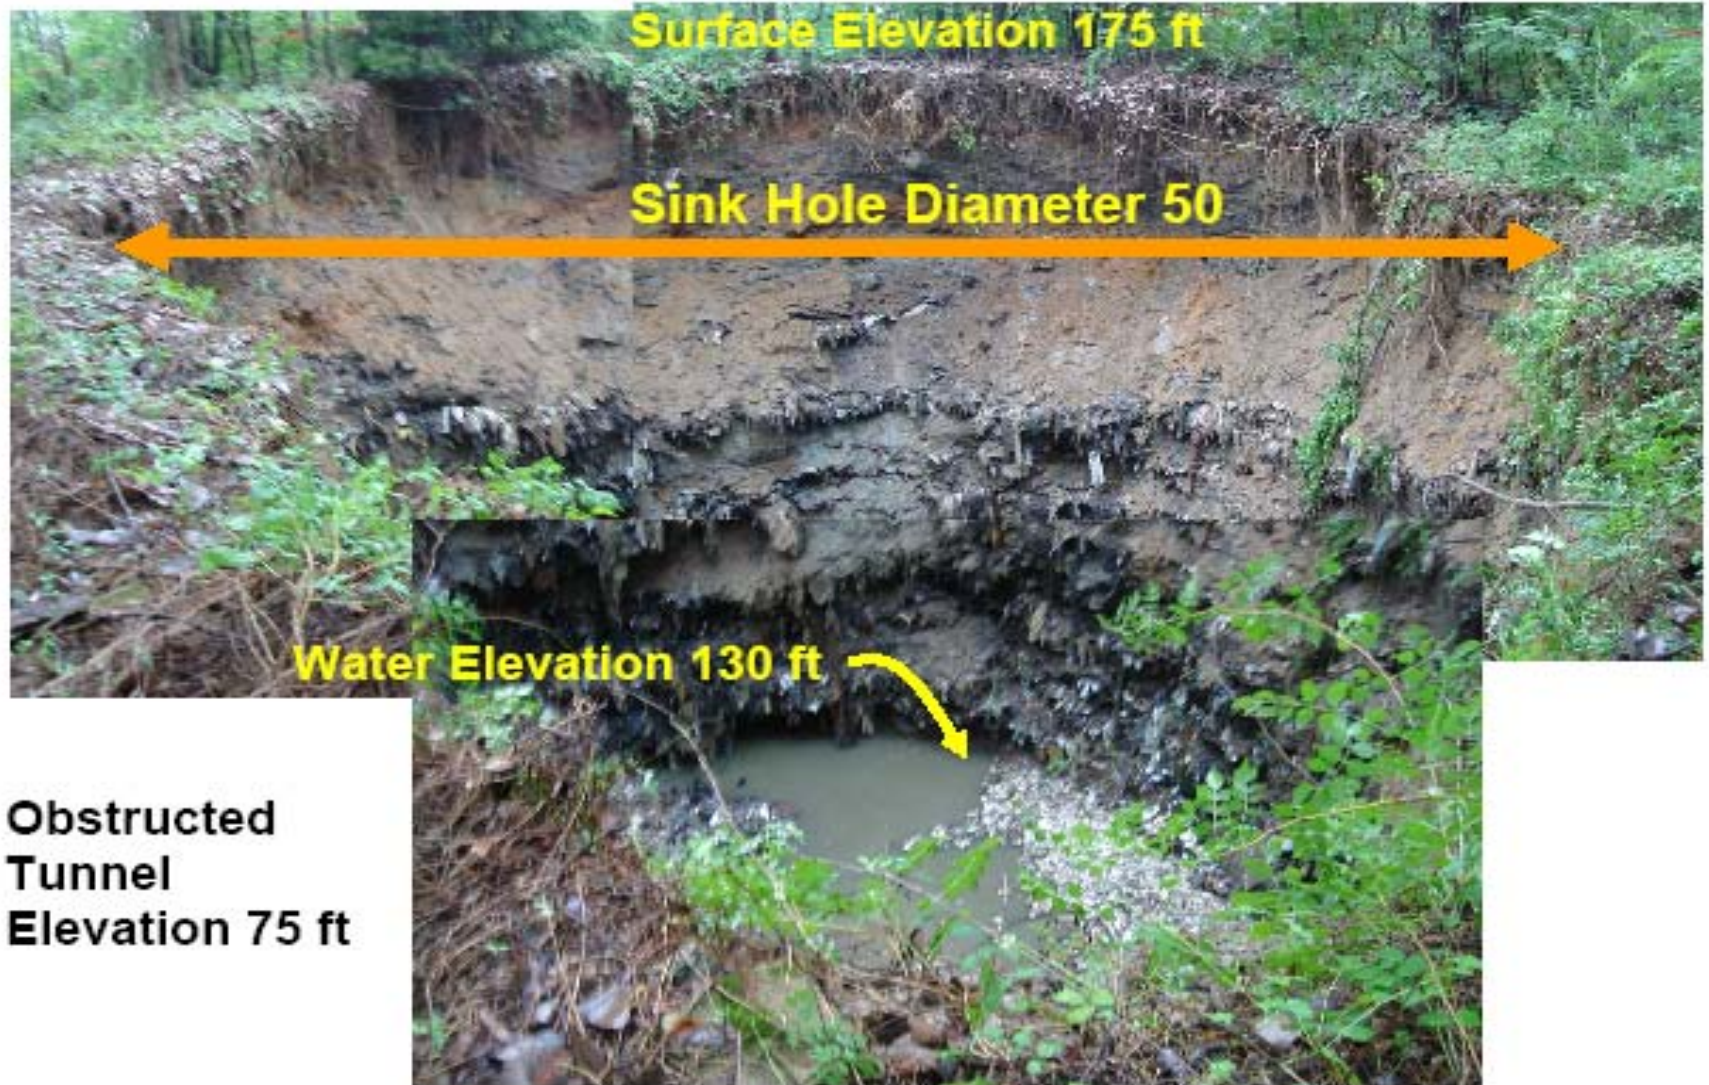
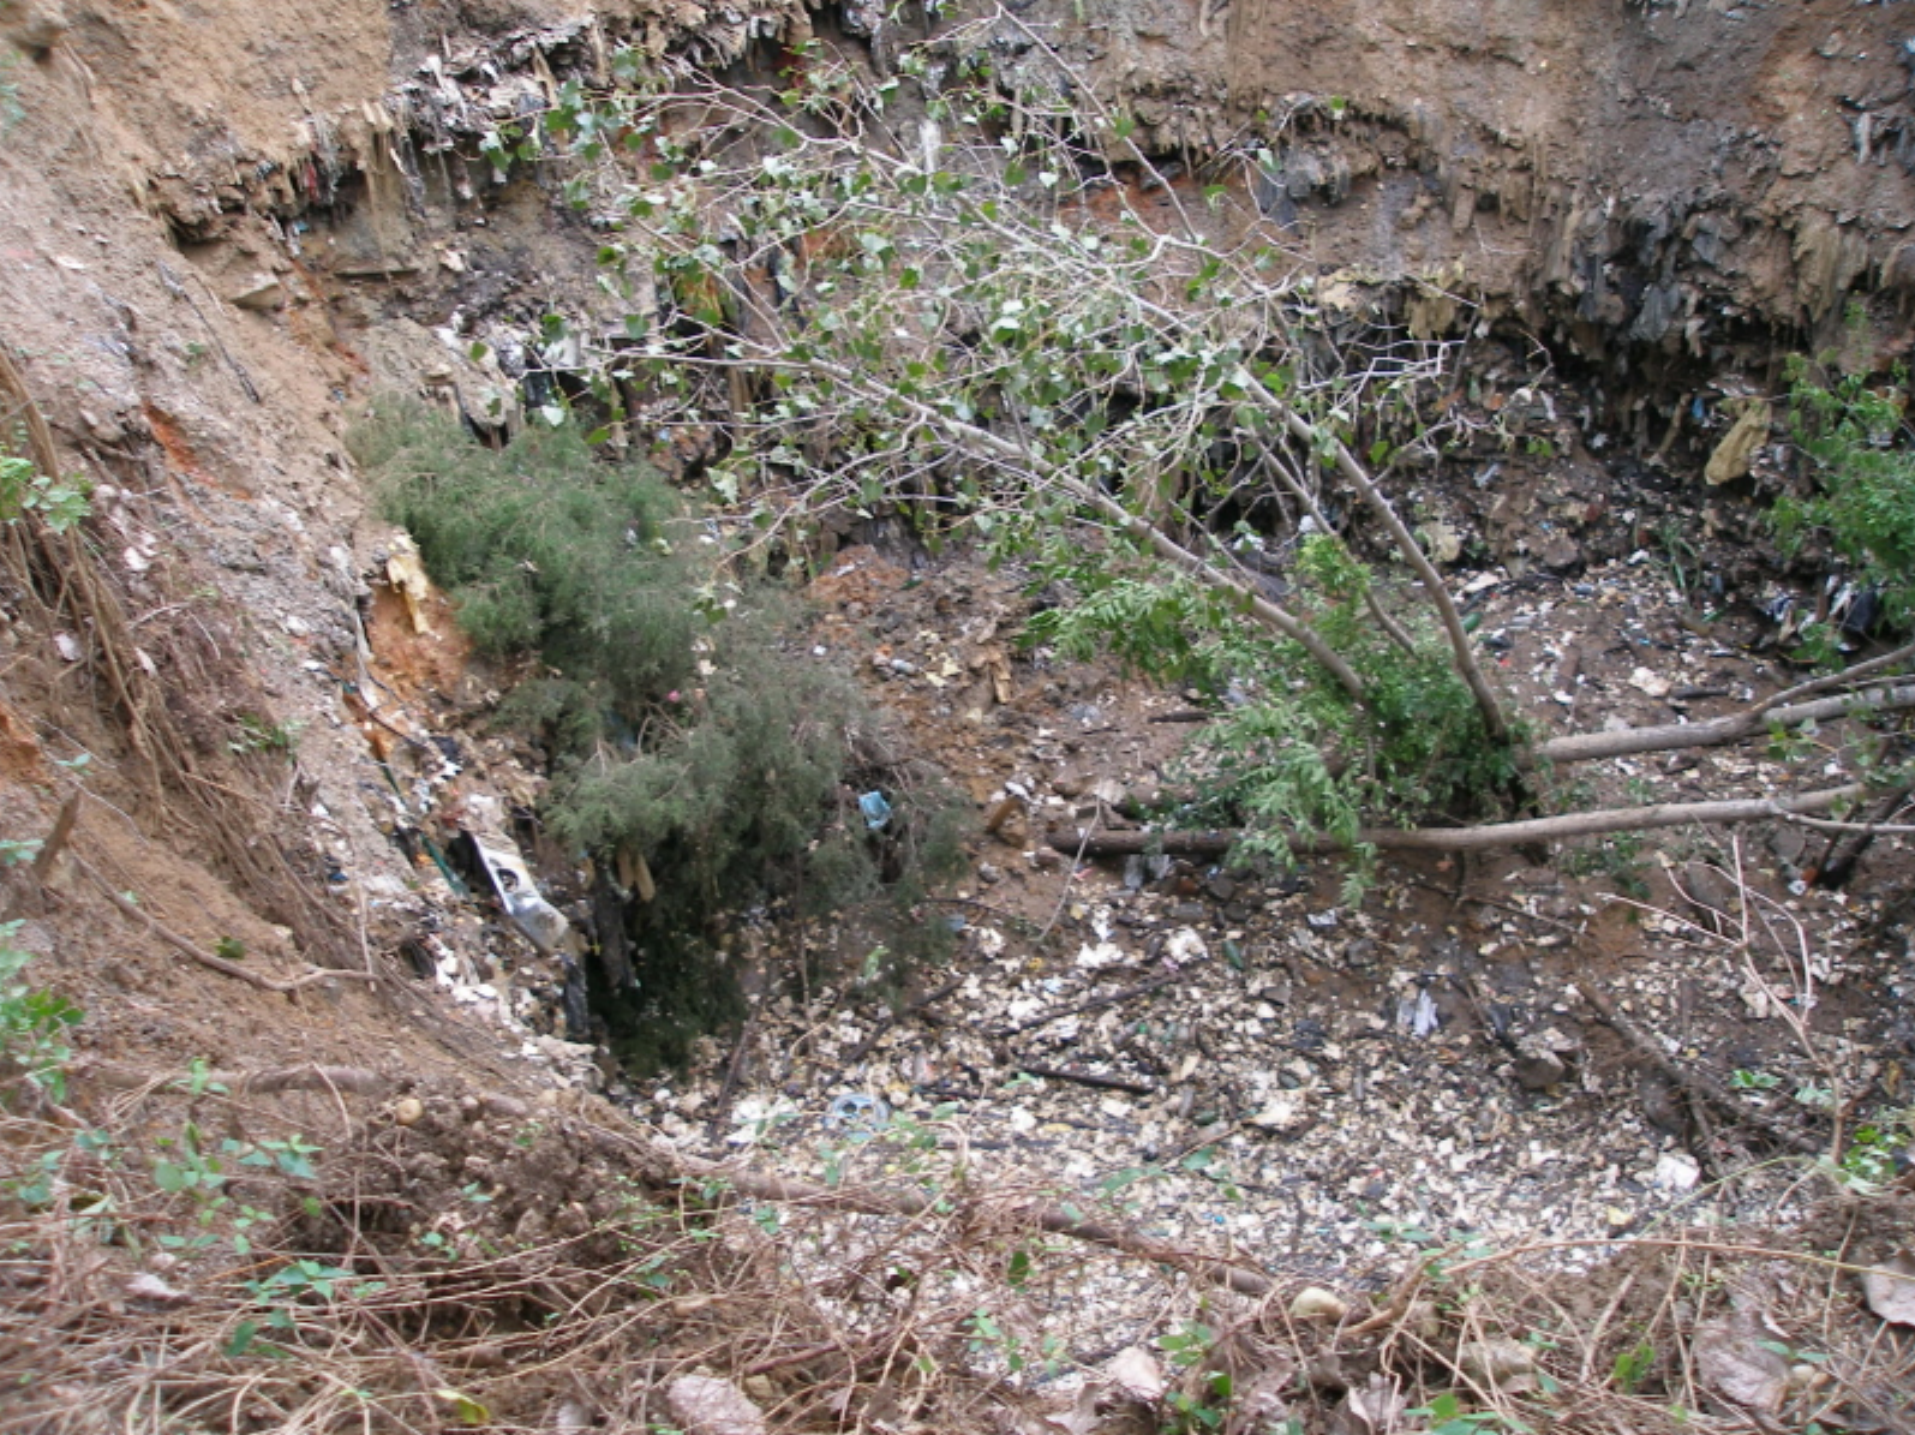
The Sinkhole

- Labor Day Weekend – 2006
- Tropical Storm Ernesto dumps 10 inches of rain
- A serious hidden problem was disclosed

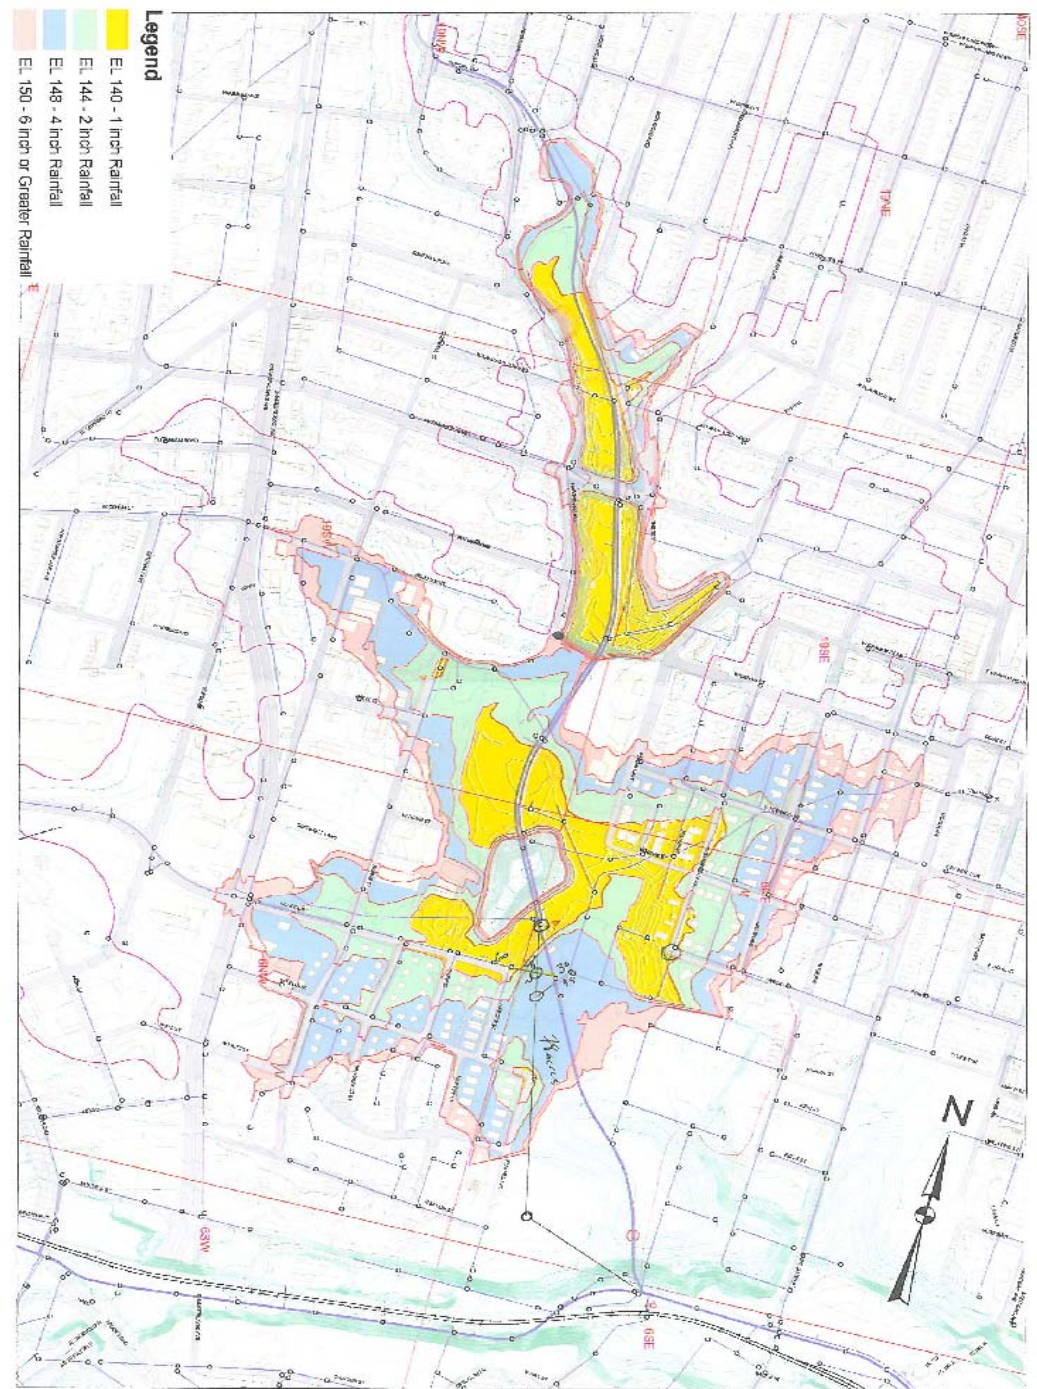
Flooding due to Blockage

- Yellow = 1" Rainfall
- Lt. Blue = 2" Rainfall
- Blue = 4" Rainfall
- Purple = 6" or > Rainfall

- Flooding developed at night 8/31/06
- 150 homes evacuated – > 20 later condemned
- 80+ acres flooded with sewage

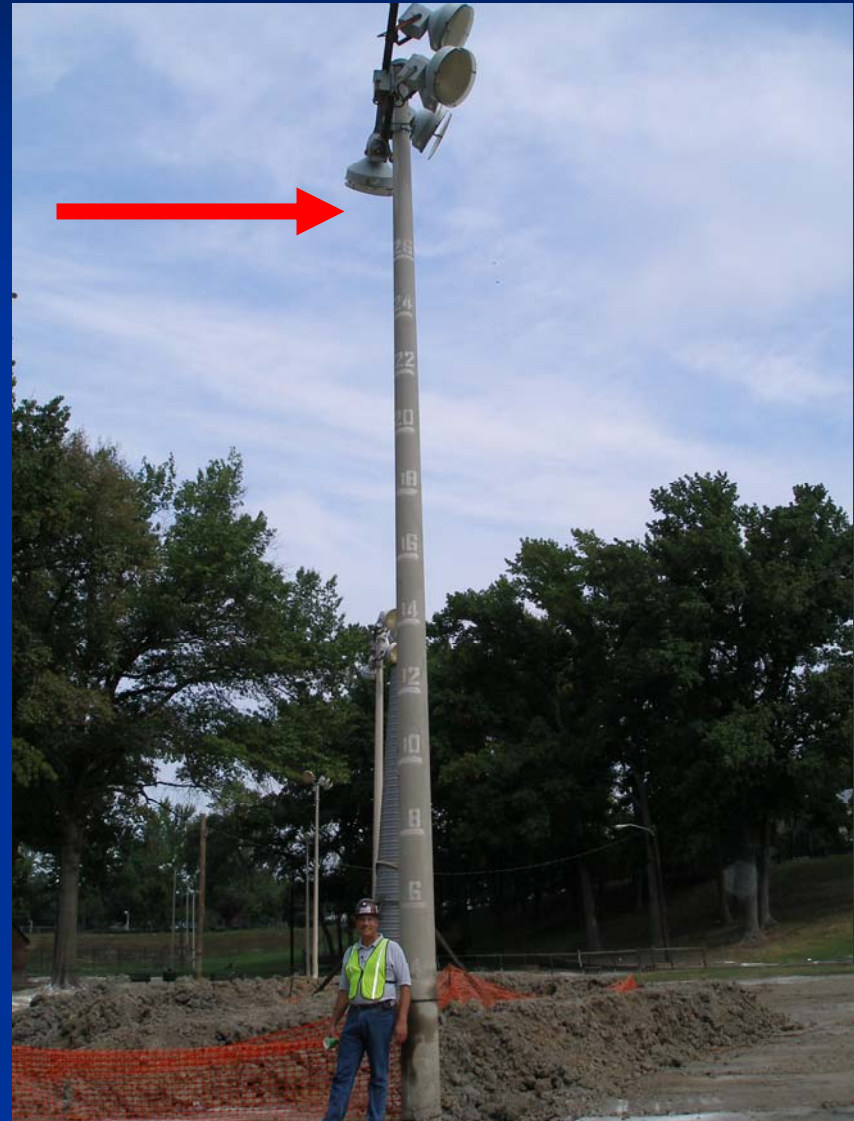
Flooding

- Picture taken at North Diversion Structure location above landfill extent
- Marker points to 26-foot level

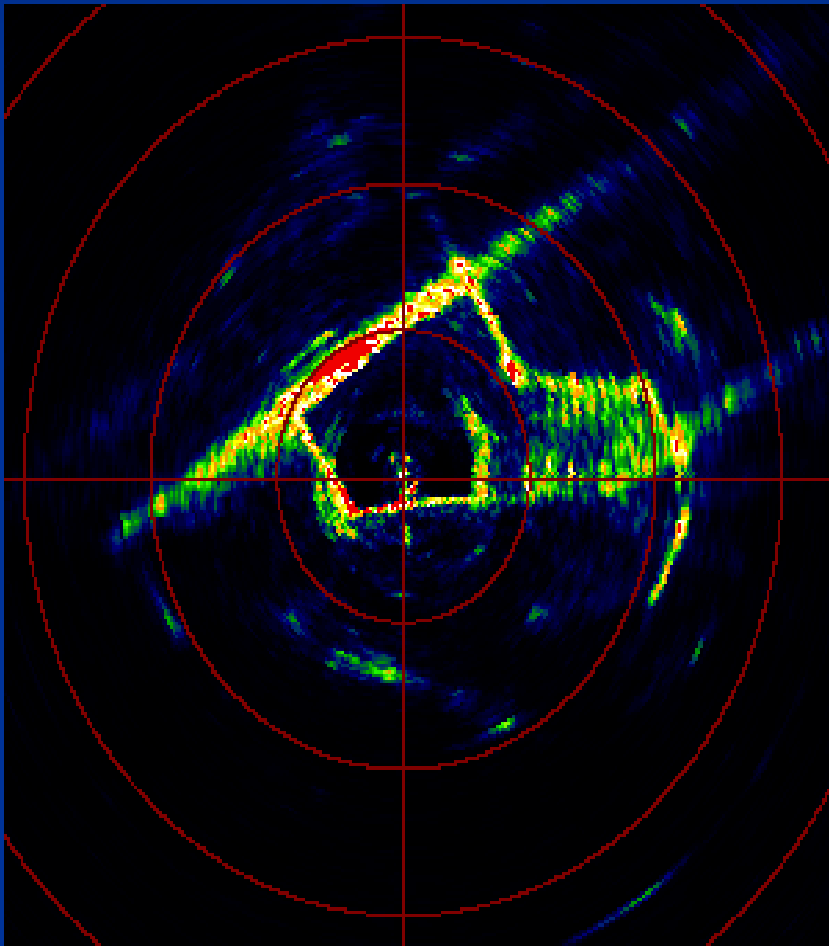
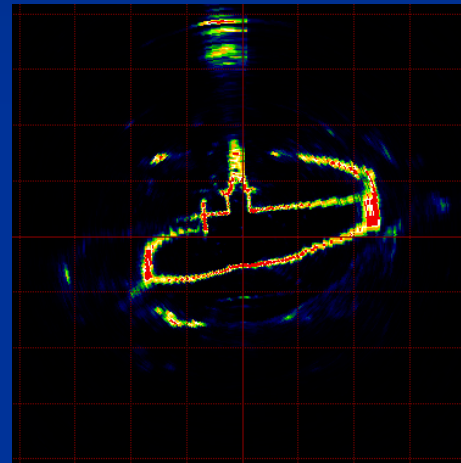
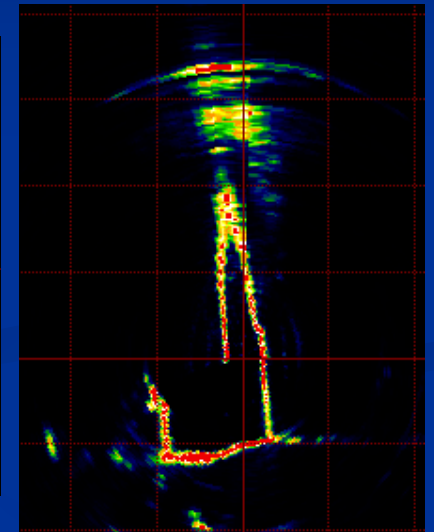
Sonar Survey of Damaged Sewer

More accidents
waiting to happen!
