S.P. Schneider, Purdue University, School of AAE, 765-494-3343, 21 May 1999  
 Measurements by Chris Tieche, Purdue University, School of AAE.

## Zygo Optical Profilometer Measurements of Hard Nickel Coupon: Sample Tests for Mach-6 Quiet-Flow Nozzle Throat

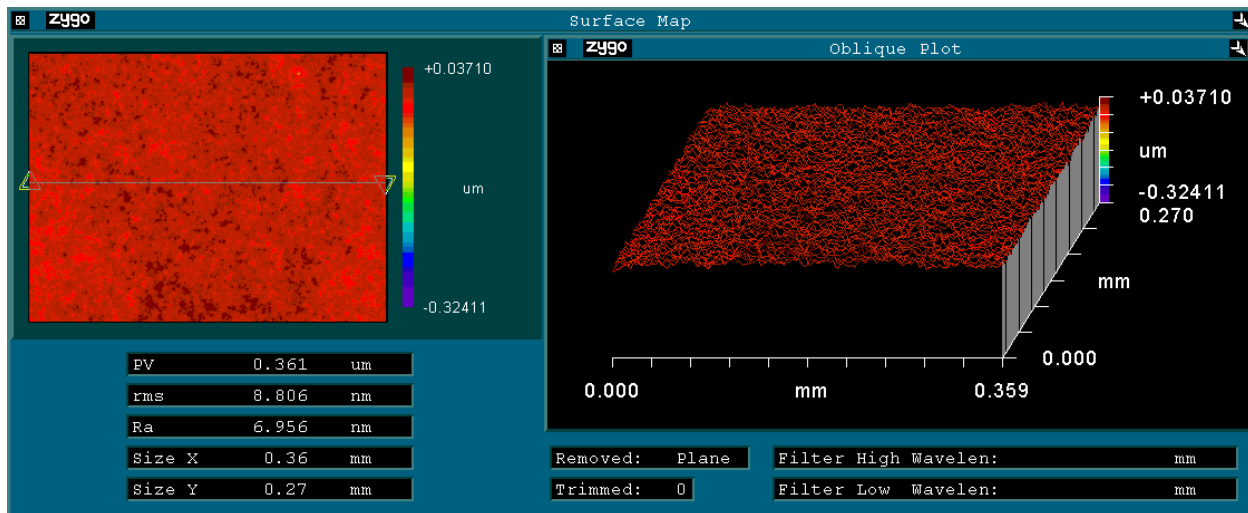
Figure 1: Area 1, Main View

Figure 1 shows the results of the first Zygo image. The rms is 8.81 nm (0.34 microinches), Ra = 6.96 nm, the max. deviation is about 40 nm, and the image size is 0.36 x 0.27 mm. This section has a very good finish.

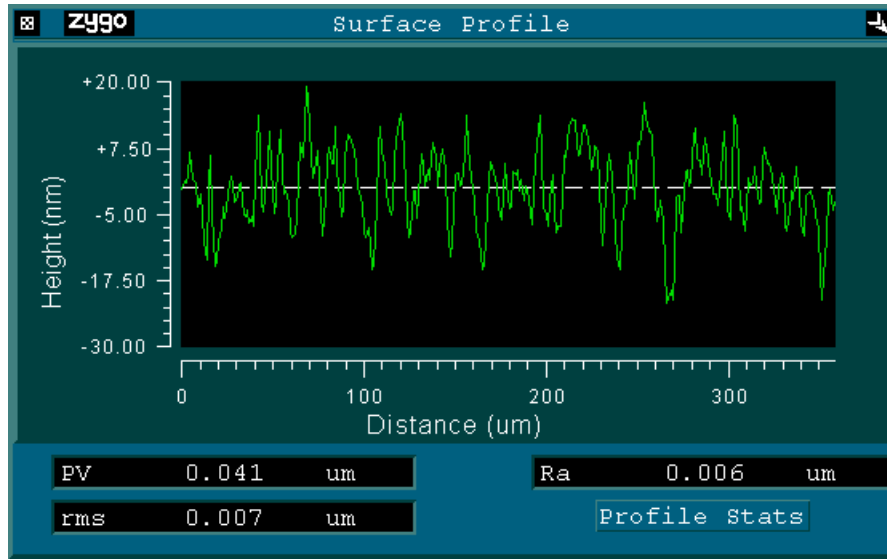
Figure 2: Profile of Area 1 along Indicated Line

Figure 2 shows a surface profile along the line indicated on the left-hand side of Figure 1. The peak deviation is roughly 20-25 nm (1 microinch) along this line.

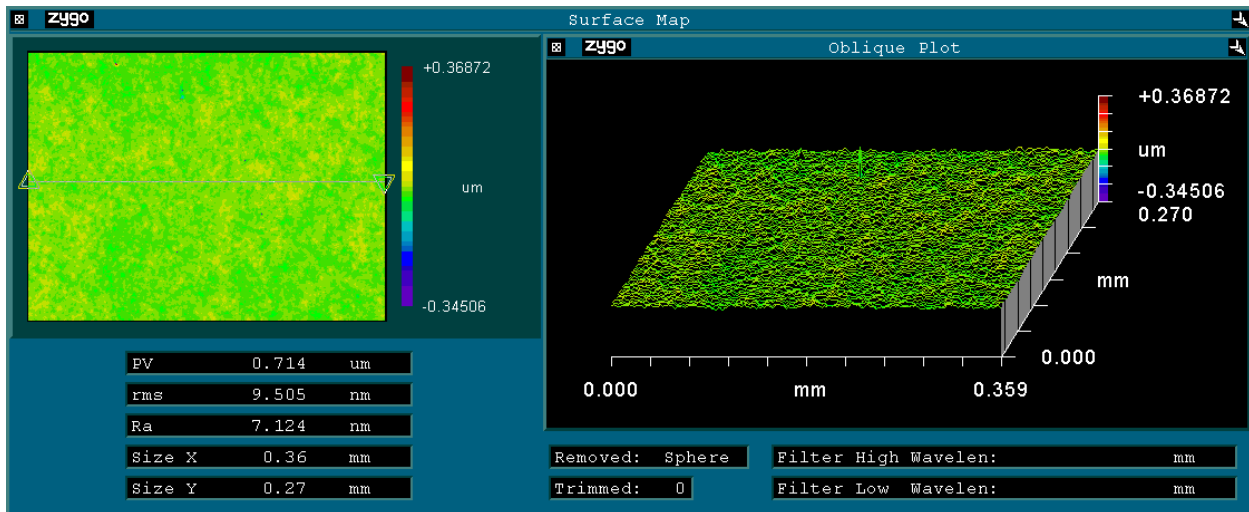
Figure 3: Main Image of Second Area

Figure 3 shows the main view of the second area. The roughness is similar.

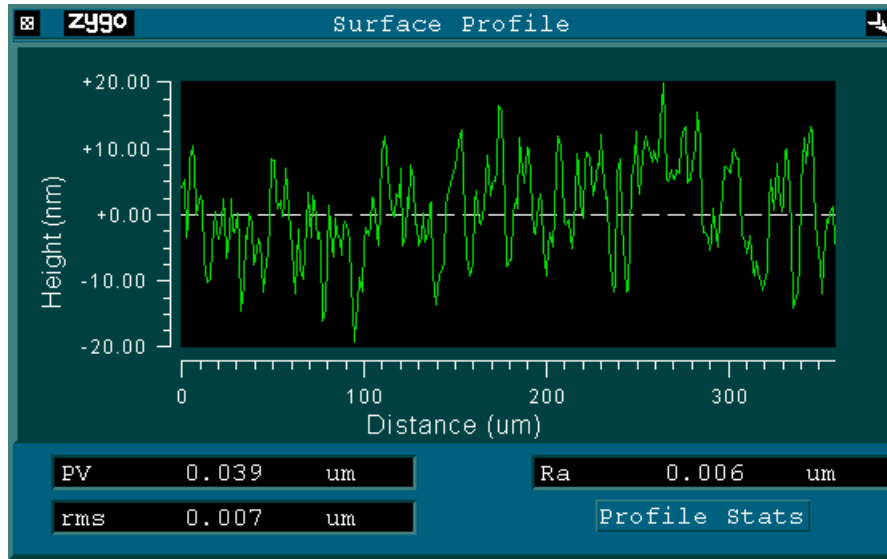
Figure 4: Profile of Second Area

Figure 4 shows the profile along the line drawn on Fig. 3. The profile again looks similar.

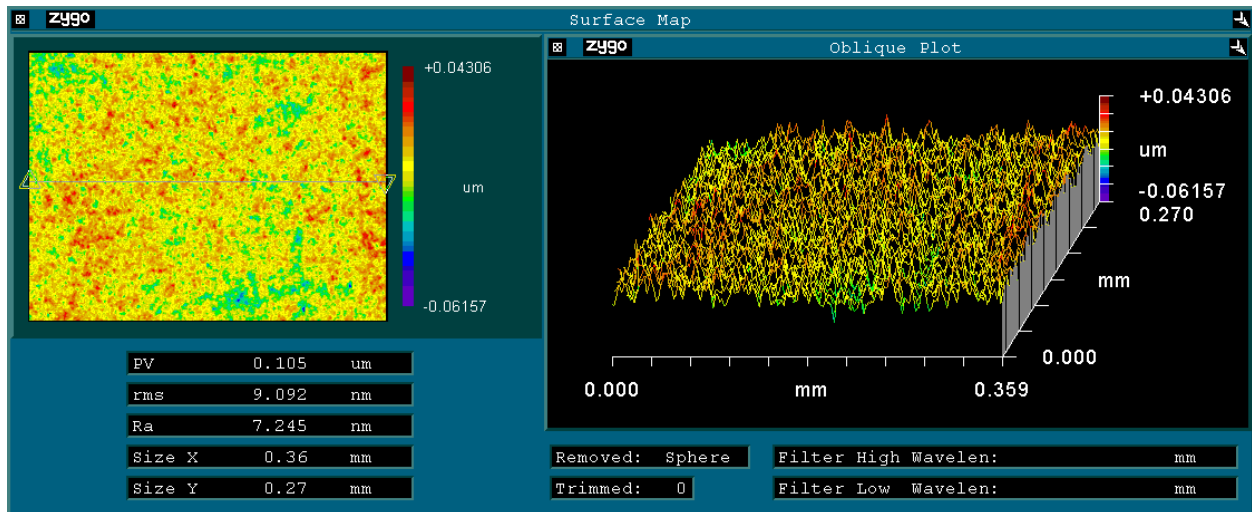
Figure 5: Main View of 3rd Area

Figure 5 shows the main view of the 3<sup>rd</sup> area, which again is similar. It appears rougher in the image because of the scaling.

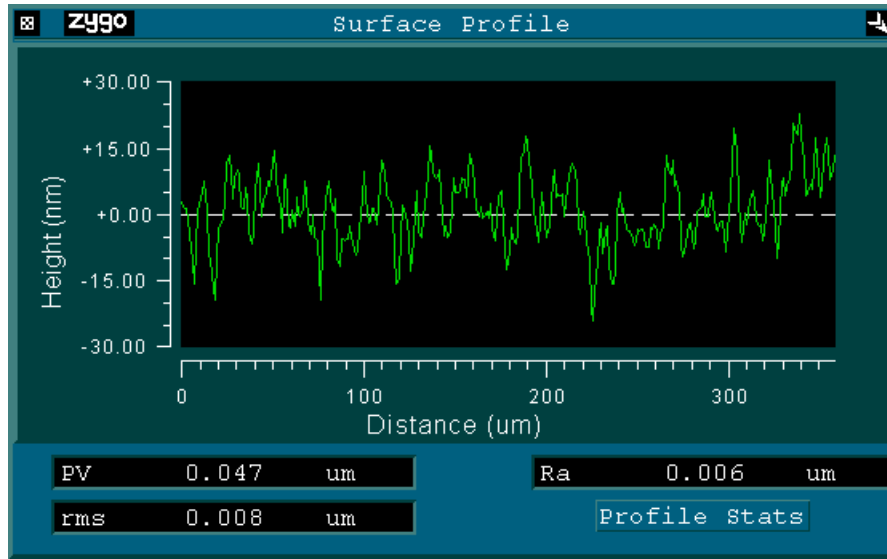
Figure 6: Profile of Area 3

Figure 6 is the profile along the line in Fig. 5, again similar.

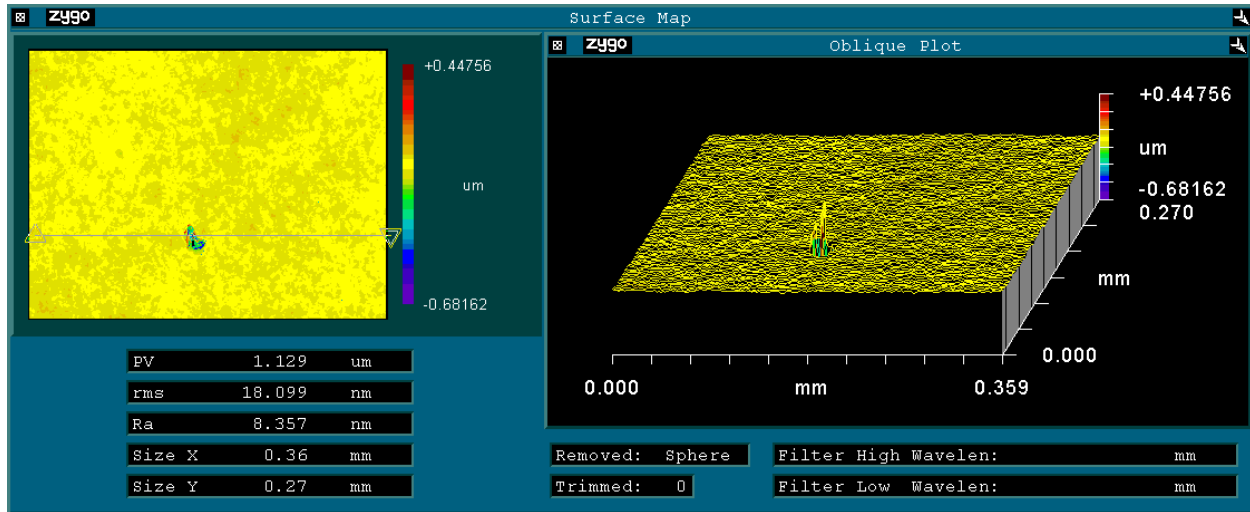
Figure 7: Main View of Area 4 with Pit

Figure 7 shows a region with a large deep pit, of which there are many in the sample. The pit is about 800 nm deep (about 31 micrometers). This is the 4<sup>th</sup> region imaged.

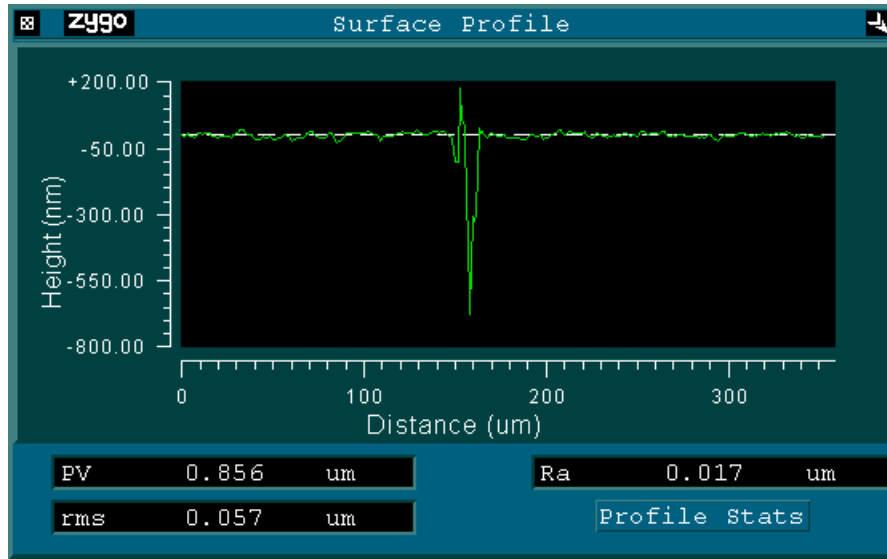
Figure 8: Profile of Area 4 Across Deep Pit

The pit depth can be seen in Fig. 8, the profile along the line shown on Fig. 7. Chris says that the Zygo cannot image the shapes of these deep pits very well, so the details of the pit geometry are not reliable.

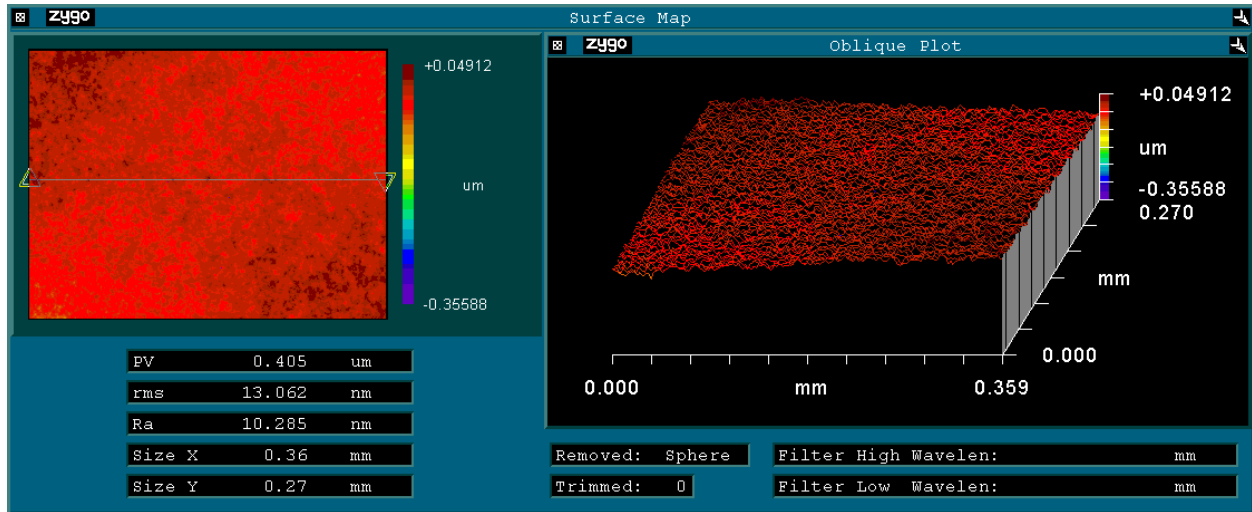
Figure 9: Main View of Area 5

Figure 9 shows the 5<sup>th</sup> and final area. This shows significant waviness, causing a significant increase in rms roughness to 13.1 nm or 0.5 microinches.

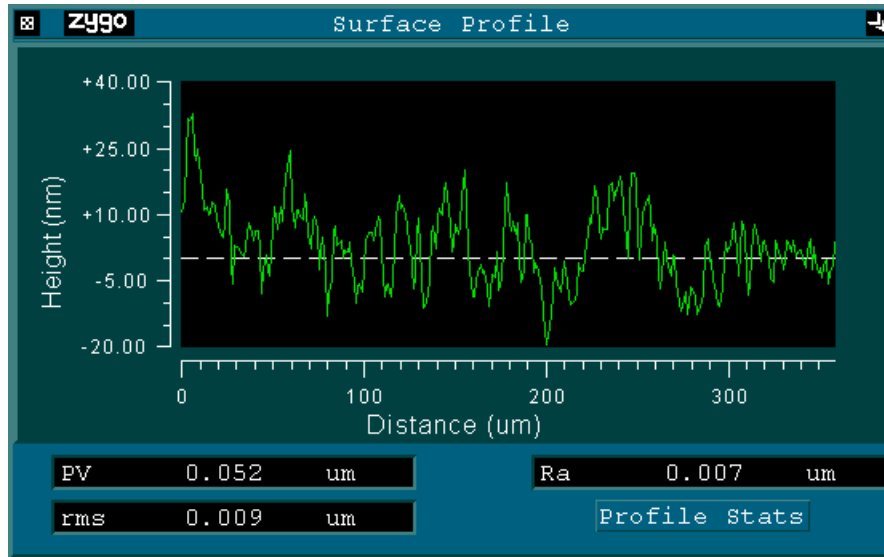
**Figure 10: Profile Across Area 5**

Figure 10 shows the profile across the line. Peak roughness of about 25 nm is also visible (this is about 1 microinch).
