S.P. Schneider, Purdue University, School of AAE, 765-494-3343, 21 May 1999
 Measurements by Chris Tieche, Purdue University, School of AAE.

Zygo Optical Profilometer Measurements of Hard Nickel Coupon: Sample Tests for Mach-6 Quiet-Flow Nozzle Throat

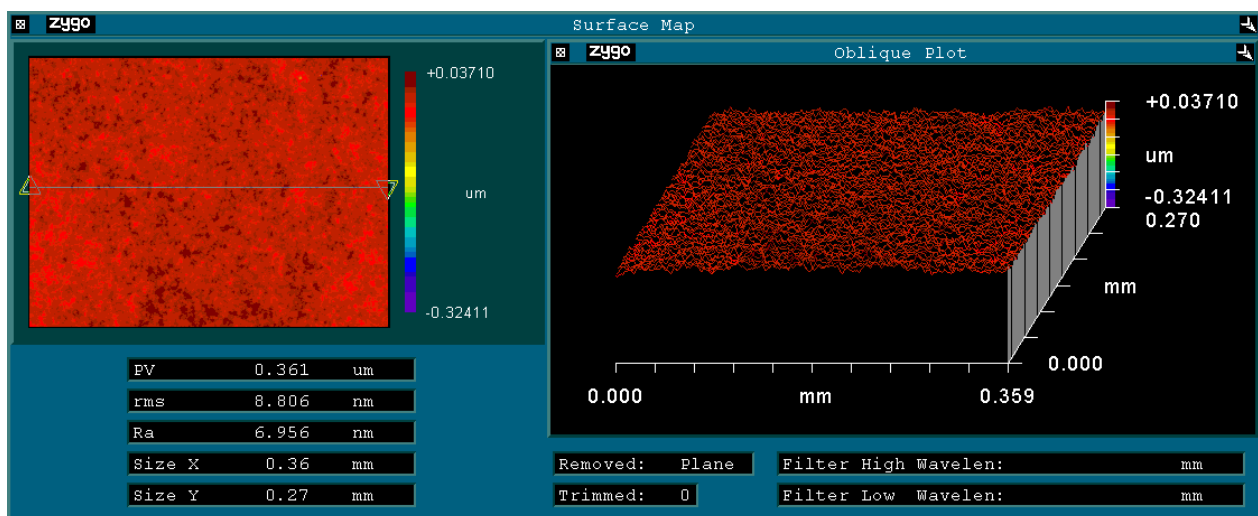
Figure 1: Area 1, Main View

Figure 1 shows the results of the first Zygo image. The rms is 8.81 nm (0.34 microinches), Ra = 6.96 nm, the max. deviation is about 40 nm, and the image size is 0.36 x 0.27 mm. This section has a very good finish.

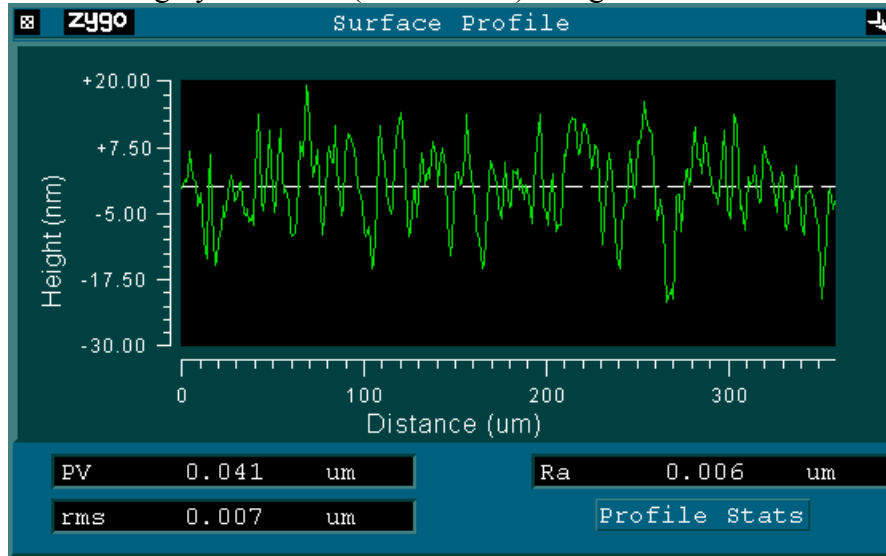
Figure 2: Profile of Area 1 along Indicated Line

Figure 2 shows a surface profile along the line indicated on the left-hand side of Figure 1. The peak deviation is roughly 20-25 nm (1 microinch) along this line.

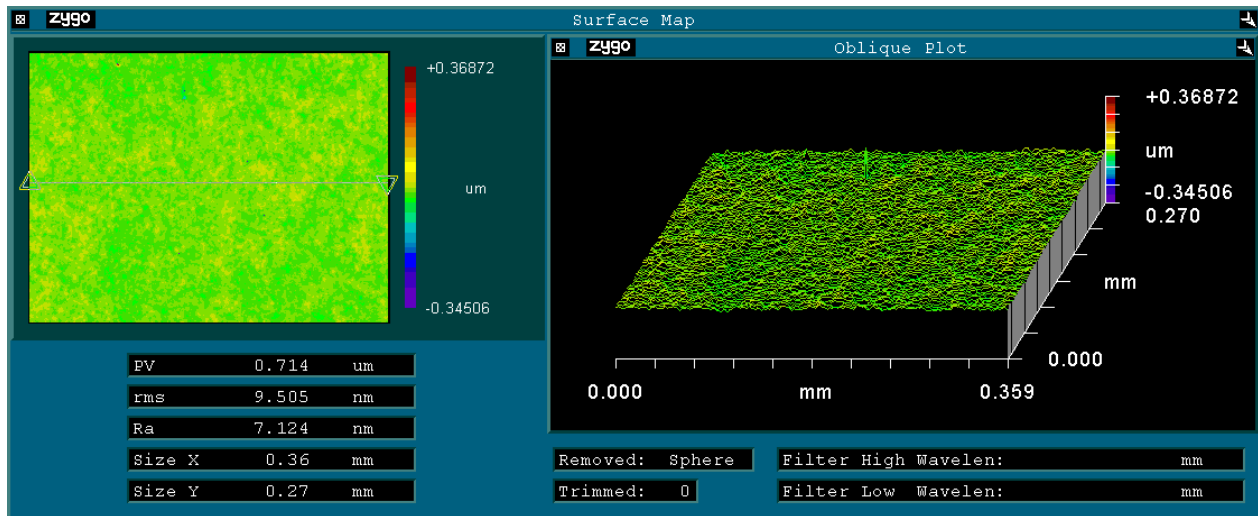
Figure 3: Main Image of Second Area

Figure 3 shows the main view of the second area. The roughness is similar.

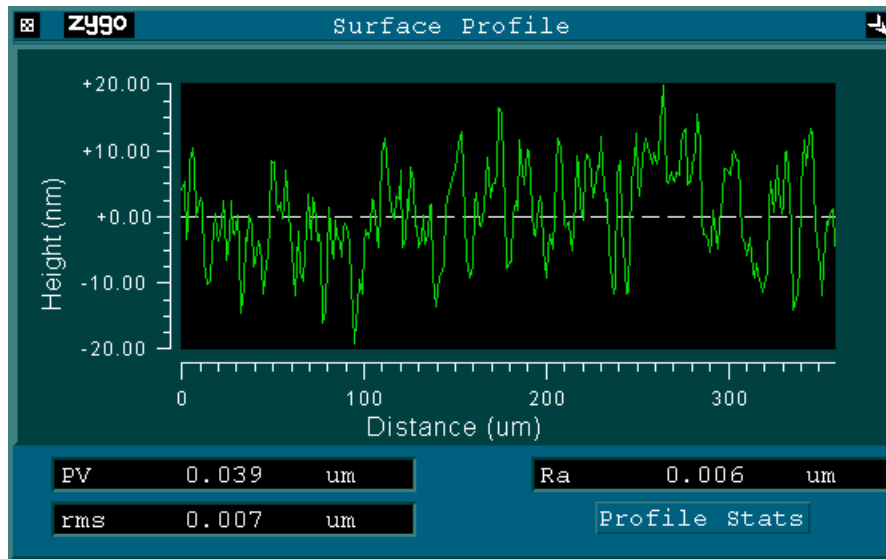
Figure 4: Profile of Second Area

Figure 4 shows the profile along the line drawn on Fig. 3. The profile again looks similar.

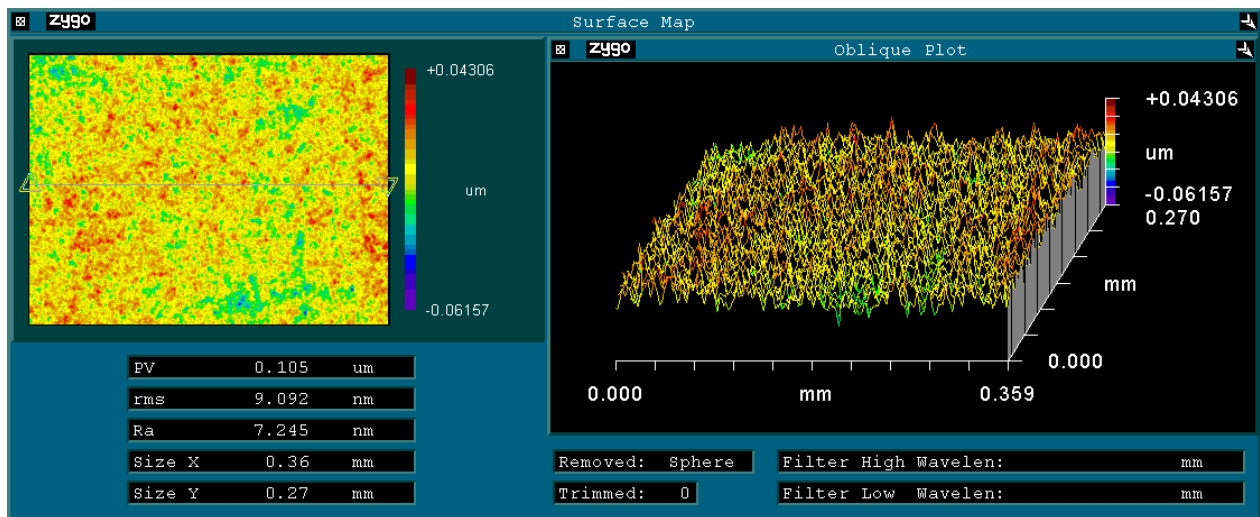
Figure 5: Main View of 3rd Area

Figure 5 shows the main view of the 3rd area, which again is similar. It appears rougher in the image because of the scaling.

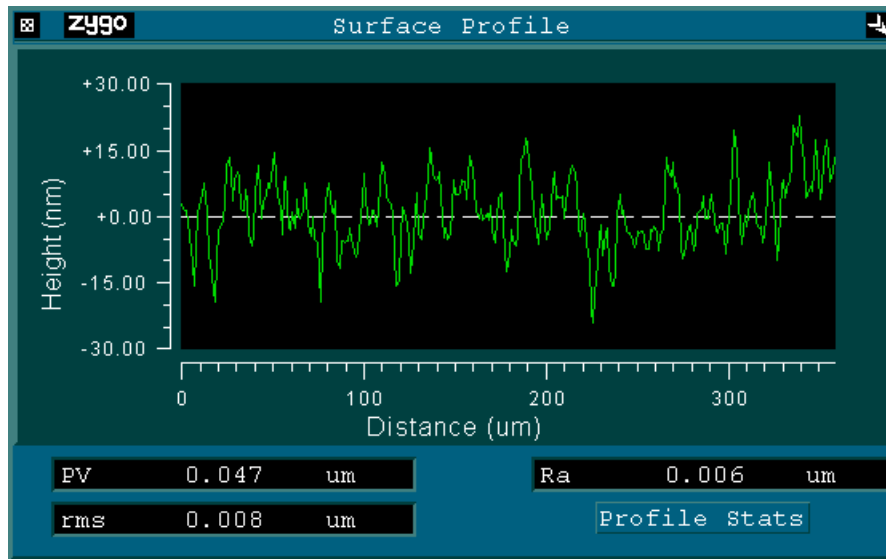
Figure 6: Profile of Area 3

Figure 6 is the profile along the line in Fig. 5, again similar.

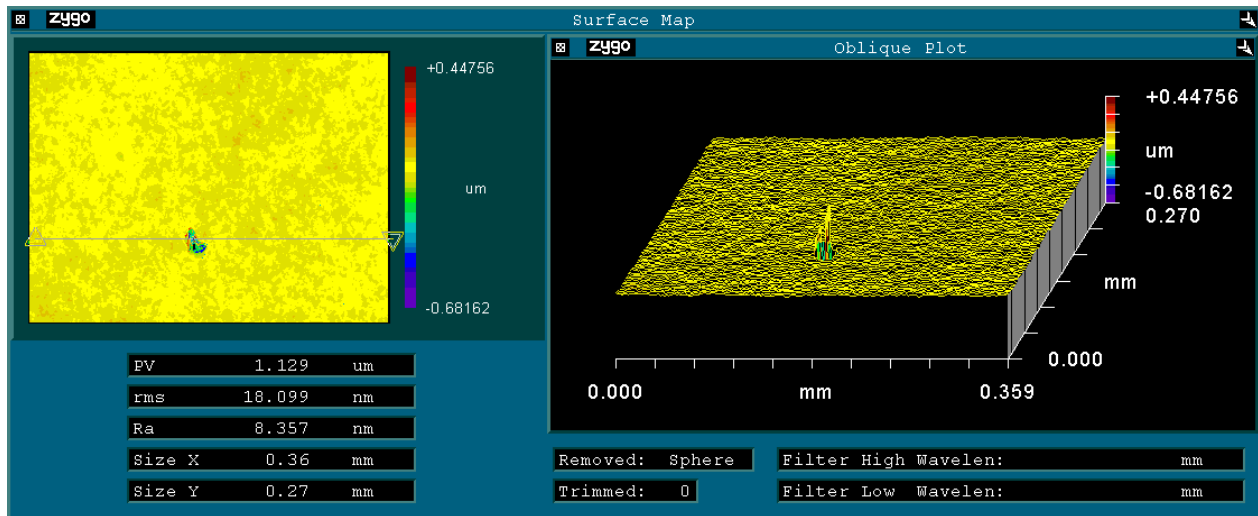
Figure 7: Main View of Area 4 with Pit

Figure 7 shows a region with a large deep pit, of which there are many in the sample. The pit is about 800 nm deep (about 31 micrometers). This is the 4th region imaged.

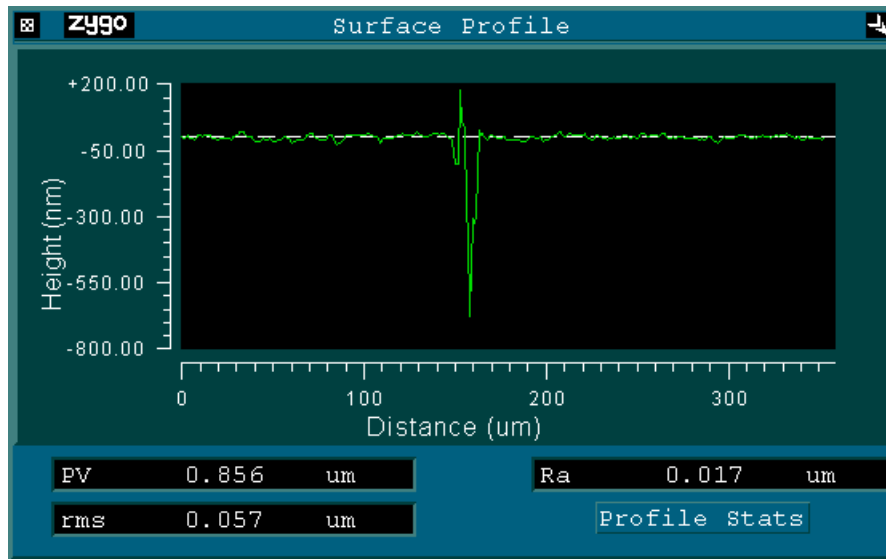
Figure 8: Profile of Area 4 Across Deep Pit

The pit depth can be seen in Fig. 8, the profile along the line shown on Fig. 7. Chris says that the Zygo cannot image the shapes of these deep pits very well, so the details of the pit geometry are not reliable.

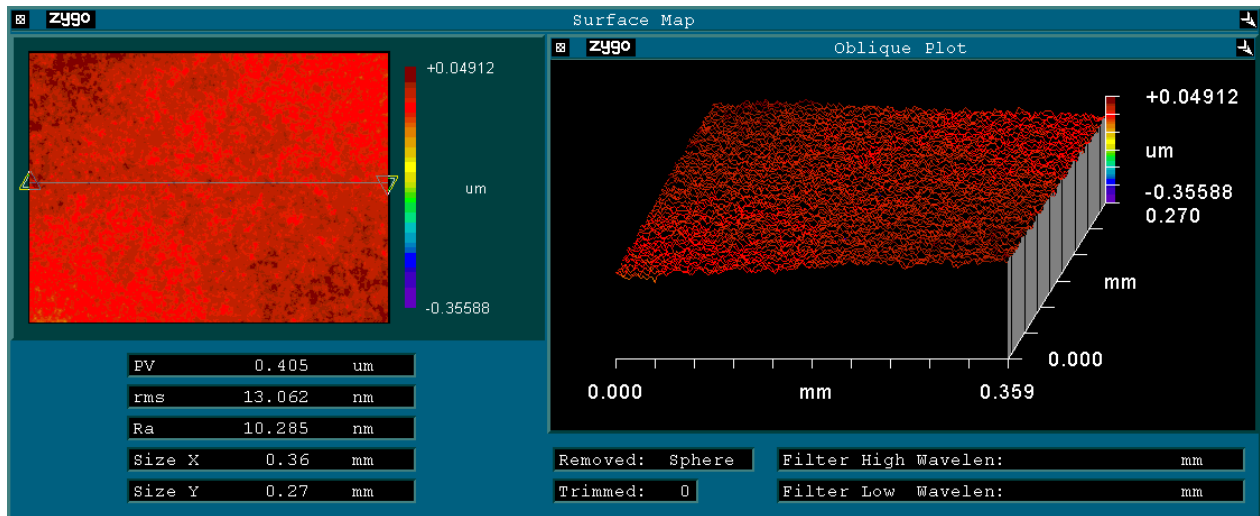
Figure 9: Main View of Area 5

Figure 9 shows the 5th and final area. This shows significant waviness, causing a significant increase in rms roughness to 13.1 nm or 0.5 microinches.

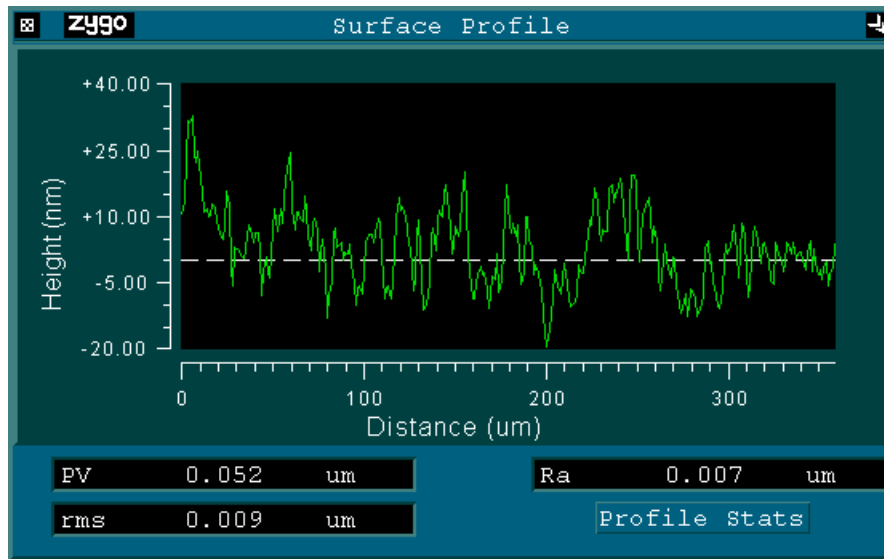
Figure 10: Profile Across Area 5

Figure 10 shows the profile across the line. Peak roughness of about 25 nm is also visible (this is about 1 microinch).
