S.P. Schneider, Purdue University, School of AAE, 765-494-3343, 19 May 1999
Measurements by Chris Tieche, Purdue University, School of AAE.
Modified 24 May 1999 to add section 6 regarding further tests.

Zygo Optical Profilometer Measurements of Soft Nickel Coupon: Sample Tests for Mach-6 Quiet-Flow Nozzle Throat

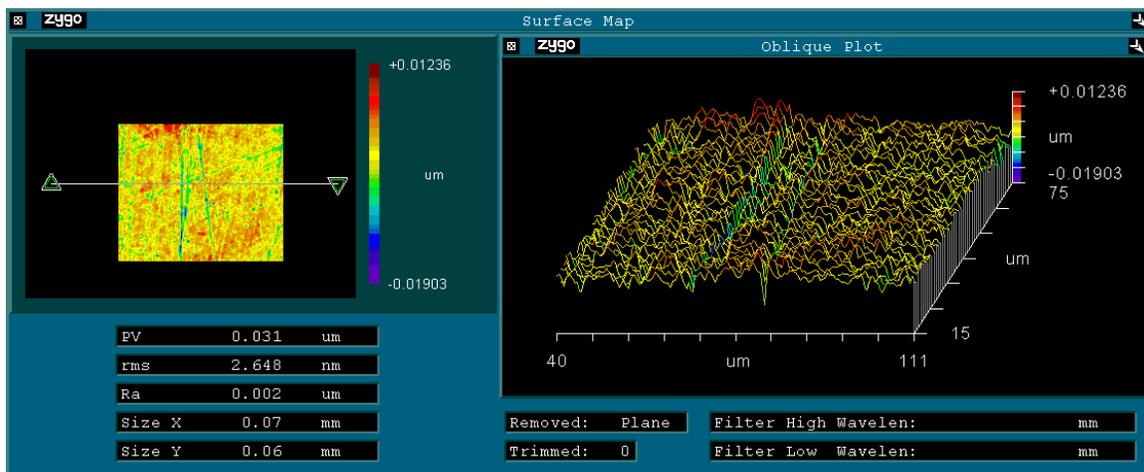
Figure 1: Top View of Polished Area, Portion 1

Figure 1 shows a top view of the area selected for the first measurement. The rms roughness is 2.6 nm and the Ra roughness is 0.002 microns (0.1 microinches). No scratches were evident on the surface.

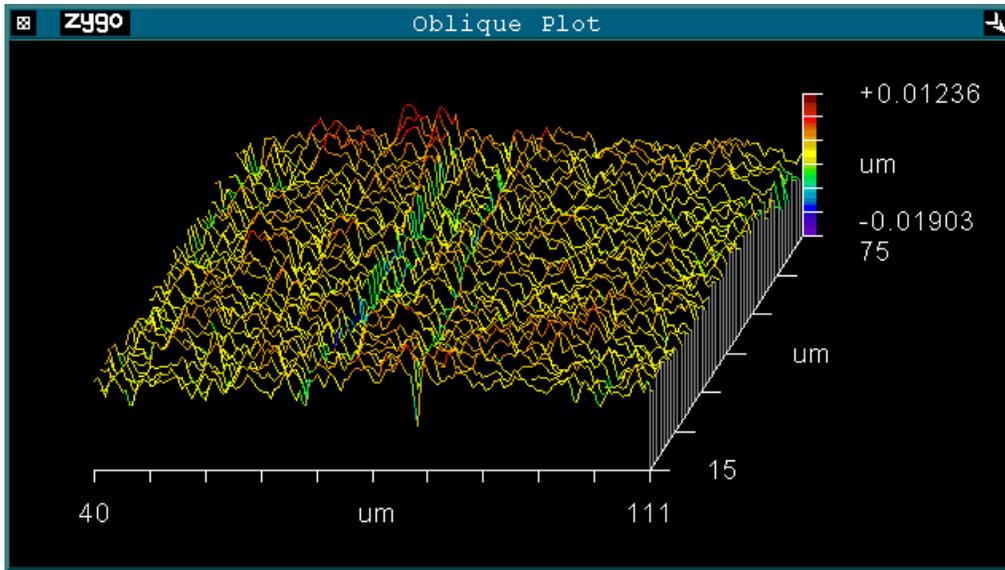
Figure 2: Oblique View of Polished Area, Portion 1

Figure 2 shows an oblique closeup view of the same area. These are available for each view but will mostly be omitted since they duplicate a portion of the image in Fig. 1.

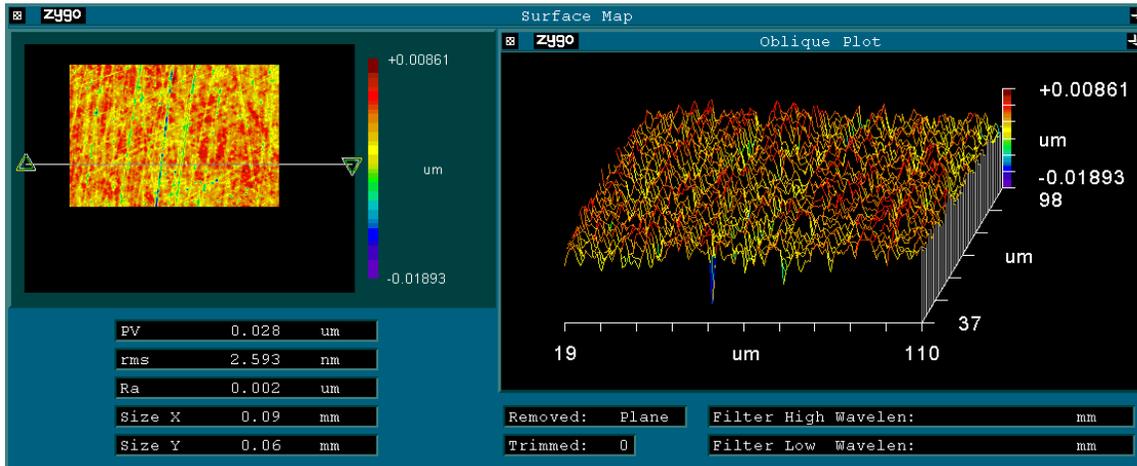
Figure 3: Polished Area, Portion 2

Figure 3 shows an image similar to Fig. 1, but from a different portion of the polished surface. Here, the rms roughness is 2.6 nm, again, and Ra=0.002 microns (almost the same value, a slightly different definition).

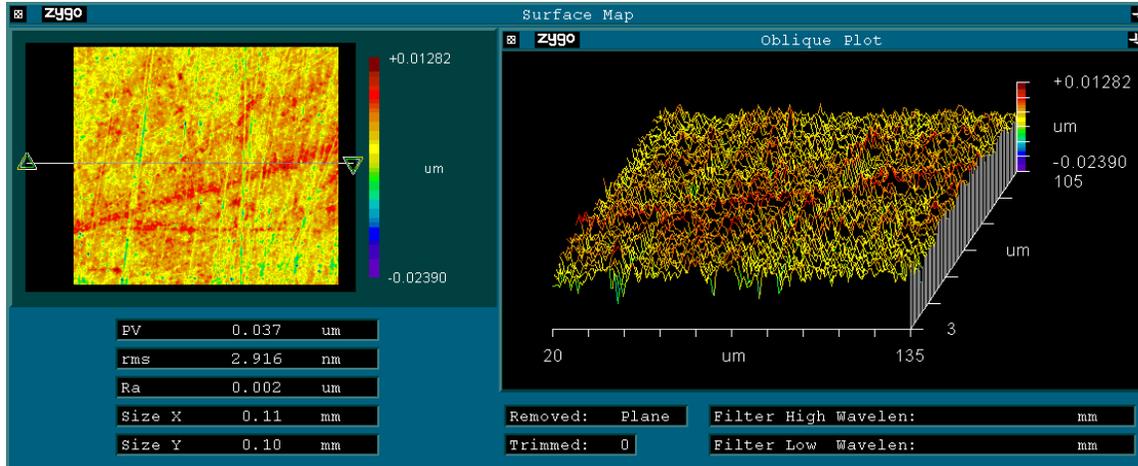
Figure 4: Polished Area, Larger Area Scan, Portion 3

A larger area was scanned for portion 3, so that scratches were integrated into Ra and the rms roughness. The rms is now slightly increased to 2.9 nm, as shown in Figure 4. Some scratches can be seen in the figure. However, the roughness is still within about 0.02 microns peak, or about 0.8 microinches.

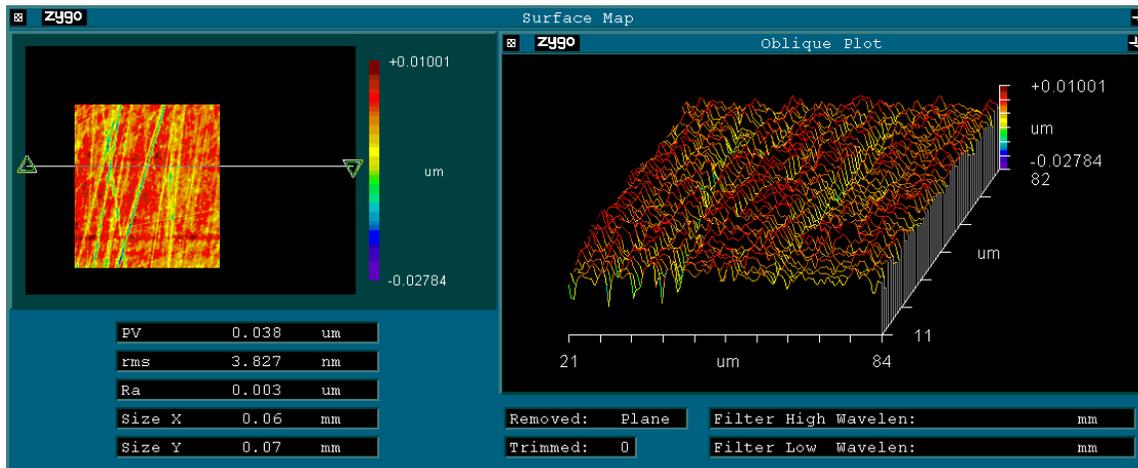
Figure 5: Polished Area, Portion 4, Some 'Deep' Scratches

Figure 5 shows another part of the polished surface, including several relatively deep scratches, about 0.025 microns deep (about 1 microinch).

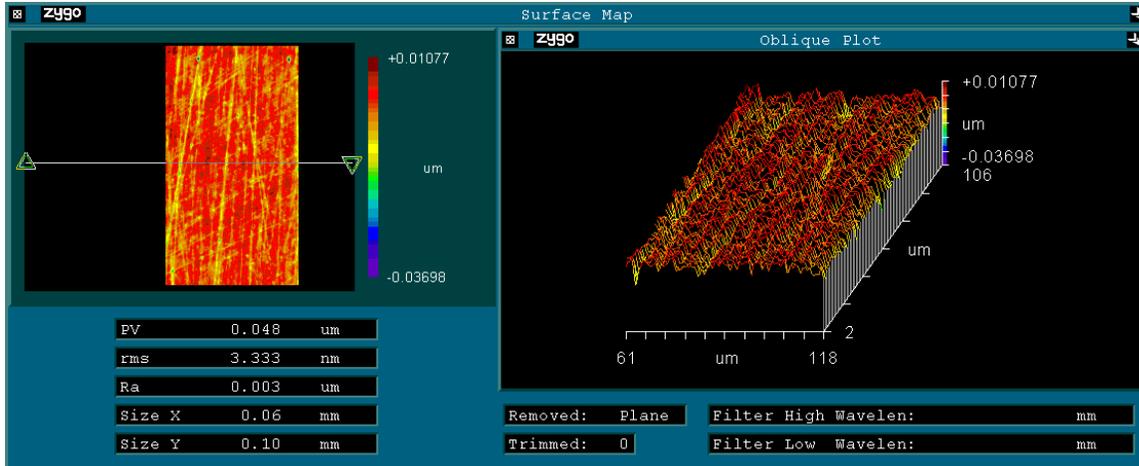
Figure 6: Polished Area, Portion 5, Larger Area Scan

Finally, Figure 6 shows the fifth image of the polished area. In this figure, a still larger area is imaged. The rms roughness has increased to 3.3 nm in this image, still about 0.13 microinches. The maximum deviations are still about 0.03 microns, or about 1 microinch, a very high quality finish.

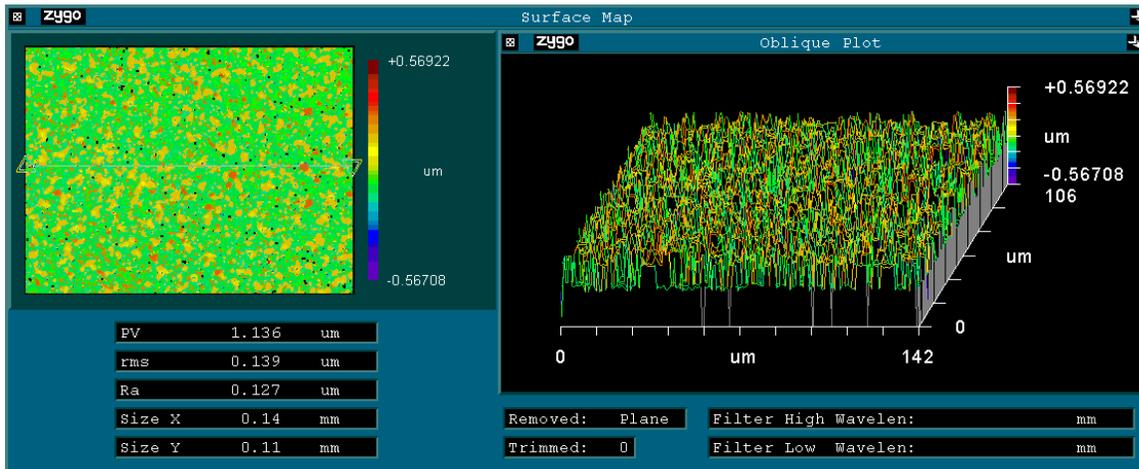
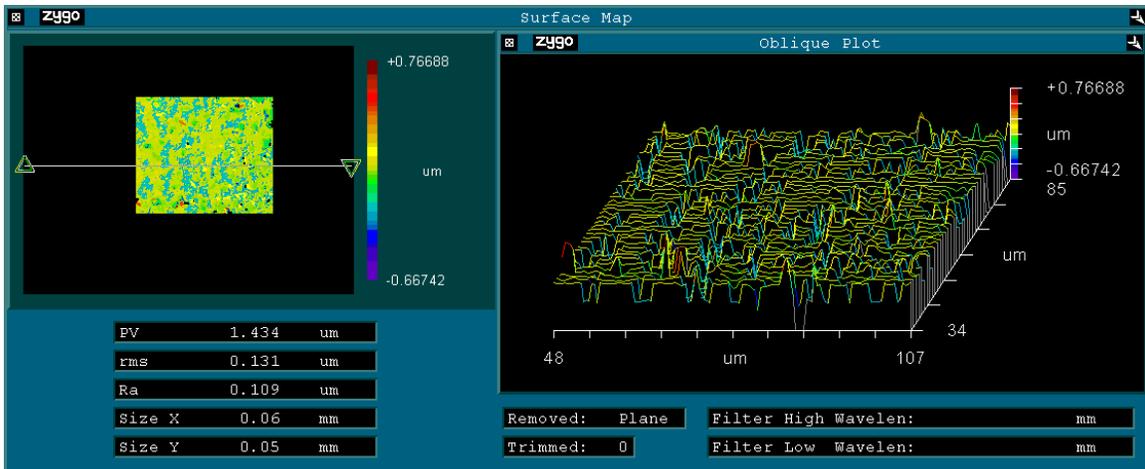
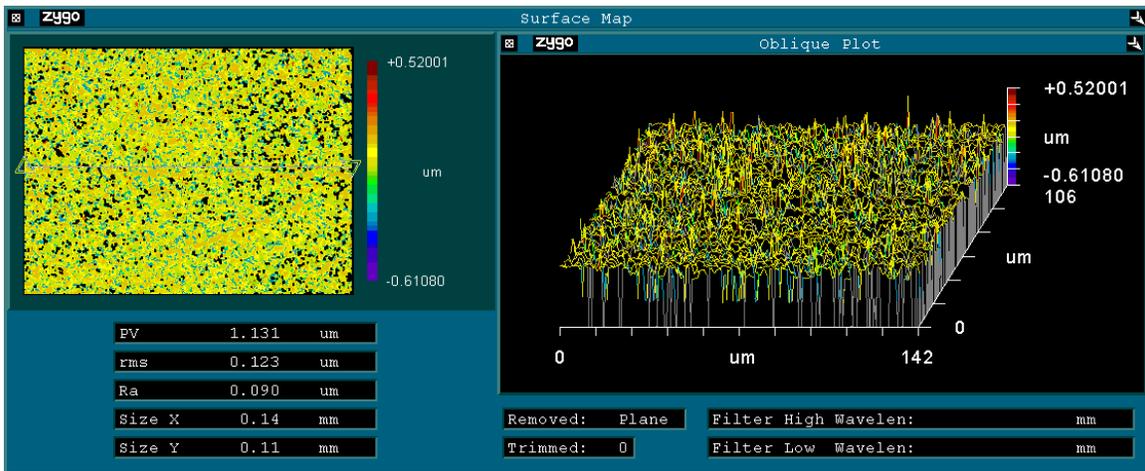
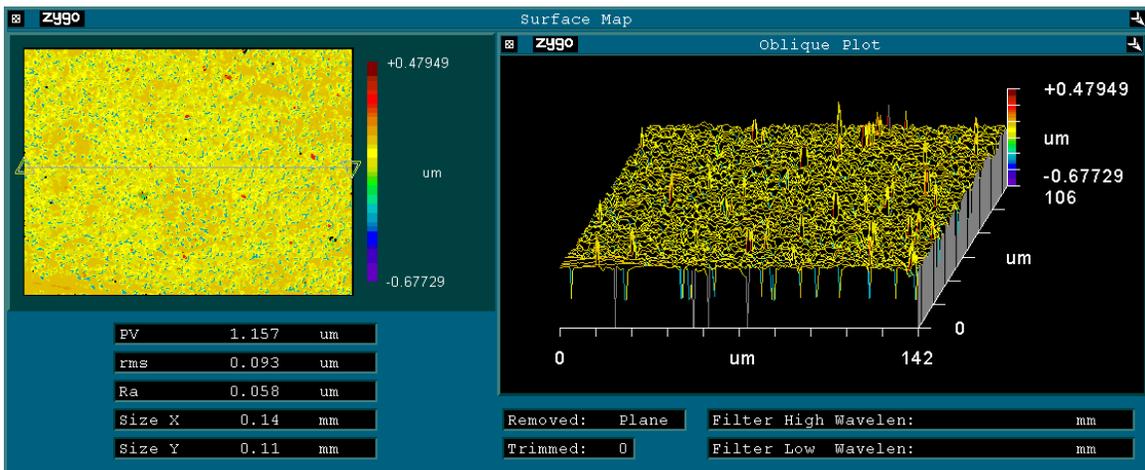
The next set of images were obtained on the “oxidized” surface. This is the area that was not polished. It was initially mirror-like, but became cloudy looking to the eye after being heated. It was never polished. Figures 7-11 show the 5 portions imaged by Chris.

The rms roughness ranges from 0.09 to 0.14 micrometers, or from 3.5 to 5.5 microinches. The peak deviations are roughly 0.8 microns, or about 31 microinches, a value that is very significant in terms of generating throat roughness that would adversely impact quiet-flow performance. These roughness values are much higher than the ones for the polished surface. Unfortunately, no Zygo data was taken before the specimens were first put in the oven, so we cannot verify directly that the temperature generated the roughness from what appeared to be an initially mirror smooth specimen. However, we have verified that once the nickel is polished, after initial heating, it remains smooth after further heating.

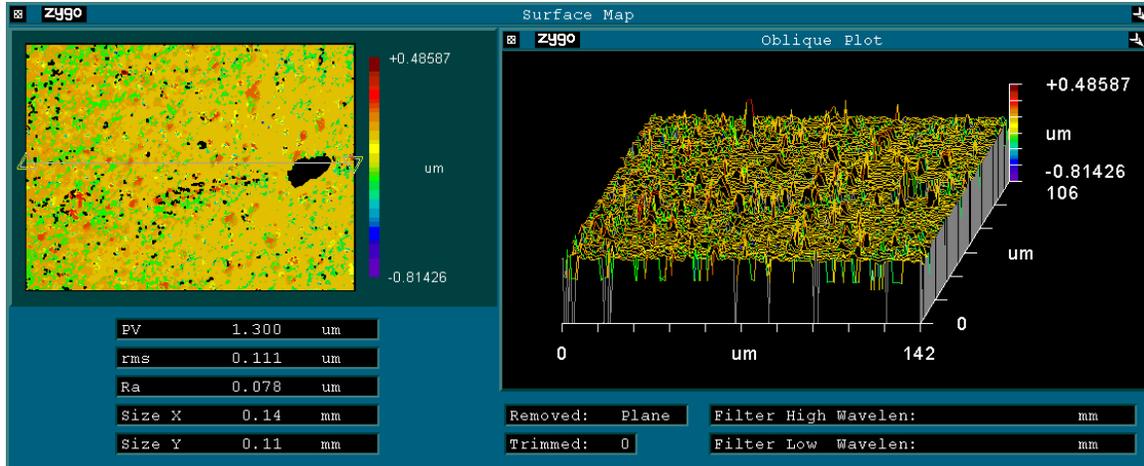
Figure 11: Unpolished Area, Portion 5, Large Cavity on Right-Hand Side

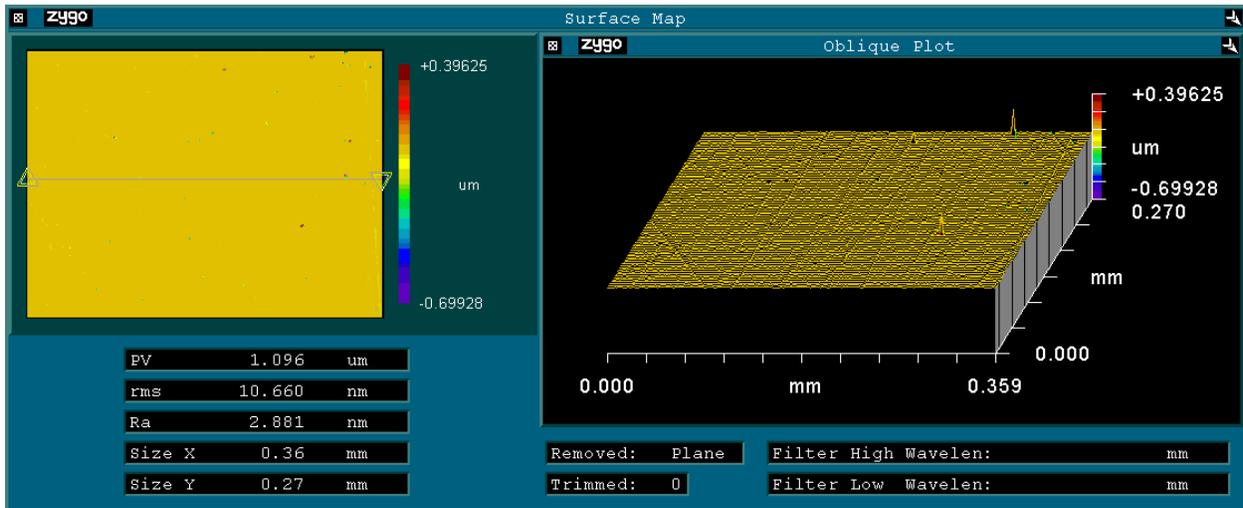
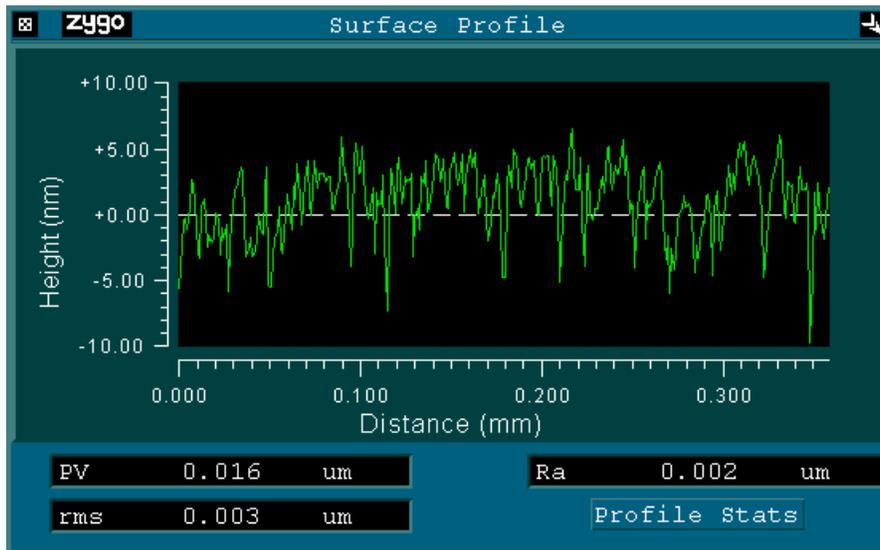
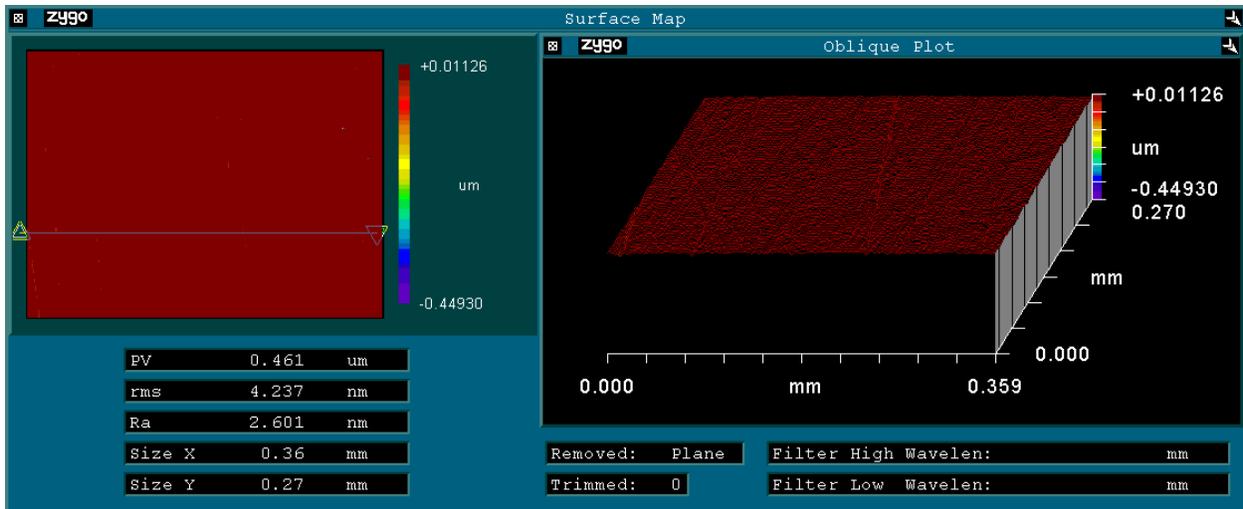
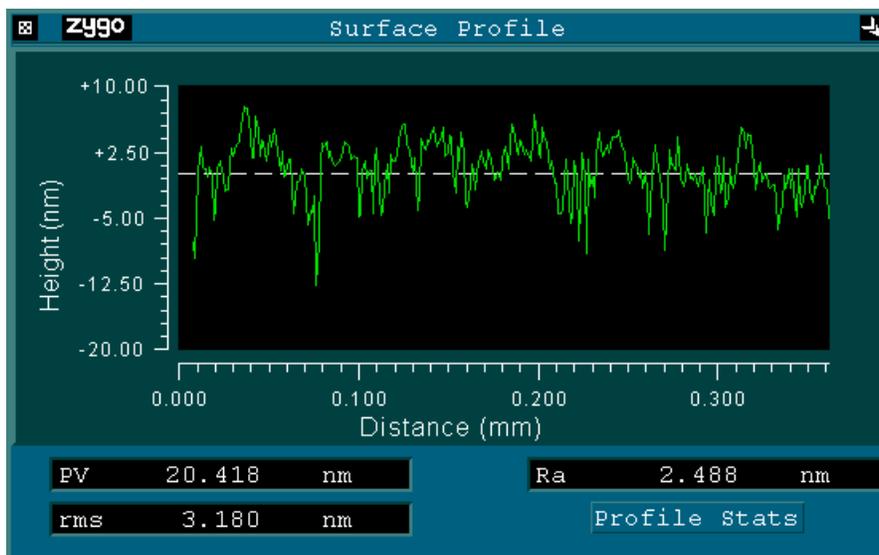
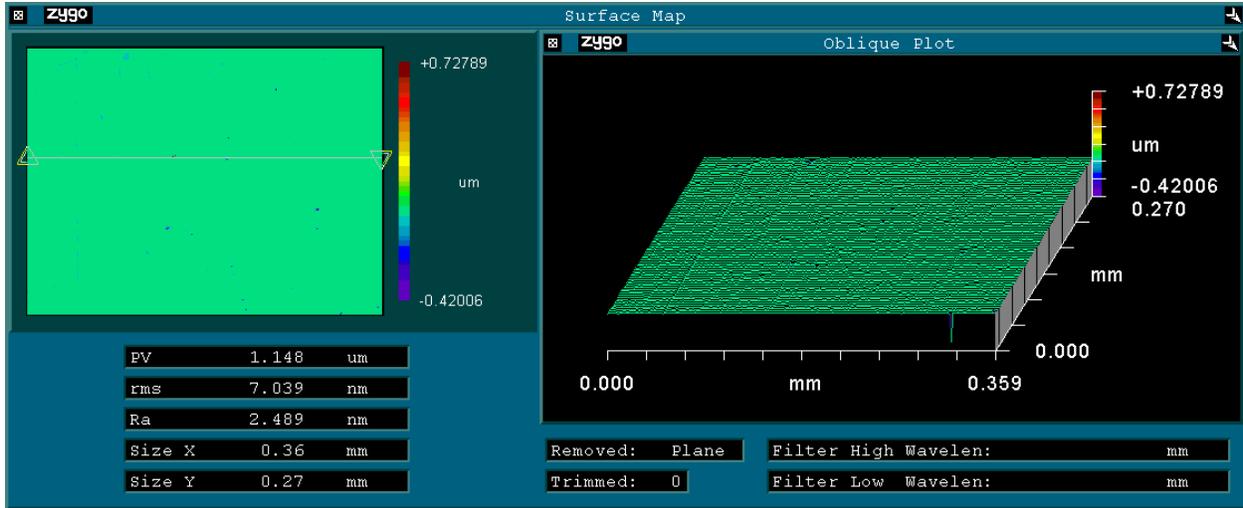
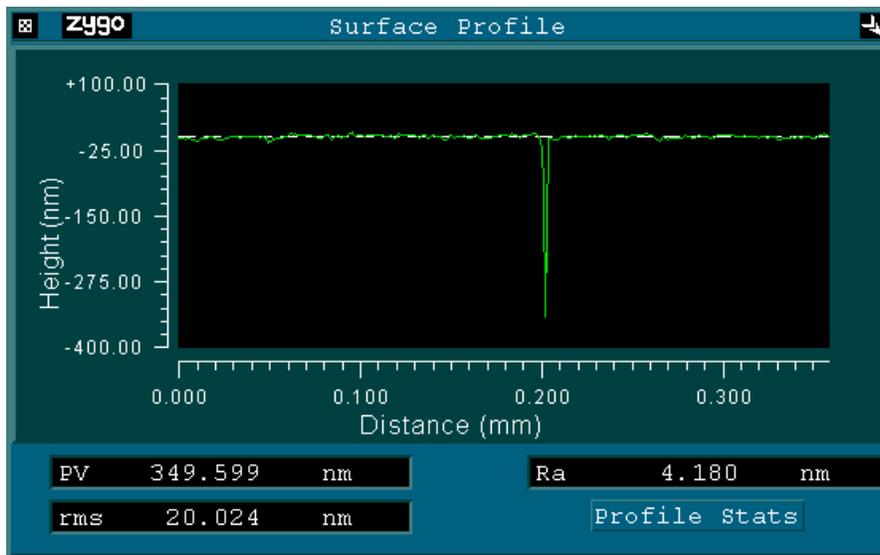
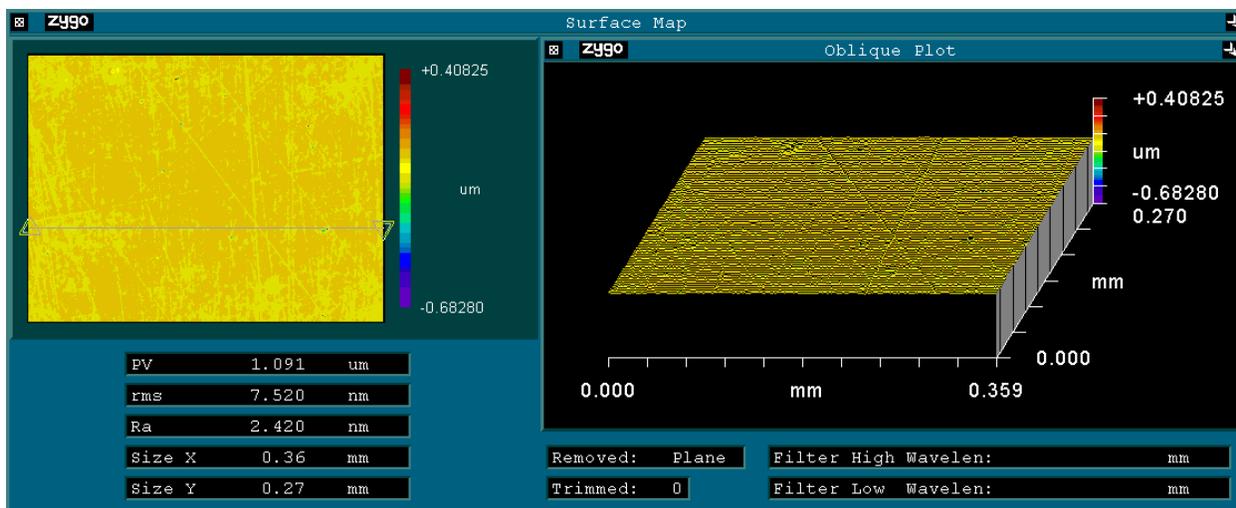
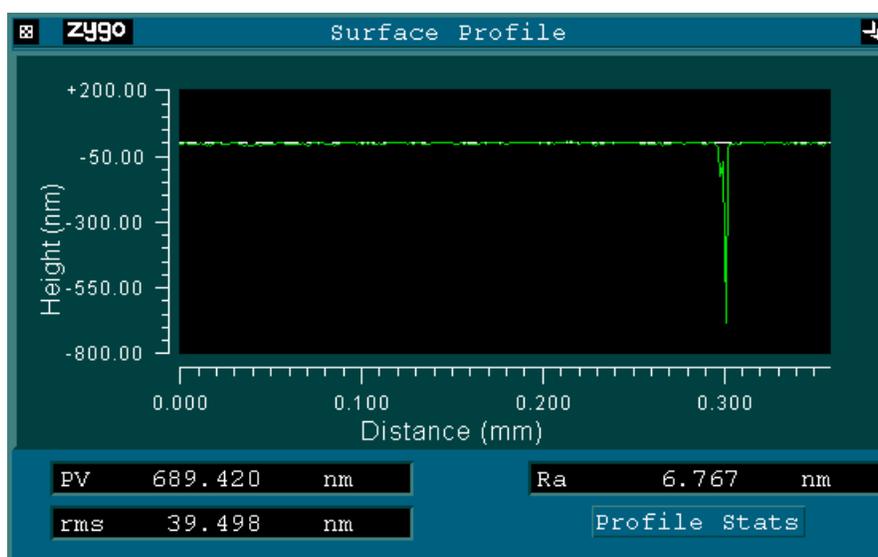
Figures 12-19 show the images corresponding to this data, for the smooth side. The 5th area imaged was not recorded, so no files are available to show here.

The rms values of roughness for the 5 portions are 10.6, 4.2, 7.0, 7.5, and 3.5 nm. Before this second heating cycle, the rms values for 5 (different) portions were 2.6, 2.6, 2.9, 3.3, and 3.8 nm. However, those earlier measurements were for smaller areas, 0.06 x 0.10 mm, so they probably have smaller rms values, since they won't include as many large scratches. The values of Ra before the 2nd heating cycle were 0.002, 0.002, 0.002, 0.003, and 0.003 micrometers, or 2-3 nm. After the 2nd heating cycle, the values were 2.8, 2.6, 2.5, 2.4, and 2.3 nm. This suggests that the 2nd heating cycle did not degrade the polished surface. I conclude that **the nickel itself is not degraded by the 425F temperature, only the initial surface layer was a problem.**

The smooth electroform still contains a number of large pits. These remain a concern, although the Ra values are low.

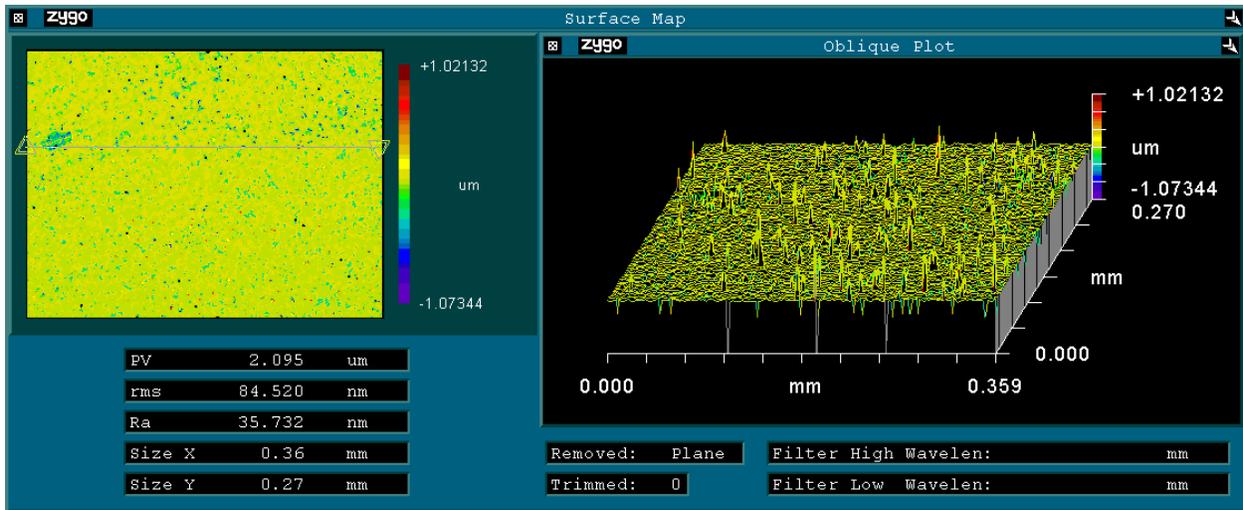
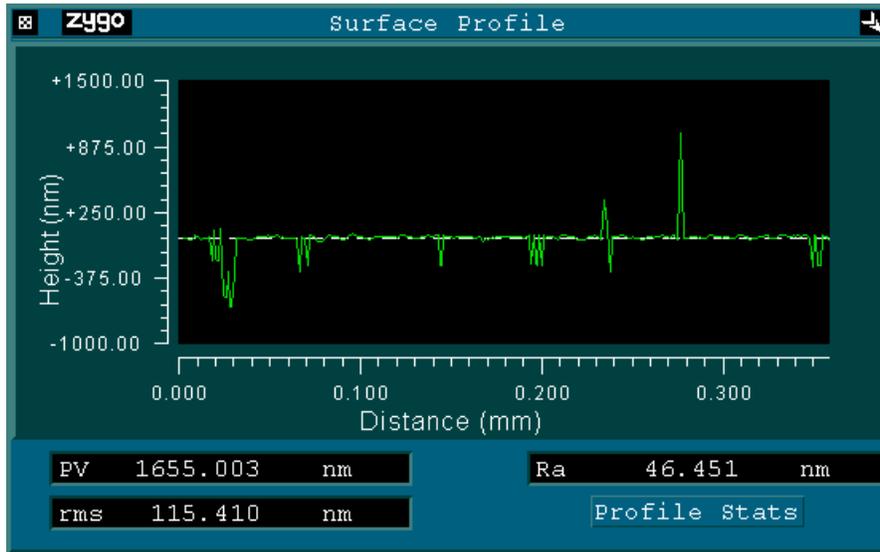
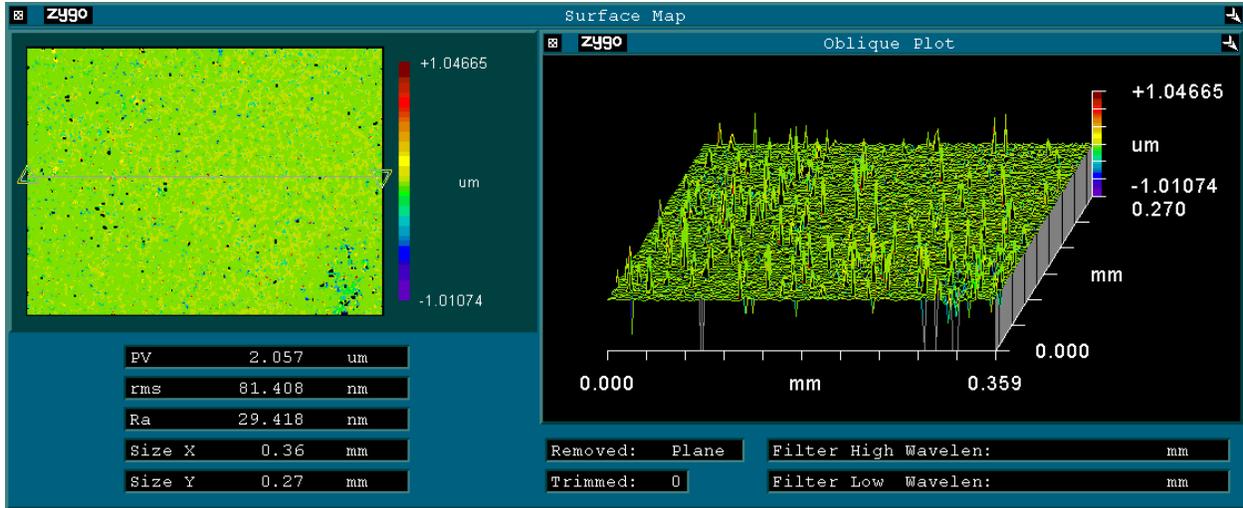
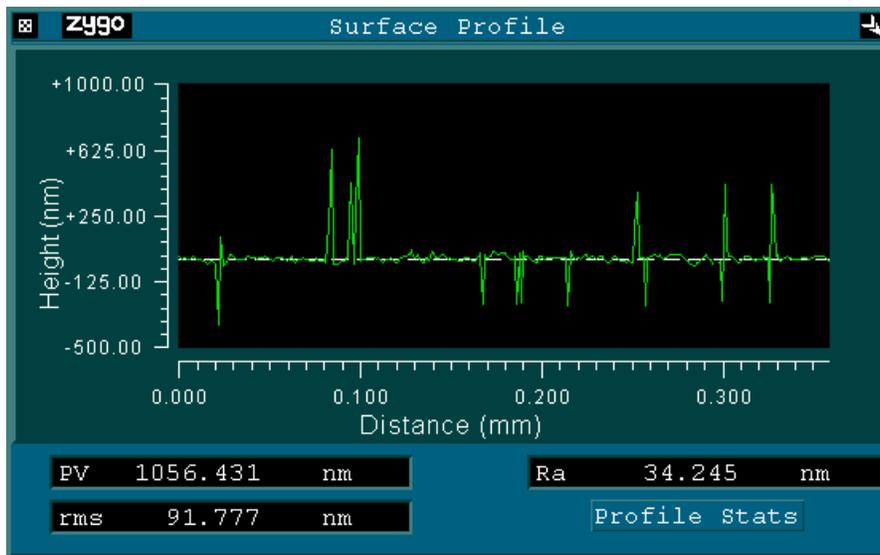
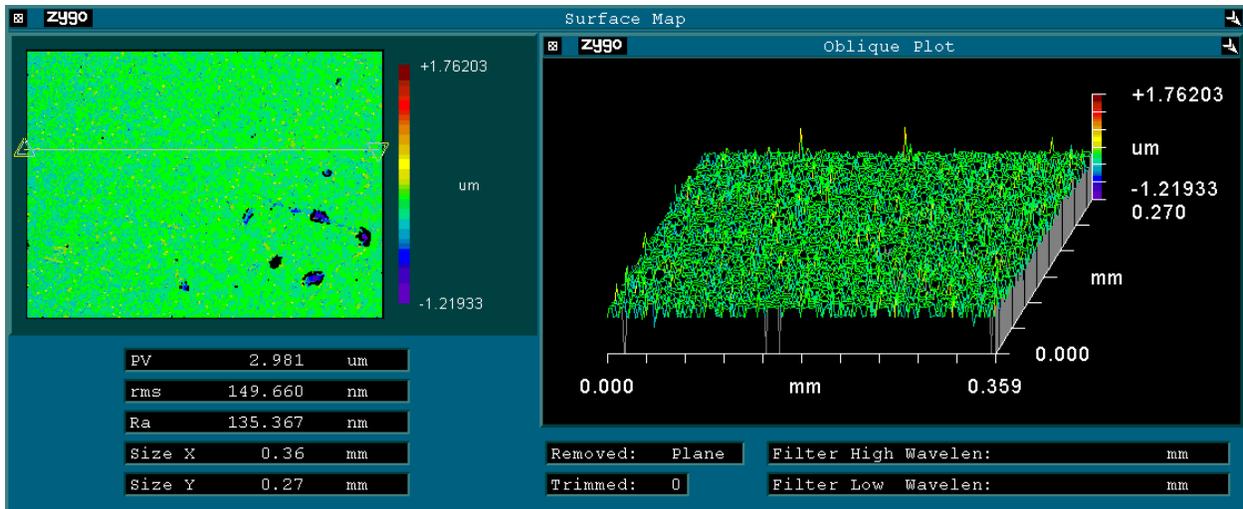
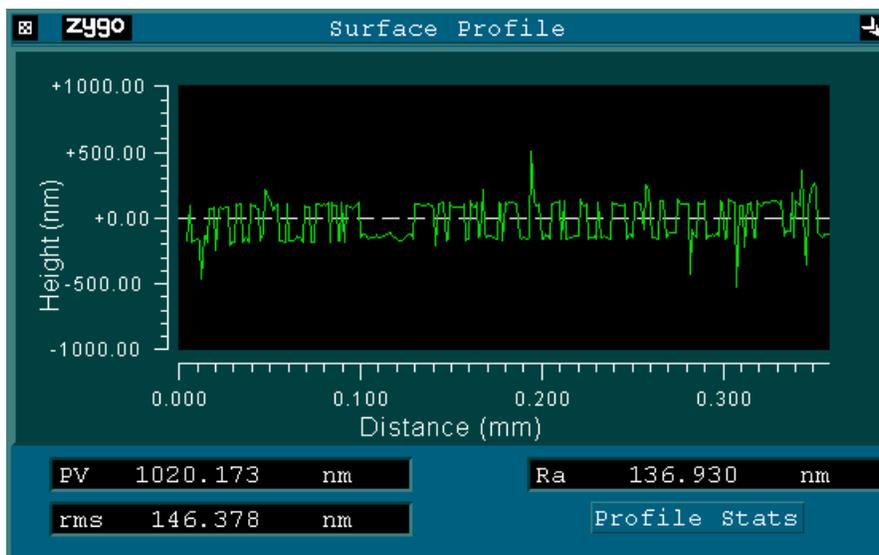
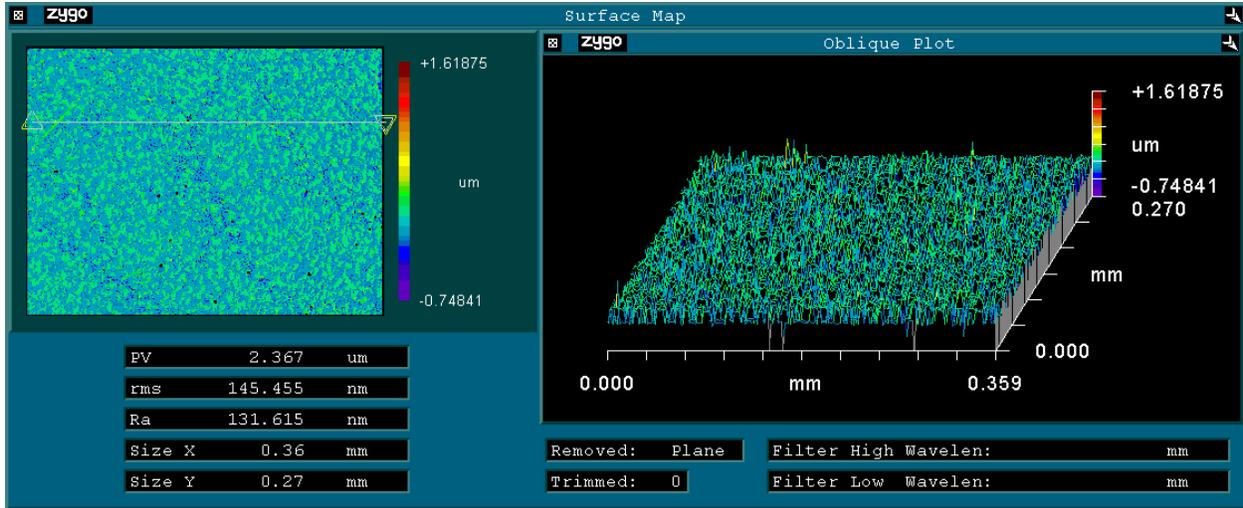
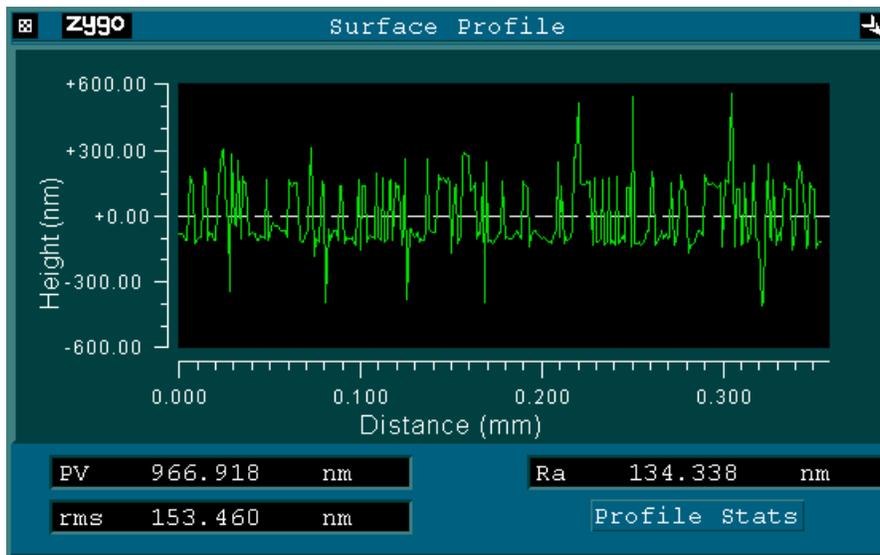
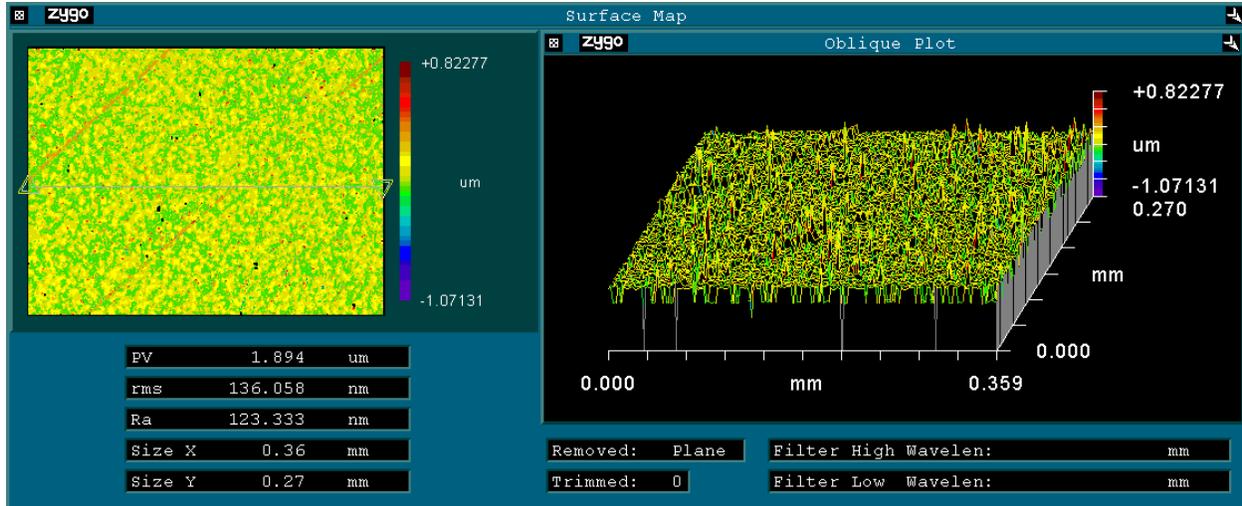
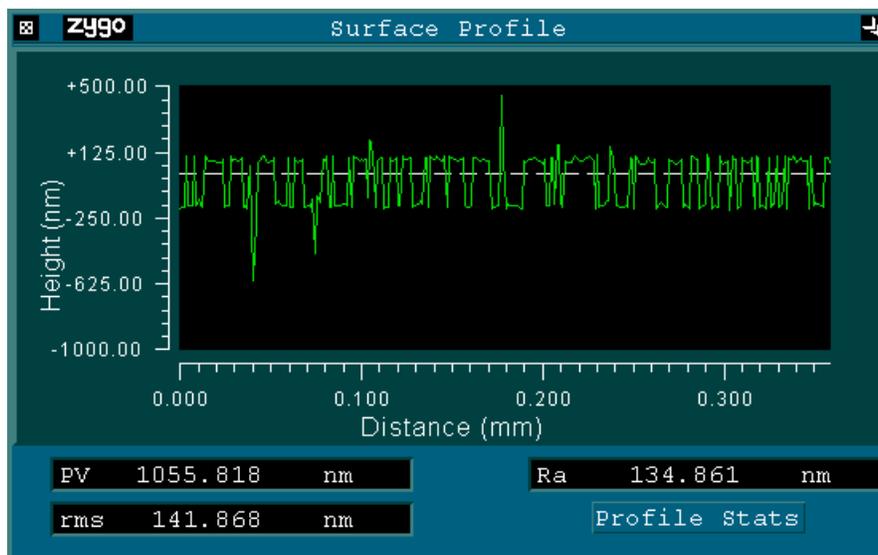
Figures 20-29 show the data for the rough side.

The values of Ra on the cloudy or rough surface before this 2nd heating were 0.13, 0.11, 0.09, 0.06, and 0.08 micrometers, or 80-130 nm. After the 2nd heating, the values were 36, 29, 135, 131, 123 nm. It appears that the 2nd heating did not noticeably further degrade the cloudy surface either. The square-wave-like profiles may be the remains of the silver layer. If so, they are about 300 nm or 10 micrometers thick. In any case, the cloudy surface would be unacceptable for a quiet nozzle throat.
