S.P. Schneider, Purdue University, School of AAE, 765-494-3343, 19 May 1999  
Measurements by Chris Tieche, Purdue University, School of AAE.  
Modified 24 May 1999 to add section 6 regarding further tests.

## Zygo Optical Profilometer Measurements of Soft Nickel Coupon: Sample Tests for Mach-6 Quiet-Flow Nozzle Throat

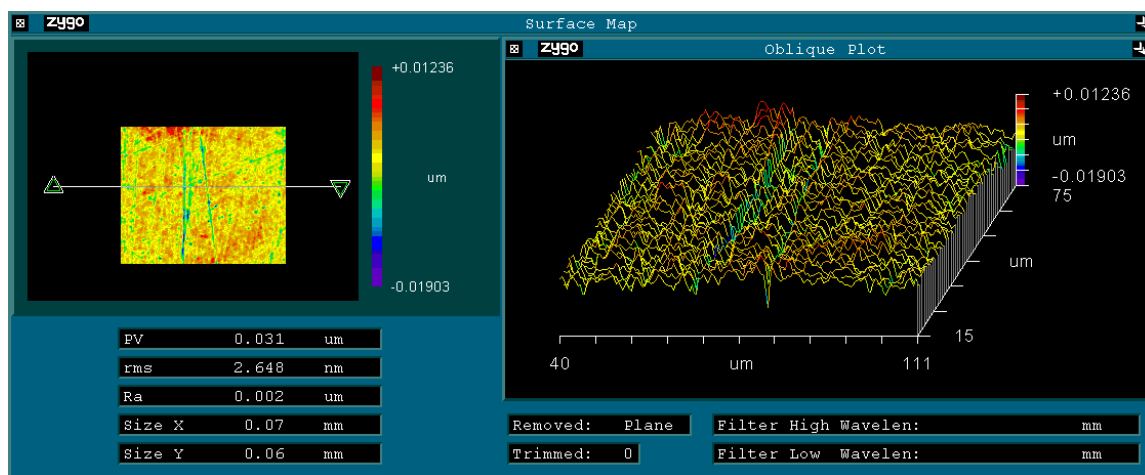
**Figure 1: Top View of Polished Area, Portion 1**

Figure 1 shows a top view of the area selected for the first measurement. The rms roughness is 2.6 nm and the Ra roughness is 0.002 microns (0.1 microinches). No scratches were evident on the surface.

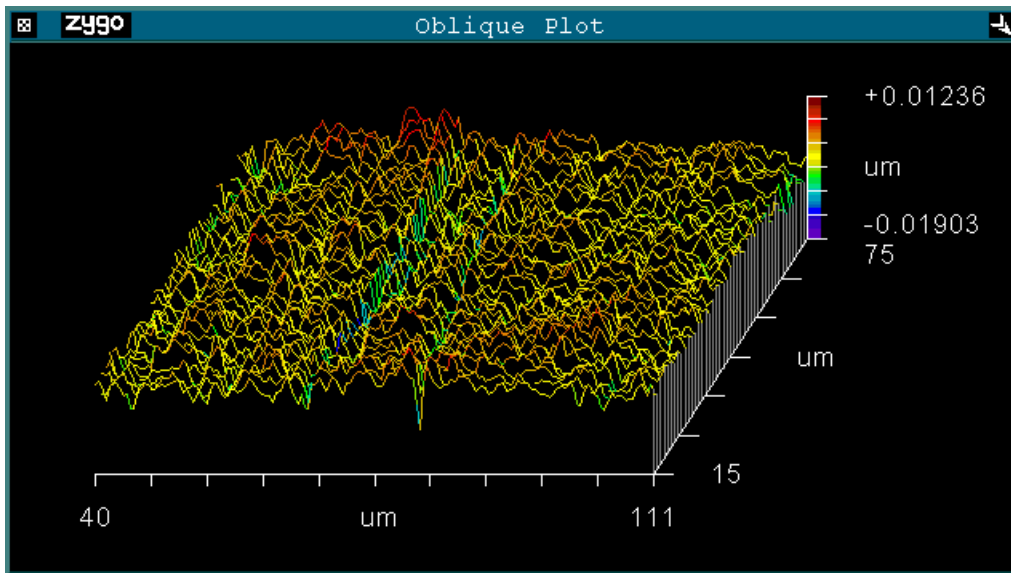
**Figure 2: Oblique View of Polished Area, Portion 1**

Figure 2 shows an oblique closeup view of the same area. These are available for each view but will mostly be omitted since they duplicate a portion of the image in Fig. 1.

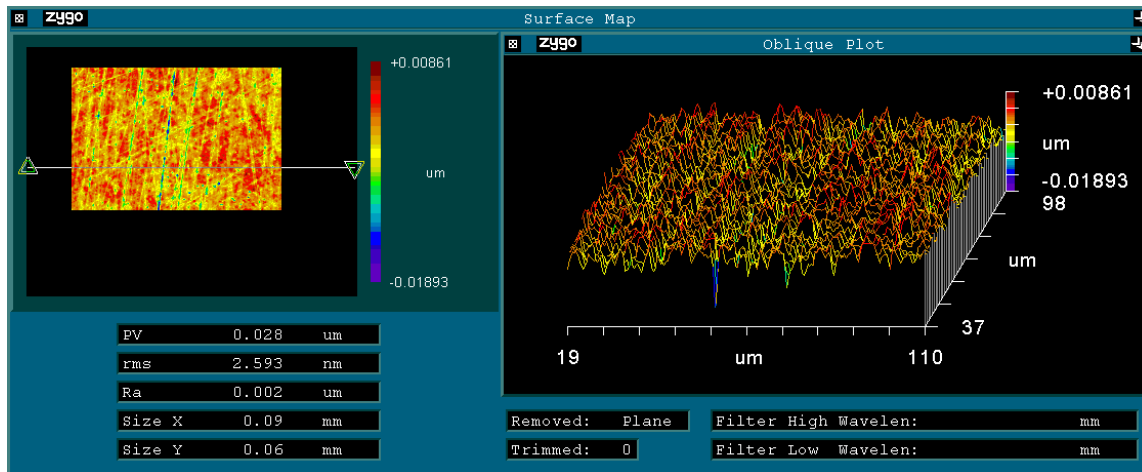
**Figure 3: Polished Area, Portion 2**

Figure 3 shows an image similar to Fig. 1, but from a different portion of the polished surface. Here, the rms roughness is 2.6 nm, again, and Ra=0.002 microns (almost the same value, a slightly different definition).

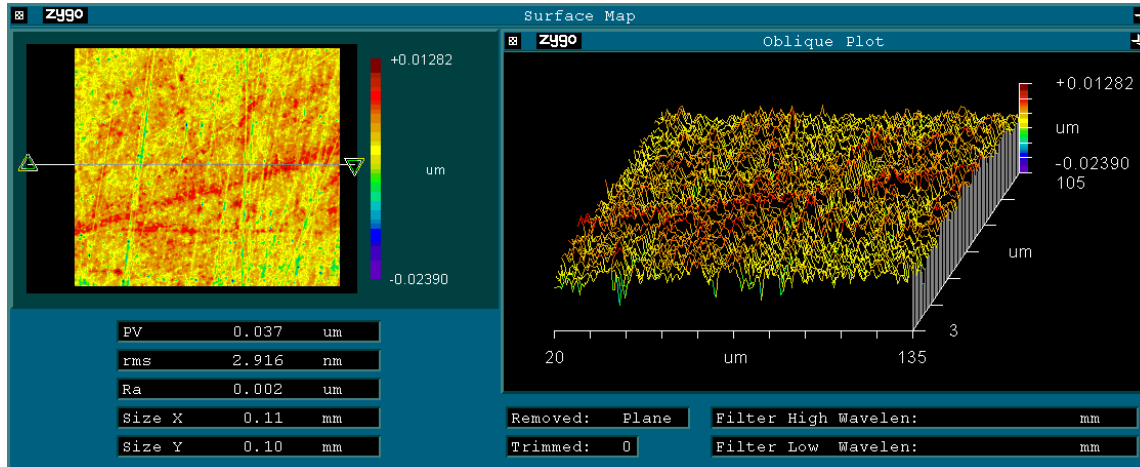
**Figure 4: Polished Area, Larger Area Scan, Portion 3**

A larger area was scanned for portion 3, so that scratches were integrated into Ra and the rms roughness. The rms is now slightly increased to 2.9 nm, as shown in Figure 4. Some scratches can be seen in the figure. However, the roughness is still within about 0.02 microns peak, or about 0.8 microinches.

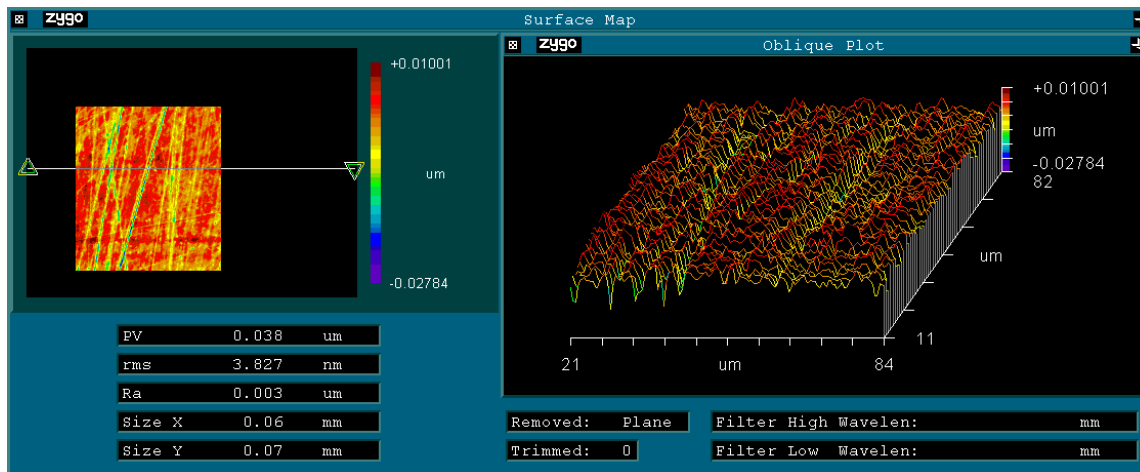
**Figure 5: Polished Area, Portion 4, Some 'Deep' Scratches**

Figure 5 shows another part of the polished surface, including several relatively deep scratches, about 0.025 microns deep (about 1 microinch).

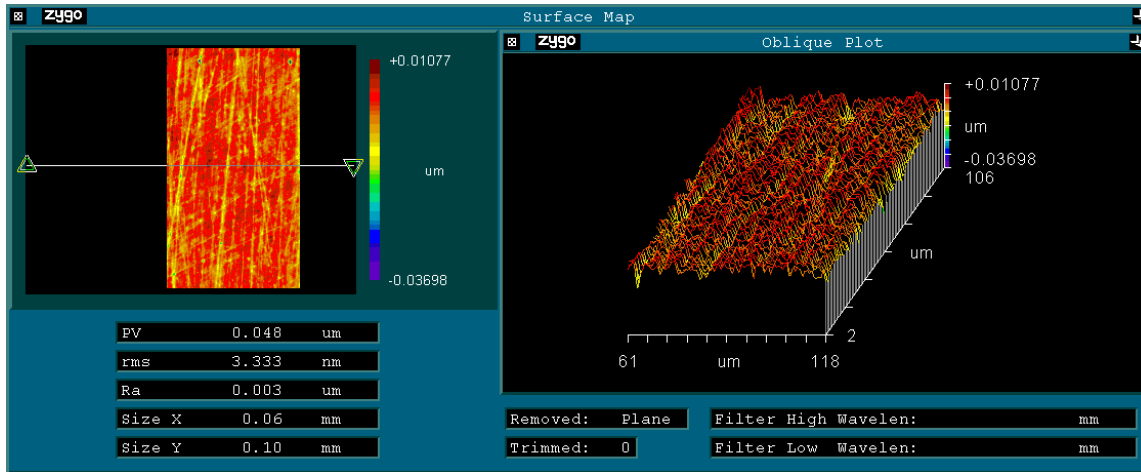
Figure 6: Polished Area, Portion 5, Larger Area Scan

Finally, Figure 6 shows the fifth image of the polished area. In this figure, a still larger area is imaged. The rms roughness has increased to 3.3 nm in this image, still about 0.13 microinches. The maximum deviations are still about 0.03 microns, or about 1 microinch, a very high quality finish.

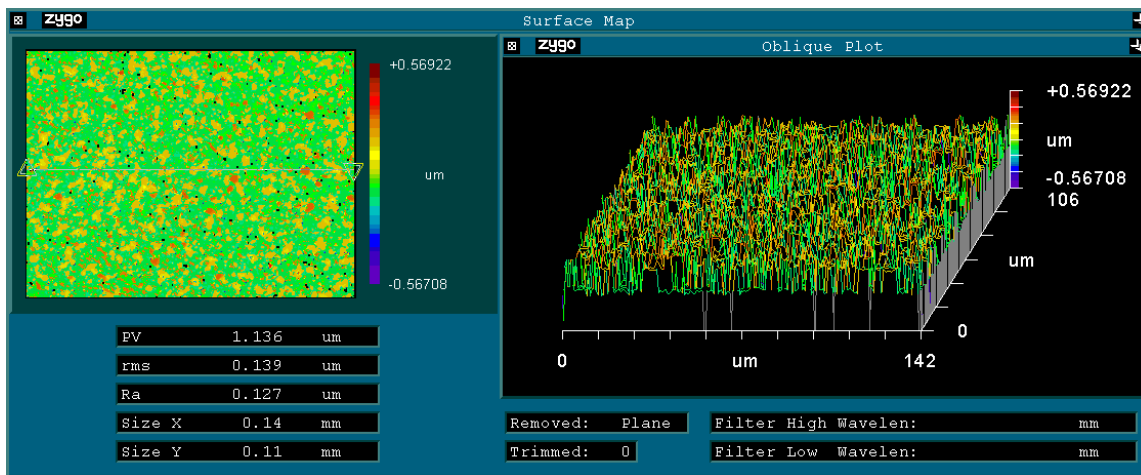
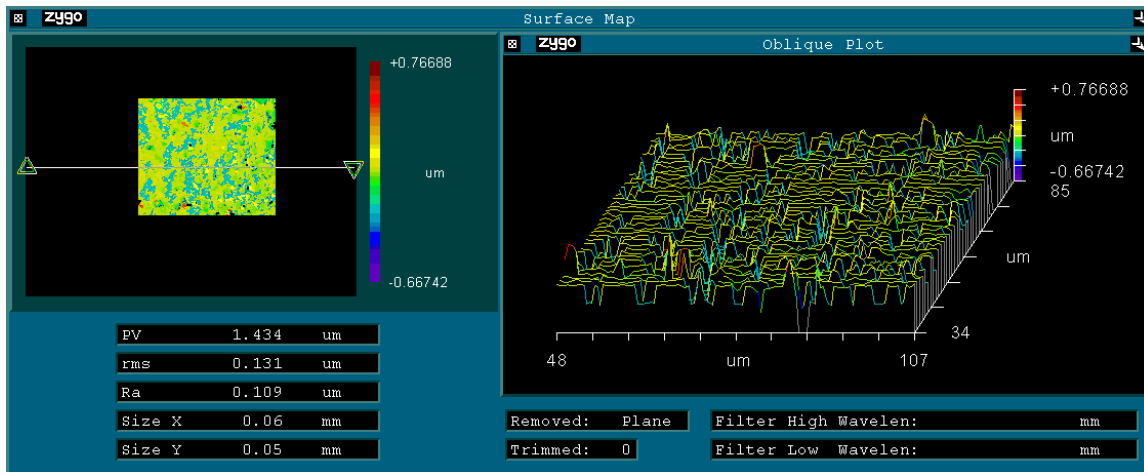
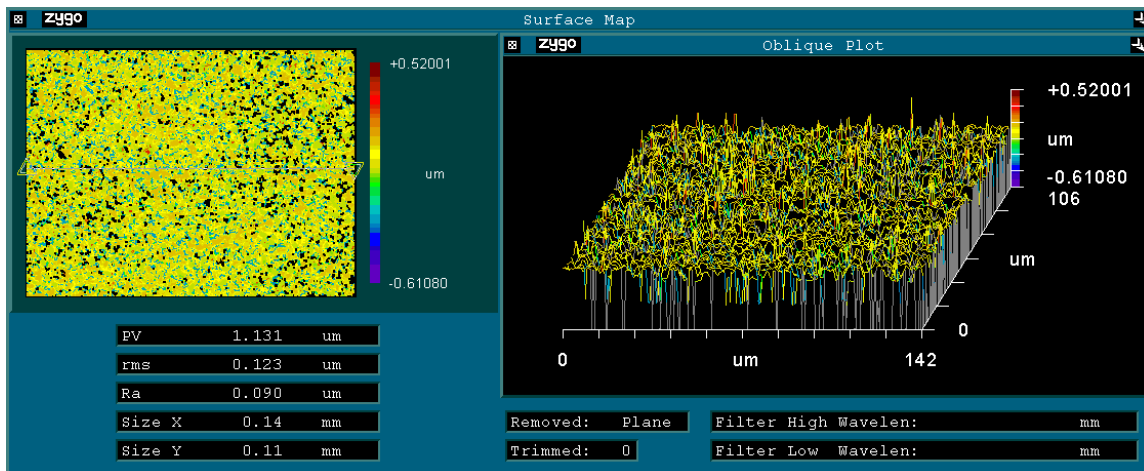
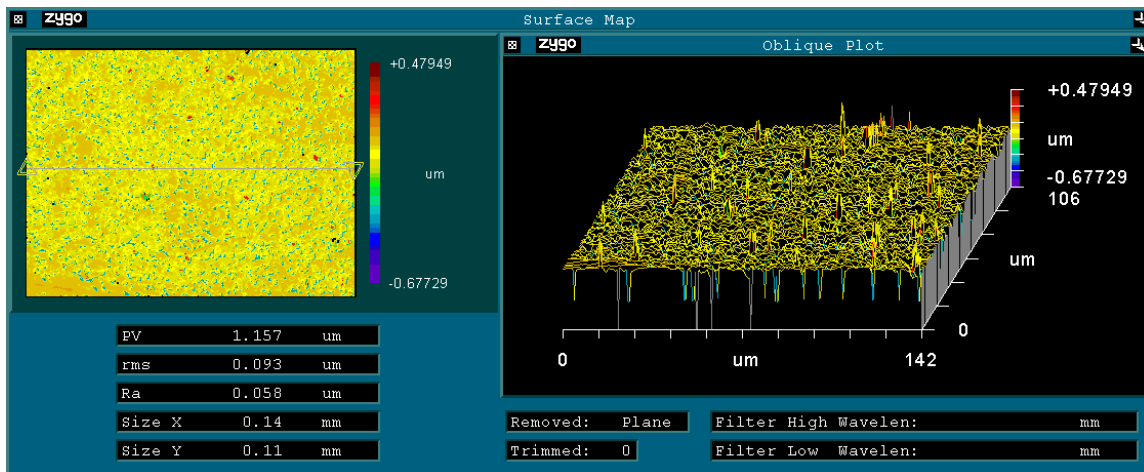
The next set of images were obtained on the “oxidized” surface. This is the area that was not polished. It was initially mirror-like, but became cloudy looking to the eye after being heated. It was never polished. Figures 7-11 show the 5 portions imaged by Chris.

The rms roughness ranges from 0.09 to 0.14 micrometers, or from 3.5 to 5.5 microinches. The peak deviations are roughly 0.8 microns, or about 31 microinches, a value that is very significant in terms of generating throat roughness that would adversely impact quiet-flow performance. These roughness values are much higher than the ones for the polished surface. Unfortunately, no Zygo data was taken before the specimens were first put in the oven, so we cannot verify directly that the temperature generated the roughness from what appeared to be an initially mirror smooth specimen. However, we have verified that once the nickel is polished, after initial heating, it remains smooth after further heating.

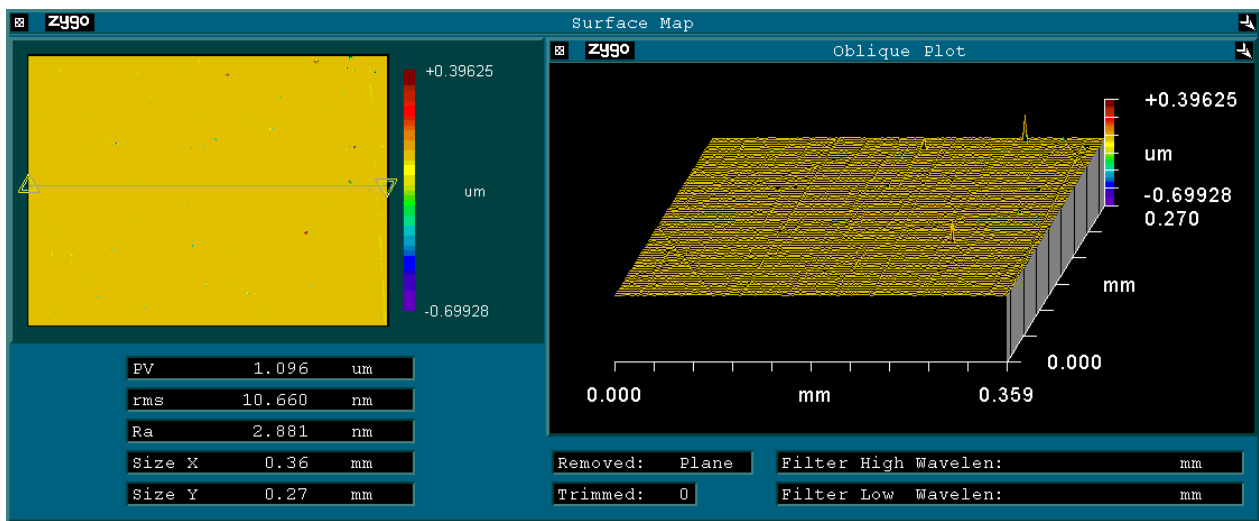
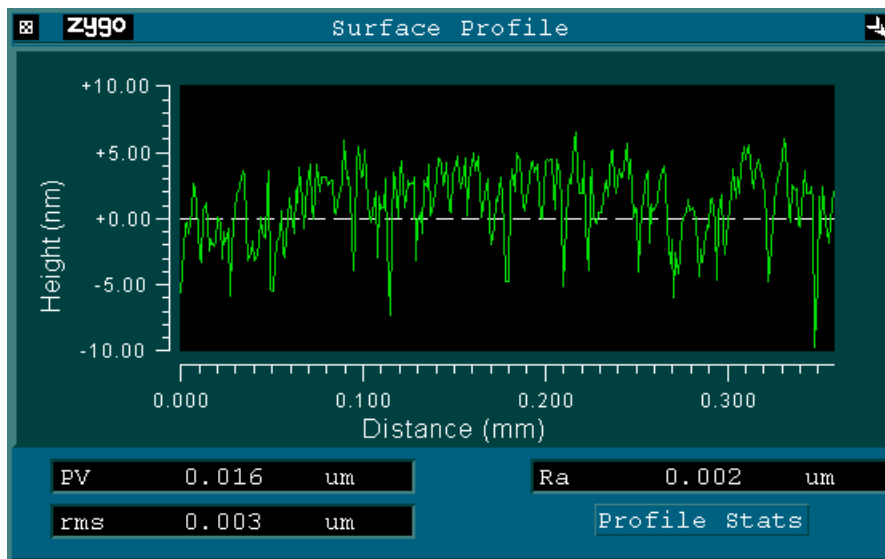
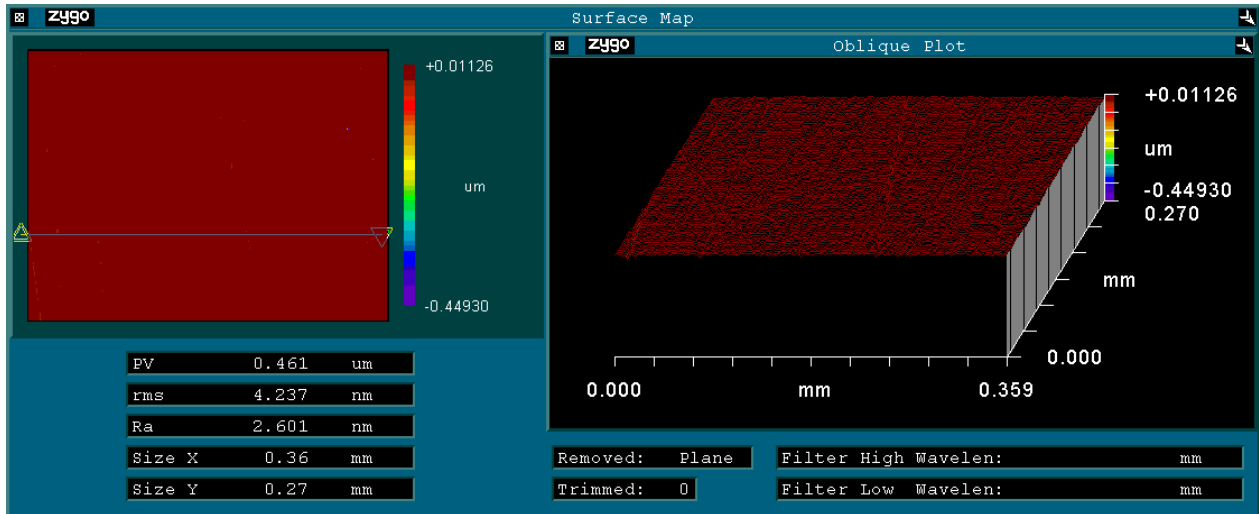
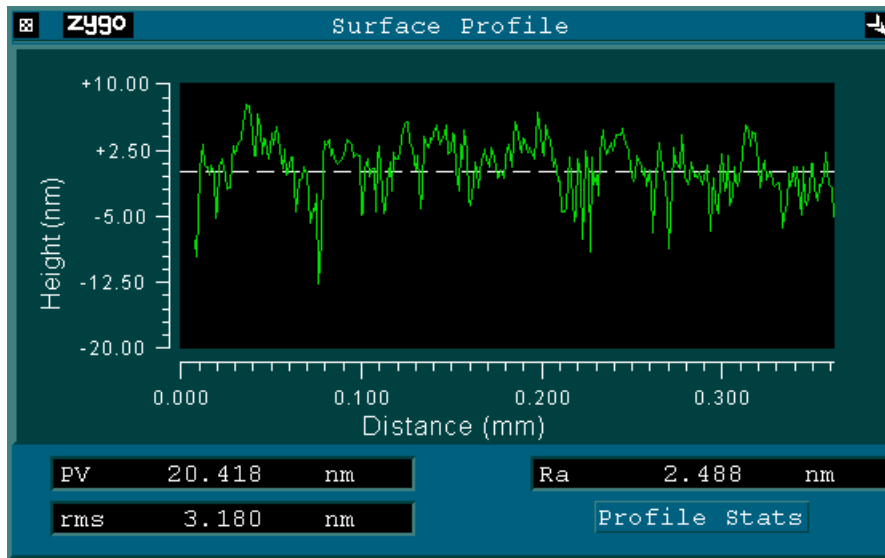
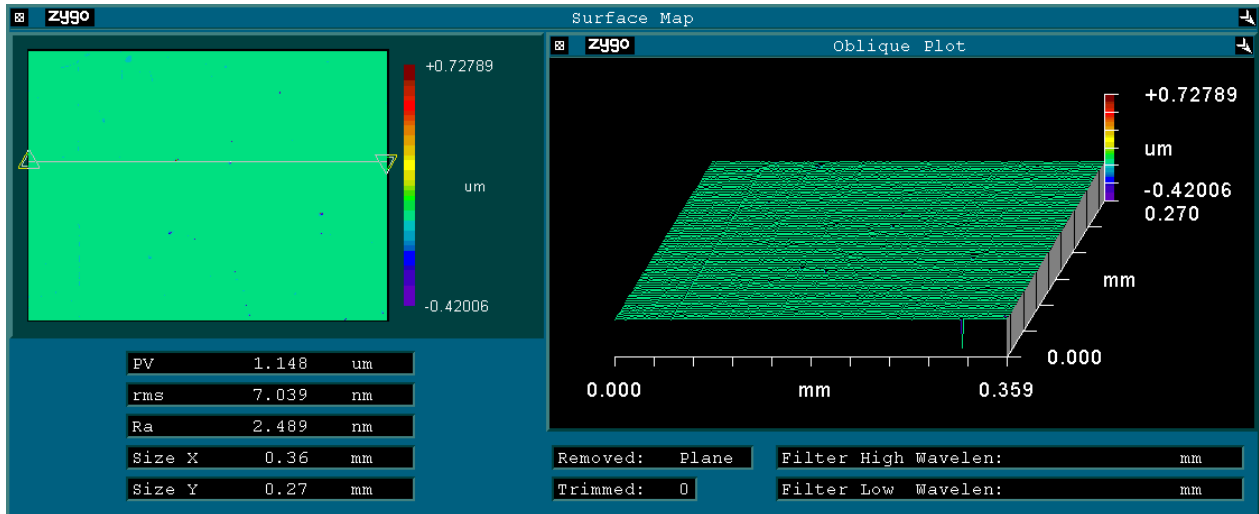
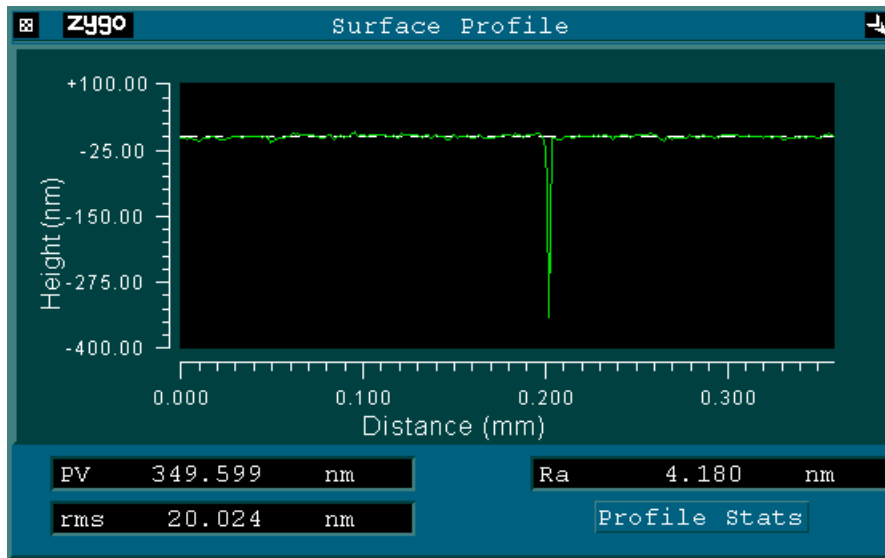
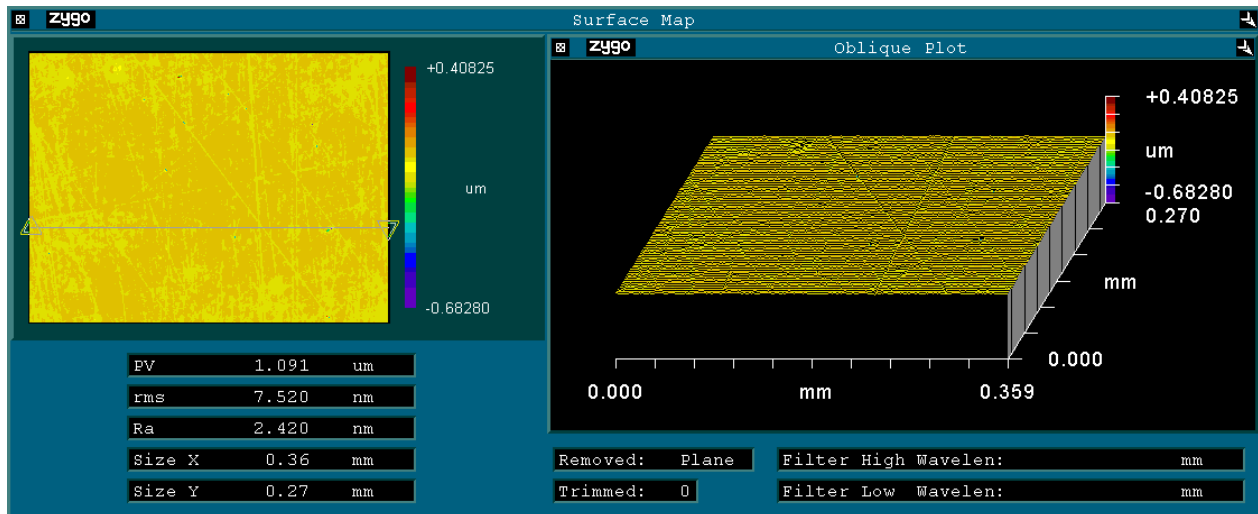
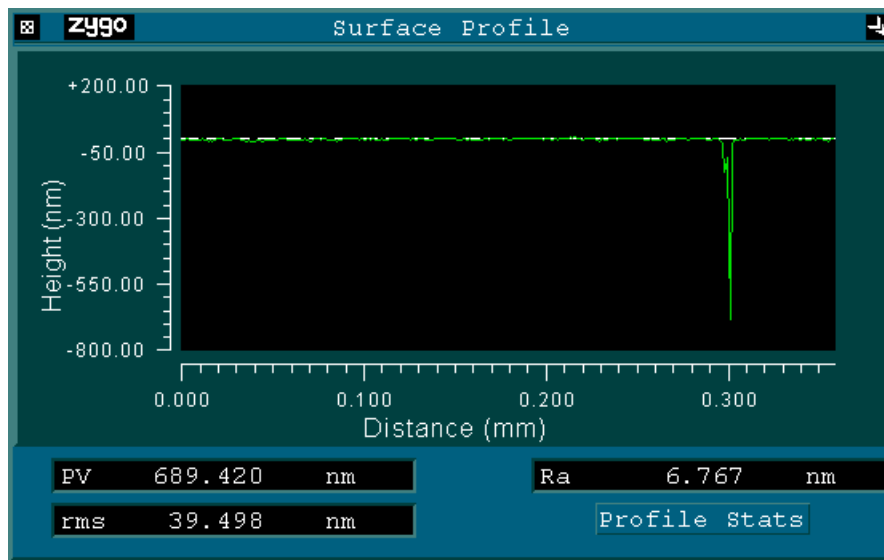
Figures 12-19 show the images corresponding to this data, for the smooth side. The 5<sup>th</sup> area imaged was not recorded, so no files are available to show here.

The rms values of roughness for the 5 portions are 10.6, 4.2, 7.0, 7.5, and 3.5 nm. Before this second heating cycle, the rms values for 5 (different) portions were 2.6, 2.6, 2.9, 3.3, and 3.8 nm. However, those earlier measurements were for smaller areas, 0.06 x 0.10 mm, so they probably have smaller rms values, since they won't include as many large scratches. The values of Ra before the 2<sup>nd</sup> heating cycle were 0.002, 0.002, 0.002, 0.003, and 0.003 micrometers, or 2-3 nm. After the 2<sup>nd</sup> heating cycle, the values were 2.8, 2.6, 2.5, 2.4, and 2.3 nm. This suggests that the 2<sup>nd</sup> heating cycle did not degrade the polished surface. I conclude that **the nickel itself is not degraded by the 425F temperature, only the initial surface layer was a problem.**

The smooth electroform still contains a number of large pits. These remain a concern, although the Ra values are low.

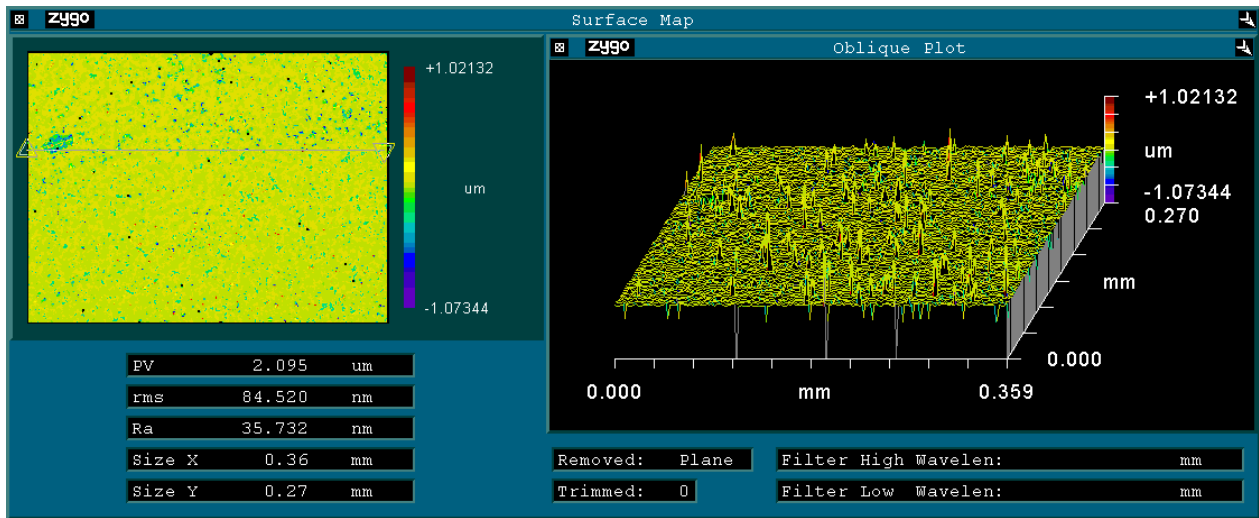
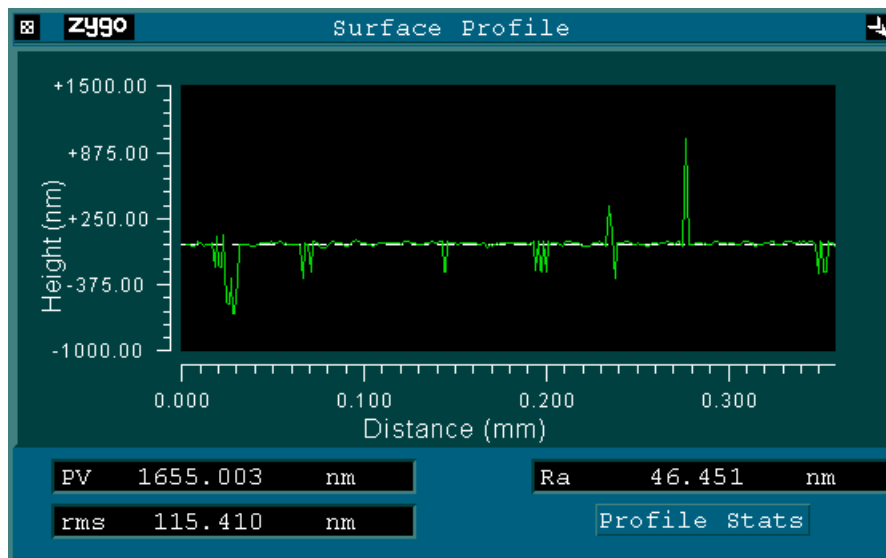
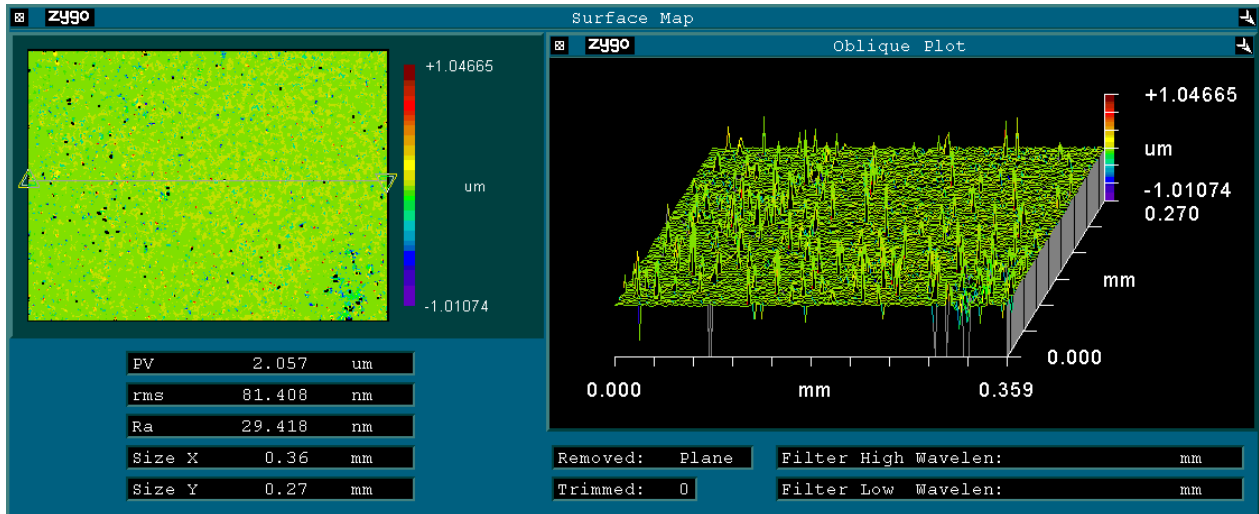
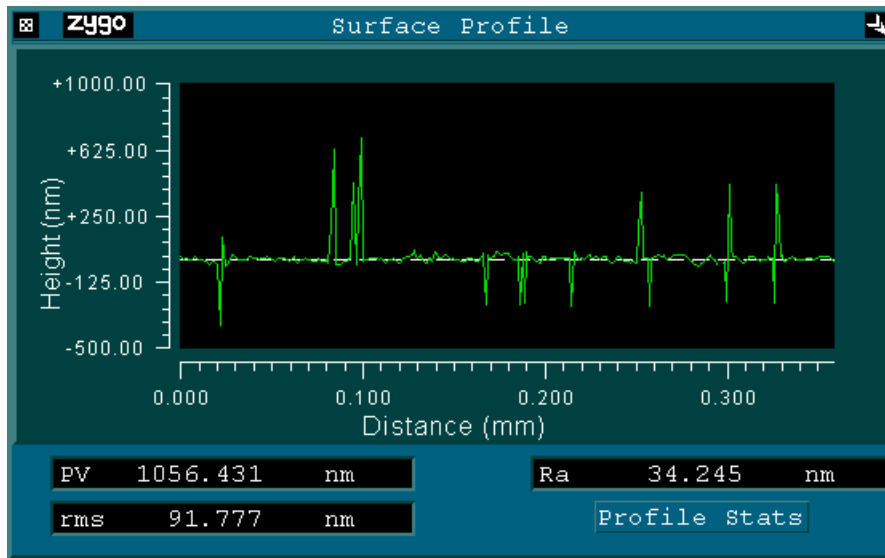
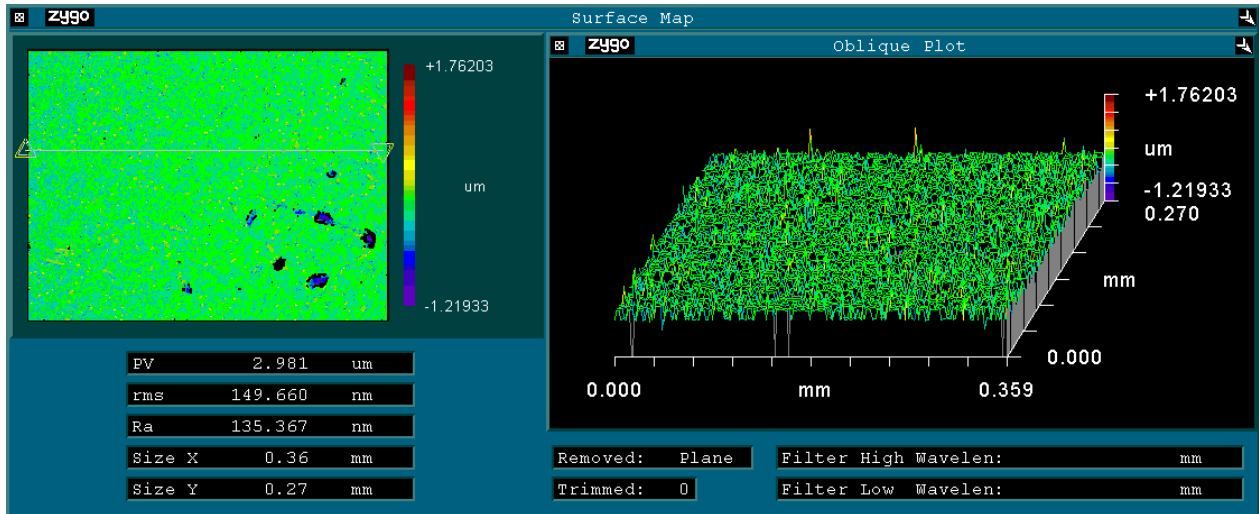
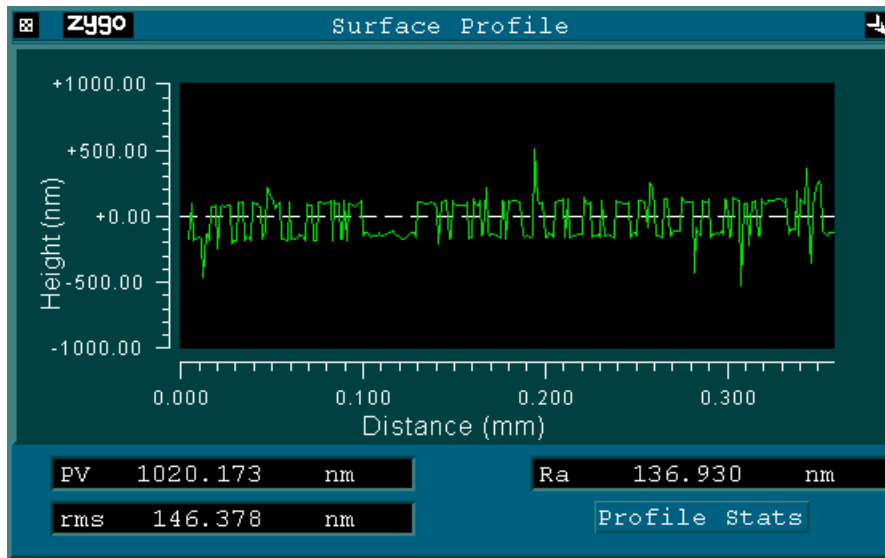
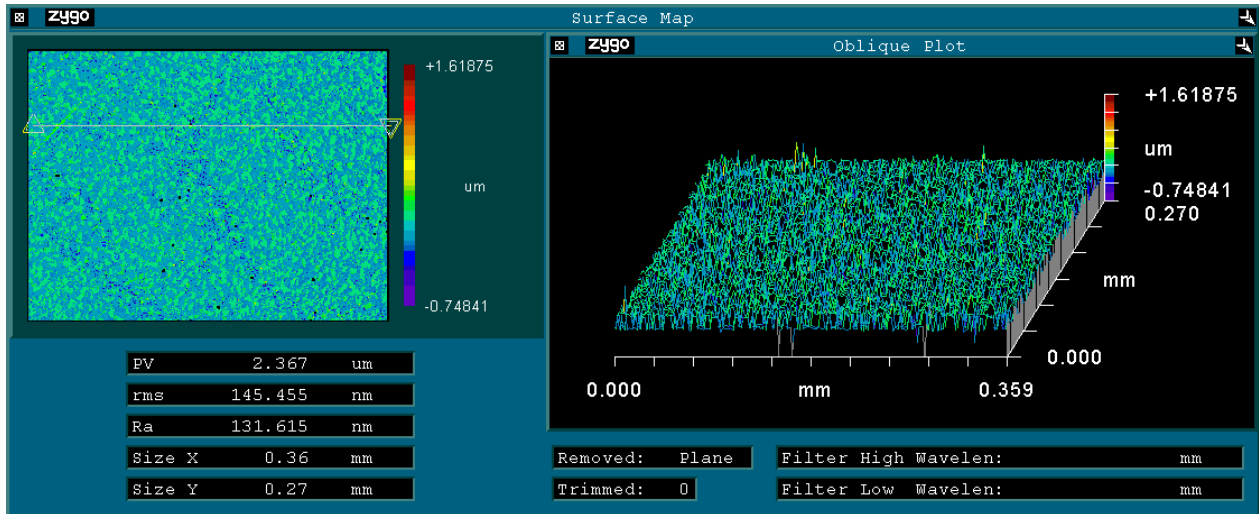
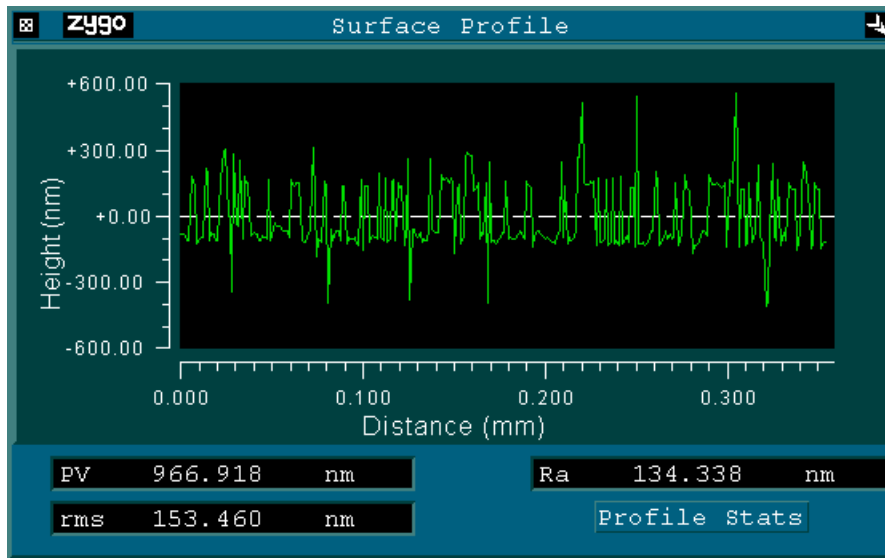
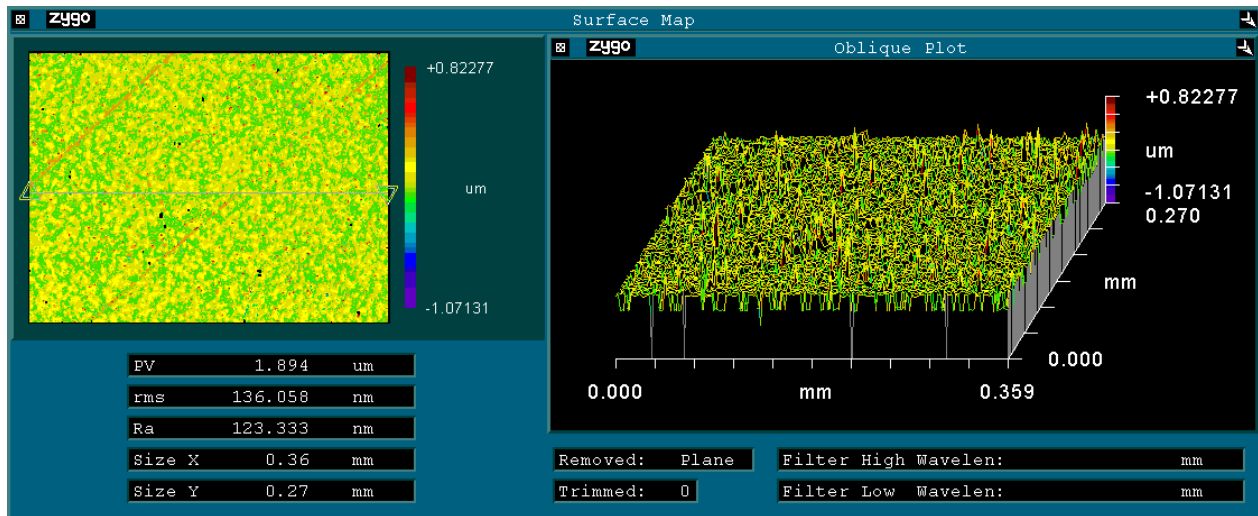
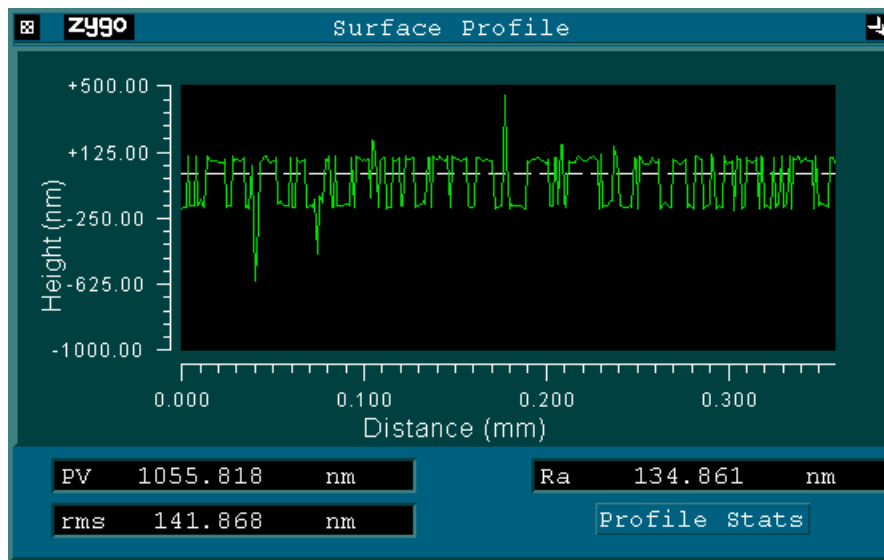
Figures 20-29 show the data for the rough side.

The values of Ra on the cloudy or rough surface before this 2<sup>nd</sup> heating were 0.13, 0.11, 0.09, 0.06, and 0.08 micrometers, or 80-130 nm. After the 2<sup>nd</sup> heating, the values were 36, 29, 135, 131, 123 nm. It appears that the 2<sup>nd</sup> heating did not noticeably further degrade the cloudy surface either. The square-wave-like profiles may be the remains of the silver layer. If so, they are about 300 nm or 10 microns thick. In any case, the cloudy surface would be unacceptable for a quiet nozzle throat.
