TITLE: Shuttle launch debris: Sources, consequences, solutions

SHUTTLE LAUNCH DEBRIS --
SOURCES, CONSEQUENCES, SOLUTIONS

Mark K. Craig
NASA Johnson Space Center
Houston, Texas

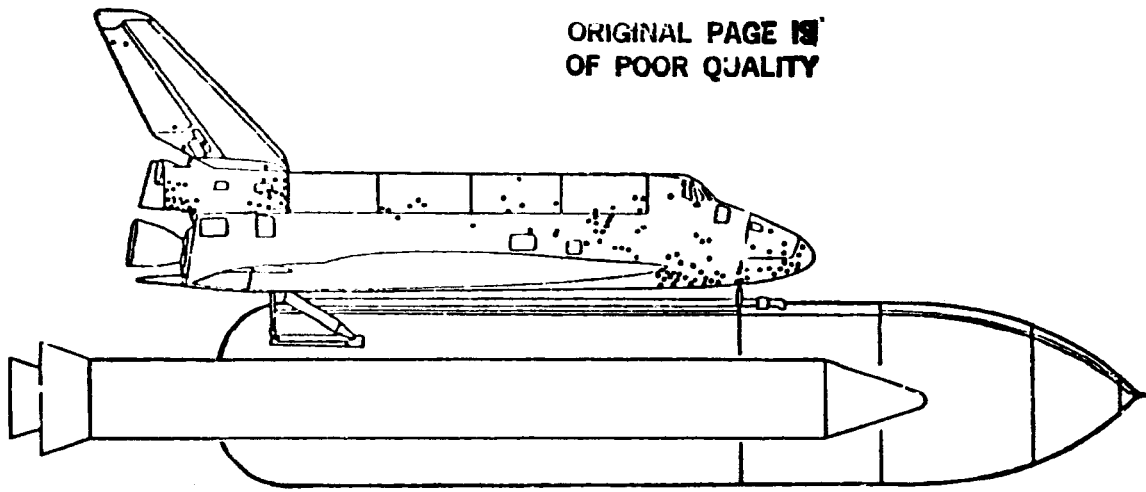
Although no severe damage was sustained on the orbiter nose, STS-2 experienced debris damage which was similar to STS-1. Damage to the body flap was significant and exhibited the substrate melting as before. The number of damage sites was roughly comparable to STS-1. The only area which was damaged in a different fashion was the base tile array between the three main engines (figure 6). A number of small damage sites were present as on STS-1 but, in addition, on STS-2 there was a long scrape or compression which damaged seven adjacent tiles. A summary of the locations of noteworthy TPS damage due to debris on flights STS-1 and STS-2 is presented in figures 7 and 8.

Figure 7.- STS-1 and STS-2 right-side debris damage composite.

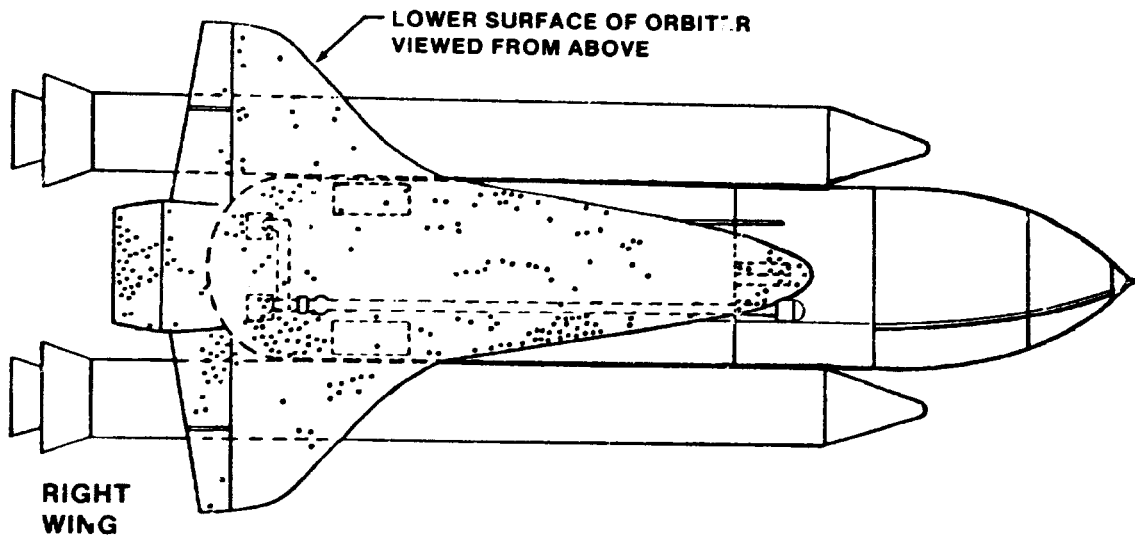
Figure 8.- STS-1 and STS-2 lower surface debris damage composite.

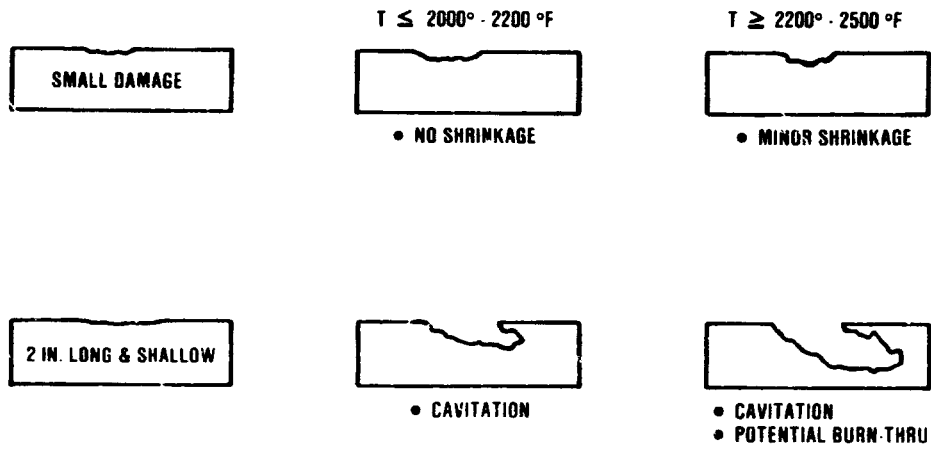
The role of entry heating in modifying impact damage characteristics can be dramatic. As noted above, this effect has been observed on both STS-1 and STS-2 at body flap damage sites. Figure 9 presents a summary of TPS tile sensitivity to damage incurred before entry. Flight and arc-jet experience has revealed that on regions of the vehicle where surface temperatures exceed approximately 2200°F (figure 10) significant growth of larger damage sites can be expected due to shrinkage of the substrate silicon matrix. This knowledge is useful in both reconstructing the appearance of the original damage, which aids in identifying the damage source, and in anticipating the consequences of damage. Body flap temperatures on STS-1 and STS-2 were relatively low (2300°F) compared to their design values (2500°F). This was fortunate in that the higher temperatures may well have resulted in a burn-through. Shrinkage of the STS-1 nose gear door tile damage was minimal because of the higher density of the tiles, even though the temperatures were also higher (2400°F).

Figure 9.- TPS tile sensitivity to debris damage.

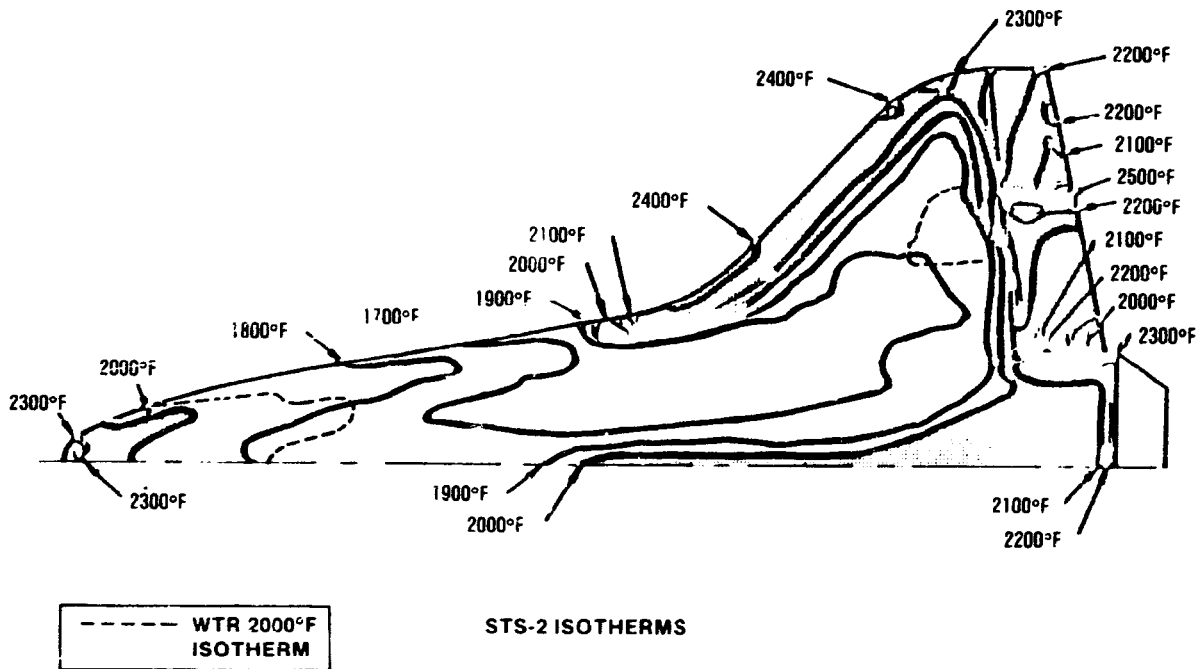
Figure 10.- Orbiter lower surface isotherms (STS-2).
