Chris R. Glaeser, LtCol, USAFR (ret), 12 March 2003

The case for a Leading Edge Reinforced Carbon-Carbon (RCC) segment failure on the Columbia Space Shuttle

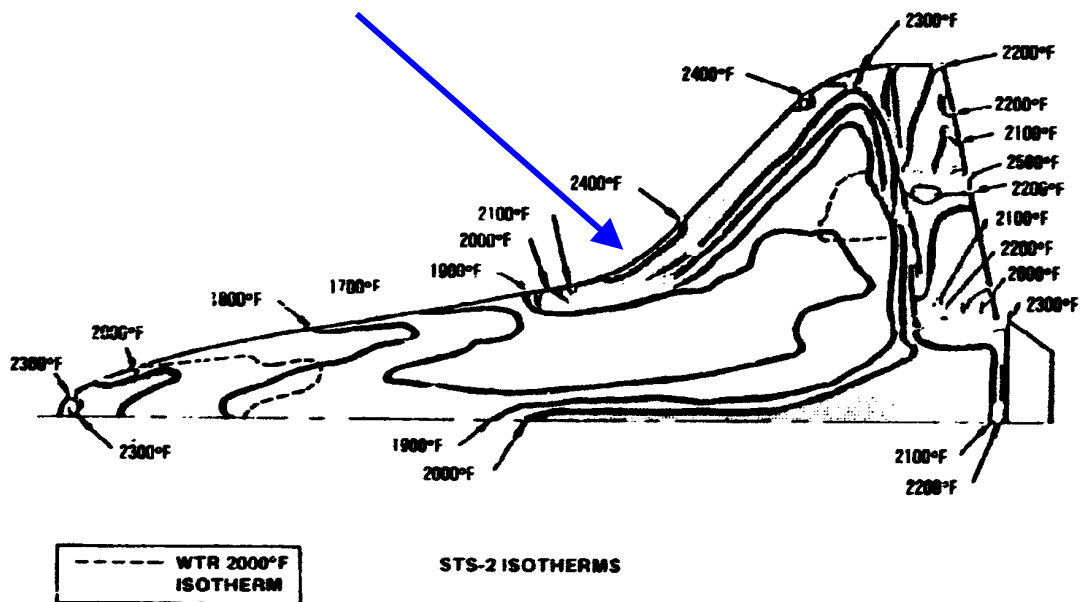
Figure 10.- Orbiter lower surface isotherms (STS-2).

This section of the LE experiences the greatest re-entry heating, and is therefore the most likely to have experienced RCC material degradation due to multiple re-entries.

- ◆ It is interesting to note that in the NASA study from which this diagram is taken, the RCC oxidation study is taken at a mid-span (55%) RCC segment, not at the wing root, where the worst case re-entry heating is experienced.

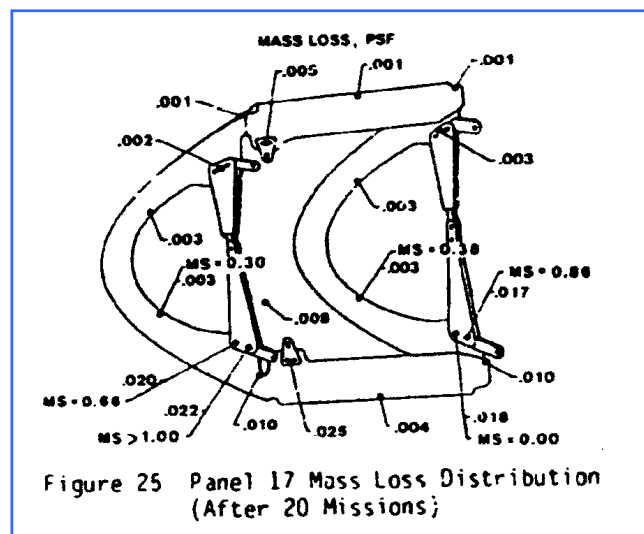
It is very interesting to note that on this diagram, the mass loss in the RCC and attachment hardware is greatest on the bottom sections of the hardware (which would have absorbed the ascent debris impact).

- ◆ this mass loss (oxidation) is based on 20 missions using nominal re-entry heating, not increased heating due to asymmetric boundary layer transition heating
- ◆ the analysis in this NASA paper utilized RCC panel 17, which has lower re-entry heating (see isotherm diagram)

Obviously, a detailed review of the remaining shuttle's RCC materials is in order to compare theoretical oxidation and that actually experienced.

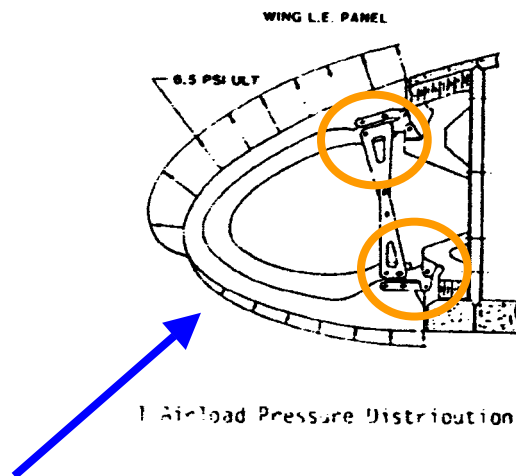
The ascent debris impact appears to have hit the wing Leading Edge (LE) at the wing root (approximately RCC segment 9), and most of the impact appears to have been at the bottom of the wing. This diagram shows the aerodynamic loading¹ of the wing leading edge (assumed impact angle and point shown with arrow).

It appears that any stress from the debris impact added to the aerodynamic loads (assuming positive AOA). Further investigation of the actual aerodynamic loading at the time of debris impact should be computed.

It would also be interesting to compute the debris impact load on the RCC lugs (circled in the diagram above), add it to the pre-existing loads, and use the worst case oxidation of

the RCC lug attach points and see if the debris impact could have caused an lug attachment failure.

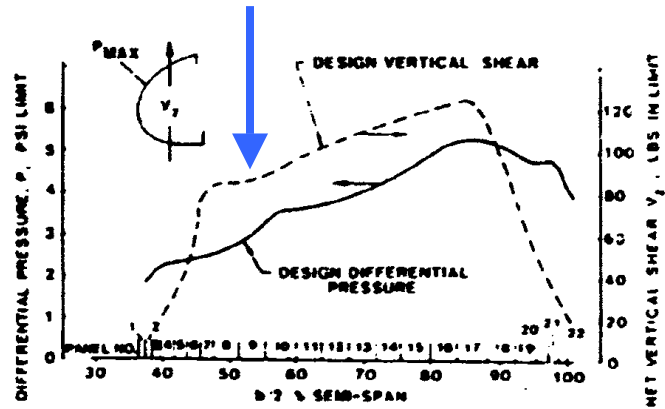
The arrow above indicates RCC panel 9 design vertical shear¹: it is possible that the debris impact could have exceeded this shear, especially if there was any degradation in RCC material at the lug attach points at the point of impact. It is also interesting to note (in the diagram above) that the design differential pressure seems to “spike” slightly at RCC segment 10 (in the suspect area), with a corresponding slight reduction in the design vertical shear margin at that point.

3. Re-examine the total load on each RCC panel during ascent; especially on RCC panels 8-10. Add the worst case debris impact stress to the accumulated acoustical and aerodynamic loading; then take the worst case oxidation of the RCC at each attach lug and determine if any design loads were exceeded.
