# Performance of School Buildings in Turkey during the 1999 Düzce and the 2003 Bingöl Earthquakes

Several school buildings were surveyed in the disaster areas of the Marmara (1999,  $M_w=7.4$ ), Düzce (1999,  $M_w=7.2$ ) and Bingöl (2003,  $M_w=6.4$ ) earthquakes in Turkey. Among them, 21 reinforced concrete buildings were found to have an identical floor plan. Lateral load resisting structural system consisted of reinforced concrete frames (moment-resisting frame) in 16 of the buildings and structural concrete walls integrated with the moment-resisting frame (dual system) in the remaining five buildings. The number of stories above ground in these buildings ranged from 2 to 4. These school buildings provide a nearly ideal test of the effect of a single important structural characteristic on the performance of buildings with structural designs that are uniform in all other respects. Our observation is that the presence of structural walls improves the behavior of reinforced concrete systems drastically.

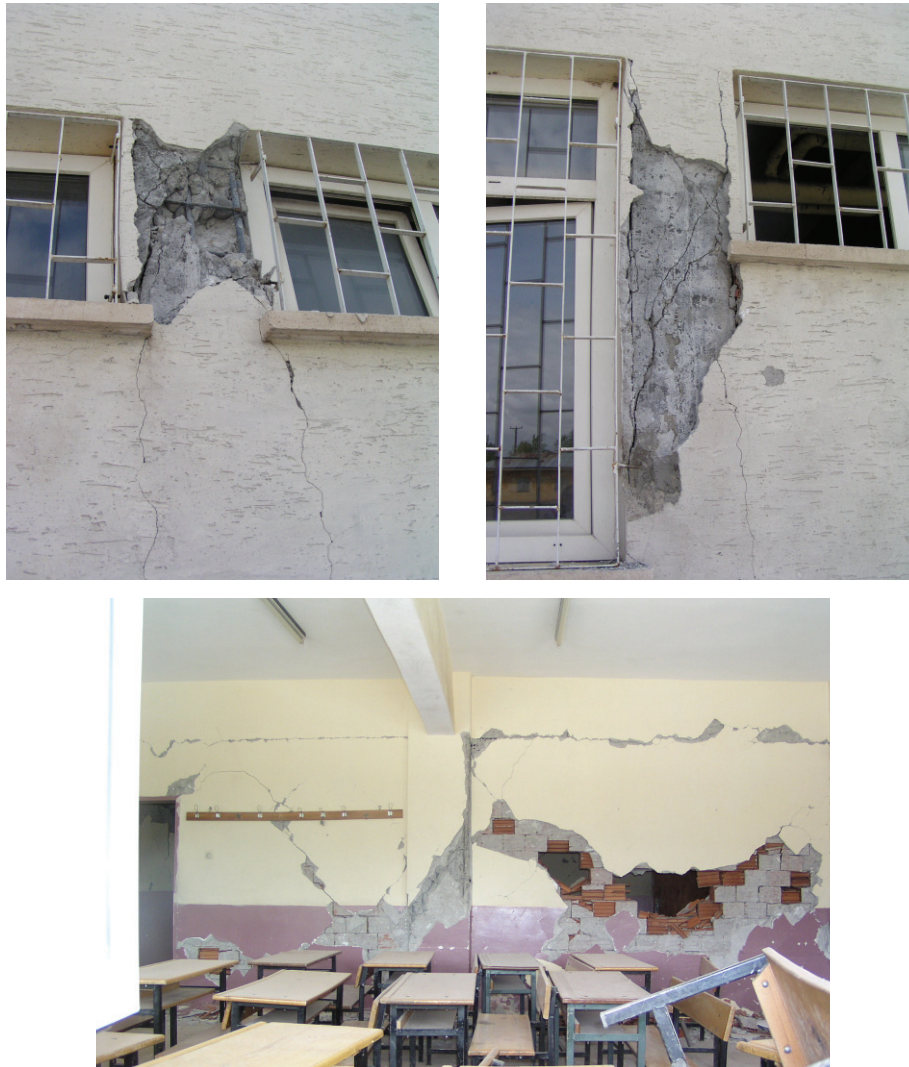
Serious damage: Structures containing columns with inclined cracks (Fig. 2). We note that inclined cracking in columns represents serious damage if the amount of transverse reinforcement is light. Observations in the field as well as information obtained from typical structural plans indicated that 8-mm diameter bars with yield strength of 220 MPa were used commonly for transverse reinforcement. The center to center tie spacing in the columns was typically 20 to 25 cm. In the column end regions of some school buildings, the tie spacing was observed to be 10 to 12 cm. The transverse reinforcement ratio in the columns ranged from 0.001 to 0.002 in the schools. The transverse reinforcement ratio is defined as the ratio of the tie reinforcement area divided by the product of the center to center spacing of tie reinforcement measured along the column longitudinal axis and the column dimension perpendicular to the direction of the applied shear.

**Figure 2.** Examples of severe column damage.

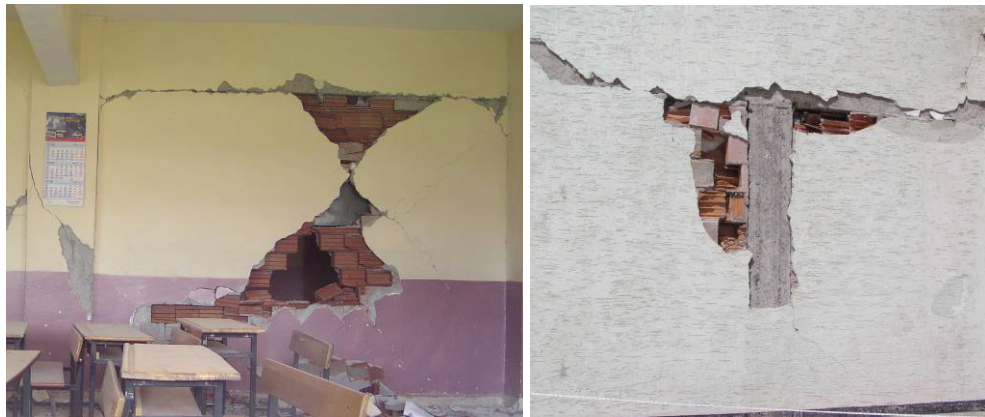
Severe damage: continuous cracking at boundaries, loss or crushing of masonry units (Fig.3).

**Figure 3.** Examples of severe masonry-wall damage.

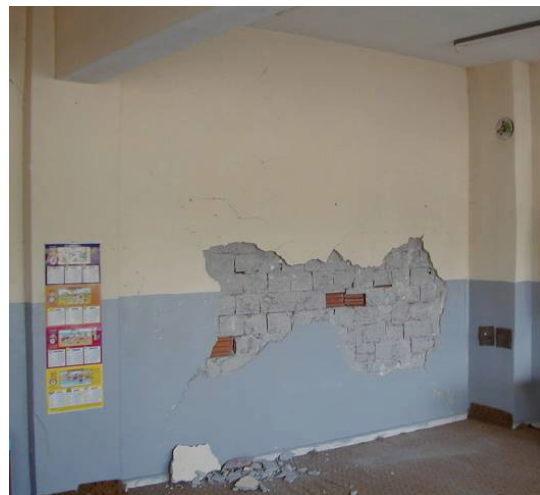
Moderate damage: fine cracks in walls and at boundaries with flaking of large pieces of plaster (Fig. 4).

**Figure 4.** A moderately-damaged masonry wall.

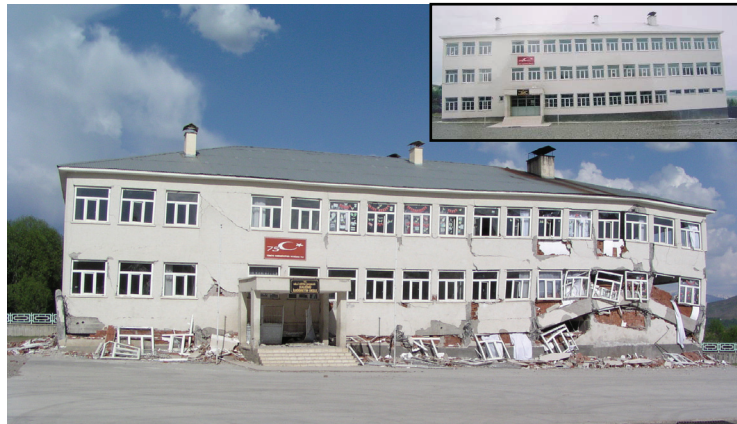
Figure 8 shows the photos of Building C13-08 before and after the earthquake. The first story of the three-story building completely collapsed. The columns of all three collapsed buildings appeared to have failed in shear. Figure 9 shows the extent of shear damage in columns in one of the severely damaged buildings (C14-01). Figure 10 shows an internal column failed due to captive column condition evolved during the earthquake. Damage to the masonry walls was rated separately. The three- and four-story buildings typically sustained severe masonry wall damage (Table 3).

**Figure 8.** Building C13-08 before (small photo) and after (big photo) the 2003 Bingöl earthquake. The first story is completely collapsed during the earthquake. The captive columns in the ground floor were shown at the right end of the school (small photo).

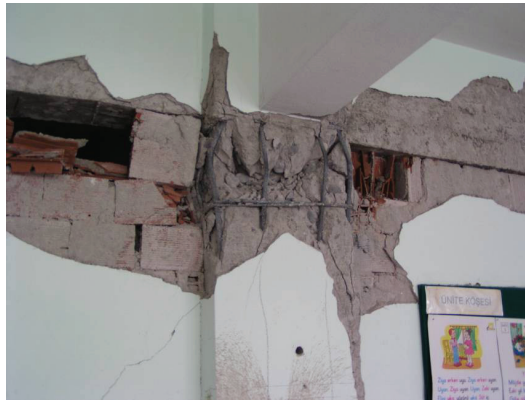
**Figure 10.** A captive column in Building C14-01 created by the crushing of the corner regions of infill walls.

- *Three- and four-story buildings:* The three dual-system structures suffered almost no damage to their concrete structural walls. Of the three buildings, only building D02 was rated as severely damaged. Unlike other buildings in the inventory, building D02 suffered damage to its basement. The exterior columns in the basement were captive columns due to the partial-height concrete earth-retaining walls restraining the columns (Fig. 12, 13, and 14). The structural walls appear to have contributed to collapse prevention. Further, columns above the basement level in D02 were not damaged. Of the twelve schools with moment-resisting frames as the lateral load resisting system, ten of them were either severely damaged or collapsed (Fig. 8 and 9). Only two survived without any damage to the columns. The displacement demand was high enough to result in severe damage to the masonry infill walls. Damage to the masonry walls appears to have affected the structural response in two ways: (1) The stiffness of the system was reduced, and (2) crumbling of the masonry at the wall corners resulted in formation of additional captive columns (Fig. 10) and the structure failed due to a loss of gravity-load capacity.

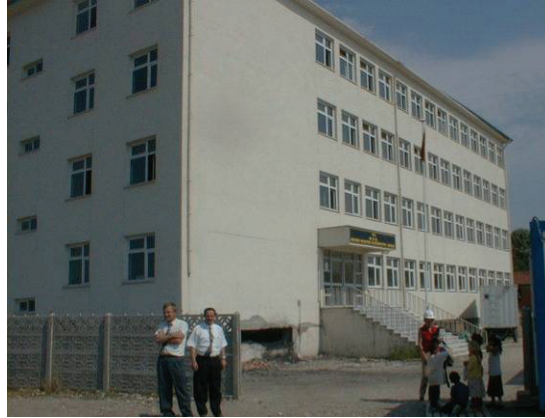
The most severely damaged dual system was one of the four-story buildings (D02) in Düzce (Fig. 12). The damage was concentrated in the half-buried basement surrounded by partial height earth-retaining concrete walls (Fig. 13). There are windows between the earth-retaining walls and the beams of the basement. The exterior basement columns, that were captive along their weak axis, failed in shear (Fig. 14). Columns and structural walls in other stories did not suffer damage. There were moderately damaged masonry infill walls in the basement. Unlike other buildings, the damage rating of building D02 was based on the damage state of the basement rather than that of the ground floor.

**Figure 12.** A four-story dual-system building in Düzce (Building D02).

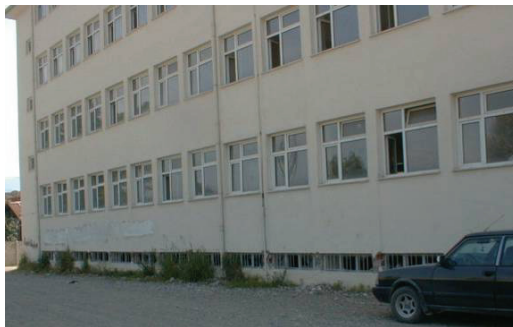
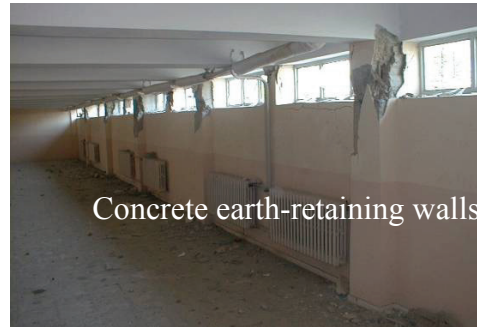
**Figure13.** View of the captive exterior columns in the basement of Building D02 from outside and inside. The columns are captive in their weak axis.

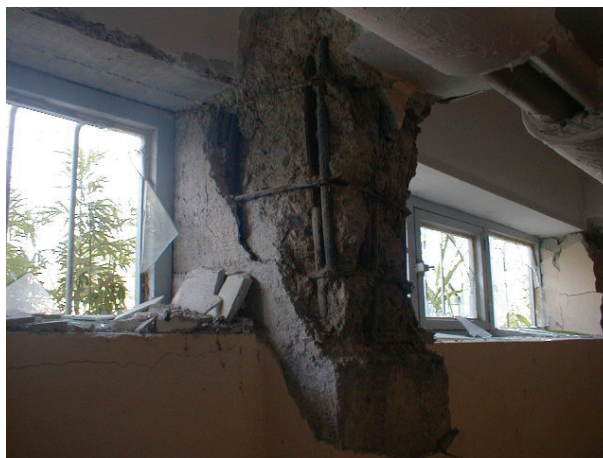
**Figure 14.** A failed captive column in the basement of Building D02.

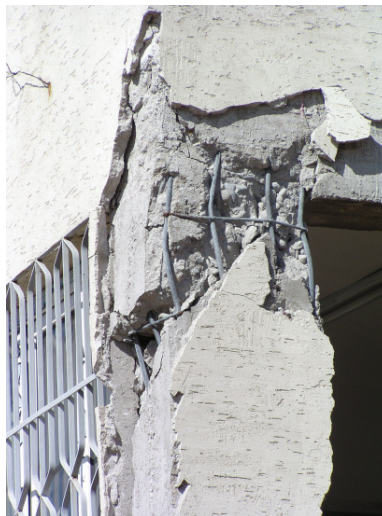
The observed difference in the performance of the dual systems and that of the moment-resisting frame systems cannot be attributed to defects arising from construction quality. The construction quality was similar and quite uniform across all of the surveyed school buildings. Visual inspection of the concrete revealed honeycombs and inclusion of disproportionately large pieces of aggregate. Unwashed river aggregate had been used in most of the buildings inspected. There were detailing problems. The ends of the transverse reinforcement were typically not anchored in the concrete core. Sufficient confinement was not observed in the column end regions. In general, ductile detailing was lacking in the structural members (Figure 15).

**Figure 15.** Typical column end reinforcement detailing exposed in Building C14-01.
