A case study of industrial building energy performance in a cold climate region in a developing country

HaoZhou¹, Weijuan Li¹, Yuanyi Chen¹, Dayi Lai¹, Hejiang Sun^{1,*}, QingyanChen^{2, 1}

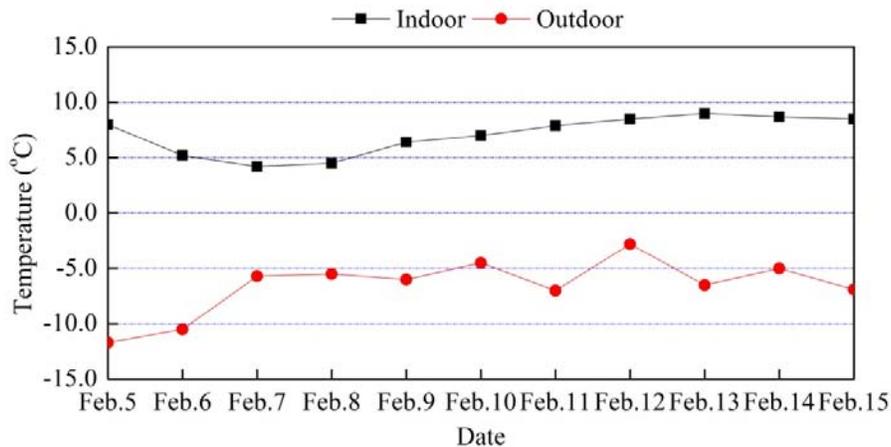
The local climate belongs to the continental monsoon region with very strong winds all year round. The outdoor design temperature in the winter was $-14.3\text{ }^{\circ}\text{C}$, much colder than that in Beijing. Although the design had been intended to meet high standards, the building energy performance in the first year was disappointing. For example, when the outdoor air temperature was well above the design temperature from February 5 to 15, 2012, the indoor air temperature in the heated area, such as the barrel rooms, was far below the design temperature ($15.6 \pm 2.8^{\circ}\text{C}$), as shown in Figure 2. In some areas, the indoor temperature was even below the freezing point. Note that the total heat supply to the building differed from day to day so the temperature did not vary linearly with the outdoor air temperature. In addition, the barrel rooms experienced condensation problems during both the cold winter and warm summer, when the indoor relative humidity was maintained at approximately 80% to avoid evaporation of wine from the barrels to the room air.

Figure 2. Indoor and outdoor air temperatures of the winery building as recorded between February 5 and 15, 2012

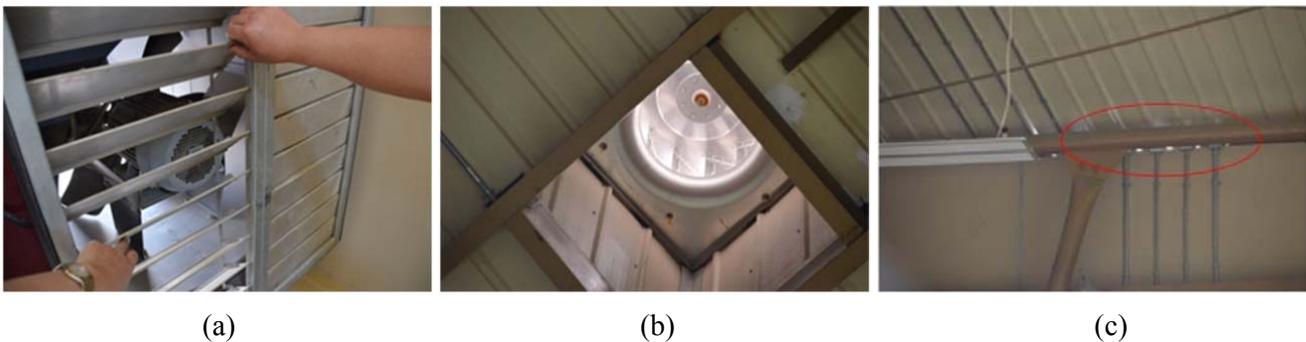
In the building, a large number of emergency ventilators were located close to floor level in case the CO_2 level became too high in the winery during fermentation. The emergency ventilators had a fan and a simple damper that closed under the force of gravity, as shown in Figure 3(a). Strong local winds in the winter could easily push the damper to the open position. Both the number and

capacity of the ventilators were greater than needed. In a discussion of the situation with the local designers, they argued that the ventilators were also used for natural ventilation. Indeed, the building was designed with natural ventilation capability, and there were many ventilation caps at roof level, such as the one shown in Figure 3(b). Because these openings were not closed by dampers, they would allow very severe infiltration in winter as a result of the chimney effect. A large opening, as shown in Figure 3(b), could account for 2% of the total heat loss in the winery. The perimeter of the winery building was greater than 1,000 m. There were numerous air leaks in the building, especially at the joints between the roof and the wall as shown in Figure 3(c). Heat loss through all leakage locations was estimated at 62% of the total heat loss.

Figure 3. Various leakage locations in the winery building: (a) emergency ventilator with a poor-quality damper, (b) roof ventilator cap without a damper, and (c) small leaks between the roof and wall.

The conceptual designer located in California designed the winery building that seems for warm or mild climate. For example, they designed the winery with natural ventilation and used light steel roof structure. In addition, they did not perform annual energy analysis so the energy performance of their design was not estimated. The local climate for the winery, in contrast, was harsh in winter with very strong wind and with a short shoulder season. The use of natural ventilation would only save 0.5% of the total energy. However, it was difficult to seal the emergency ventilators and roof ventilation caps to prevent leakage. Strong winds could blow snow through the ventilators into the building as far as 6 m. The local craftsmanship for light steel roof structure was very poor. They normally used heavy concrete roof. For the steel roof, they were not trained for carefully placing the insulation and making the joint between panels. The local designer in China was reluctant to communicate with the conceptual designer because of a poor command of English and could be afraid to challenge the expert design made by the California designer because they did not know much about winery design. Chinese building owners tend to trust the foreign

designers rather than the local Chinese designers if the design was different. Therefore, these design deficiencies could not be corrected in the design phase. The problem led to very serious infiltration.

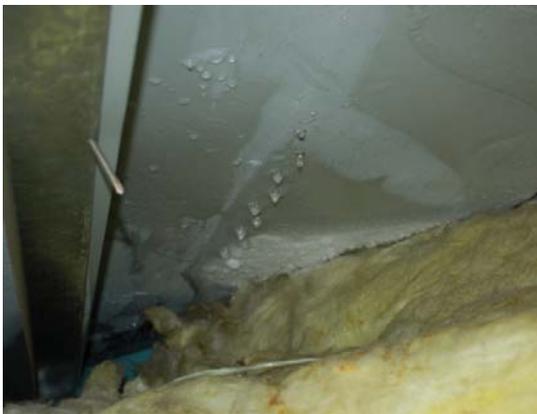
A steel roof system was used, with a light structure suitable for a long-span building such as the winery. However, because of design deficiencies and poor-quality construction, the roof allowed rain leakage and air infiltration/exfiltration. Various kinds of junctions are required for leakage prevention with a steel roof. The moisture barriers used to block summer moisture penetration from outside to inside, and winter moisture penetration from inside to outside, had failed because they were placed in the roof fragmentally. The design used a soft layer to support the moisture barrier, making continuous placement of the barrier impossible. Winter exfiltration of moist indoor air to the outdoor environment, and summer infiltration of moist outdoor air to cool indoor spaces, caused condensation in the insulation materials, as shown in Figure 4(a). The insulation would likely fail in a few years, and the rich nutritional content and yeast in the winery air would encourage mold growth in the roof structure. Another problem was the dripping of condensed water onto wine barrels, as shown in Figure 4(b).

Figure 4. Condensation problems found in the winery building: (a) condensation on a beam on the roof, and (b) condensed water dripping onto a barrel

Because the local designer had failed to complete all the construction documents, part of the roof joint design was completed by the steel roof supplier. In order to save money, the supplier did not break the thermal bridges, and Figure 4(a) shows the resulting condensation on a cold beam.

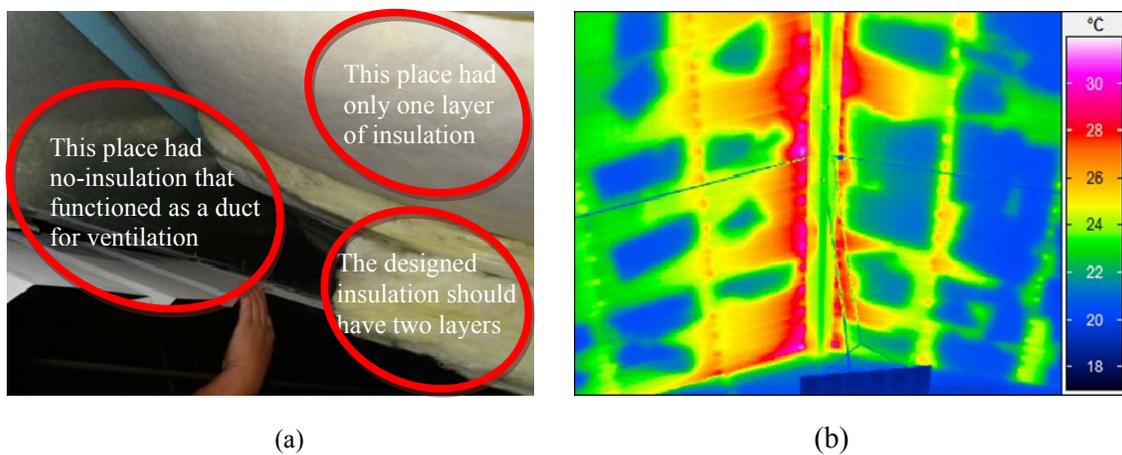
Figure 5(a) shows that insulation was insufficient or absent in some parts of the roof. The design had specified a very good insulation value for the roof in order to combat the cold winter and warm, humid summer. However, because of poor workmanship and lack of supervision during building construction, the insulation materials were not properly placed in many areas of the roof, and air could flow freely. Figure 5(b) shows the measurements of the interior surface temperature of the roof. The outdoor air temperature was about 29 °C at that time, but the exterior temperature of the top metal layer of the roof was as high as 72 °C due to solar radiation. The insulation value was finally estimated at only 70% of the design specification.

Figure 5. A poorly insulated roof: (a) missing insulation materials in the roof and (b) the temperature of the interior roof surface as measured on a summer day by an infrared camera

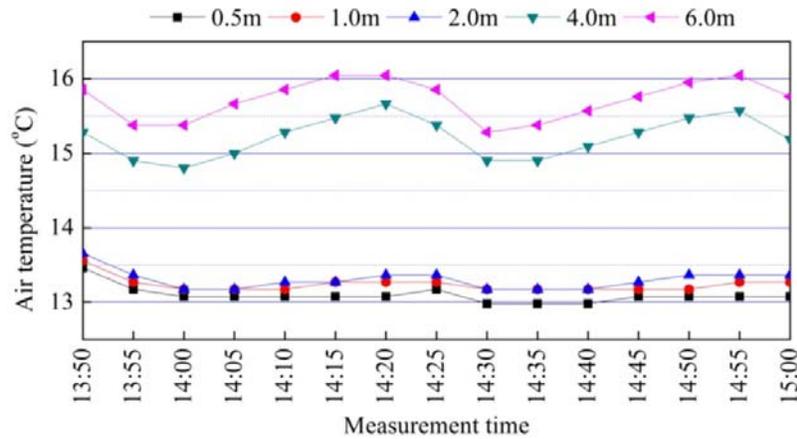
In the barrel rooms, the air temperature was supposed to be controlled at 15.6 ± 2.8 °C. The rooms were cooled by fan coil units and heated by forced air heaters. The fan coil units were hung in the centers of two opposite walls about 6m above the floor, and the heaters were hung in two opposite corners, also about 6m above the floor. Because the fan coil units were positioned high above the floor, negative buoyancy allowed the cold air from the units to be distributed uniformly. However, the warm air from the heaters remained in the upper parts of the rooms because of positive thermal buoyancy. Figure 6 shows the air temperatures at different heights in a barrel room as measured on a winter day when the outside temperature was about -5°C. During measurement, the room was almost empty, so the warm air could be easily circulated. However, the measured temperature stratification between 0.5m and 6.0m above the floor was 3K.

Figure 6. Indoor air temperatures at different heights as measured on a winter day

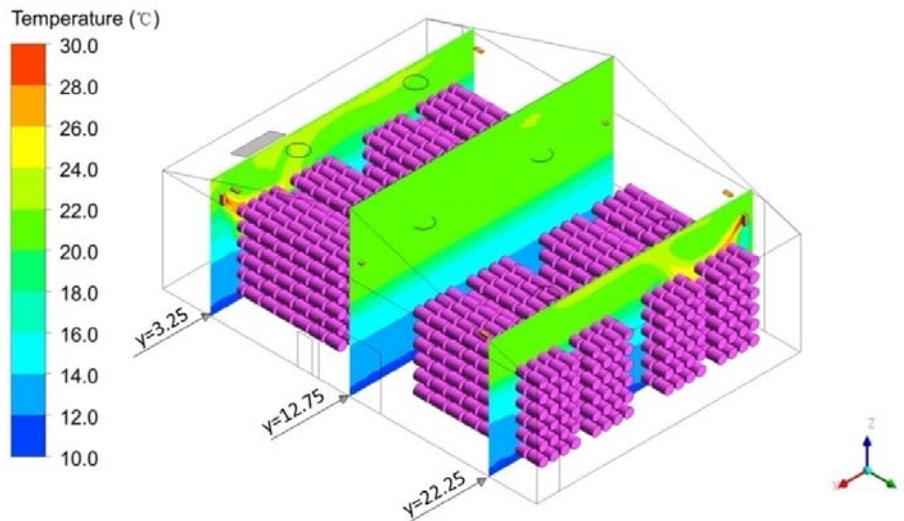
If the outdoor environment was at the design condition and the room was full of barrels, the temperature difference could be as large as 10K, as shown in Figure 7, which was simulated using a computational fluid dynamics (CFD) program, ANSYS Fluent (version12.1). The CFD program for indoor environment has been validated by our team by using different experimental data, such as Zhang et al. (2007) and Wang and Chen (2009). Due to limited space available, this paper did not provide the validation results. Figure 7 shows the temperature distribution at three representative sections, and the heaters were in the upper-left corner and upper-right corners of the room. The heaters supplied warm air at a 45° downward angle, but this air remained in the upper part of the room because of the buoyancy effect. The designers did not simulate the air temperature distribution in the barrel room and assumed that the air would be perfectly mixed by the forced air heaters. The assumption was obviously incorrect for this case.

Figure 7. Air temperature distribution in three cross sections in a barrel room with two forced air heaters in opposite corners (where the cylinders represent wine barrels)

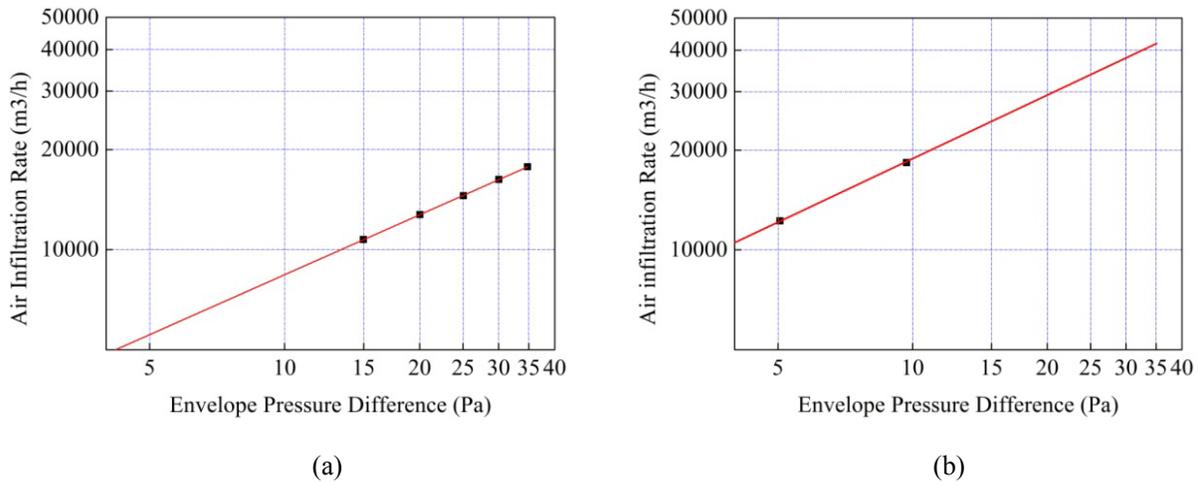
Following standards JGJ/T 177-2009 and EN 13829, the investigation performed blower-door pressurization tests in two barrel rooms, an exterior room, and an interior room. Figure 8 illustrates the relationship between the measured infiltration rates and the pressure differences for the two rooms. Because of the large volume of the two rooms, the blowers were able to maintain a pressure difference of up to 35Pa in the exterior room and 10Pa in the interior room, as shown in Figure 8. However, the two curves were quite linear and could be extrapolated. The leakage rate and pressure difference for the two rooms can be determined from the test data as:

Figure 8. Relationship between infiltration rate and pressure difference: (a) exterior room and (b) interior room

When the rooms were pressurized to winter design conditions, the infiltration rate of the exterior room could reach 3.2 ACH (Air Changes per Hour), and that of the interior room could reach 3.0ACH, as determined by using Eqs. (2) and (3), respectively. Note that the infiltration rate for such a building is typically around 1.0ACH in China. Therefore, we can conclude that this winery building had a high level of leakage.

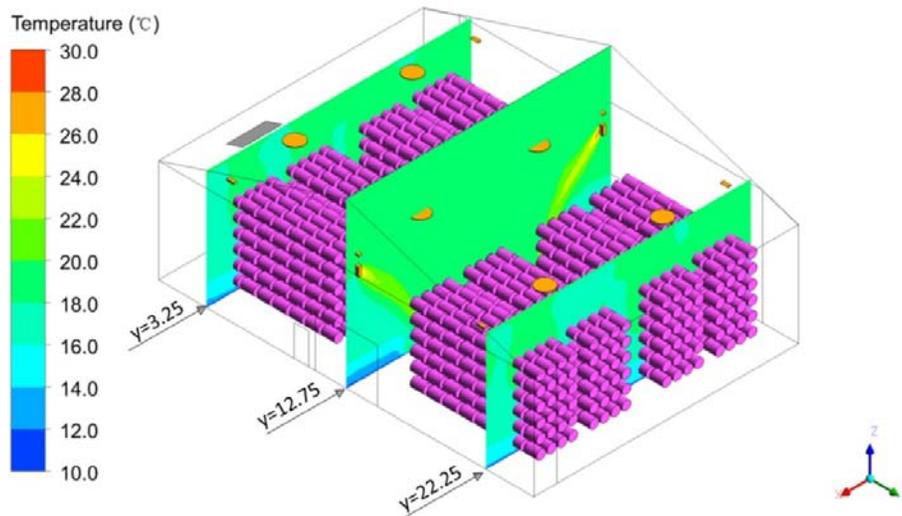
Figure 9. Air temperature distribution in three cross sections in a barrel room with two forced air heaters and six ceiling fans (where the cylinders represent wine barrels)

As is typical in a winery building, the barrel rooms were in the basement. The ceiling height in the basement was quite low, so the air in the barrel rooms would normally be considered well mixed. However, for a large space, the usual wisdom of complete mixing of air does not hold. Because the winery designer did not perform an air distribution analysis, the design allowed for a considerable temperature gradient in the barrel room in winter. For a large indoor space, accurate air distribution analysis is not easy, but it should be conducted. The most popular and trusted method is probably CFD. The investigation used the RNG κ - ε model to simulate high Reynolds number turbulent flow because its performance in predicting indoor airflows has been validated by Zhang et al. (2007). Figure 7 shows a very significant stratification of air temperature. Using CFD, this investigation positioned six ceiling fans in the barrel room and moved the heaters to the centers of the two opposite walls to reduce stratification. Figure 9 shows that the ceiling fans would reduce the temperature stratification from 10 to 4 K for the barrel room with full barrels or to 1 K without barrels, which would meet the design requirements.

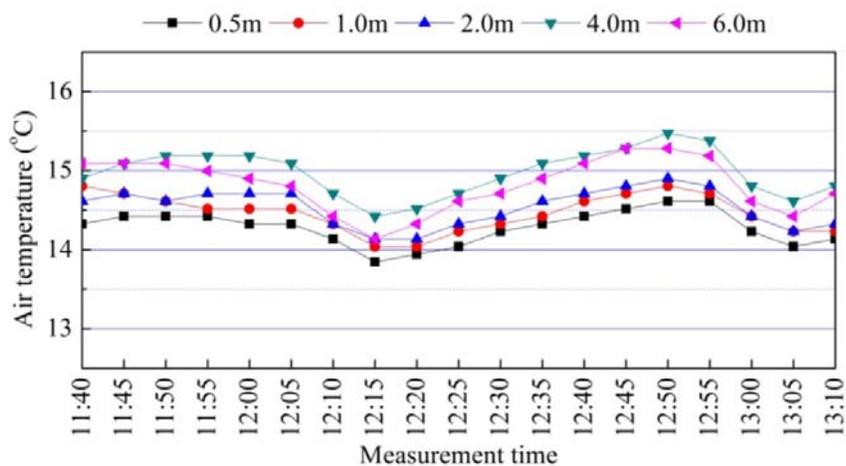
Figure 10. Indoor air temperatures at different heights with remedial measures in place

As a supplement to the CFD simulation results, the investigation measured the air temperatures at different heights in the barrel room when remedial measures were in place: the fans had been installed and the heaters had been relocated. Figure 10 shows the measured temperatures on another winter day when the outdoor temperature was very close to -5°C . All the fans were running, and the room was almost empty. The measured temperature difference between 0.5m and 6.0m above the floor was no more than 1K; thus, there was almost no stratification. This further proves that CFD would be a very useful tool for the design.
