Afeef Ahmad, Alejandro Calvo, Salma El-Azab, Hannah Fowler
Advisors: Dr. John Blendell, Dr. Carol Handwerker
Industrial Sponsor: Dr. Peng Su

Materials Engineering

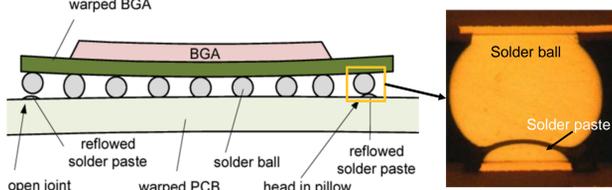
Figure 1: Head-in-pillow defect (1. Bušek, D., et al, 2. Arazna, A.)

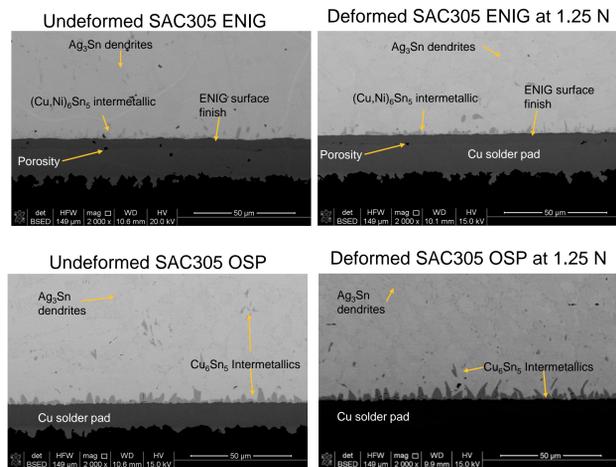
Deforming the solder balls did not have a quantifiable impact on the solder ball microstructure. There were no unusual defects in the deformed solder ball interfaces.

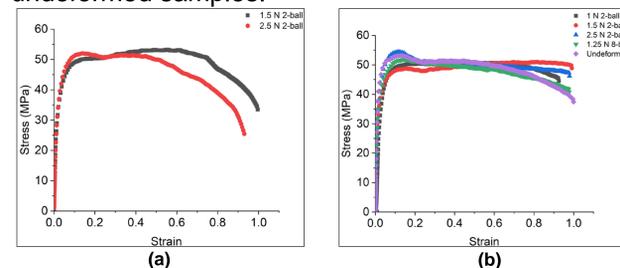
Figure 4. Stress vs strain curves from shear testing of deformed and undeformed, sandwiched SAC305 (a) OSP and (b) ENIG

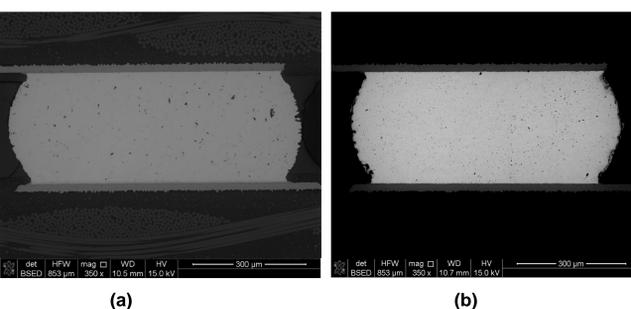
Figure 5. Micrographs of (a) an undeformed, sandwiched SAC305 ENIG board and (b) a deformed, sandwiched SAC305 ENIG board. Solder joint (b) was deformed at 1.25 N prior to forming the joint. The micrographs show that the undeformed ball and the deformed ball form intermetallics with the top board.

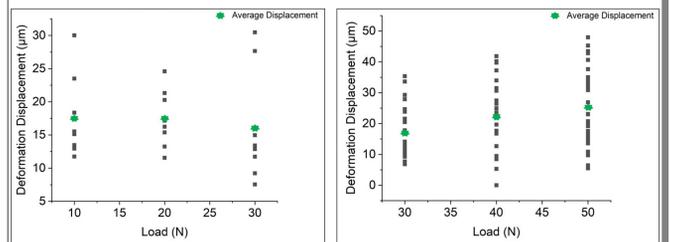
Figure 6. Load versus deformed displacement graphs for (a) SAC305 ENIG and (b) SAC305 OSP solder balls. Average displacements are shown in red. No trend can be observed.

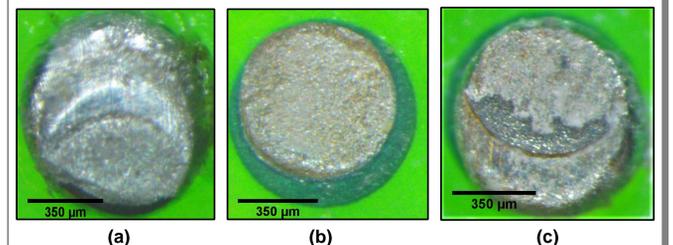
Figure 7. Optical images of 2 $\mu m/s$ constant velocity sheared sandwiched ENIG solder balls showing (a) ductile fracture, (b) brittle fracture and (c) brittle fracture after initial ductile slip.
