Trail Conservation at Celery Bog Nature Area

Ian Hahus (ENRE) and Scott Kreeger (ENRE)

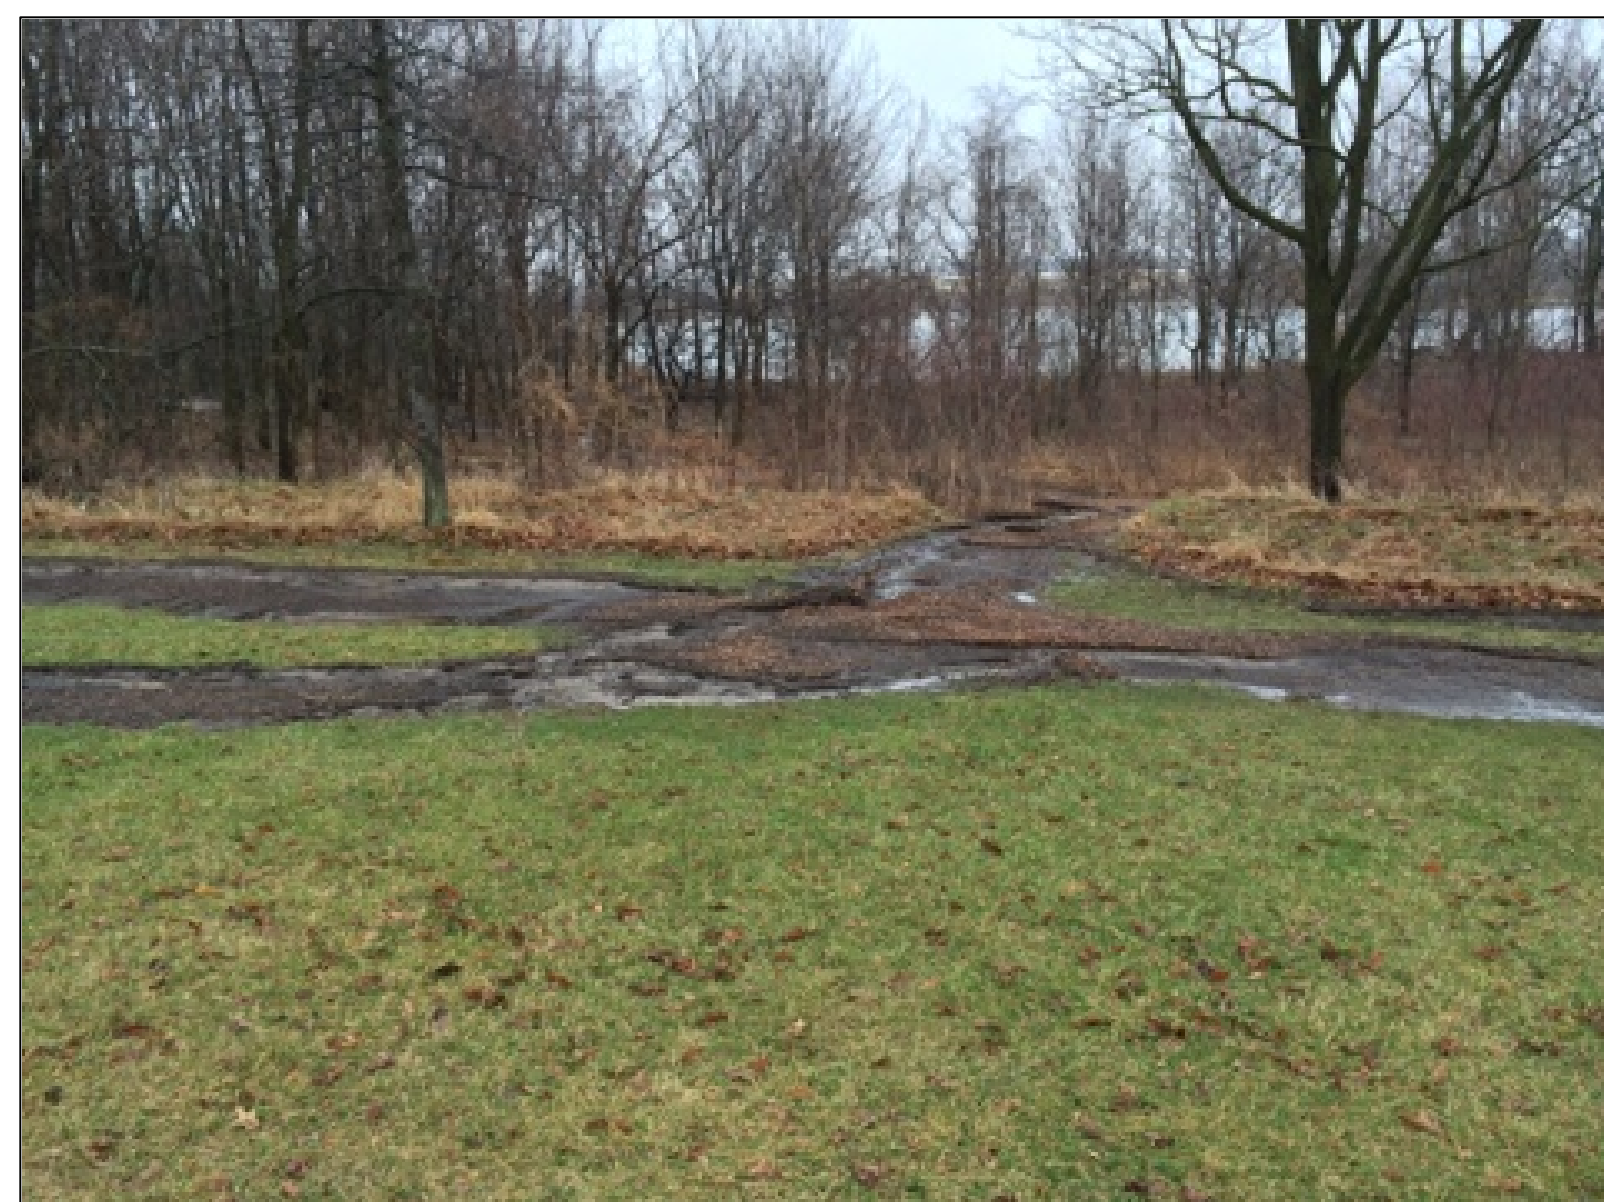
During short duration, high intensity rainfall events, the trails experience high amounts of erosion, as illustrated in Figure 1.

Figure 1: Severe trail erosion at vehicular access point.
