Resident Erosion Control

Daniel Madson, ASM

The objective of this project was to evaluate an erosion concern at a residential property. The property is located at 1820 Arrowhead Drive, West Lafayette. Homeowner Lynn Hiser approached the capstone personnel looking for assistance with gully erosion on the property. Over the course of the last two years, the above-average precipitation has destabilized the gully, causing large sections to slide down the slope. The increased erosion and destabilization has caused the residents to become concerned about loss of property and damage to homes. The gully itself merges with Goose Creek and is a waterway to the Indian Creek system. The project final design approach is to break up the multiple aspects causing the erosion into two or three heritage capstone projects.

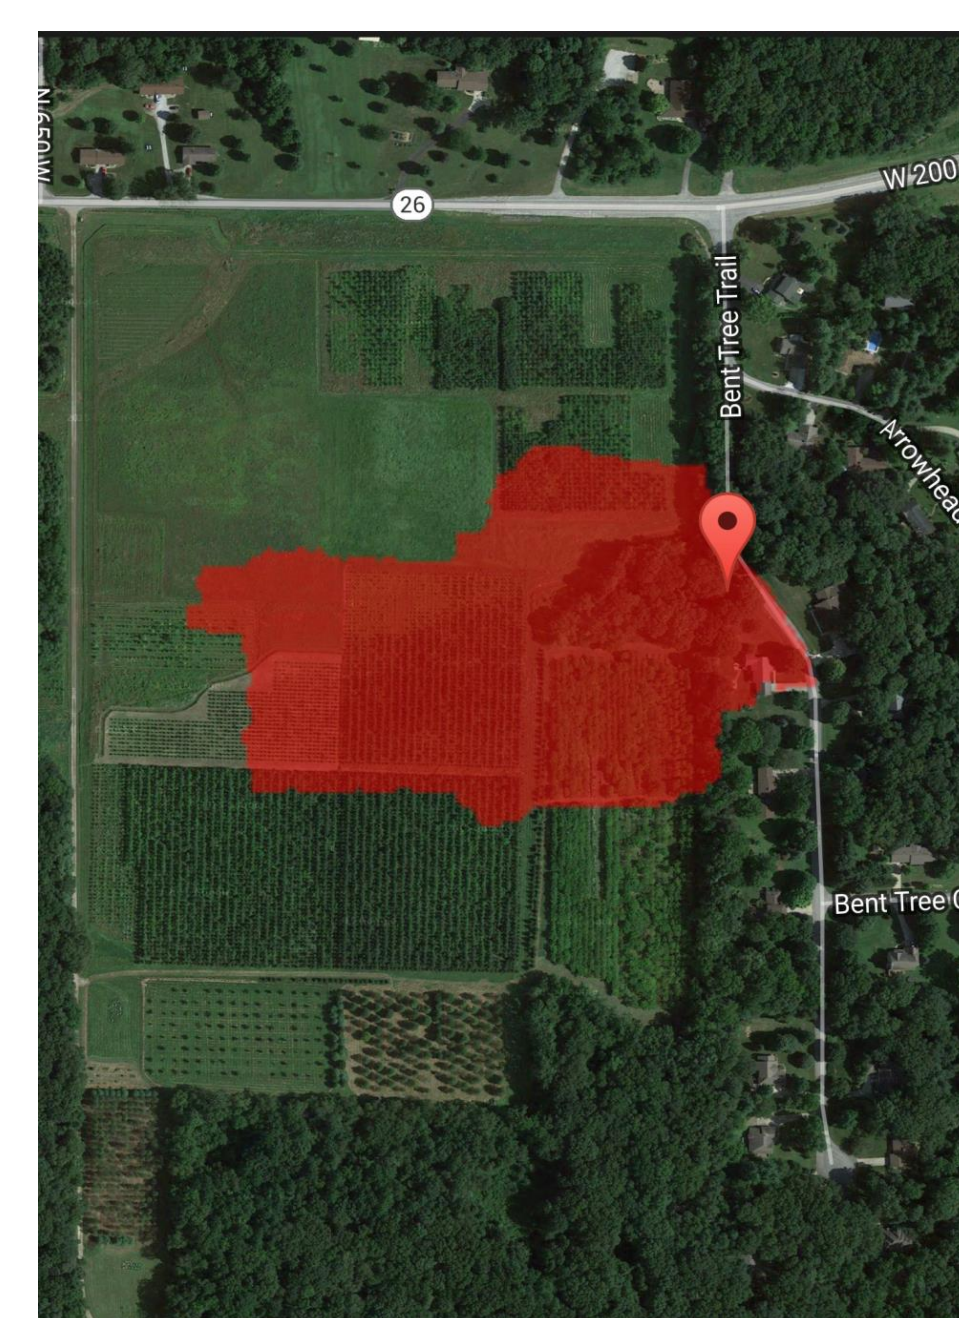
Figure 2: Watershed on Bent Tree Trail 14 Acres

- Bent Tree to culvert -14 Acres
- Total area to Goose Creek - 29 Acres

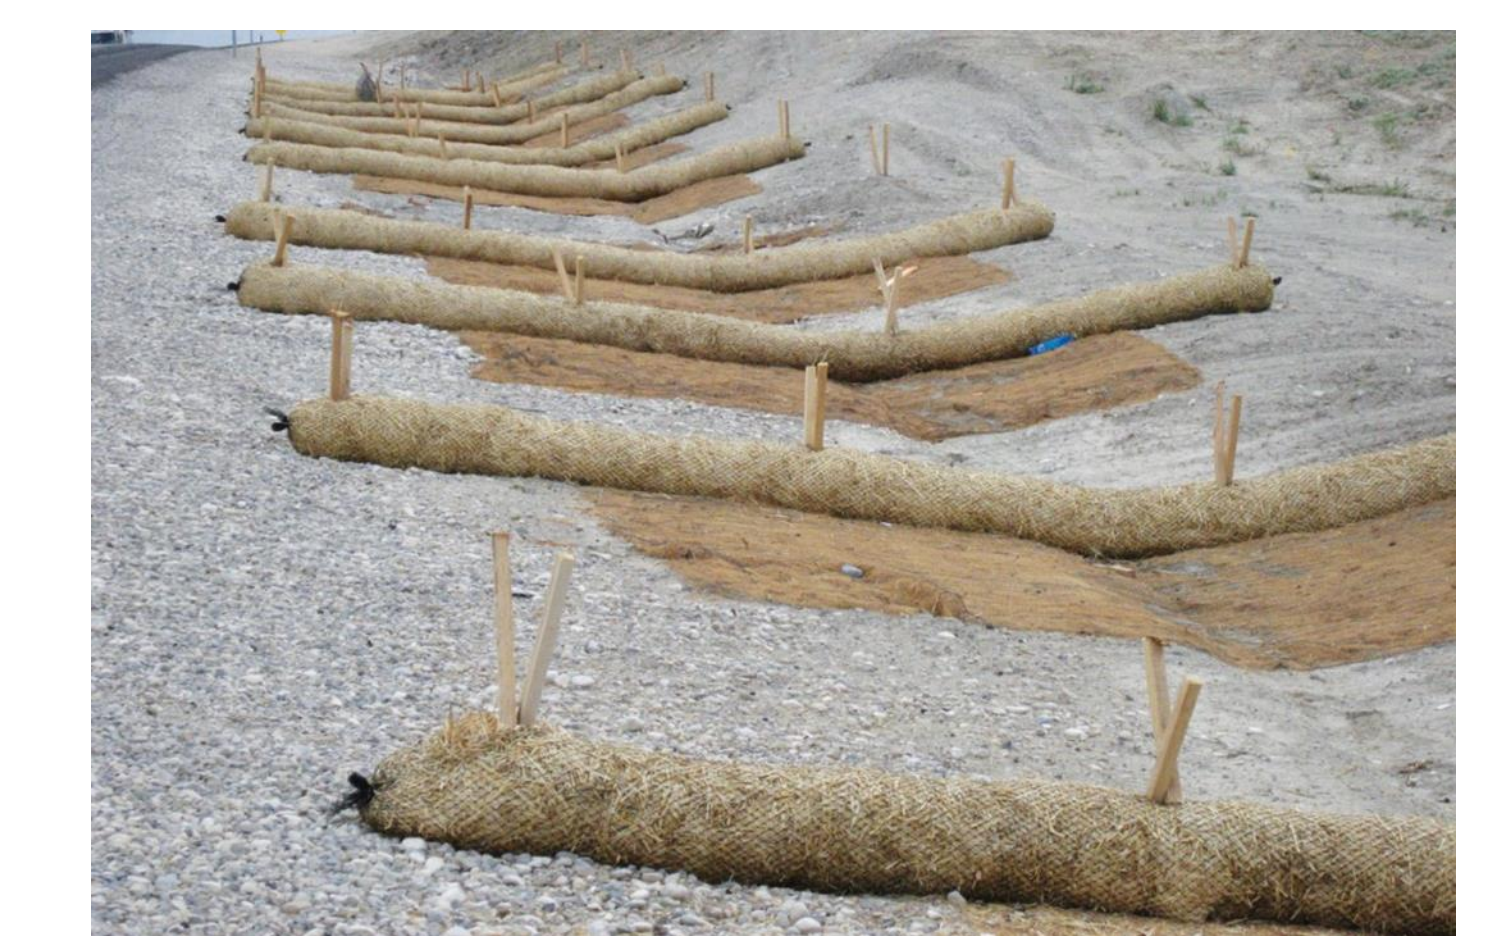
Figure 9: Contour Waddling

- The channel will need to be lined first with a series of check dams (Figure 6)
- Remove invasive species
- Reduce canopy cover to allow 15% sun light infiltration
- Contour the ridges (Figures 8 & 9)
- Backfill and profile steep areas
- Riprap existing water channels (Figure 7)
- Revegetation of ridge and slopes (Figure 8)
