Matthew Baker (ENRE), Kayley Hodson (ENRE), and Qijue Chen (ENRE)

1. Problem Statement

The current instability of the slope along the Monon Trail poses a risk to human safety and threatens the existence of the trail. There is an urgent need to prevent further expansion of the gully and stabilize the bank if the trail is to remain open to the public.

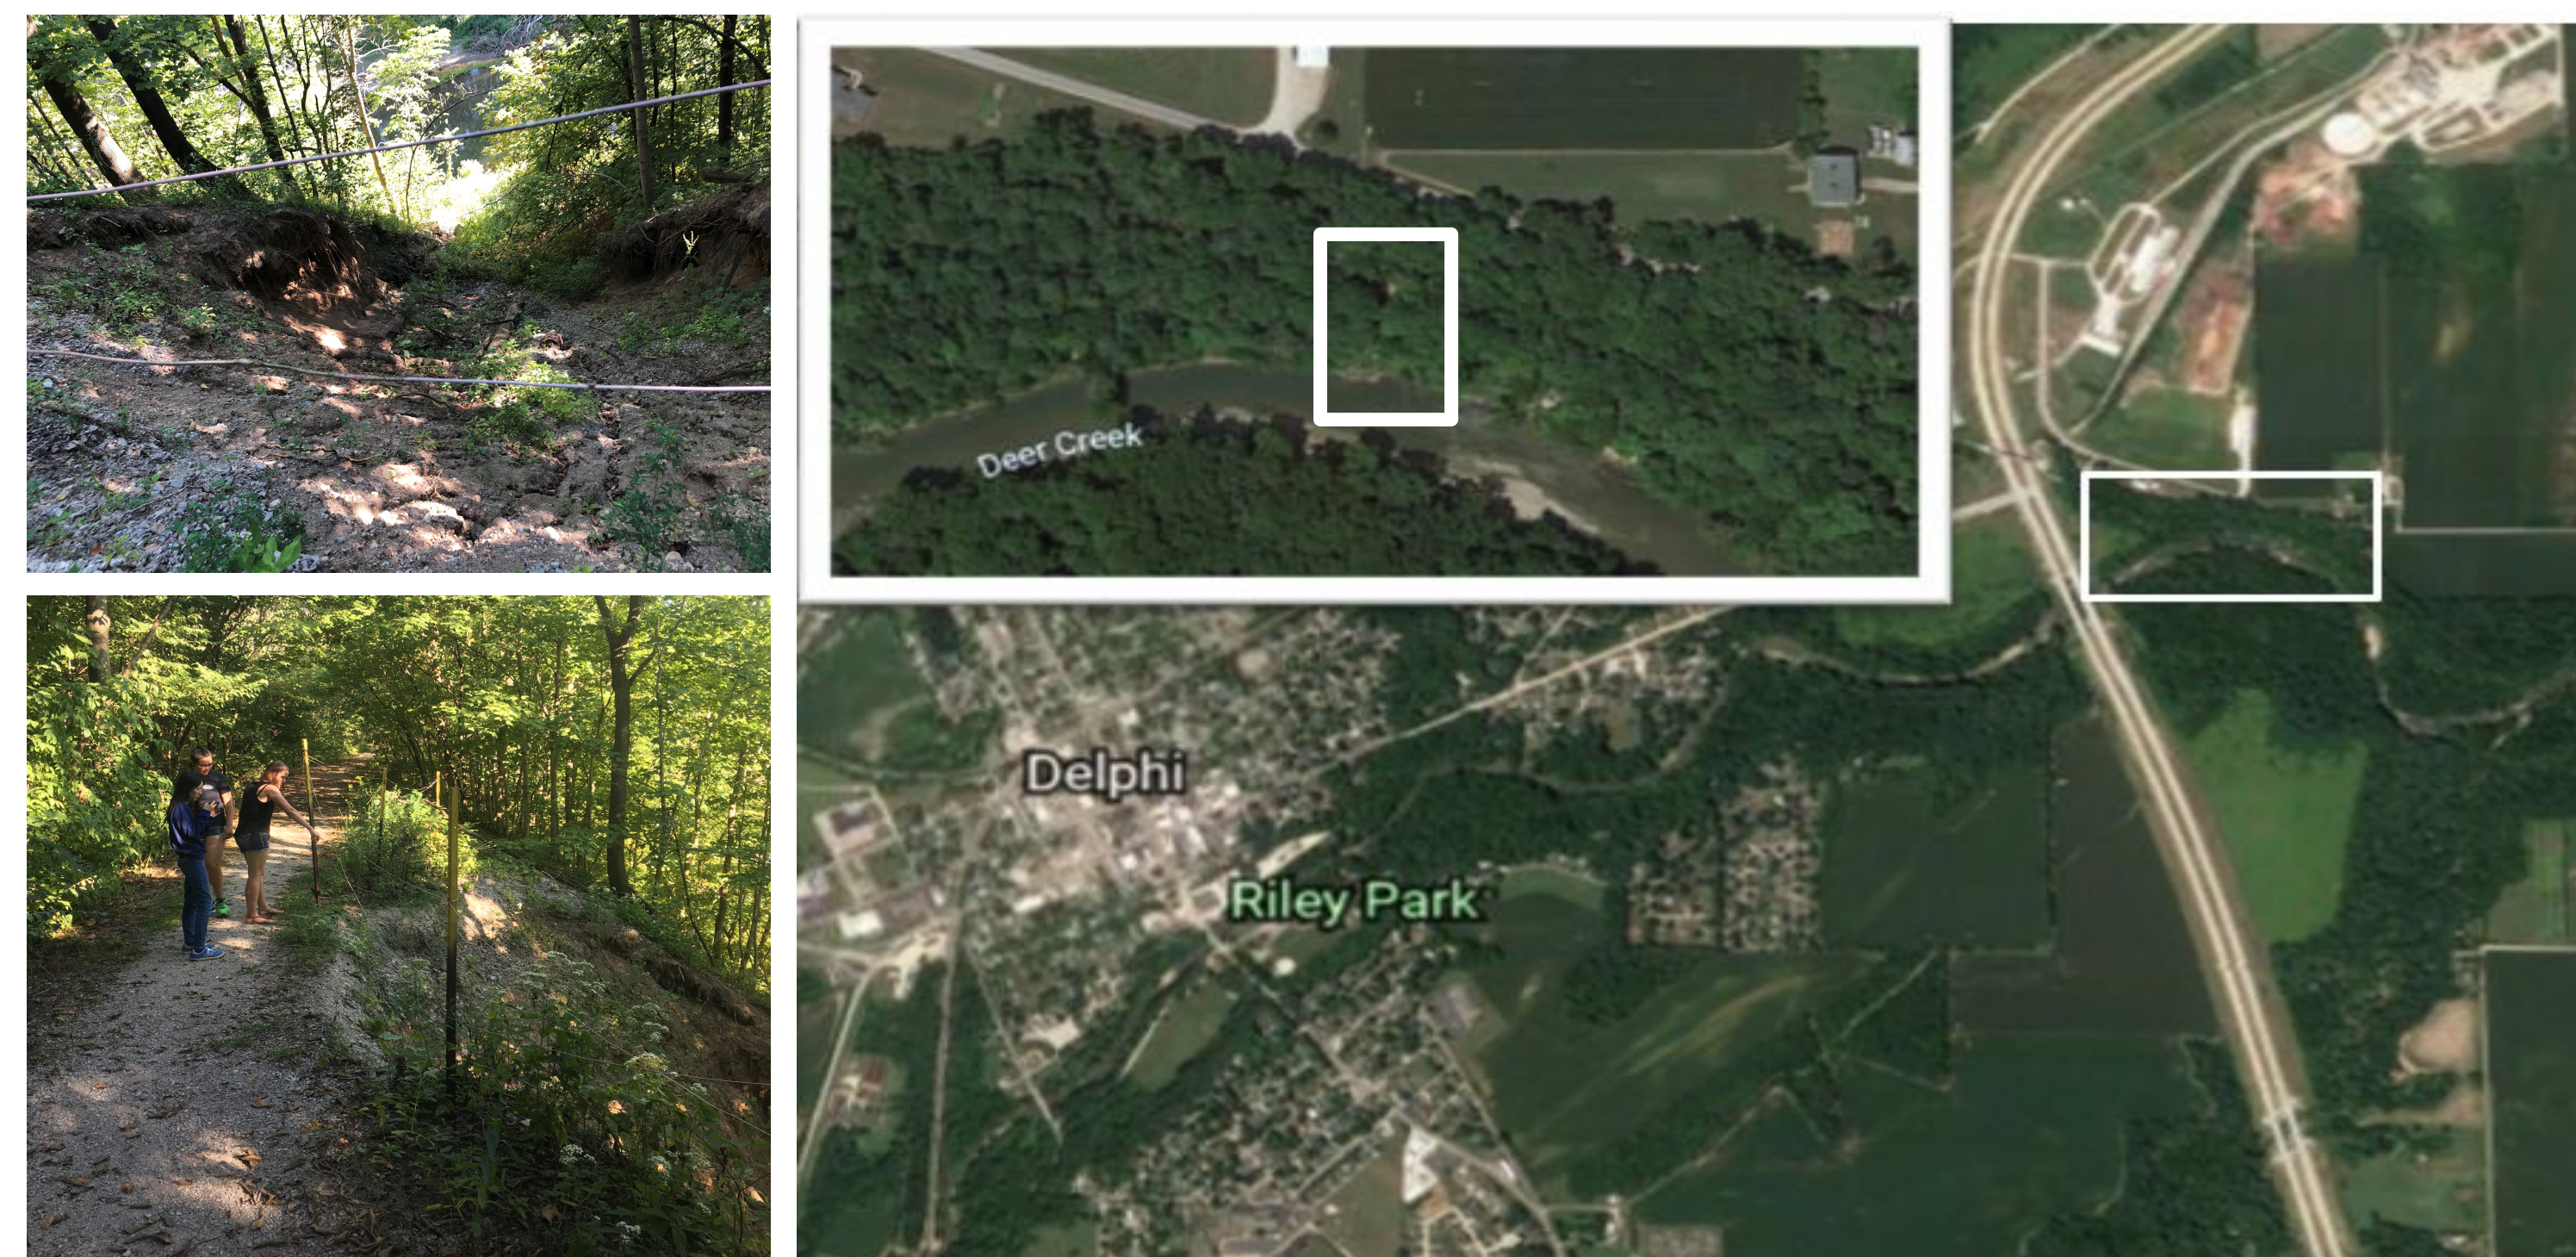
Figure 1 Photos from the site taken at the Monon Trail
Figure 2 Aerial map of site location along Deer Creek

The Monon High Bridge Trail (Delphi, Indiana) follows an old railroad line as it runs along the banks of a local creek (Deer Creek). A portion of the bank has recently collapsed and is cutting into the trail (Fig. 2).

The depression that was formed is 60 feet tall from trail to streambed over a horizontal distance of 120 feet. The collapsed portion measures 30 feet at the trail in width and widens at the toe (Fig. 3).

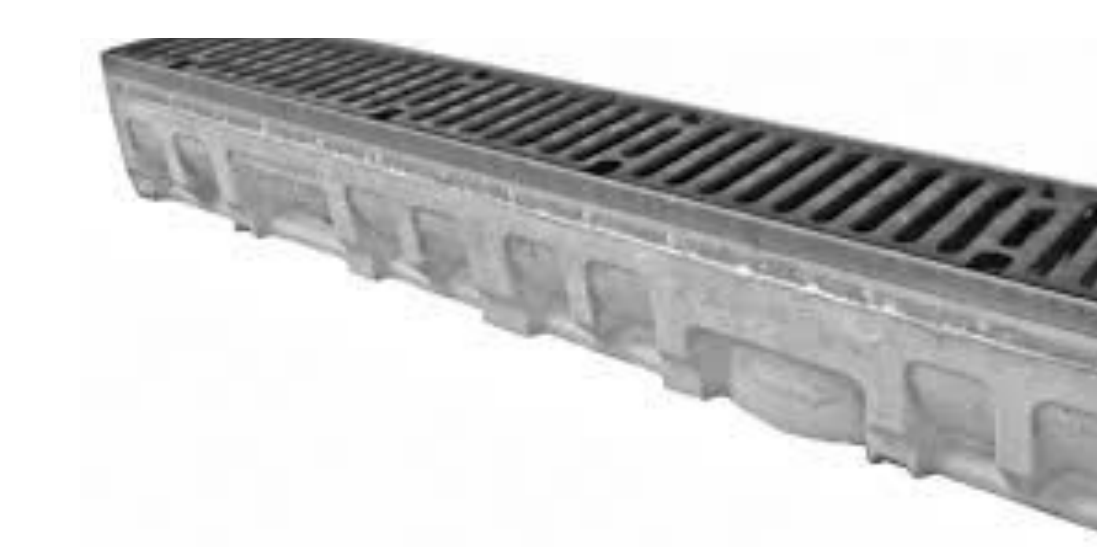
Figure 6 Selected Trench Drain to place along trail

- Surface MIFAB T-300 Trench Drain installed along new trail (Fig. 6)
- Subsurface tile drains placed behind walls
- Benefits
 - Avoids backfilling with water
 - Prevents flooding along trail

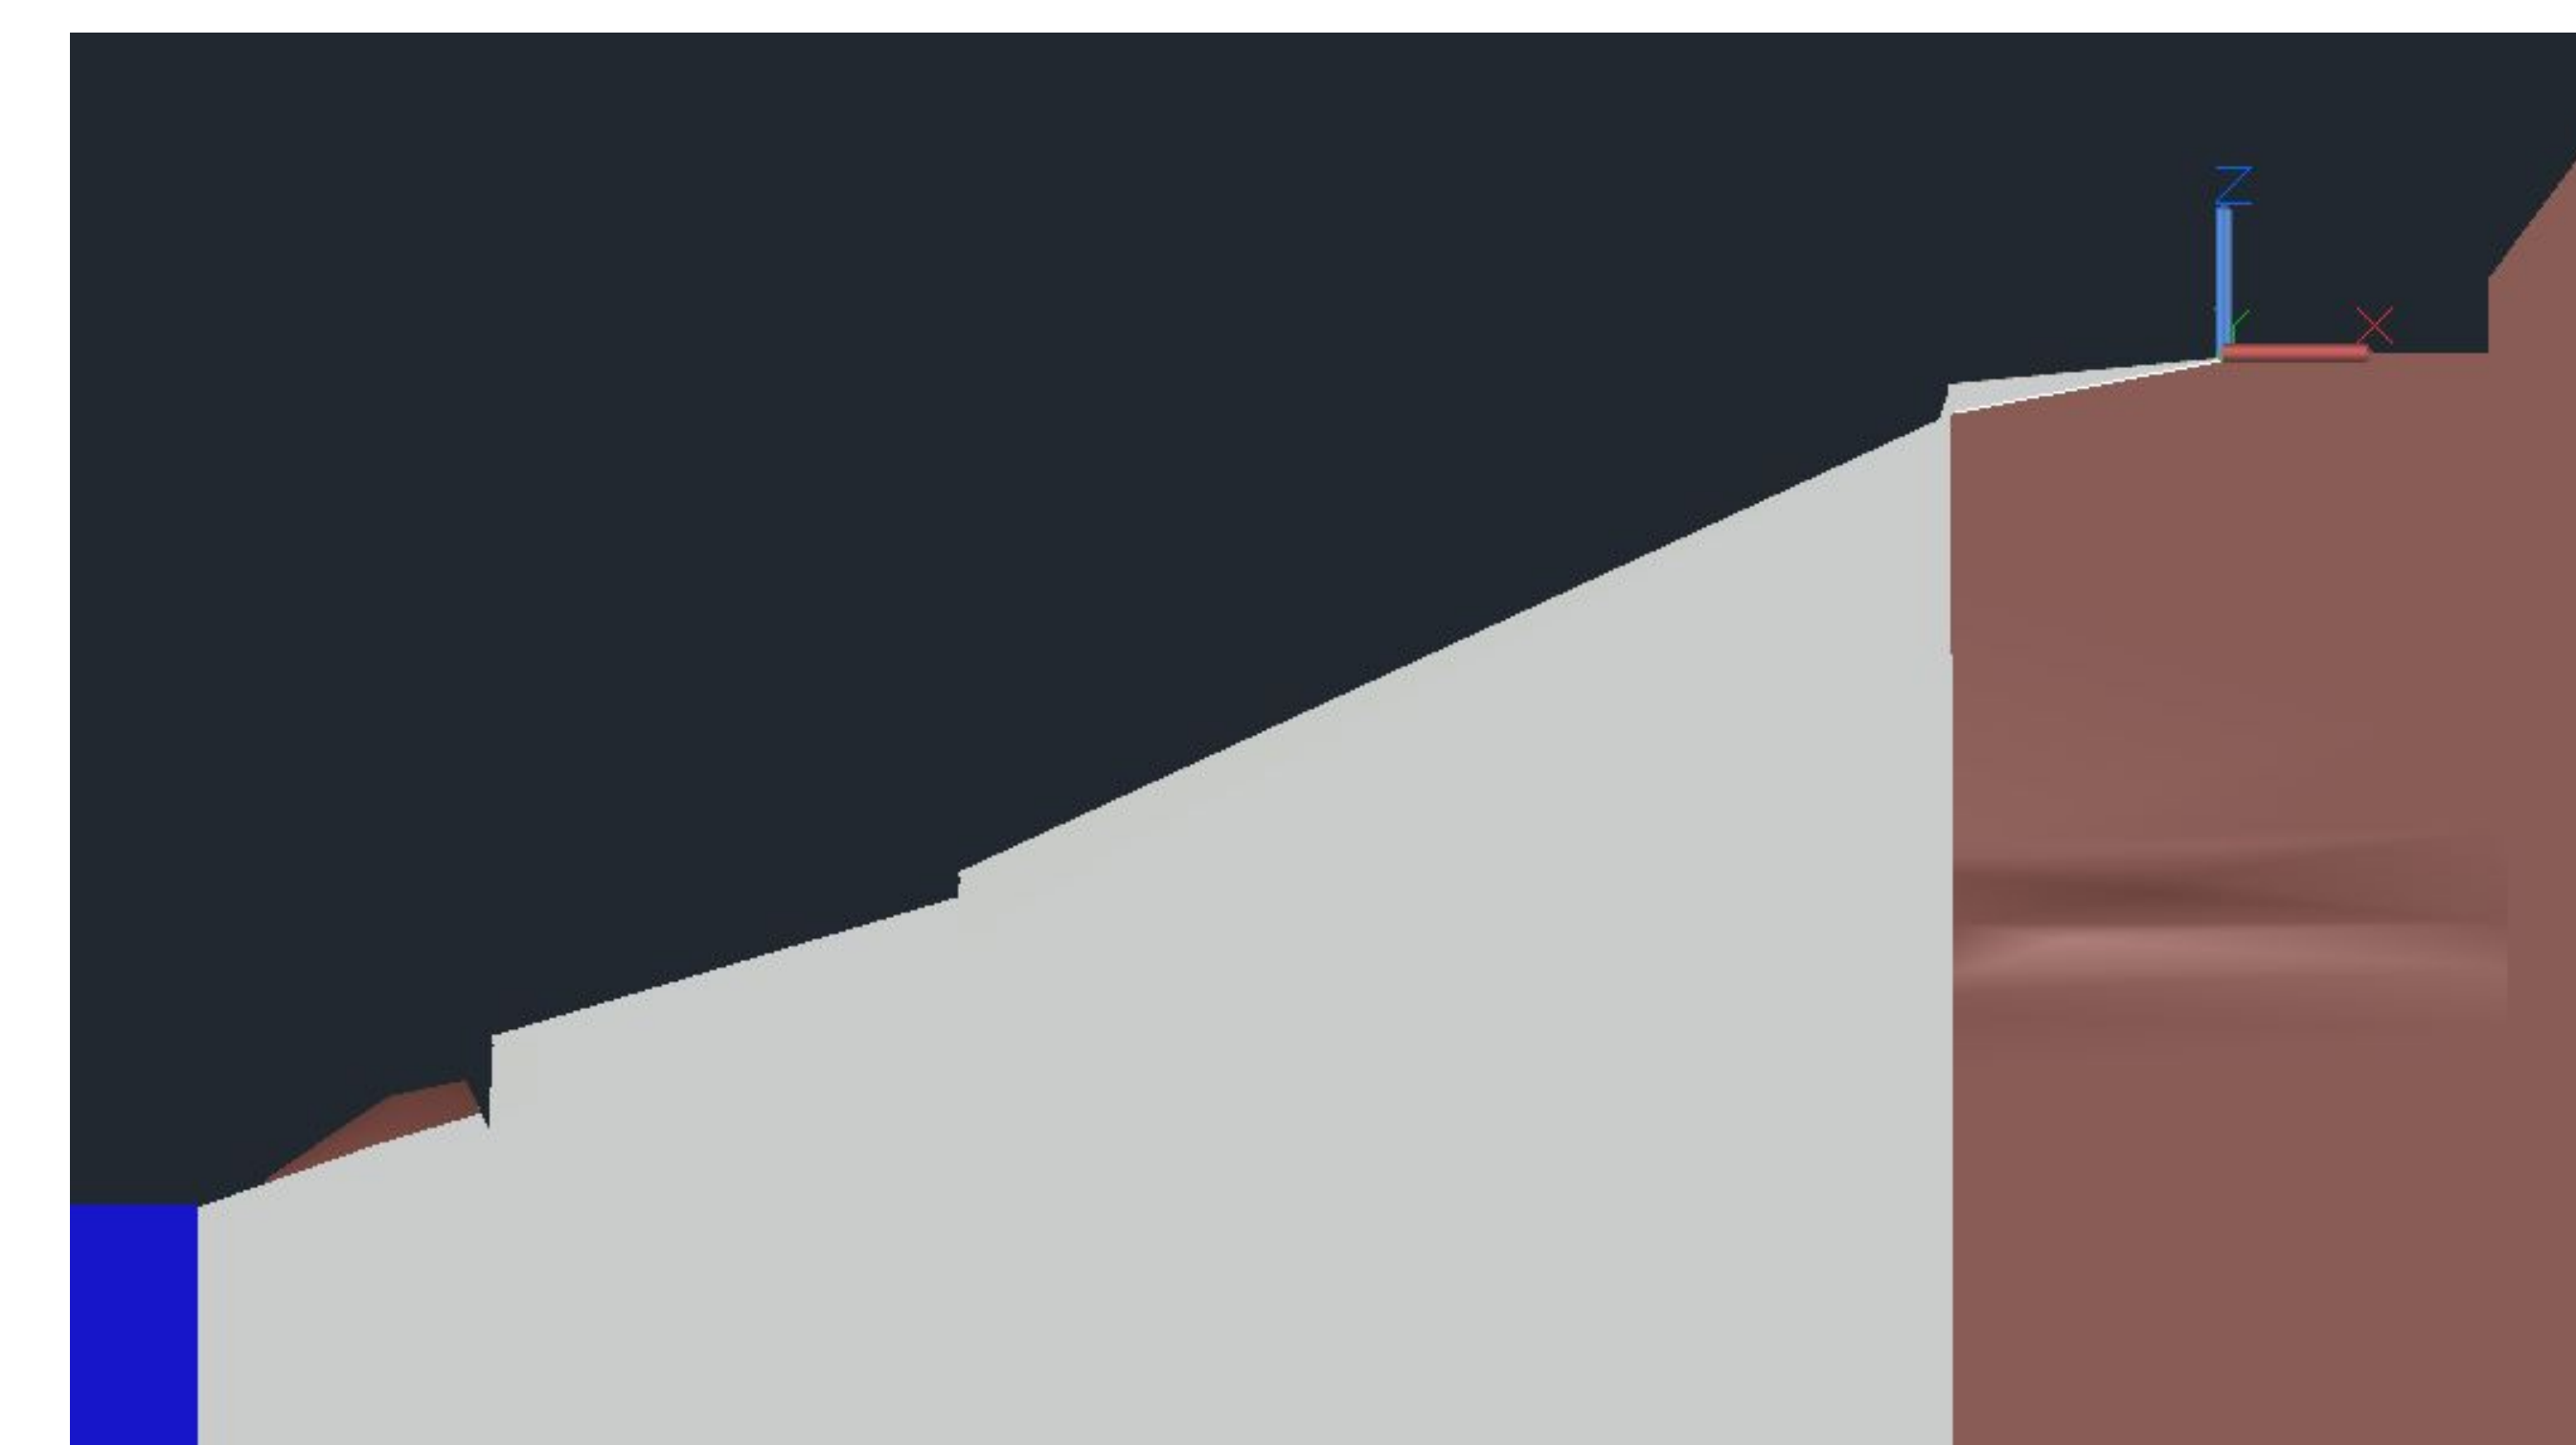
Figure 7 CAD Model of Crib Wall and Gabion Basket design
Wall Dimensions (from high elevation to low):
Log wall - 5x3x36 ft Gabion wall middle - 4x2x36 ft Base Gabion - 6x3x36 ft

- Crib walls designed to meet safety factors in different categories:
 - Foundation bearing failure, sliding, rotation
- Global analysis finds critical slip surface, local analysis determines size and locations of walls
- Final wall properties (Fig. 7):
 - 2 Gabion Baskets → Near base
 - 1 Log Crib → Near trail
- Benefits
 - Retains soil mass and prevents further collapse
 - Multiple small walls advantageous due to earth pressure theories
 - Gabions allow easy installation while crib gives aesthetic appeal
