[A Few] Emerging Issues for Plastics with Infrastructure Rehabilitation & New Construction: *Pipes, Coatings, Liners and Composites*

Andrew J. Whelton

November 16, 2016

Water 2.0 – Indianapolis, IN

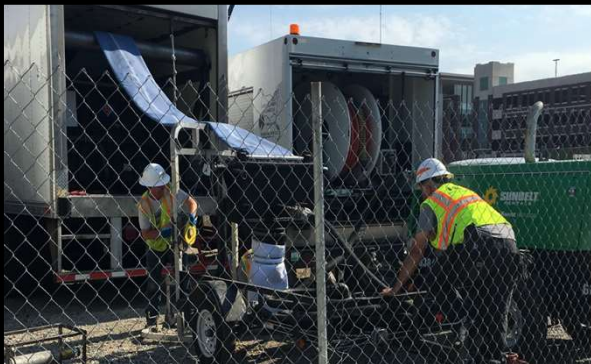
Trenchless technology: "No Dig" "No Excavation"

Resin impregnated tube hardened in a broken pipe

Curing method: Hot water, Steam, UV light

Deliberate curing time: Hours to many days

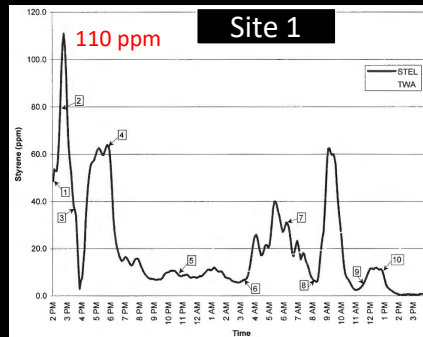
AirZone, Inc. (2001)

A Report on the Monitoring of Styrene in Toronto Homes During the Cured in Place Pipe (CIPP) Process for Sewer Pipe Rehabilitation by Insituform

3.2 ppm

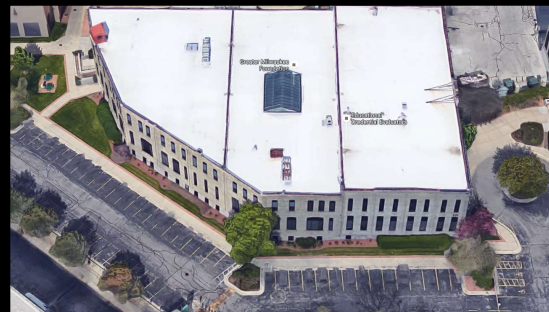
ATSDR. 2005.

In 2005, ATSDR Found CIPP Styrene and Other VOCs Entered Office Building through the Foundation, Chemicals Lingered for Months

Date	Total VOC, ppm	Styrene, ppm
12/10	Evacuation	Evacuation
12/13	Evacuation	Evacuation
12/13-22	nd – 1.45	Not tested
12/22	nd – 199.0	Not tested
1/12	0.5 – 30.0 ⁺	Not tested
1/13	nd – 1.77	nd – 0.30
1/18	nd – 1.60	Not tested
1/21	nd – 0.86	nd – 0.22
2/4	nd – 0.21	nd – 0.15
2/7	nd – 0.57	nd – 0.04
3/28	nd – 0.22	nd – 0.01

*"...past conditions at the site are classified as a
public health hazard."*

Styrene odor threshold < 0.1 ppm

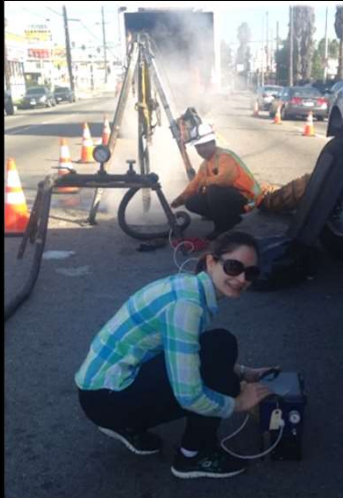
Adjari (2016)

2015, CIPP Styrene Exited Sewer Manhole and Exceeded the NIOSH IDLH

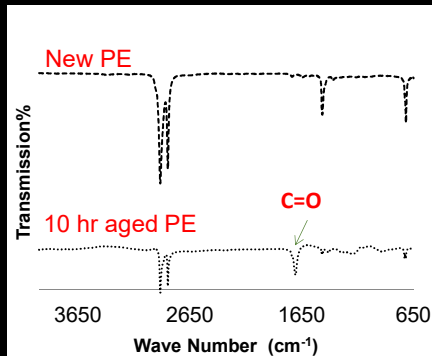
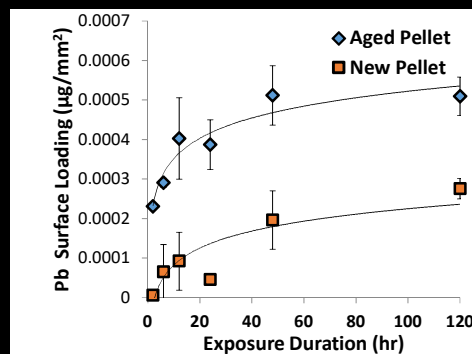
Material Aging Can Cause Plastic to Act as a Better Deposition Site for Heavy Metals

Example: pH 7.8, Pb 300 µg/L; 23 °C

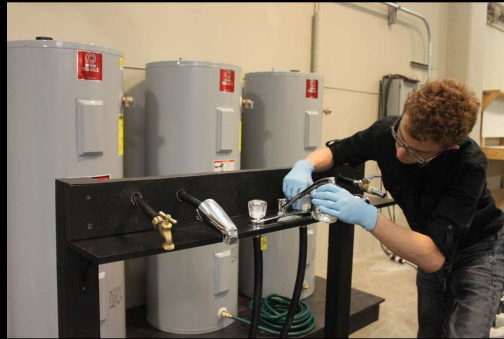
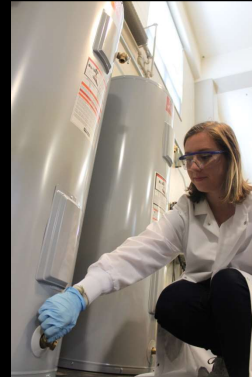
Water Infrastructure and Testing & Evaluation Facility for Renewal (Purdue WATER)

Recreate field conditions, Evaluate system design and contamination scenarios, Explore material-contaminant interactions, Challenge decontamination aide effectiveness
