High Heat Flux Erosion of Carbon Fibre Composite Materials in the TEXTOR Tokamak*

Presented at the Eighth International Conference on Fusion Reactor Materials (ICFRM-8)

High Heat Flux Erosion of Carbon Fibre Composite Materials in the TEXTOR Tokamak

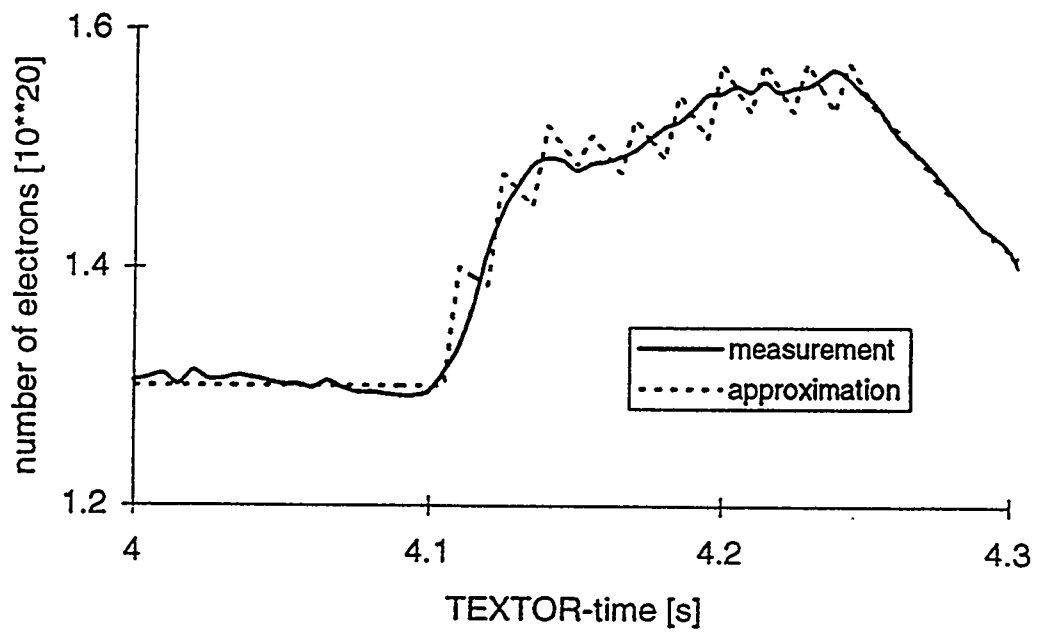
Figure 1: Increase of the electron number in the TEXTOR plasma during the plasma exposure of N11, 9 cm probe insertion into plasma, discharge no. 64246

The evolution of the electron number in a typical discharge with exposure of N11 to an insertion depth of 9 cm is shown in figure 1. The erosion of atoms from the probe tip and the subsequent ionization of the eroded atoms in the plasma causes the increase of the total number of electrons present in the plasma. From the increase of the electron number and the decay after probe retraction the influx of impurity atoms from the probe tip can be estimated [9]. The average confinement time of the impurity induced electrons was derived from the decay of the electron number after retraction of the probe from the hot plasma. For N11 this gave an approximate confinement time $\tau_p = 60$ ms and for the Si-containing material NS11 $\tau_p = 100$ ms. Figure 1 shows the numerical approximation of the electron generation from the ionization of the inflowing impurity atoms and the subsequent loss of these electrons from the discharge. For the estimate of the inflow of impurity atoms which was derived from the variation of the electron number in the plasma it was assumed that in the case of the N11 material, where only C-atoms were eroded, these C-atoms ($Z=6$) were fully ionised within the plasma which leads to the liberation of six electrons per C-atom. In the case of NS11 it was assumed that preferentially Si entered the plasma due to the significantly higher vapour pressure compared to C

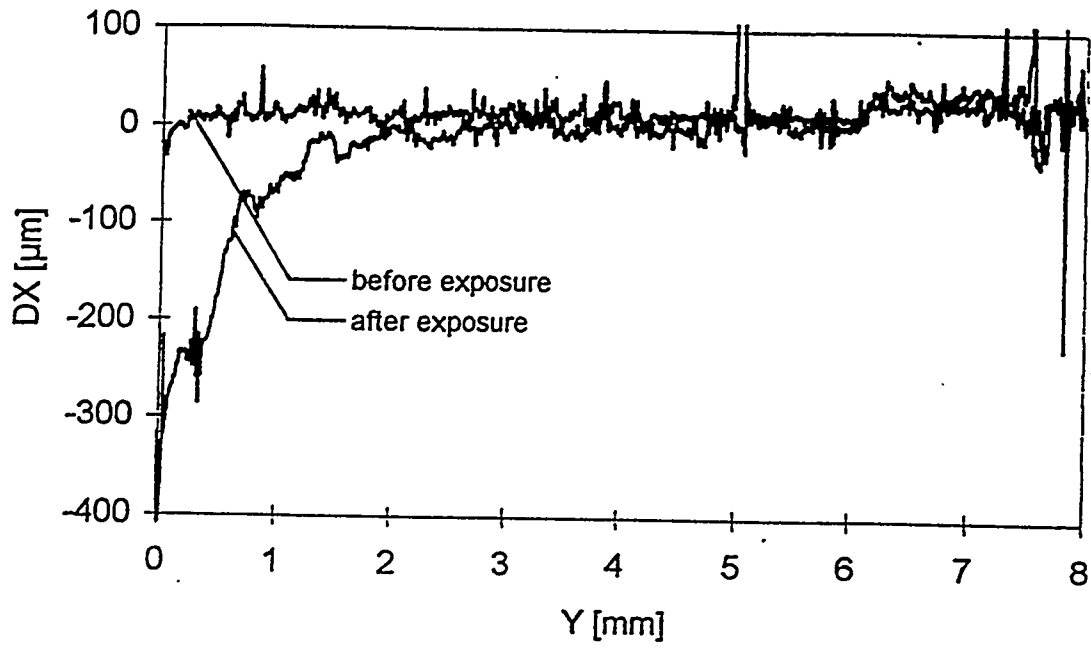
Figure 2

Figure 2: Laser profilometer measurement on N11 after 10 plasma exposures, surface was oriented perpendicular to the magnetic field of TEXTOR.

After the experiments the surface profile of the N11 probe tip was measured by laser and stylus profilometry. The side surfaces which were positioned perpendicular to the magnetic field showed erosion, see the representative measurement in figure 2. At the edge the erosion depth reached $300 \mu\text{m}$. In length (y-) direction away from the edge the erosion strongly decreased until a radial distance from the edge of $y \approx 2.5 \text{ mm}$. This indicates that the high heat flux only hit at the very edge of the probe and that the heat flux decay length in radial direction was very small. No significant erosion was measured on the end face of the tip and on the side surfaces which were oriented parallel to the magnetic field. The summation of the erosion volume measured on the surfaces perpendicular to the magnetic field gave a volume of 6.8 mm^3 , corresponding to a weight loss of 1.2 mg per plasma exposure which gives an ablation of $6 \cdot 10^{19}$ atoms C per plasma exposure for the N11 material. This is a factor of 5 higher than the estimate of ablated C-atoms from the increase of the electron number in the plasma, cf. 3.1. This difference may have the following reasons:

Calculations were carried out using a 2-d computer code with direction dependent material data for the N11 material. The simulation included thermal conduction, evaporation and radiation from the specimen surface. A starting temperature of 2000 K was assumed to include the temperature rise of the probe during the inward stroke phase of the probe. The heat flux was assumed as constant over a period of 80 ms. It was found that the erosion profile of fig. 2 could be simulated with an exponentially decaying profile of the deposited heat flux of the shape $Q(y) = Q_0 * \exp(-y/y_0)$. Values of Q_0 and y_0 were systematically varied until satisfying accord was found between the measured and the calculated erosion profile. Figure 3a,b shows the profile of the deposited heat flux with $Q_0 = 12.5$ kW/cm² for 80 ms, $y_0 = 2.7$ mm and the resulting erosion profile per exposure which matches well with the erosion profile accumulated over ten exposures of fig. 2.

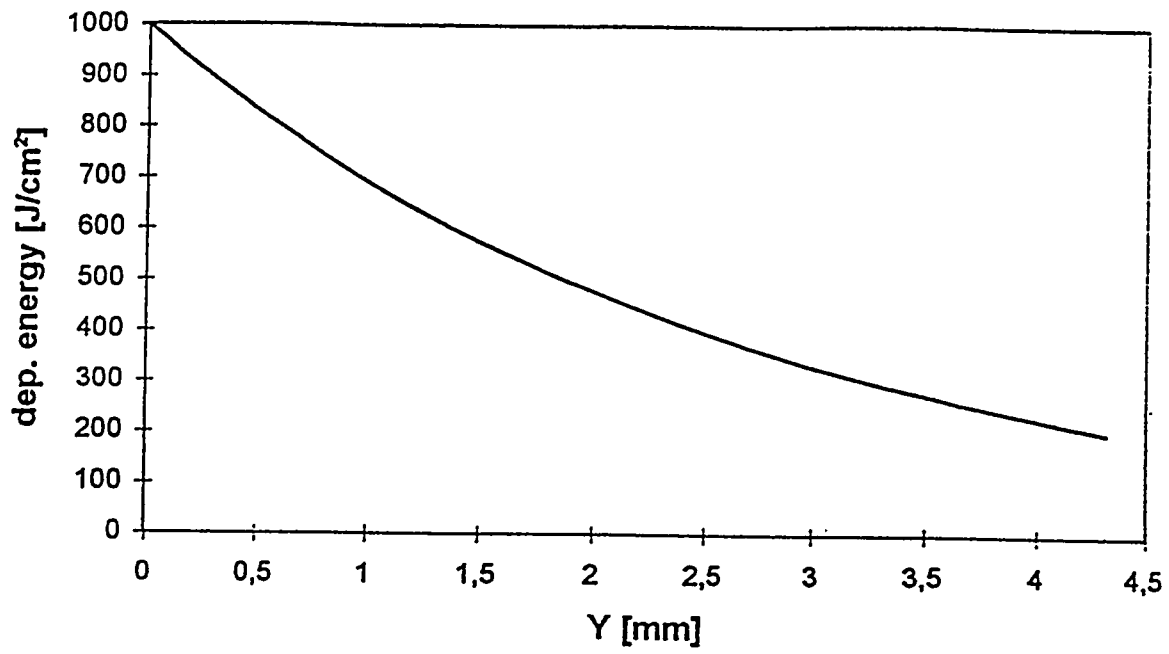
Figure 3a

Figure 3: Results of 2-d numerical calculations to simulate the erosion profile near the probe tip (see also fig. 2)

a) Profile of the deposited energy density with $Q_0 = 12.5 \text{ kW/cm}^2$, $y_0 = 2.7 \text{ mm}$

The result shows that the power scrape-off length (y_0) at the probe tip with 2.5...3 mm is very short compared to usual values at TEXTOR limiters of 7...10 mm. In addition the average deposited heat flux at the very probe tip is a factor of two lower than the estimated heat flux in the undisturbed plasma, see cf. 2.

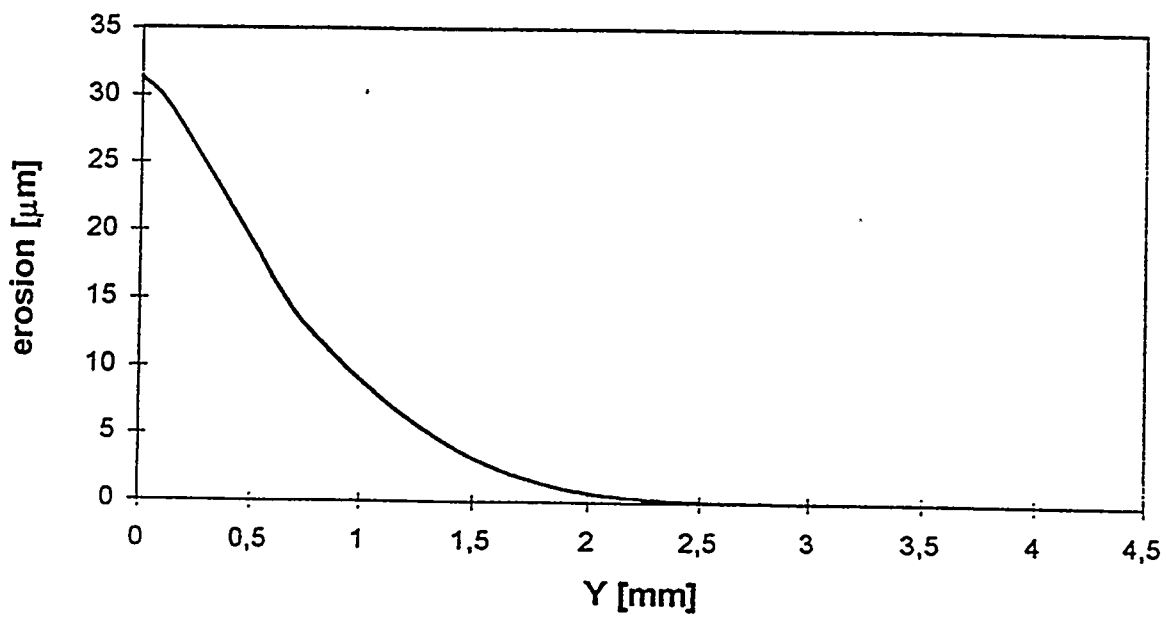
Figure 3b

b) Erosion profile per exposure resulting from the energy deposition shown in fig. 3a
