### Client Background:

Applied Fabricators, Inc. (AFAB) is a family-owned architectural sheet metal shop in Greenfield, Indiana. The company specializes in fabricating metal for various building exterior components.

### Problem Statement:

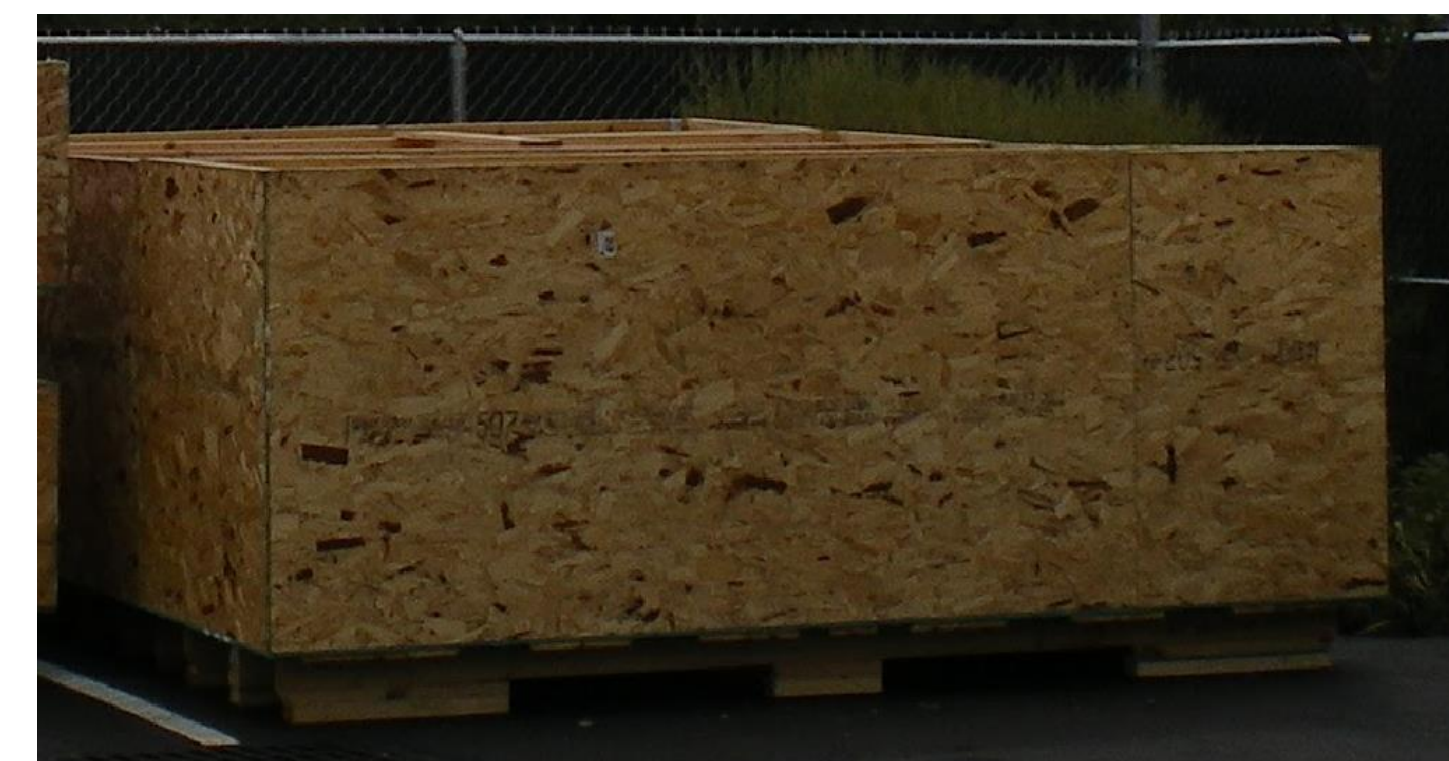
Current packaging

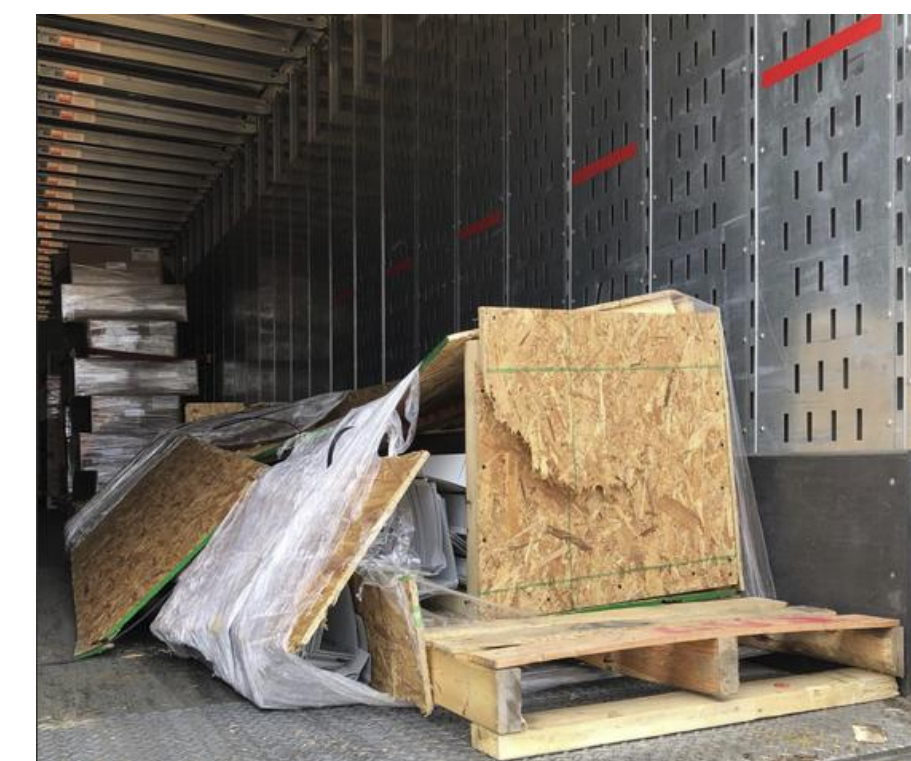
Damaged crates

- 1) Why are we having **quality issues** with the shipment?
  - o Packaging (crates) break down during transport.
- 2) Why did the crates break down during transportation?
  - o Forklift impacted the crate when handling, causing damages.
- 3) Why did the forklift impact the crate?
  - o Because the crate dimension matches the pallet it sit on exactly, leaving no room for buffer.
