# Investigation of Microstructural Evolution in Advanced 3-D Logic and Memory Devices

**Nikita Gaurav, Brenden Hamilton, Matthew Muschar, Ce Ouyang**  
Faculty Advisors: Professor John Blendell & Professor Carol Handwerker  
Industrial Sponsors: Peng Su, Juniper Networks

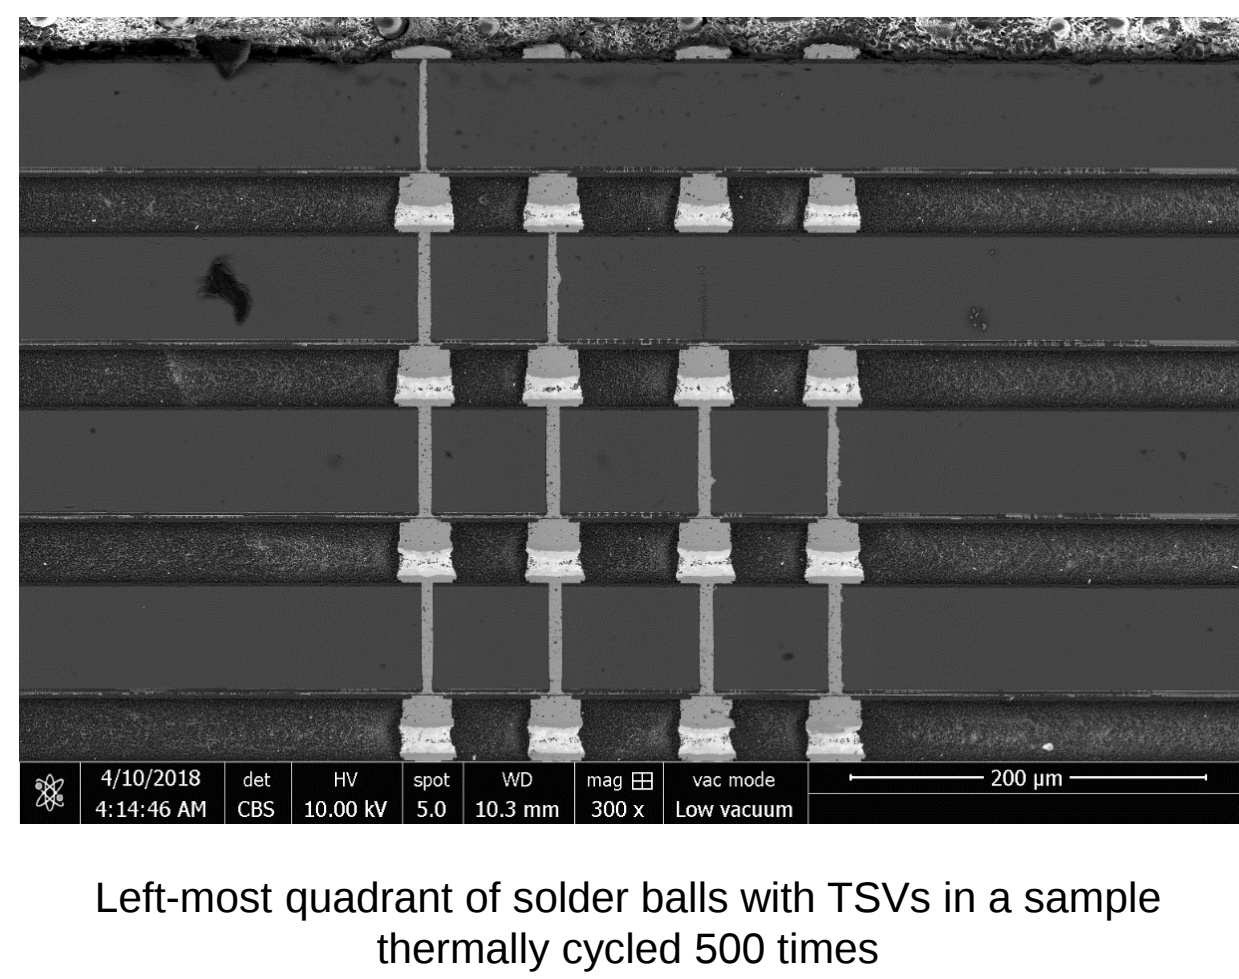
By stacking layers of logic and memory devices in a 3-Dimensional architecture, systems can utilize less space and increase computation via shorter signal pathways. However, it is relatively unknown how this new architecture will affect the reliability of the solder joints, a vital component. Statistically significant data must be obtained to analyze the response of the solder to different stress states. During fabrication, the tin alloy is reflowed to attach each layer; the solder joint on the bottom level has seen 3 more heat cycles than the top level. As the 3D device thermally expands, the solder on the edges will experience a greater overall displacement and resulting in larger forces applied. Thermal aging can be utilized to assess solder damage.

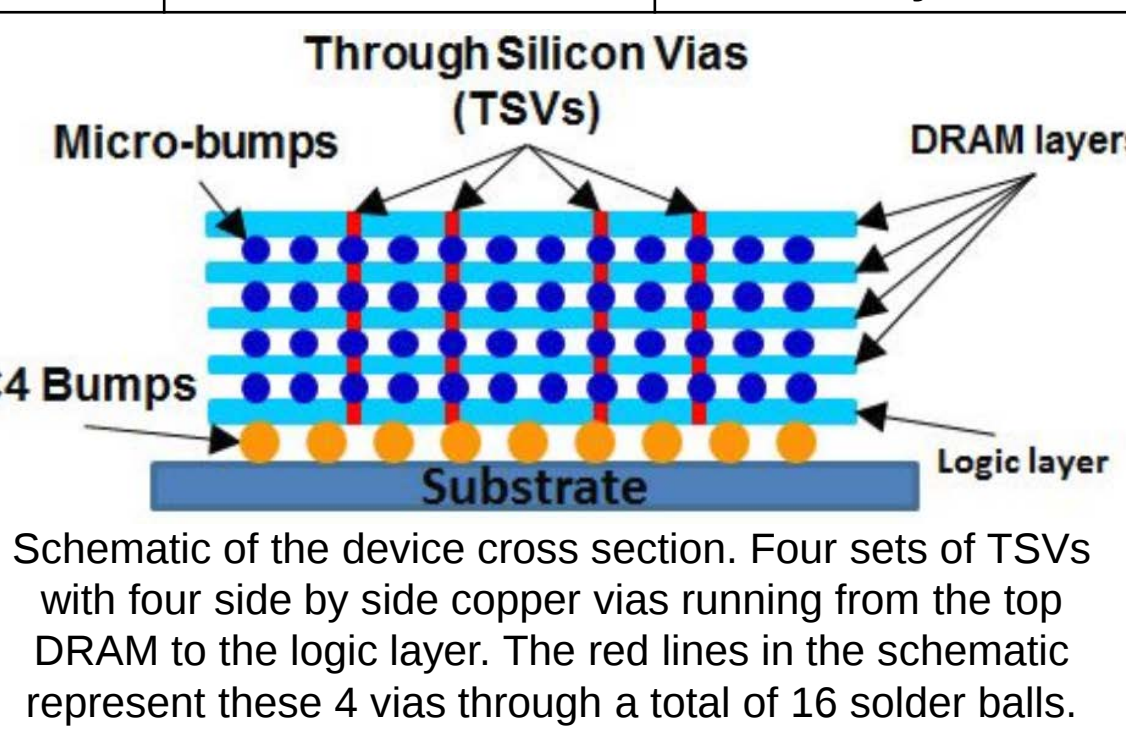
At each read point, the analysis focused on four sections of the chip, the four sets of Through Silicon Vias (TSVs) and the solder bumps attaching them. The four points of interest consist of 16 solder bump/TSVs each, with the outer two and inner two being equivalent due to axisymmetric geometry. At each point, the solder is analyzed for

relative damage and IMC growth. Using BSE SEM imaging, the IMC layers can be determined by contrast and their thickness measured. Using the same image, the damage is measured. The damage exists as necking, large single cracks, and regions of numerous small cracks. The damage is defined as the percentage of the width that the cracks/necking extend across the solder ball, hence, 100% damage (or a score of 10/10) will have cracks extending the entire width, preventing electronic transport through the solder ball and TSV. Damage, especially cracking, will enable both electrical and mechanical failure of the device. Hence, it is vital to understand the effects of geometry and dimensionality on damage.

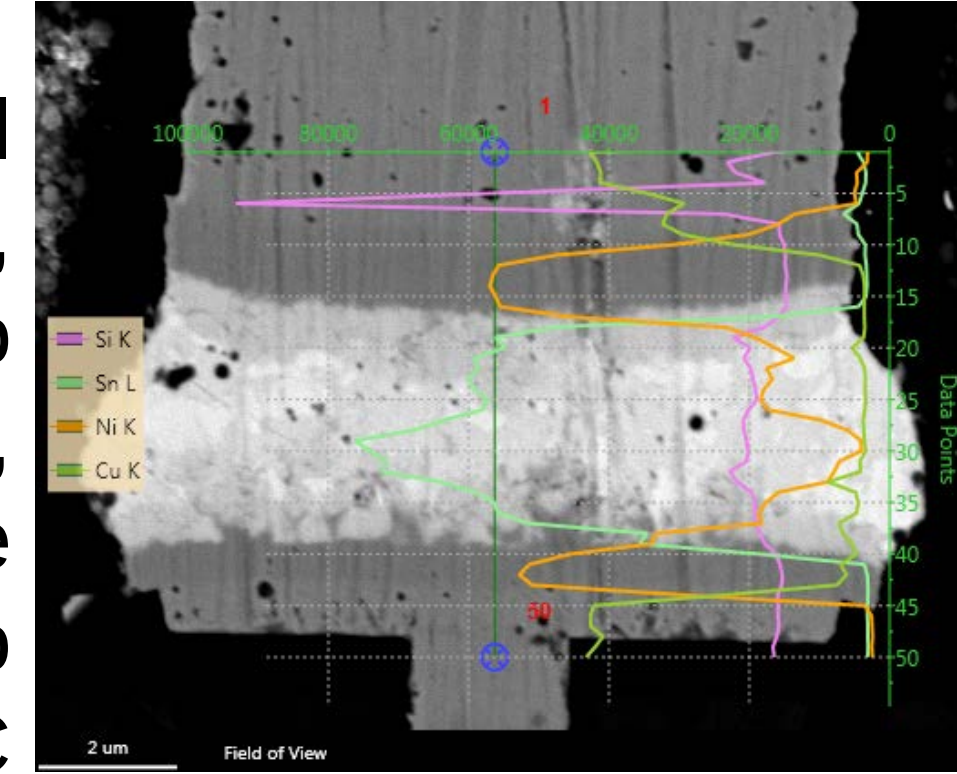
Via EDS scans, the solder ball composition can be confirmed, defining the regions from top to bottom as Cu, Ni, Ni<sub>x</sub>Sn<sub>y</sub> IMCs, tin, Ni<sub>x</sub>Sn<sub>y</sub> IMCs, Ni, and Cu. More precise scans are necessary to determine the specific MC compositions.

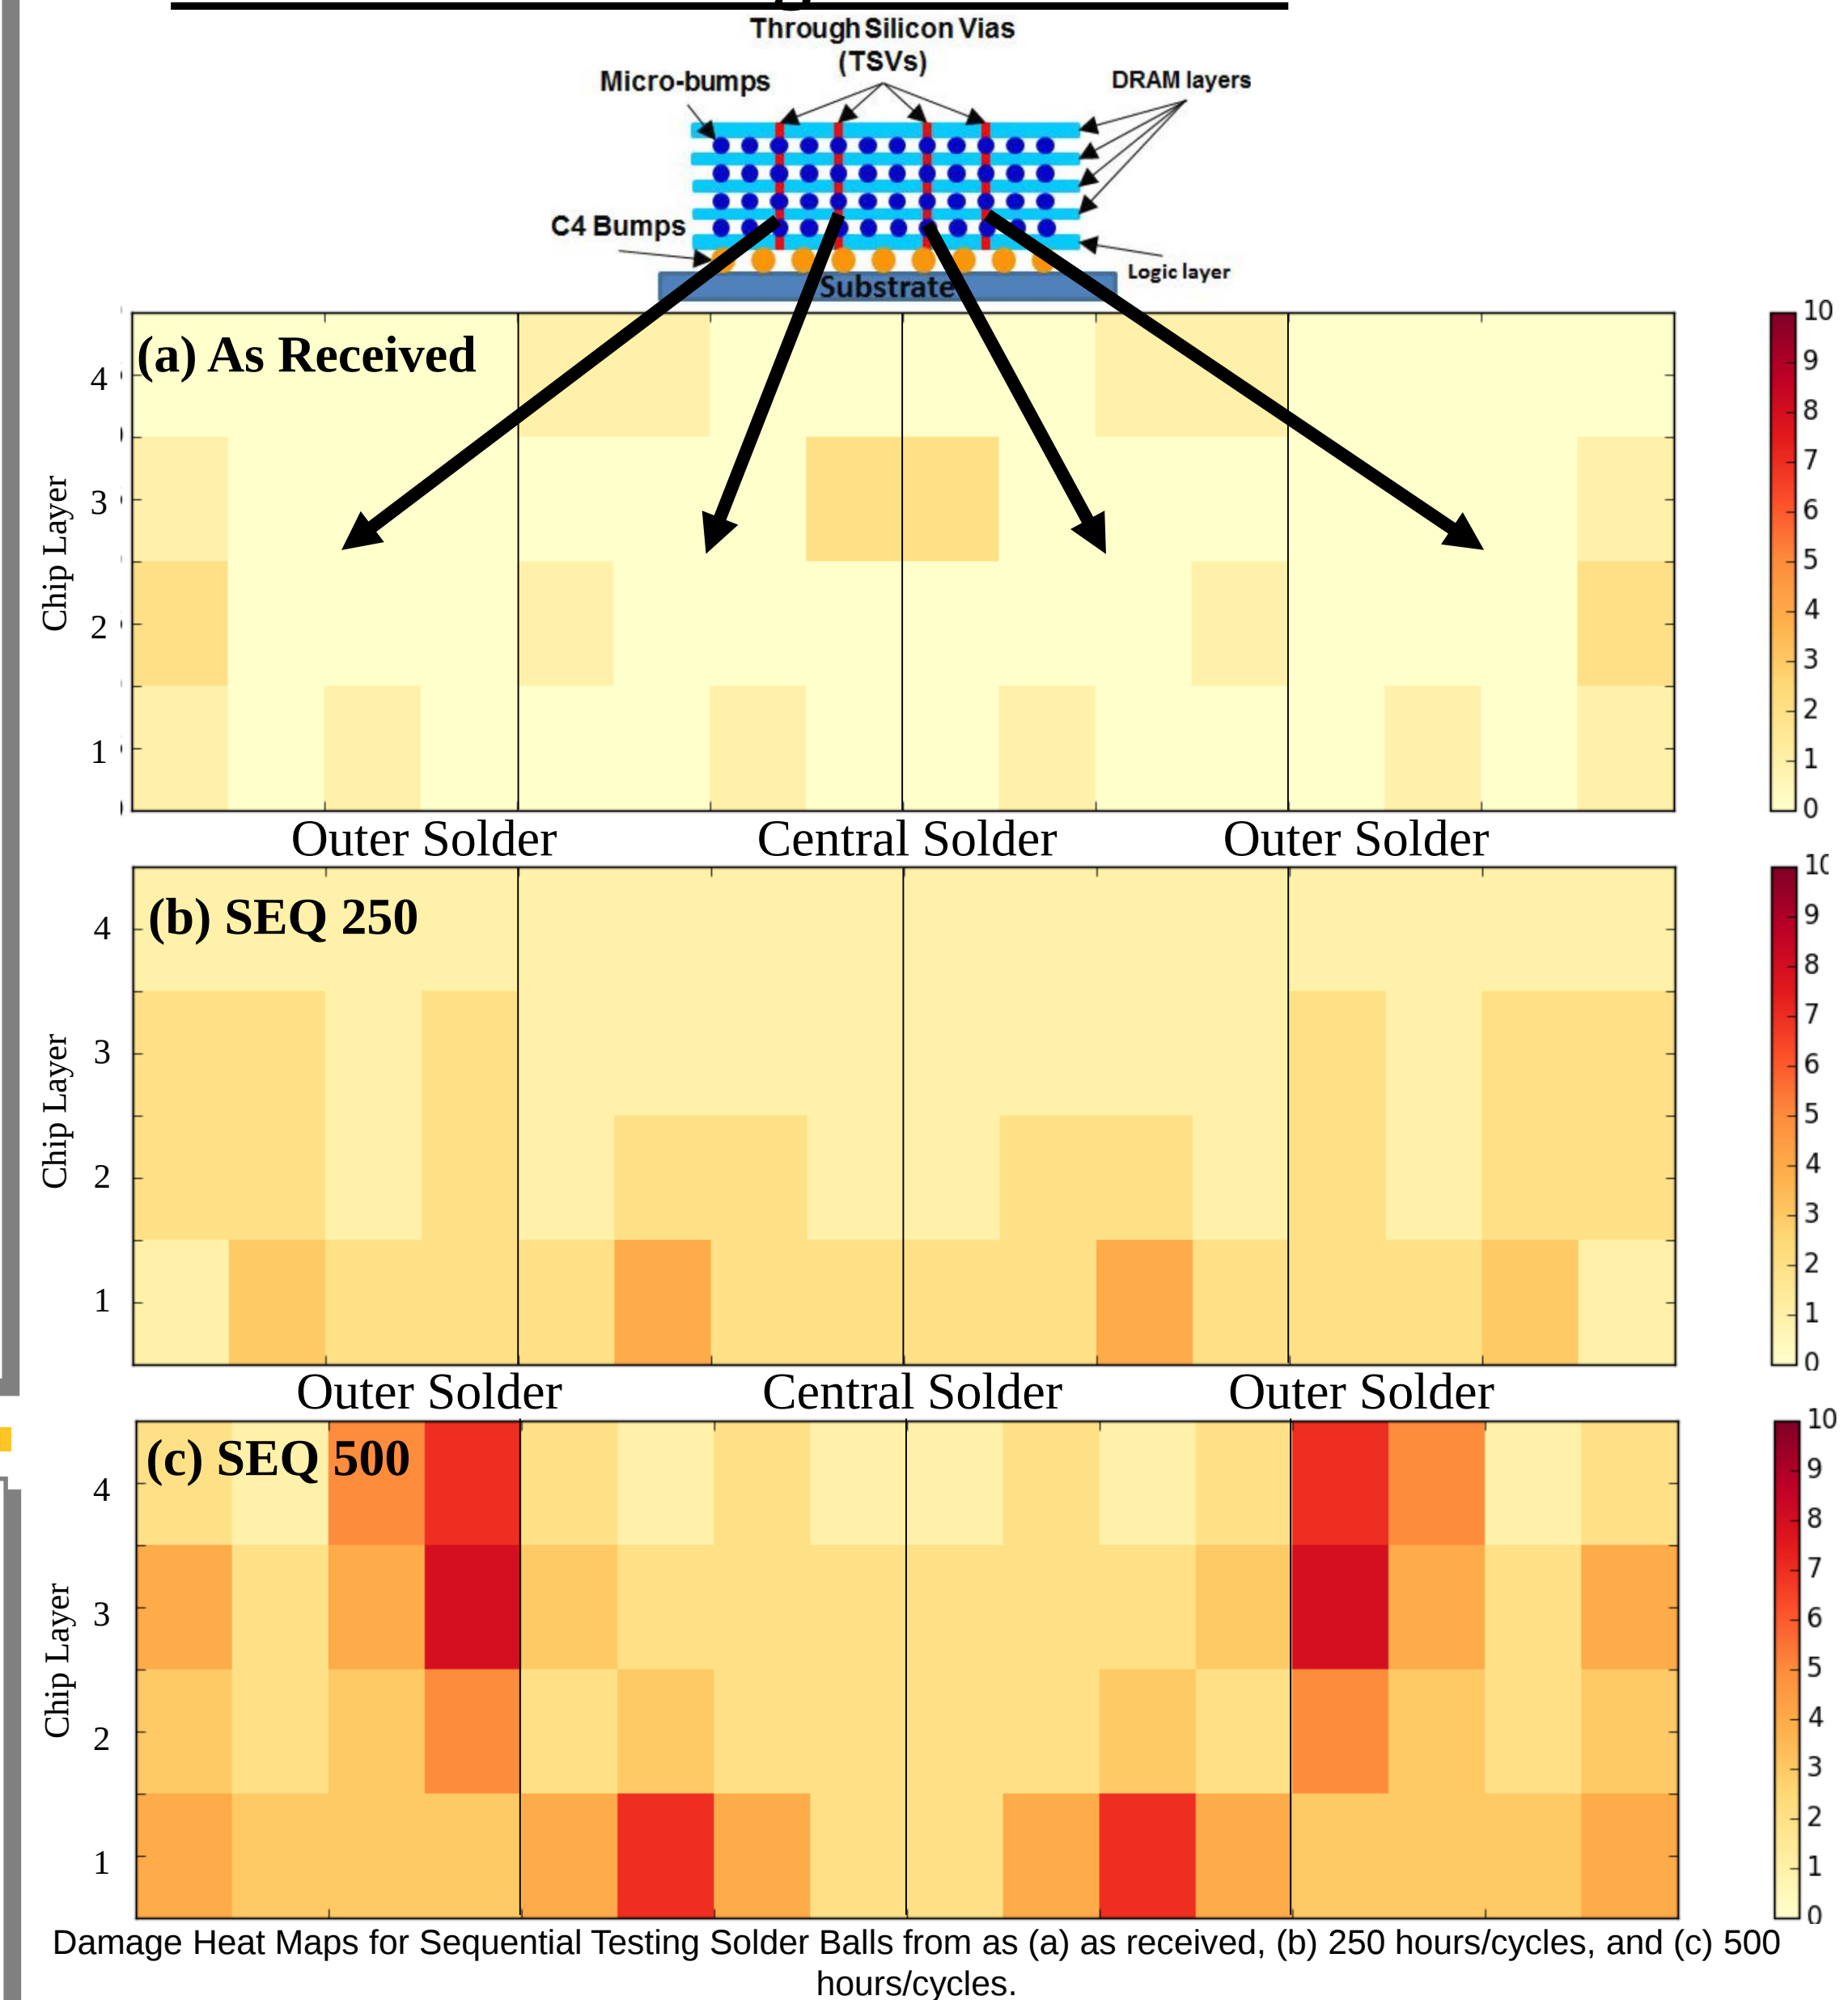
By analyzing the mechanical damage in the solder due to cracking and necking, the damage can be mapped to the location of the solder ball. The lowest layers and near the perimeter appear more susceptible to mechanical damage over extended use. This is due to additional tin reflows and increased displacement during thermal cycling.

Through damage analysis, it is shown that damage is more likely on solder balls near the edges of the chips and at the lower layers. This is most likely due to both increased displacement fields and multiple reflows of the solder during fabrication. It is recommended that use conditions similar to the sequential testing be avoided to prevent severe damage to the solder.

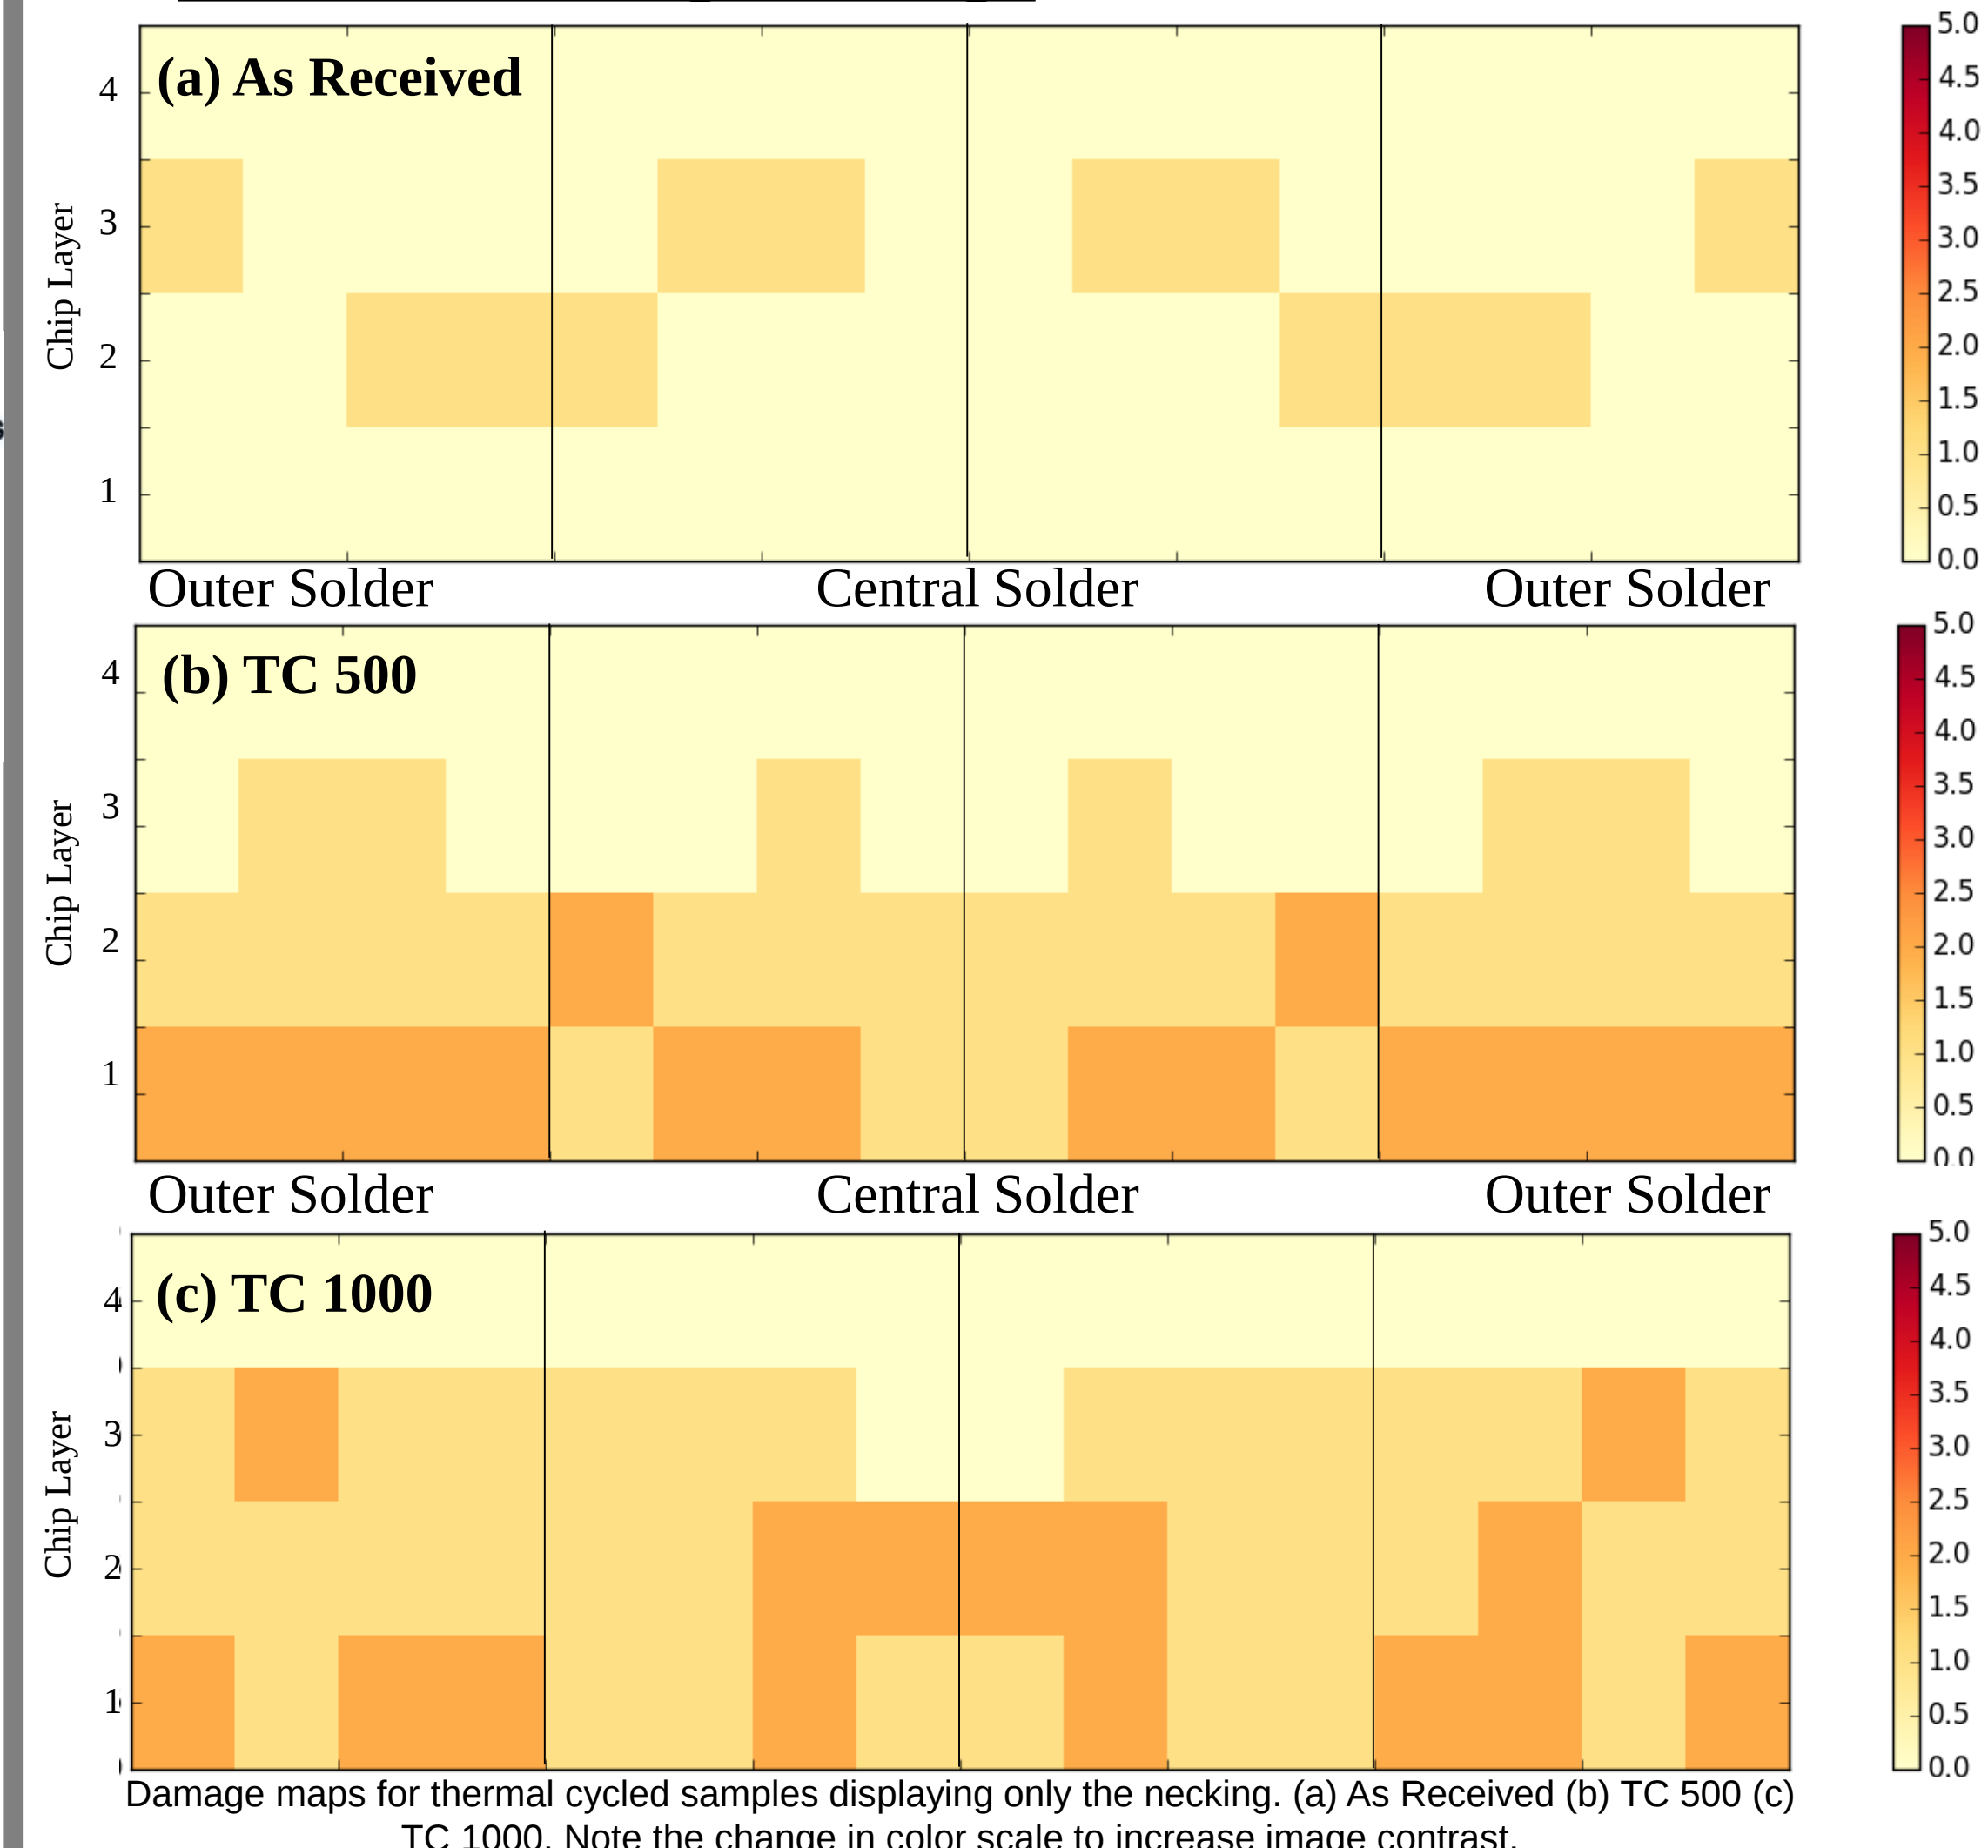
Analysis of the necking of the solder ball shows two distinct trends. The necking seems to increase in lower layers, however, there is very little difference from inner to outer locations. Additionally, only the early cycles appear to influence necking.

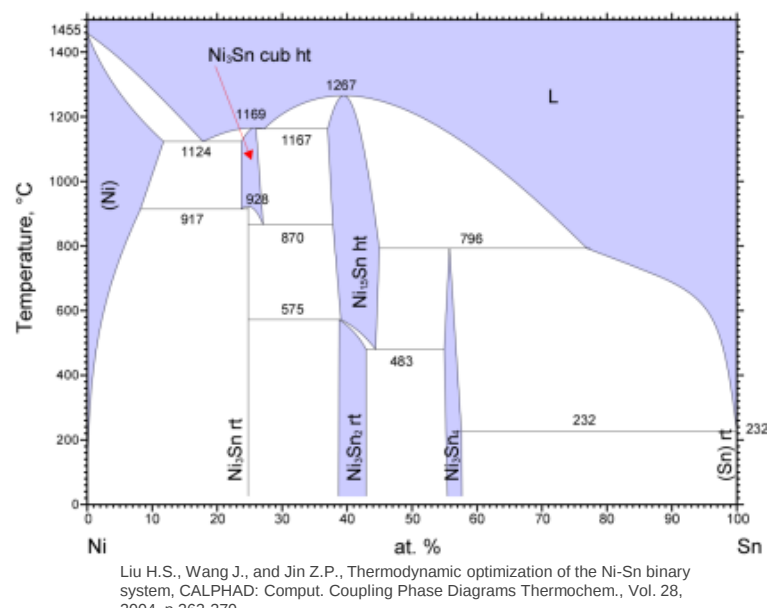
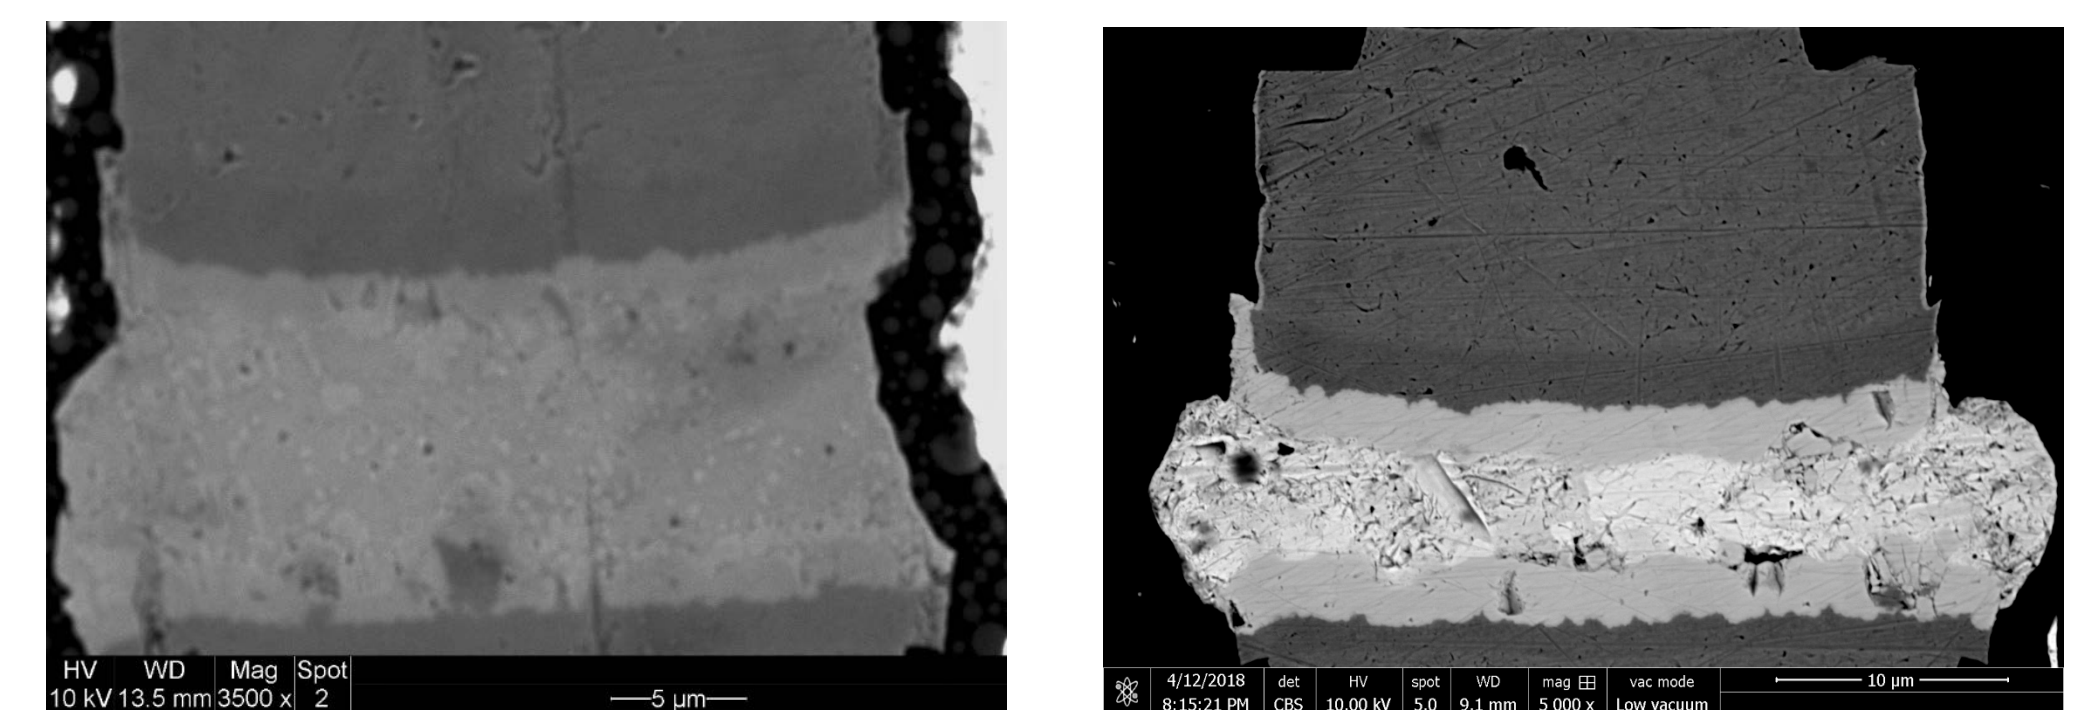
The nickel layers are used as a barrier between the tin and copper. Nickel forms an IMC with tin significantly slower than with copper, helping to prevent critical failure early in the lifetime of the solder.

$$3.28 * \frac{2T_{Ni}}{T_{Sn}} \geq 1$$

The coefficient of the inequality stems from the molar mass and density of the Ni and Sn systems

The inequality represents the necessary ratio of thickness for nickel and tin to guarantee excess nickel is present and prevent considerably amounts of copper tin intermetallic within the lifetime of the component.

The nickel present is more than double the necessary size to consume the tin. The ratio minimizing boundaries values from the uncertainty still produce a significantly large ratio. Hence, the IMC regions analyzed in this study should be from the Ni-Sn system, exclusively.

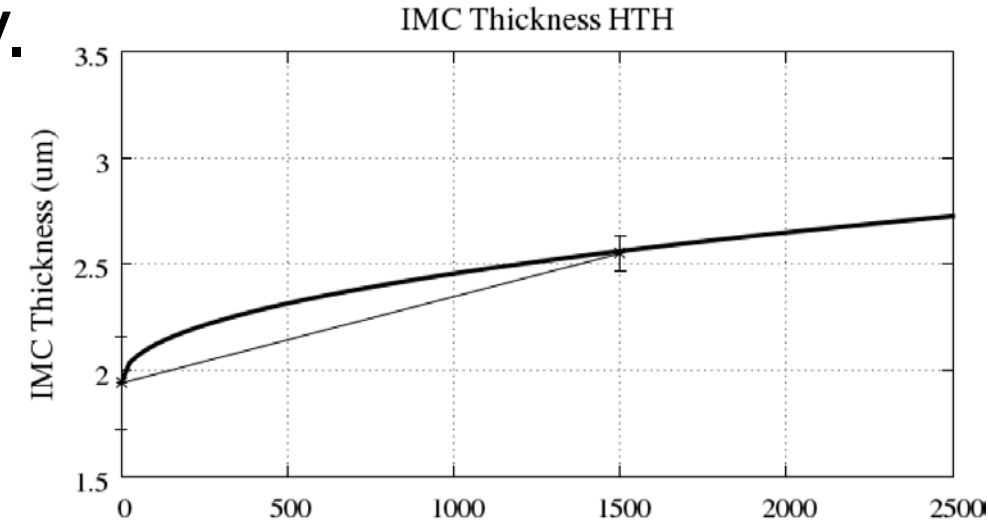
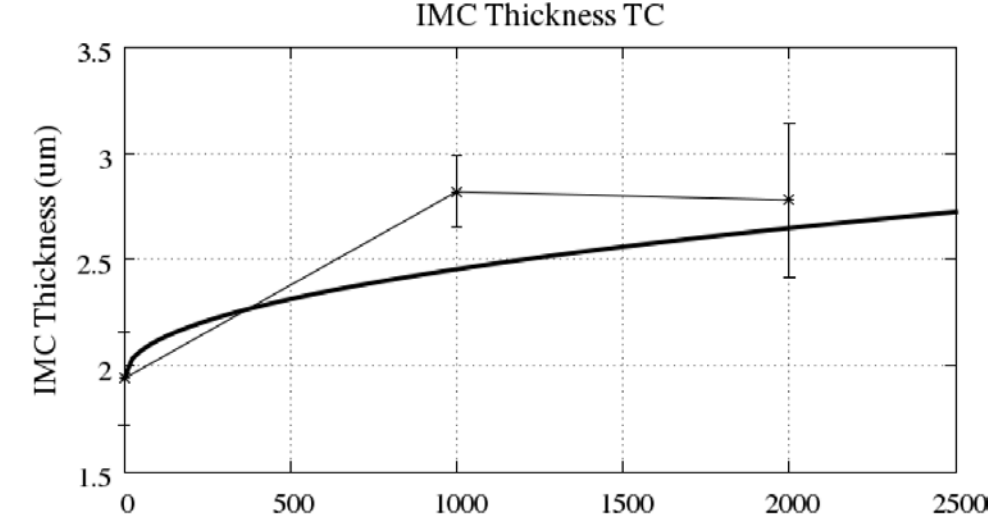
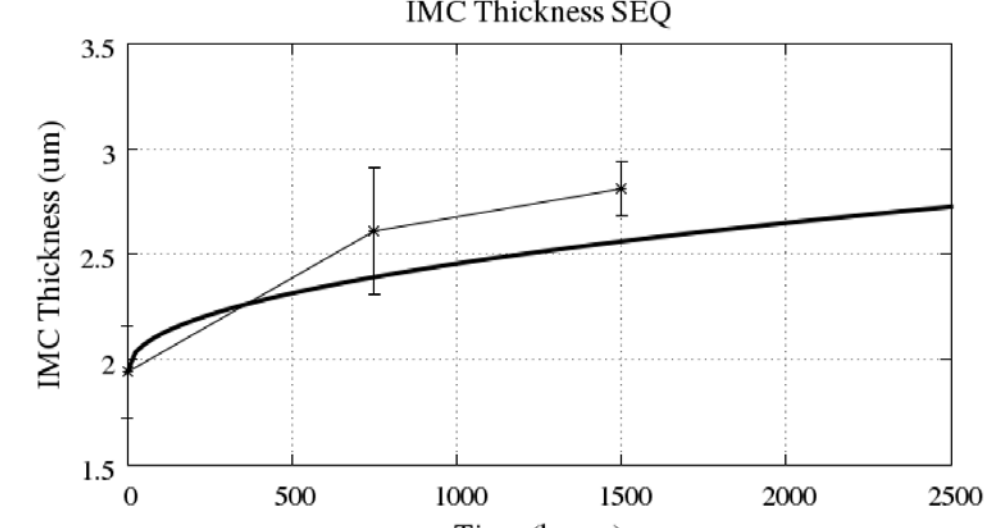
Through the thermal tests, the IMC growth was measured at various read points and plotted against a numerical model for constant temperature growth at 150°C fit from an Arrhenius relationship.

$$X = X_0 + At^n e^{\frac{-E_a}{RT}}$$

The Ni-Sn system is known to have n value of 0.46 as well as an activation energy of -47.1 kJ/mol. The fitting constant of A was found to have a value of ~19,000. The HTH was expected to have the highest IMC growth

rate, followed by SEQ, due to the largest time spent at high temperature. The difference in expected and actual trends shown can possibly be attributed to the large uncertainty in X<sub>0</sub> value from the as received samples.

IMC Thickness for each test. Note that for TC and SEQ, 2000 hours is only 1000 cycles. The dark black line represents the numerical model.
