Buehler has had issues with environmental stress cracking (ESC) of the polycarbonate (PC) hoods of their abrasive cutters after switching to a new coolant. MALDI was used to identify the components of the coolant in order to study their effects on degradation of PC and PETG polymers were studied. An alkanol amine was identified as the likely cause of ESC in the hoods. PETG was found to be more suitable than PC in the presence of coolant.

This work is sponsored by Buehler in Lake Bluff, IL.

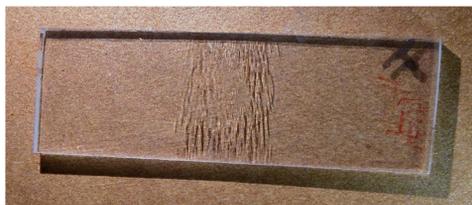
Environmental stress cracking induced in PETG during a continuous strain test soaking in Cool 3, 1 to 5 dilution, for 5 days.

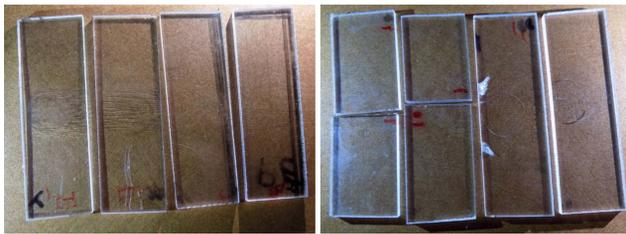
PETG (left) and PC (right) samples, displayed from left to right with decreasing strain.

- ESC occurs more strongly in samples at higher stress, low stress samples show no response. This indicates that there is a minimum stress required for ESC to occur.
- Individual chemical components of the new coolant were tested to determine which cause ESC.

**Conclusion:** PETG shows more resistance to ESC than PC as it does not fail catastrophically. However, the optical clarity of PETG becomes impaired under ESC conditions. The alkanol amine component in the new coolant is the likely facilitator for ESC.
