Development of Na_2SO_4 Application Technique for Hot Corrosion Testing

Sarah Boes, Sydney Cooley, John Keil, and Charles Lasky
 Faculty Advisor: Prof. Rod Trice
 Industrial Sponsors: Dr. Stephanie Gong and Linda Cook

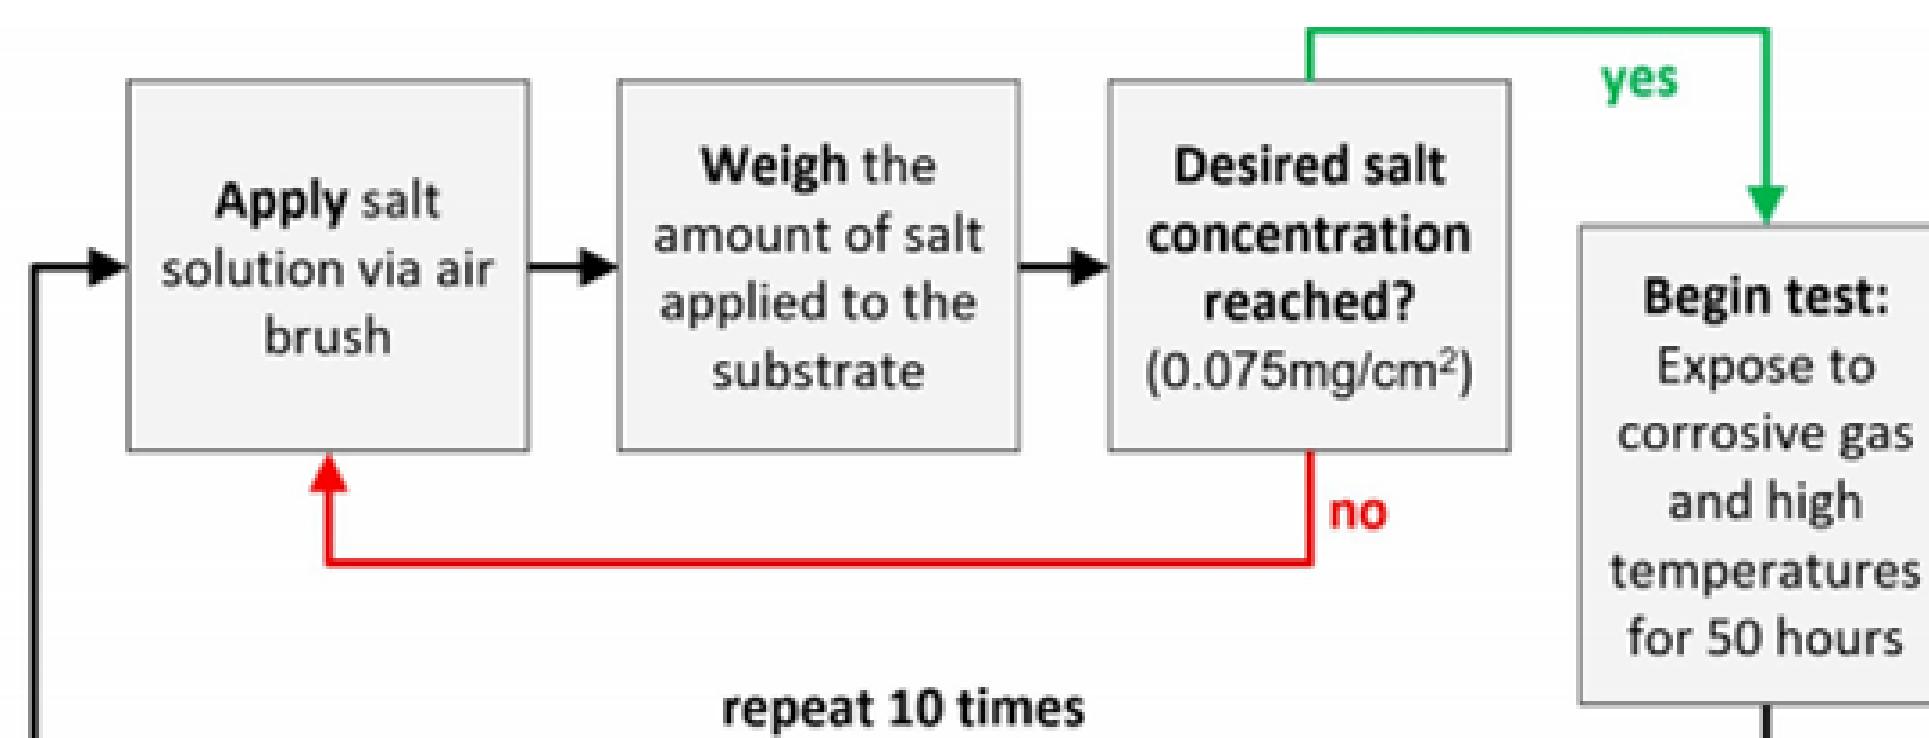
Rolls-Royce is a leading manufacturer of turbine engines for aircraft. These engines experience hot corrosion in the presence of Na_2SO_4 , which forms from Na in marine environments and S from jet fuel. Low temperature hot corrosion is the focus of our study and occurs from 650 – 850 °C when high partial pressures of SO_3 are present. Hot corrosion degrades the alloy and can cause catastrophic failure. Rolls-Royce utilizes hot corrosion tests to determine the performance of their alloys when these conditions are present. During this test, Na_2SO_4 is applied to the surface of a small sample and exposed to SO_2 gas and high temperatures to simulate hot corrosion. Currently, the manufacturer uses a salt-spray to apply Na_2SO_4 to samples for corrosion testing. The application process is illustrated below.

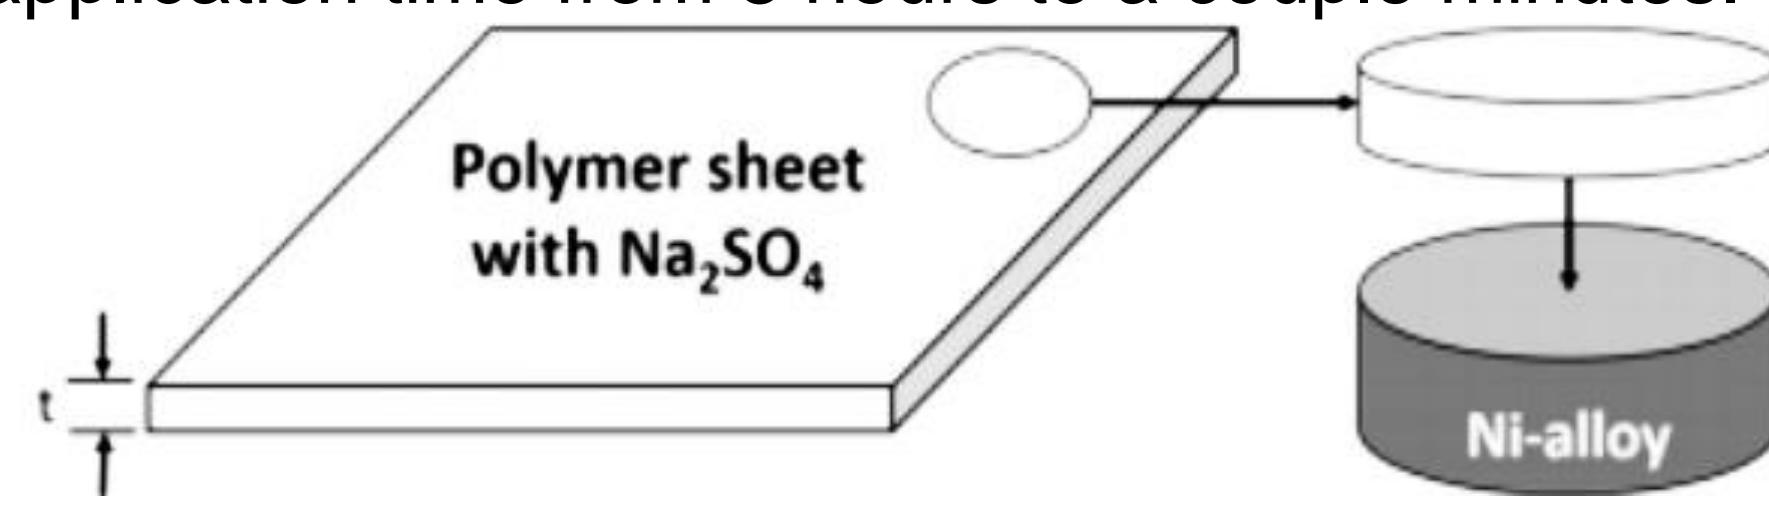
This salt application process is inefficient. To reduce preparation time, a polymer film has been proposed to replace the salt spray technique. The film has a known salt concentration per unit area and is cut to the shape of the alloy sample, then placed directly on the sample surface. This application process reduces salt application time from 8 hours to a couple minutes.

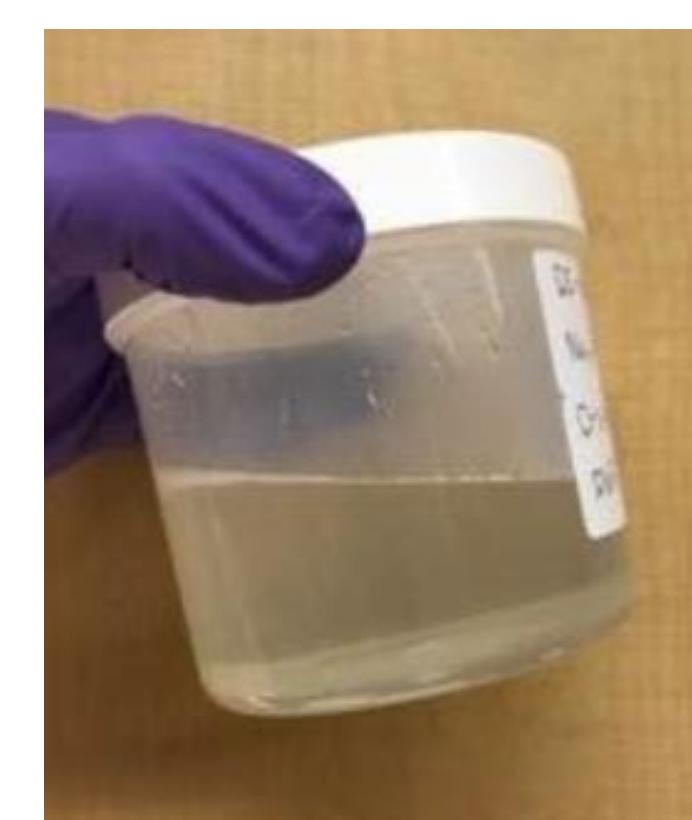
Using water as a solvent, a solution was prepared of 10 vol% polyvinylpyrrolidone (PVP), 3.5 vol% D-Xylose, and the mass of Na_2SO_4 such that when cast it will have an area concentration of 0.075 mg/cm². After the polymer completely dissolved, the solution (right) was speed mixed to ensure homogeneity.

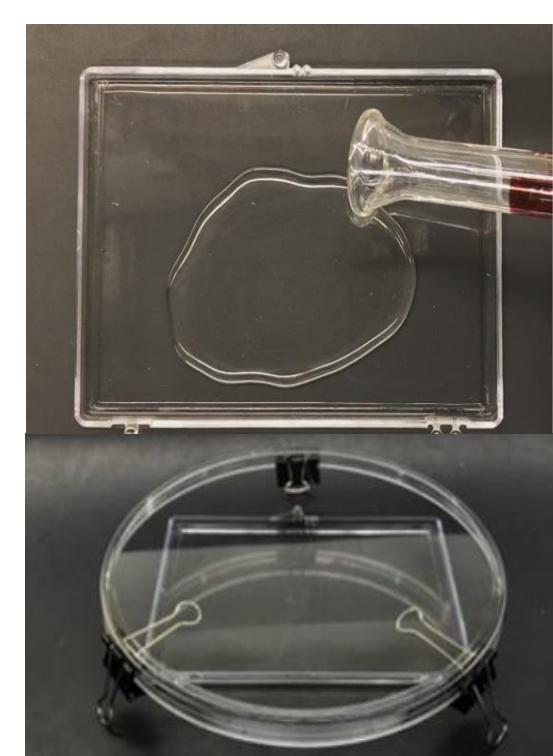
The polymer solution was poured into a polystyrene container coated with an organic mold release. The solution dried for 24 hours at room temperature on a flat surface with a cover to block dust (left).

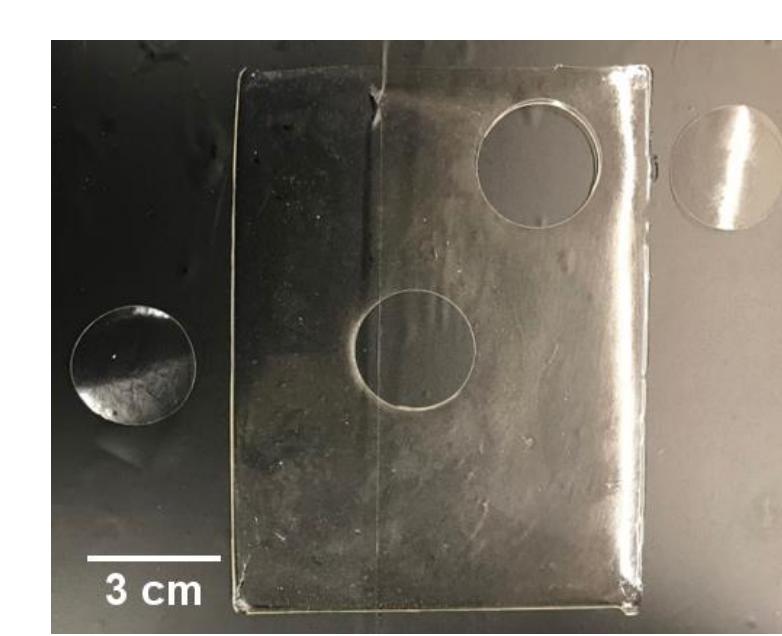
The dried polymer film was removed from the mold, cleaned with acetone, and cut into the desired shapes (right).

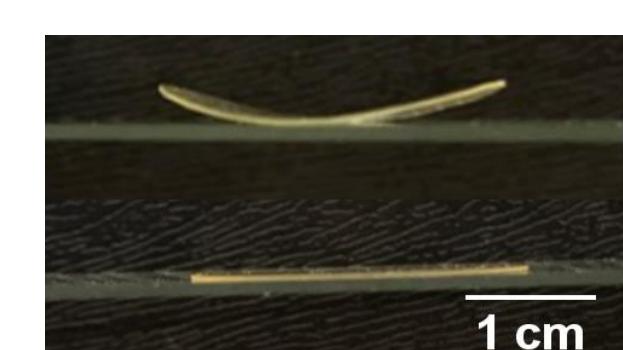
To resolve warping, the samples were annealed at 160°C until completely flat (left).

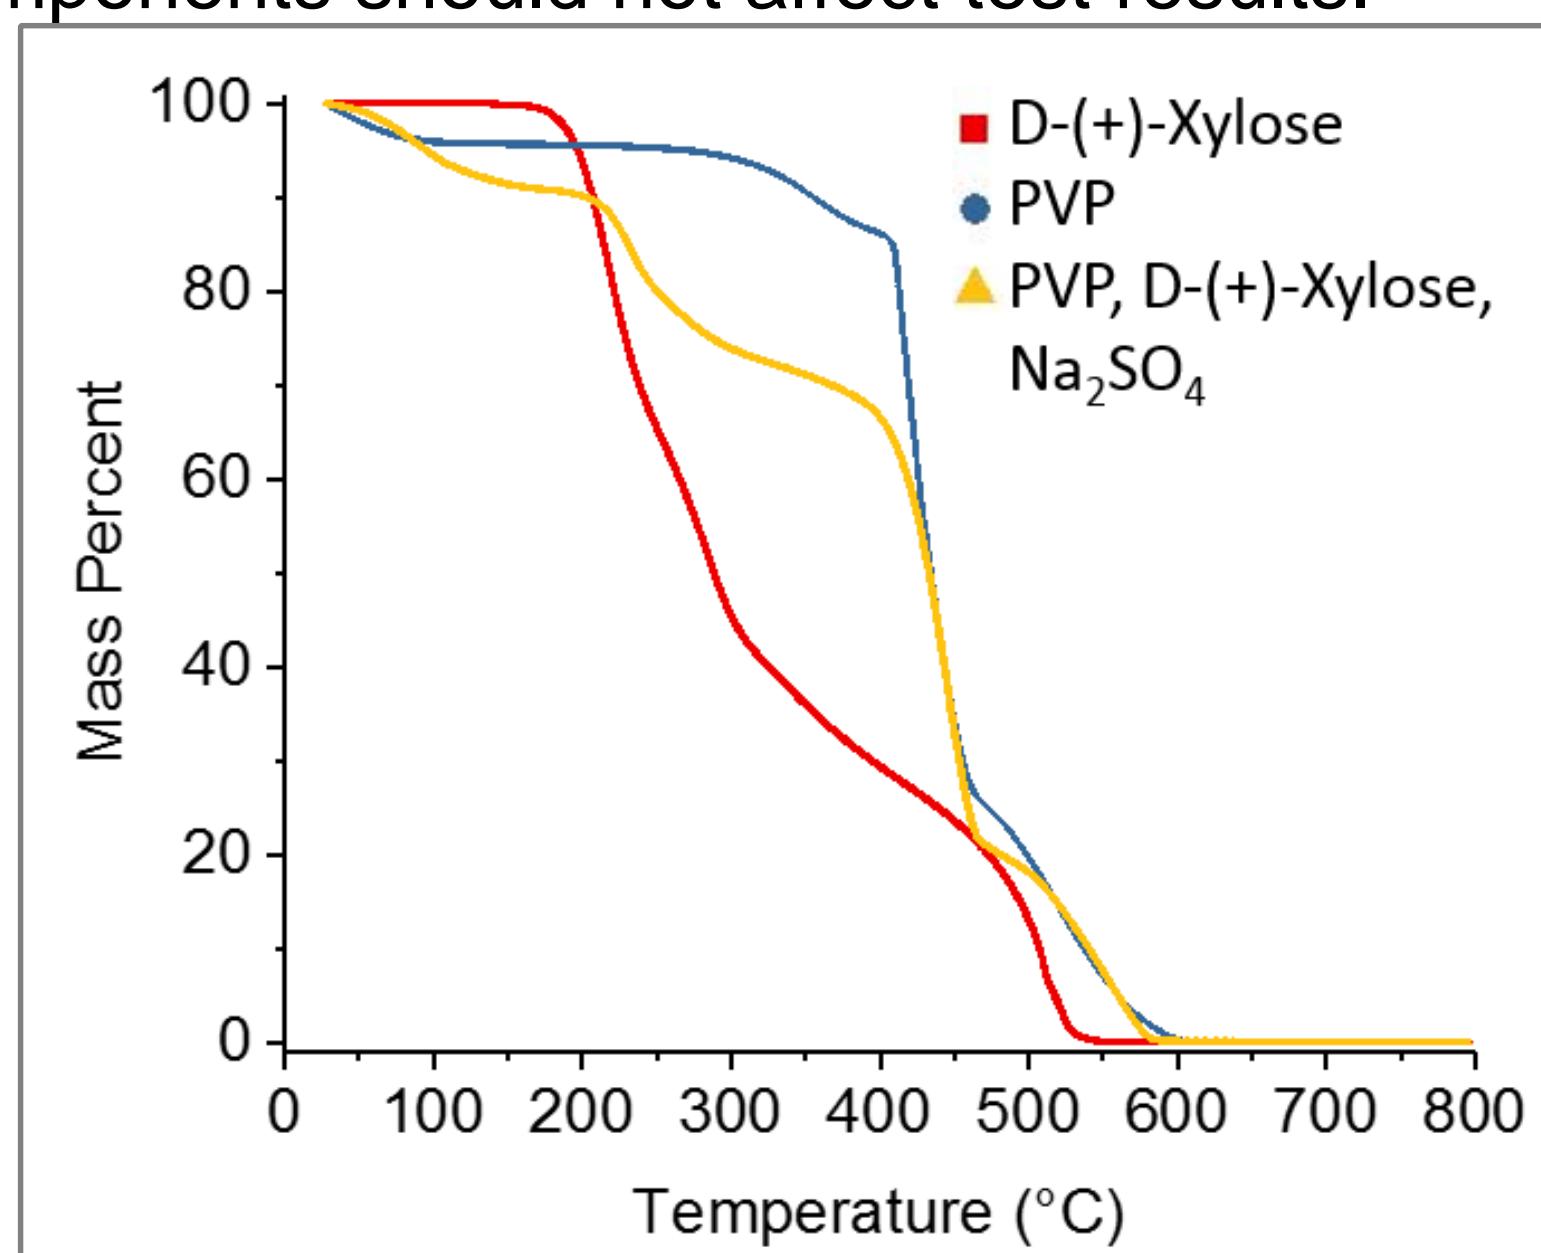
To characterize the burn-off of the PVPX film, thermal gravimetric analysis (TGA) was performed. A sample of a PVPX film was tested which comprised of PVP, D-Xylose, and Na_2SO_4 . Pure D-Xylose and PVP were also tested to examine the influence of the individual components on the film's degradation. The results indicate that the polymer film had completely burned off at 600°C, leaving only Na_2SO_4 . This is below the hot corrosion test temperature of 700°C, indicating the organic components should not affect test results.

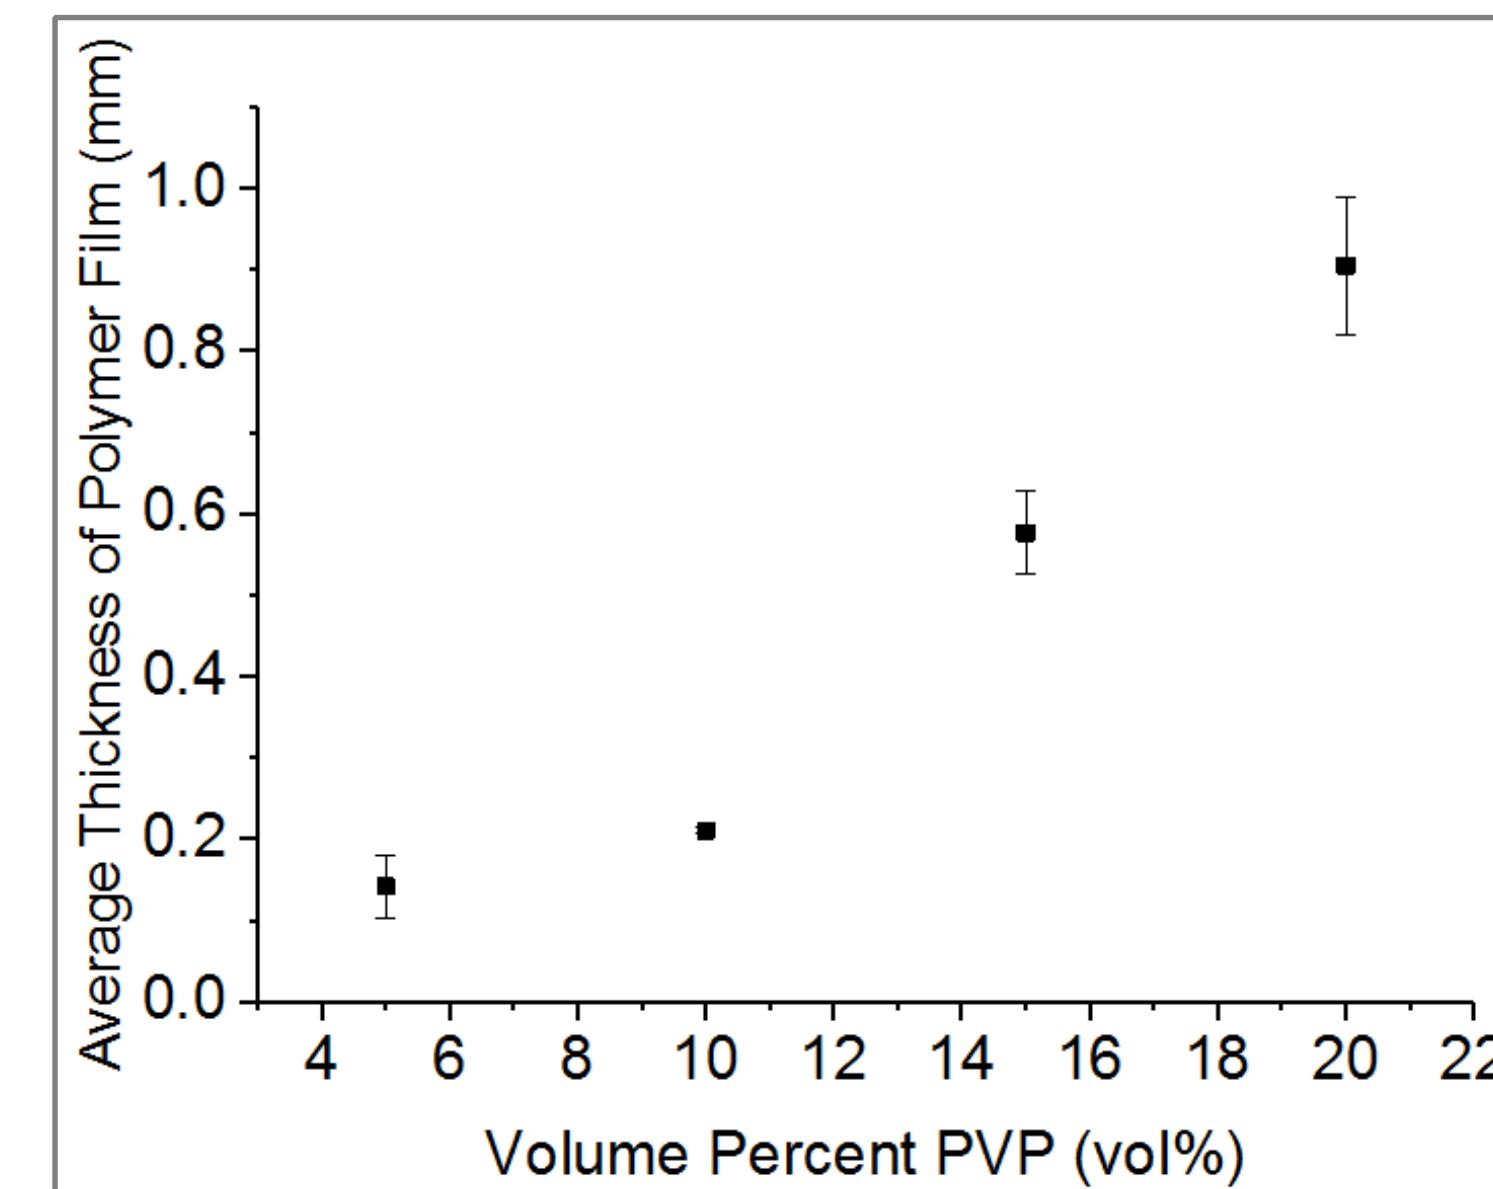
The thickness of the film was measured with respect to the volume percent of PVP in the casting solution. The most uniform film created reached a thickness of 0.2 mm, obtained from a 10 volume percent PVP solution. Previous sheets made last year were measured to have 22 volume percent PVP and yielded a thickness of 1.0 mm.

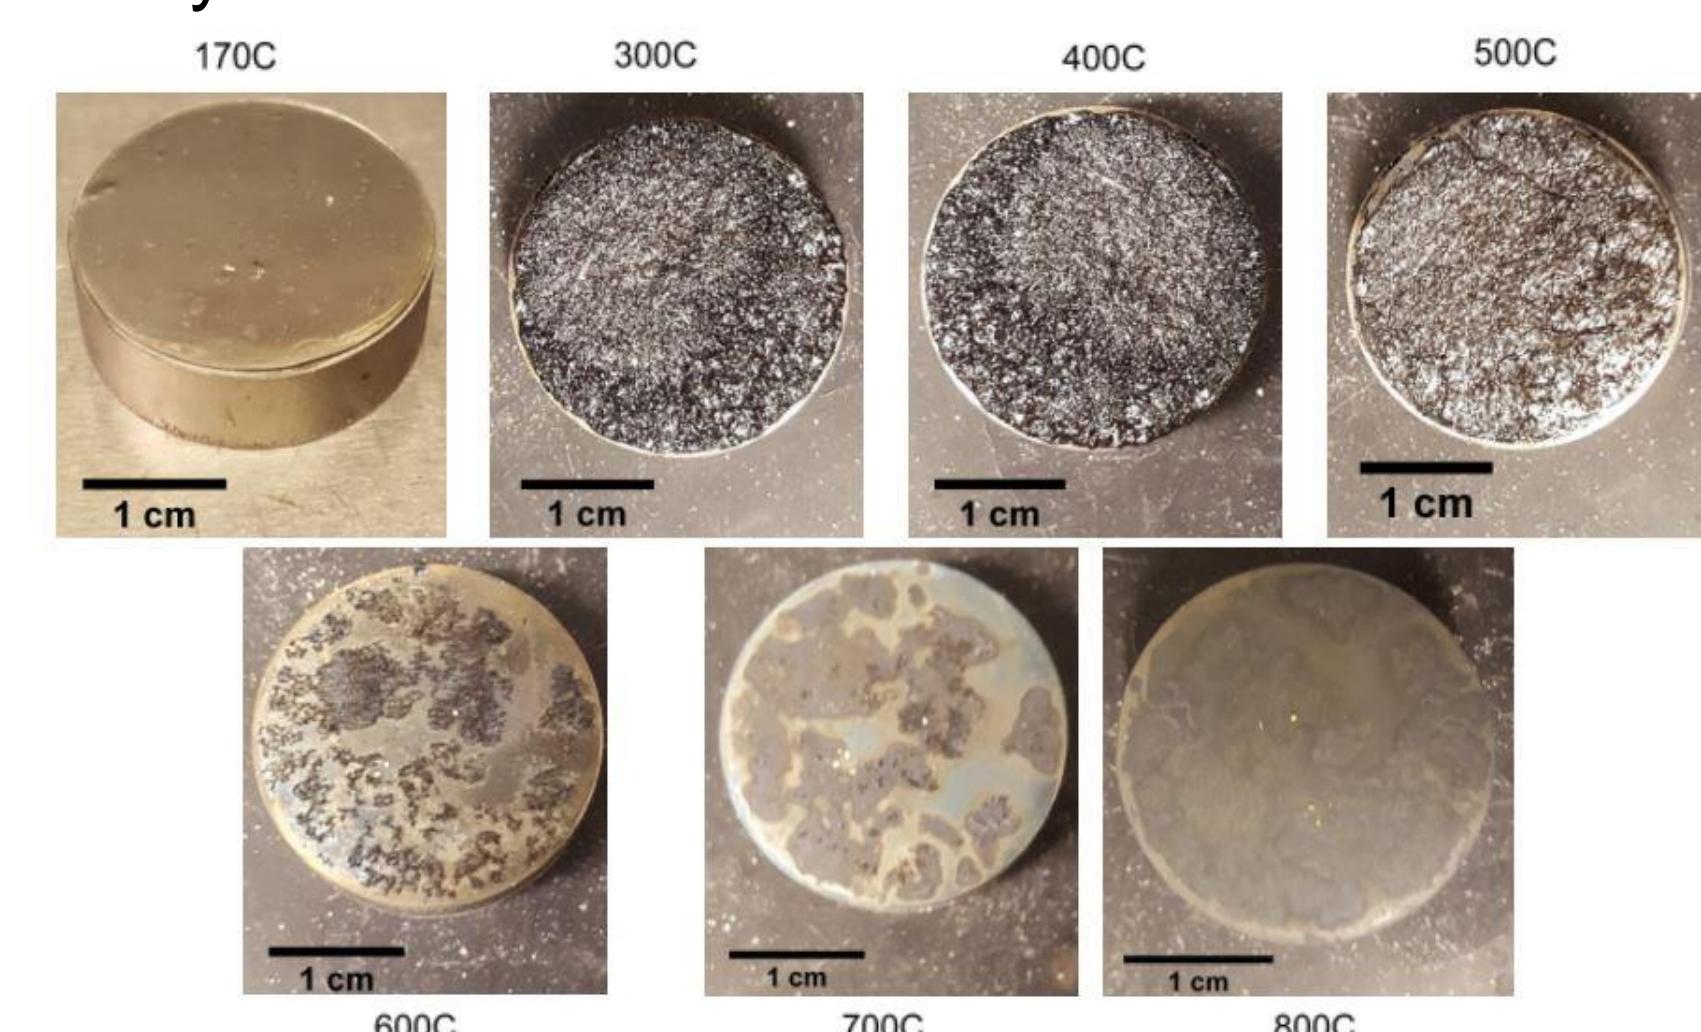
A polymer burn off test was conducted in an O_2 environment to understand the salt distribution once the polymer has been burned off. The furnace heating rate was approximately 12.5°C/min. A single, large bubble formed during film burn-off. However, after reaching 800°C the sample surface appeared relatively uniform.

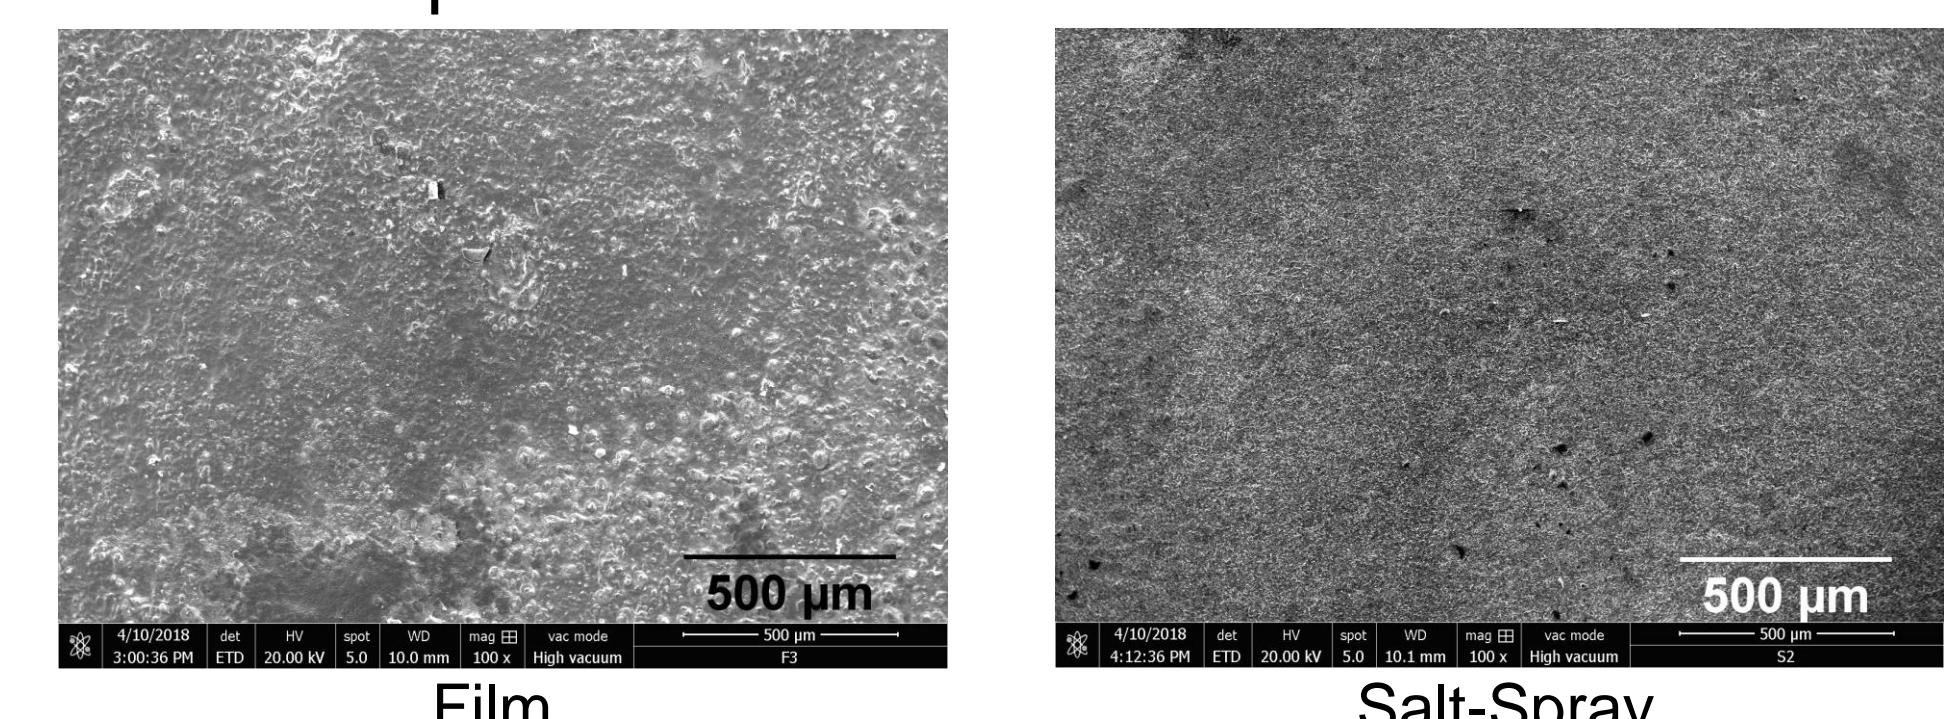
Hot corrosion testing was performed on 3 samples: Na_2SO_4 was applied via the salt-spray method for 1 sample, and applied via the polymer film for 2 samples. The test was performed at 700°C in an SO_2 - O_2 balanced environment for 100 hrs. The salt was reapplied at the 50 hour mark. SEM images of these samples are shown below.

The surface of the film-applied sample was more textured than the salt-sprayed sample. This indicates that the film-applied sample experienced more corrosion than the salt-sprayed sample due to the higher sodium content in the film.

The mold casting process was successful in creating a homogeneous polymer film with a uniform thickness throughout. The area concentration of the Na detected in the films was higher than desired, and the polymer film burned off completely and induced more hot corrosion than the salt-sprayed sample. Some nonuniformity can be seen in the SEM images of the film-applied sample. The increased amount of Na is due to the release agent used during the molding process. The amount of hot corrosion was increased due to the excess Na reacting with SO_2 gas to create extra Na_2SO_4 during testing.
