Our group was tasked with looking for a correlation between the microstructure and Charpy impact energy of two steel alloys. We were charged with introducing hydrogen into the Charpy samples and observing any changes in impact energy. We were able to determine the transition temperature needed to perform the Charpy test and determine which alloy is more brittle. The microstructures of each alloy were analyzed, and TDA was done to analyze existing hydrogen trapping sites.

This work is sponsored by ArcelorMittal, East Chicago, IN

## Project Background

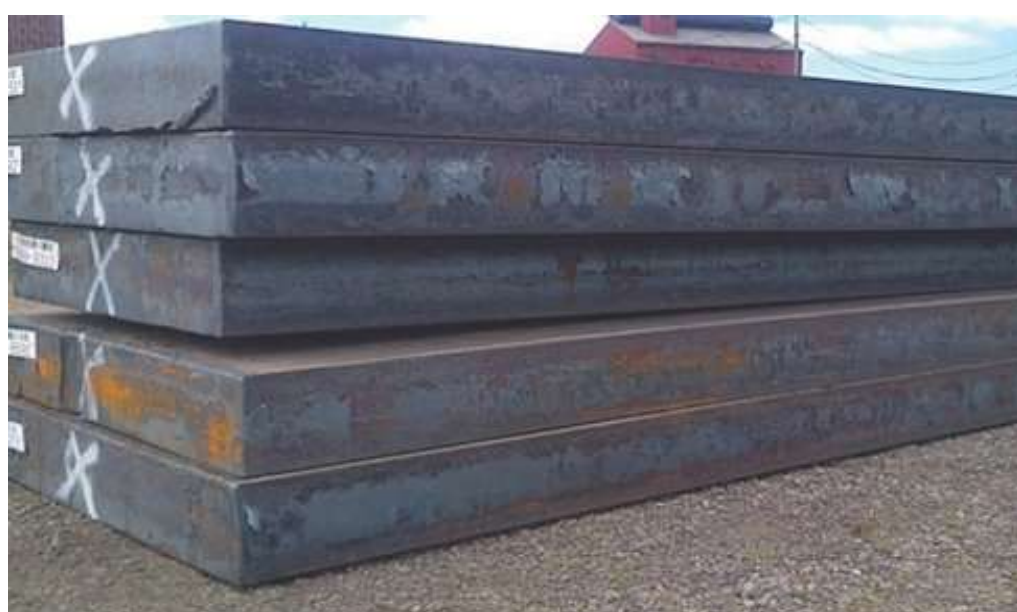
Stacked steel slabs after being cast at ArcelorMittal. [2]

10" thick slabs of two grades of steel at ArcelorMittal, 302 and 304, had been stress cracking across the thickness in the cooling yard after being continuously cast and cut. It is worth noting that these slabs are cracking prior to any further processing and the final desired microstructure is finer grained than what is being observed in this project. Continuous casting is when metal is heated to a liquid and allowed to solidify into a slab by going through a mold. This process must be constant and run uninterrupted to prevent solidification within the mold itself. ArcelorMittal often runs several ladles in shifts to keep the caster full. Usually, several slabs of the same grade of steel are made on the same shift to minimize changeover. ArcelorMittal has five continuous casters at the Indiana Harbor facility.

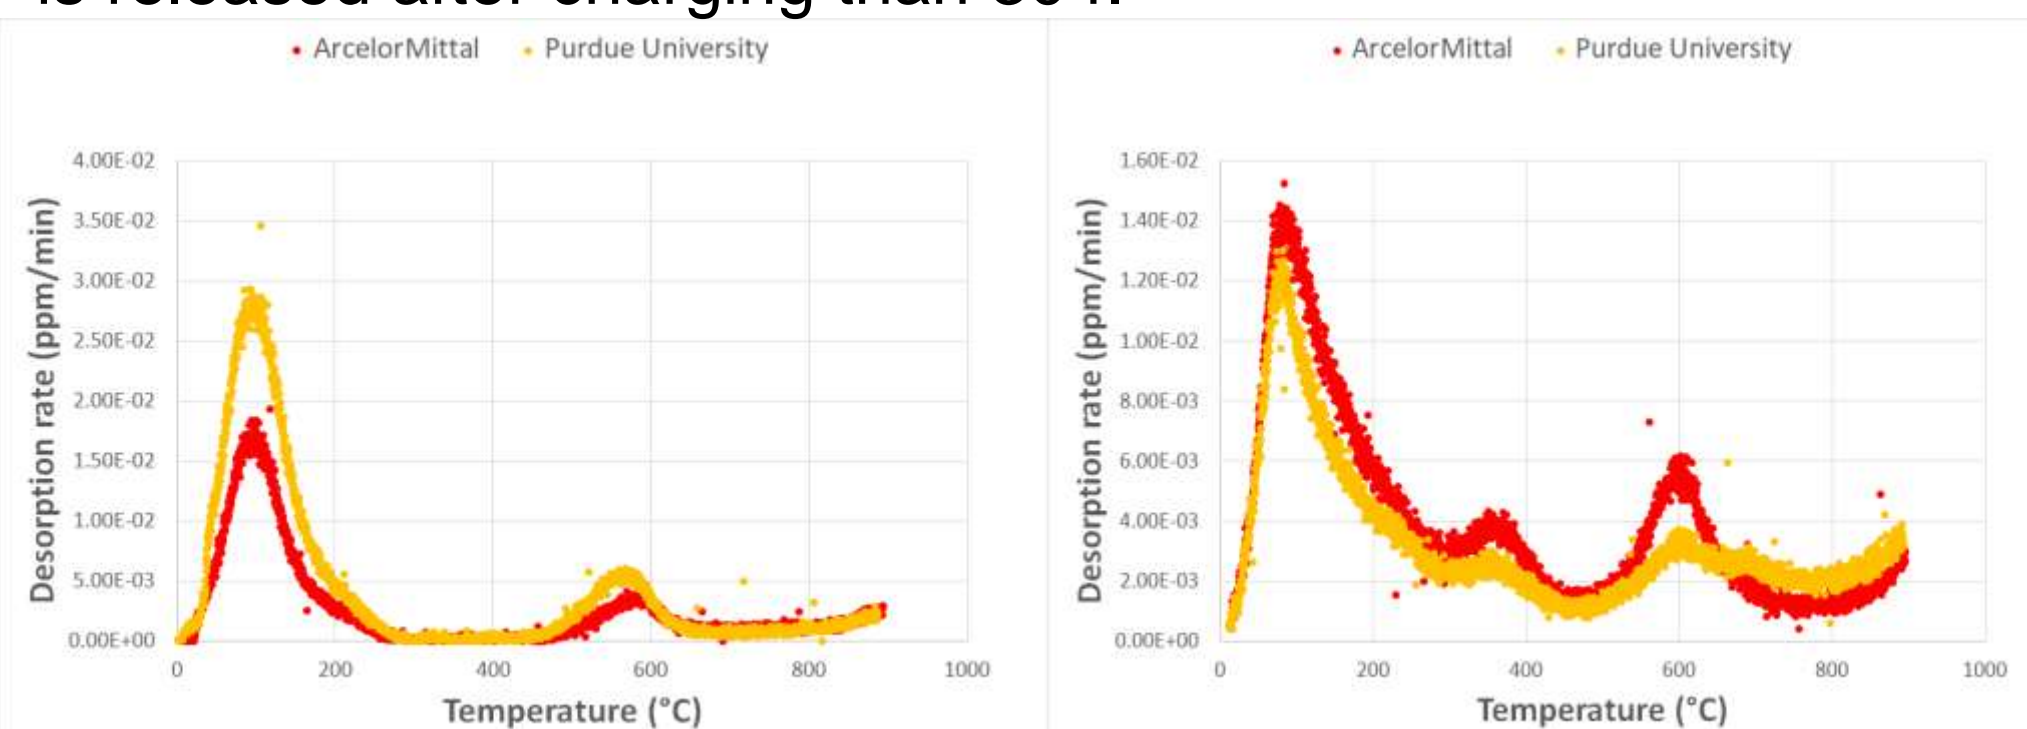
Looking at the TDA results, which represent hydrogen charging, we can see that the hydrogen adsorption at a given temperature is similar between the ArcelorMittal and Purdue University setups; therefore, charging and testing can be done at Purdue because the results are similar. The differences can be attributed to limited TDA tests, since ArcelorMittal normally averages three samples per charging duration for precision. The low temperature peaks correlate with reversible hydrogen trapping sites. The greater desorption rate of the 302 TDA results show that more hydrogen is released after charging than 304.

302 (left) and 304 (right) TDA results from ArcelorMittal using the setups from ArcelorMittal (red) and Purdue University (gold). Samples were charged for 60 minutes. Data was obtained once per setup at 60 minutes for each grade of steel.

Analysis of the TDA data allowed us to determine the presence of different kinds of trapping sites in both steels. Low temperature peaks are indicative of reversible trapping sites and are more prominent in both samples than high temperature peaks, which indicate irreversible trapping sites. Reversible trapping sites require a lower energy to desorb hydrogen. This means that reversible trapping sites have a higher presence in the samples. [3]

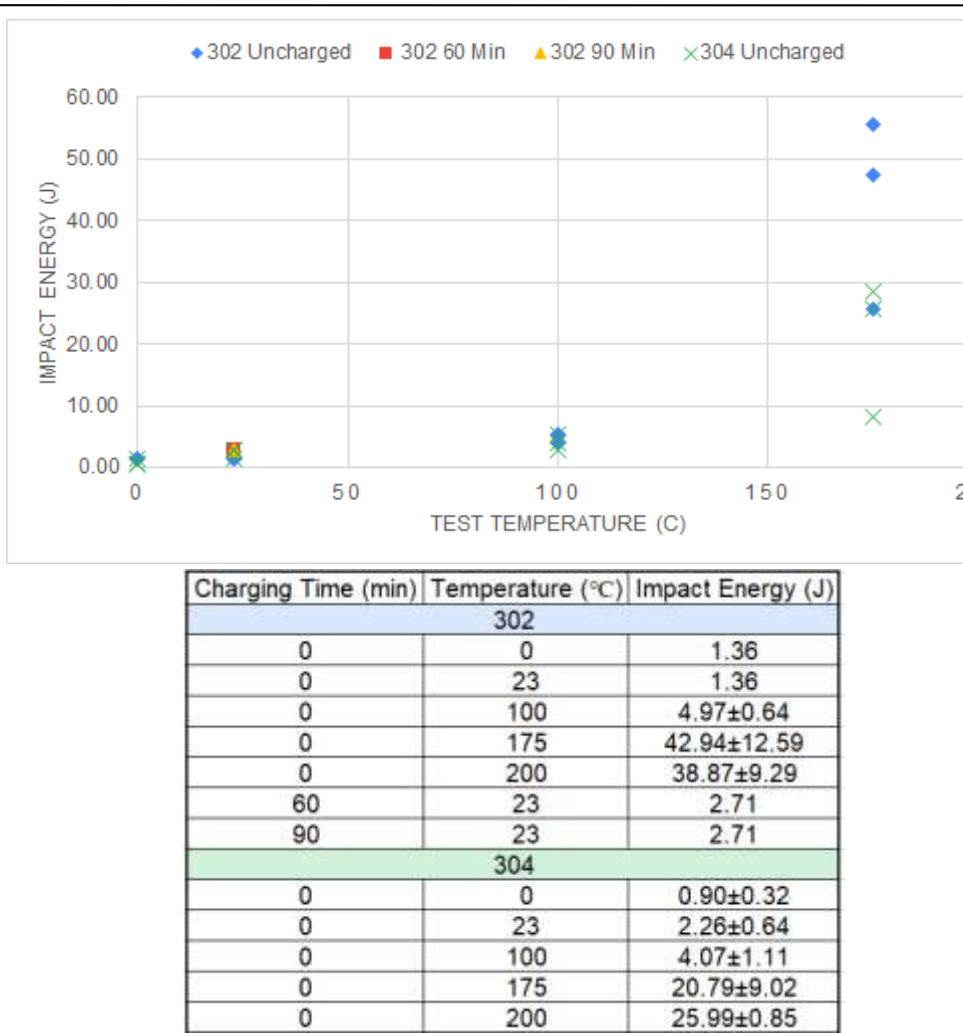
The figure to the right shows the procedure of establishing an effective testing temperature. 25 C and 100 C were determined to be on the lower temperature shelf leading to the usage of a furnace to test around 200 C, where discernible differences between charged and uncharged samples as well as between 302 and 304 were found.

After determining the DBTT range, the Charpy test results showed that the 304 samples are more brittle than the 302. Through comparison of the samples tested at room temperature and in the DBTT range, presence of microvoid coalescence was observed. The alloying elements in 304 facilitate carbide formations near grain boundaries, as shown by the presence of pearlite near the boundaries to decrease grain size. The pearlite near grain boundaries decreases the toughness of 304. This is supported by the lower Charpy energy, as observed in the results. [3]
