# Characterization and Properties of Surface Modified Steels for Fuel System Components

This work is sponsored by Cummins Inc., Columbus, IN

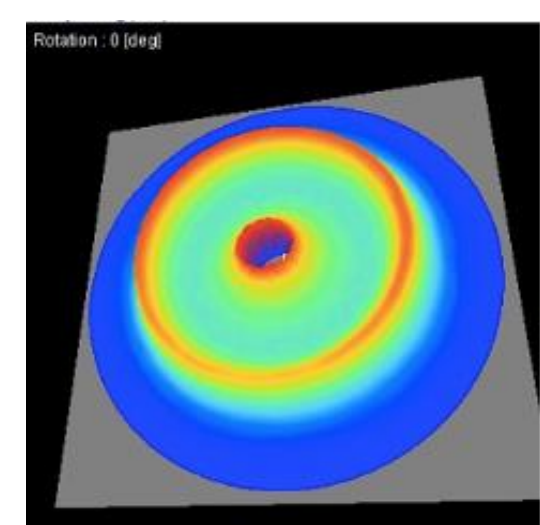
Figure 1: Debye ring result from residual stress measurements

- Pulstec  $\mu$ -X360
- Testing completed parallel and perpendicular to line textures.
- Notable results were Debye ring and residual stress

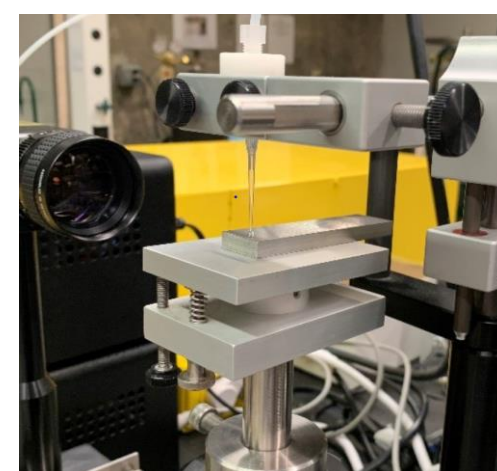
Figure 2: Goniometer set up

- Coupons cleaned in ultrasonic bath
- Static contact angle measured using the ramé-hart goniometer
- Liquids used: DI water, calibration fluid, and oil
- Five angles were measured for each type of liquid

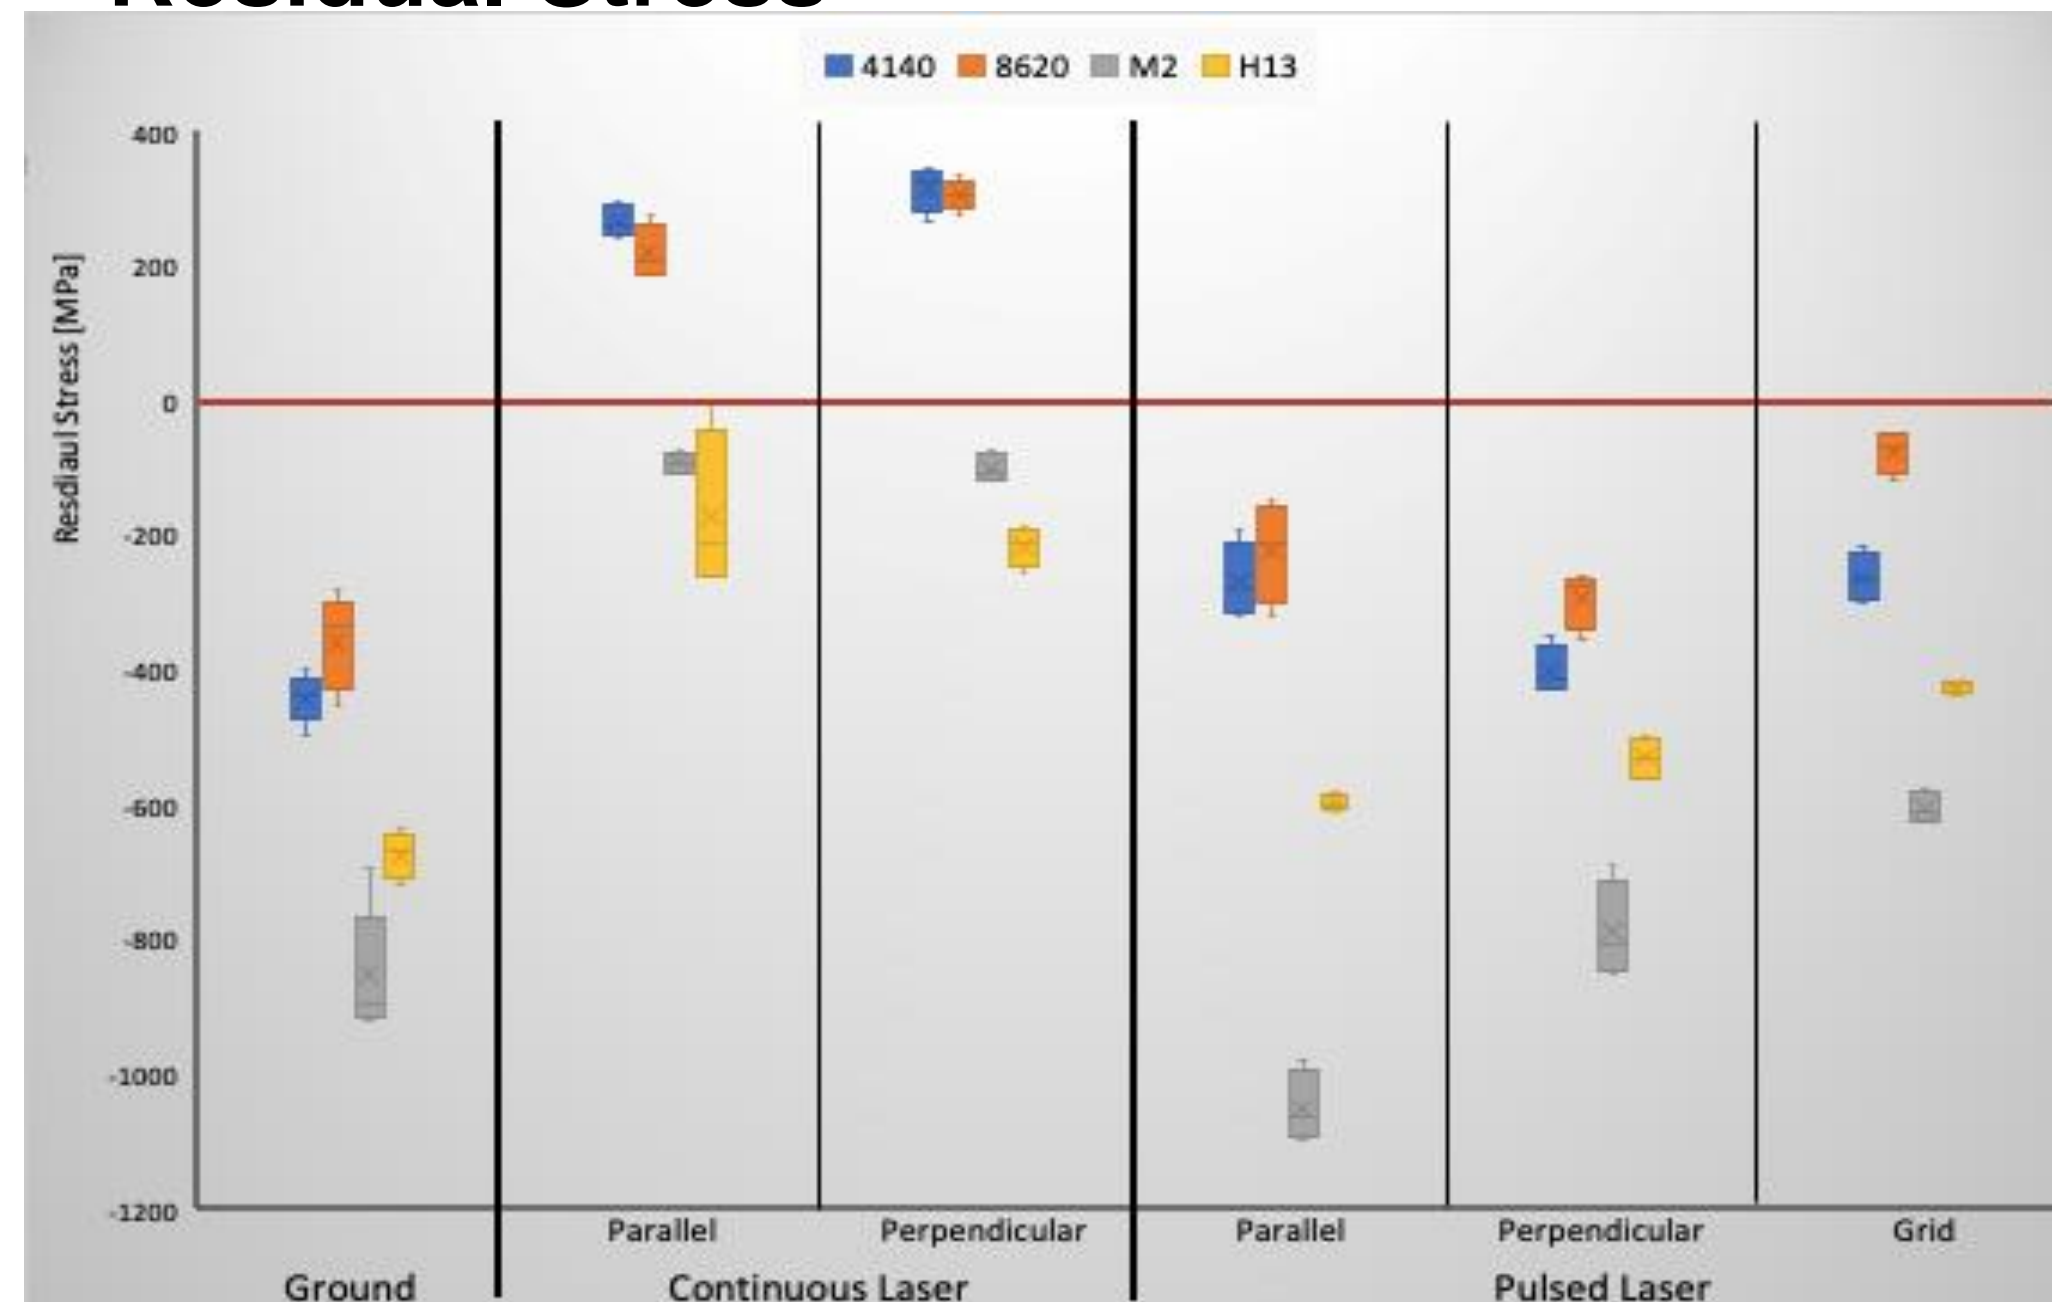
Figure 5: Residual stress plot of the four steels from untextured ground (left) to the pulsed grid texture (right) in order.

The pulsed laser retained the majority of or generated more compressive stress. Red line is threshold between compressive and tensile stresses.

- Pulsed laser retained significant or increased compressive stress than continuous laser**

- M2 reached an apex performance over all steels in parallel orientation for Coupon Set 3
- Residual stress between textures on same coupon are significantly different from t-test (not repeatable accurately)
- Residual stress was not uniform across the coupon prior to texturing so may be potentially responsible for stress variation after texturing

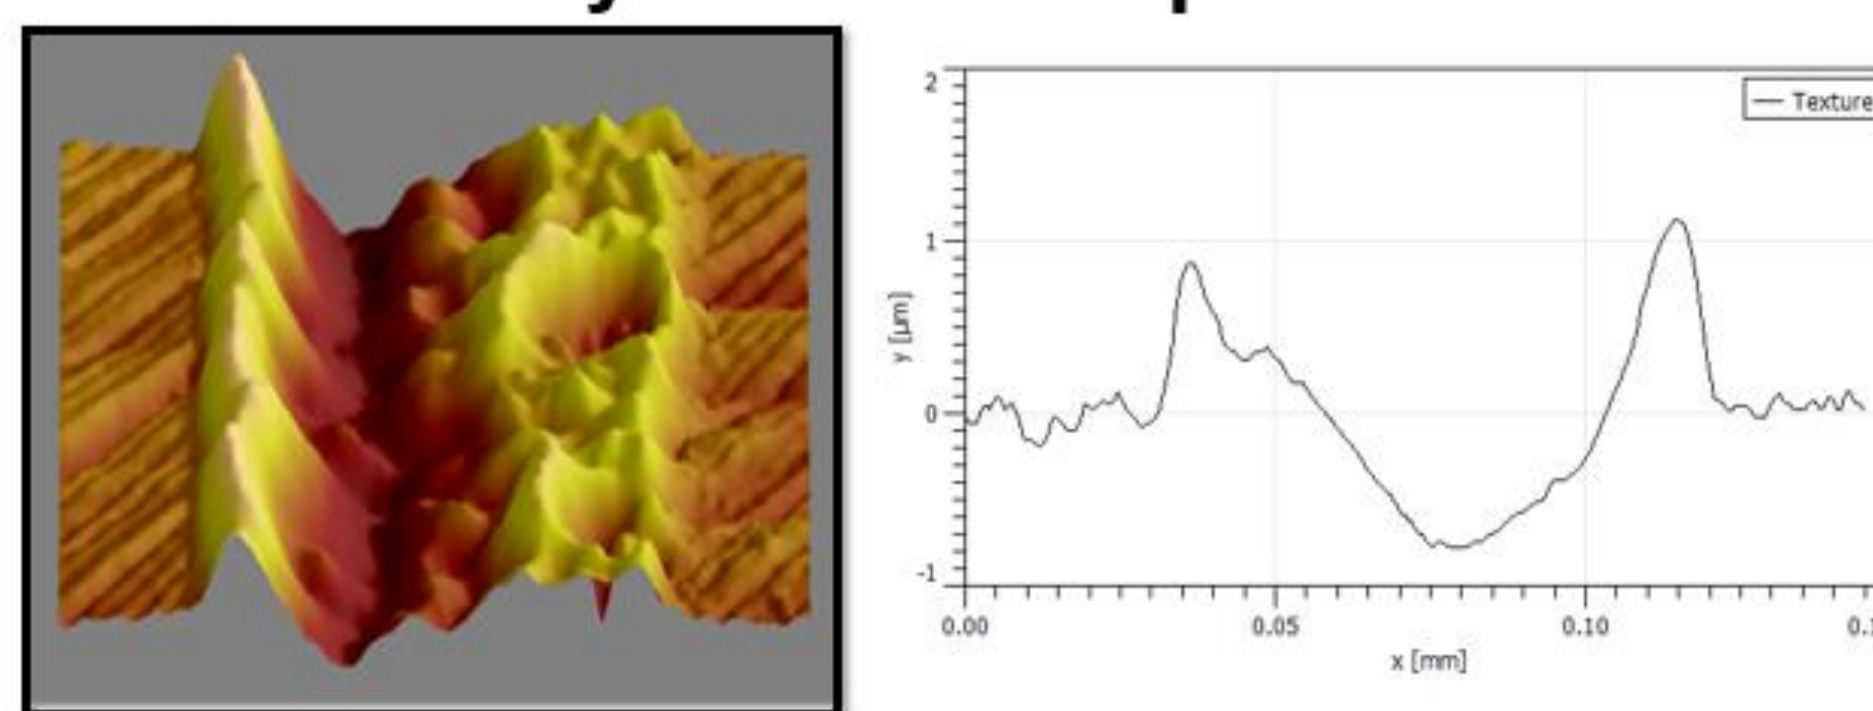
Figure 6: The image on the left is AFM scan of 4140 line continuous laser texture and its surface profile on right. Thermal expansion due to large thermal gradients led to plastic yielding led to accumulation of residue around the texture.

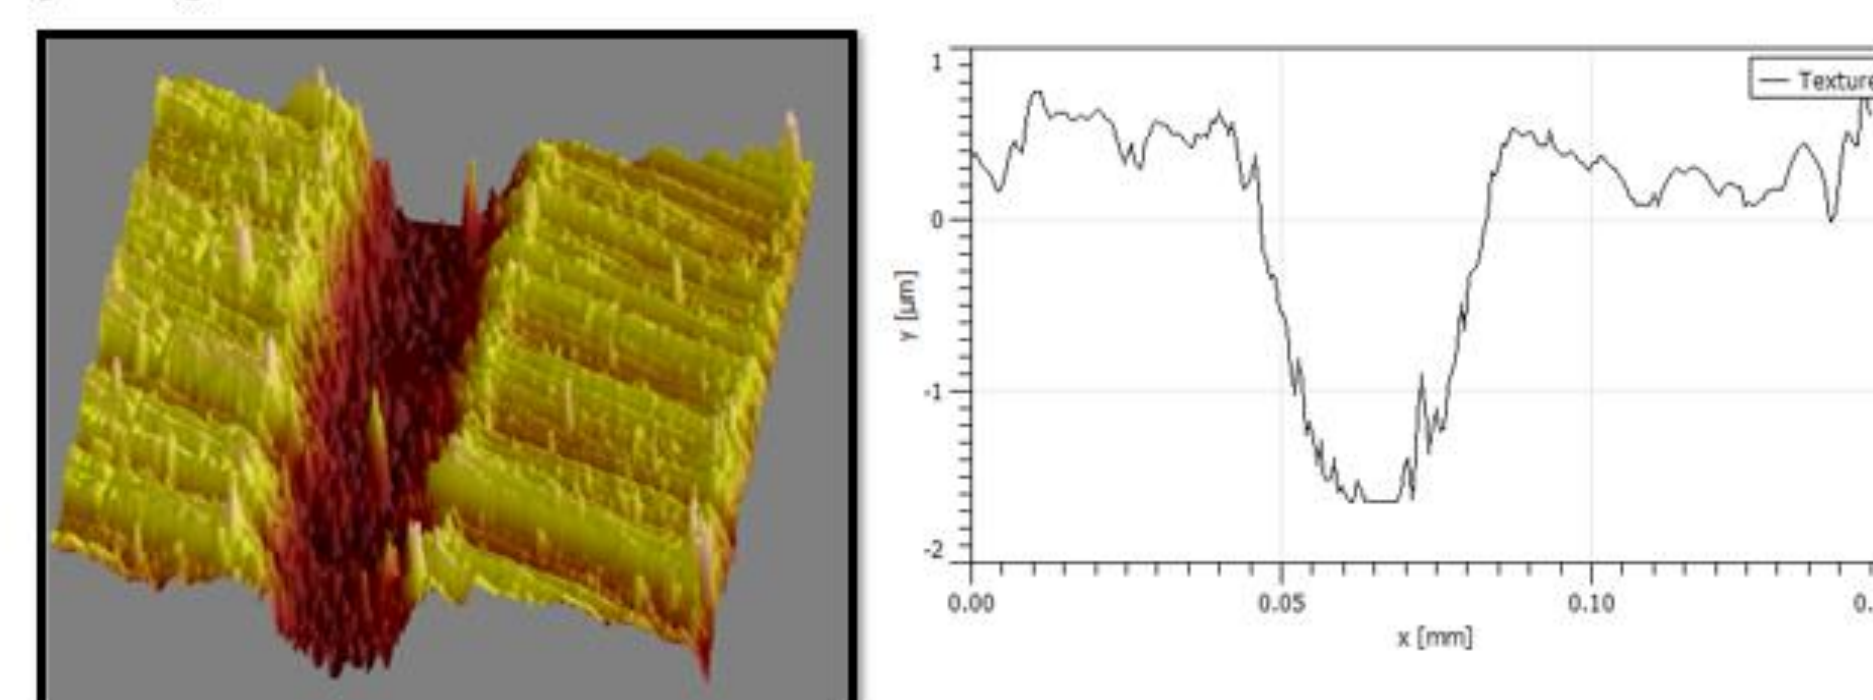
Figure 7: The image on the left is AFM scan of 4140 line pulsed laser texture and its surface profile on right. The pulsed laser resulted in sharper edges and low residue deposition.

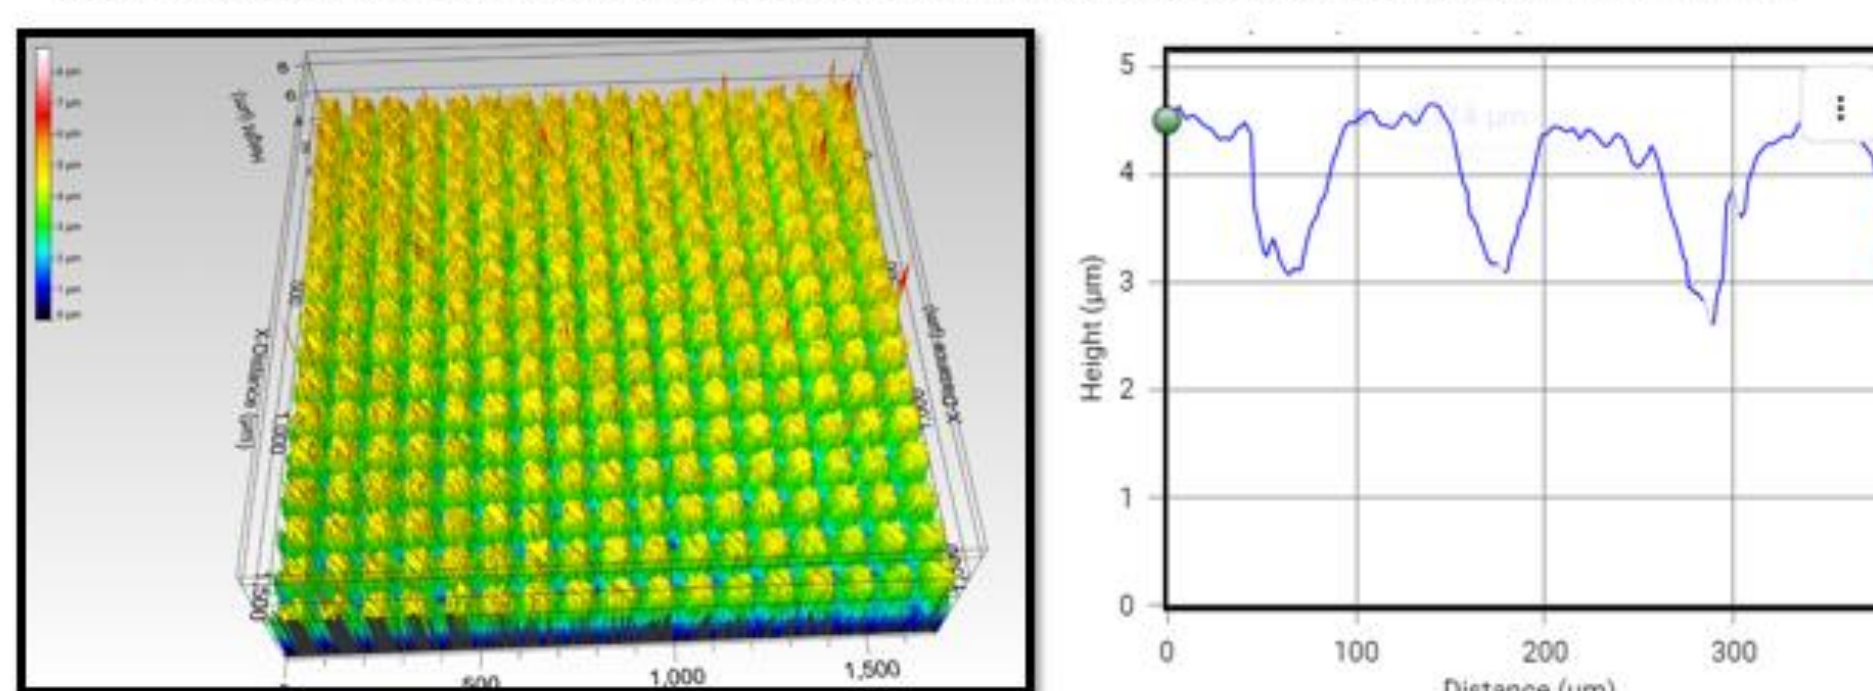
Figure 8: The image above is a surface scan of 4140 grid texture using an optical profilometer. The grid was made using pulsed laser and has a texture similar to line texture.

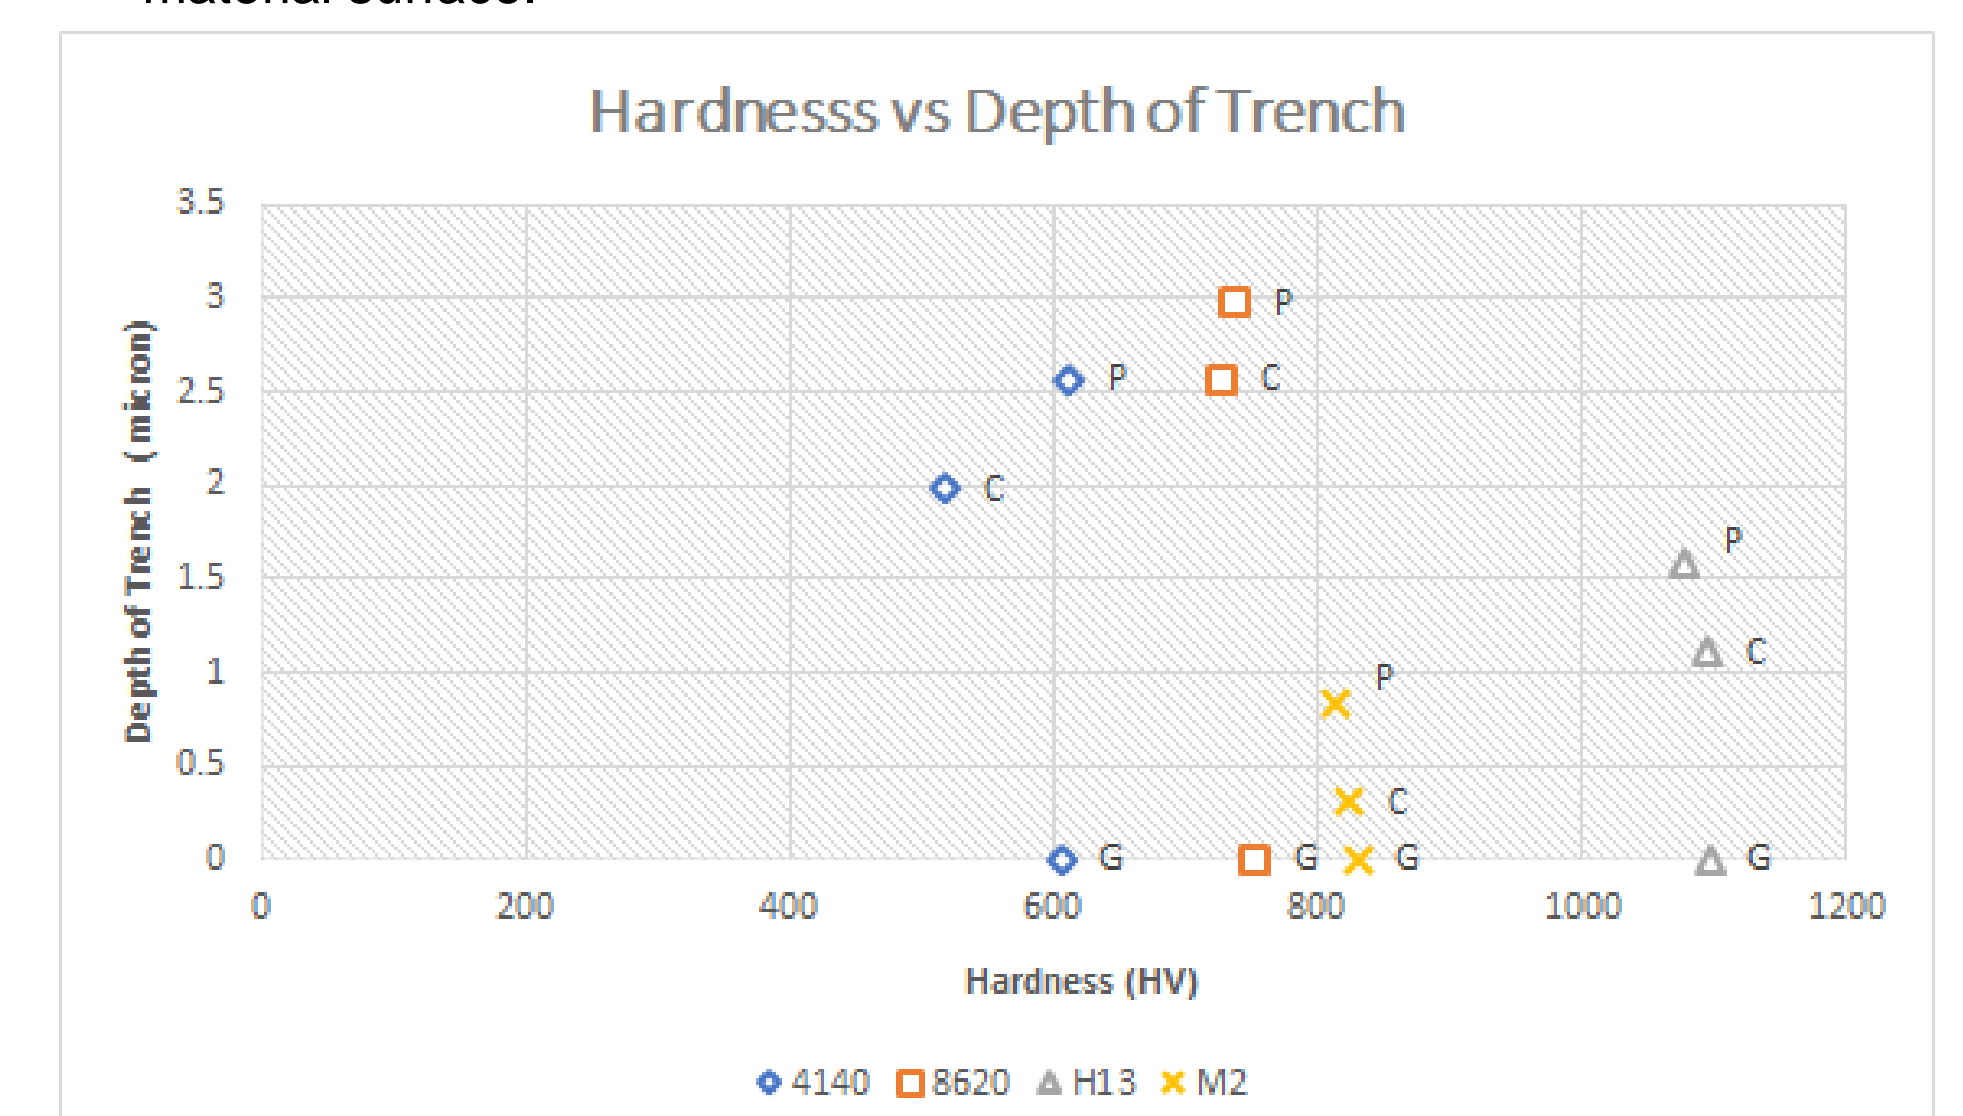
Figure 9: Graph showing average depth of trench vs hardness (HV) along with continuous laser (C) vs. pulsed laser (P)

- Laser Texturing is driven by thermal diffusion length, Heat Affected Zone & Surface Roughness**

- Higher Thermal diffusion length allows HAZ to dissipate heat outwards into the material lattice at faster rate in M2 and H13, which hinders ablation.
- In 4140 and 8620, lower thermal diffusion length provides HAZ with enough energy to undergo ablation but sometimes excess energy causes plastic yielding.
- The average surface roughness could dictate how laser will interact with the material surface.
