# Advanced 3D Integrated Packaging: Manufacturing and Reliability

High bandwidth memory chips were used to investigate the reliability of advanced 3D integrated packaging for NSWC Crane. The chips were annealed at 125°C for 5, 10, and 15 weeks. The microbumps were imaged to measure IMC thickness, and a plot of IMC thickness over time was generated. It was found that industry criteria for resistance failure was reached in 5 weeks. Due to lab shutdowns, the effect of thermomechanical stresses on microbumps and TSVs was inconclusive off of data alone. Therefore, expansive literature compilation was created. As a consensus of the FEA and annealing papers about 3D packaging, it was shown that TSVs plastically deform when annealed from 25°C to 450°C, as well as create high stress concentrations in silicon.

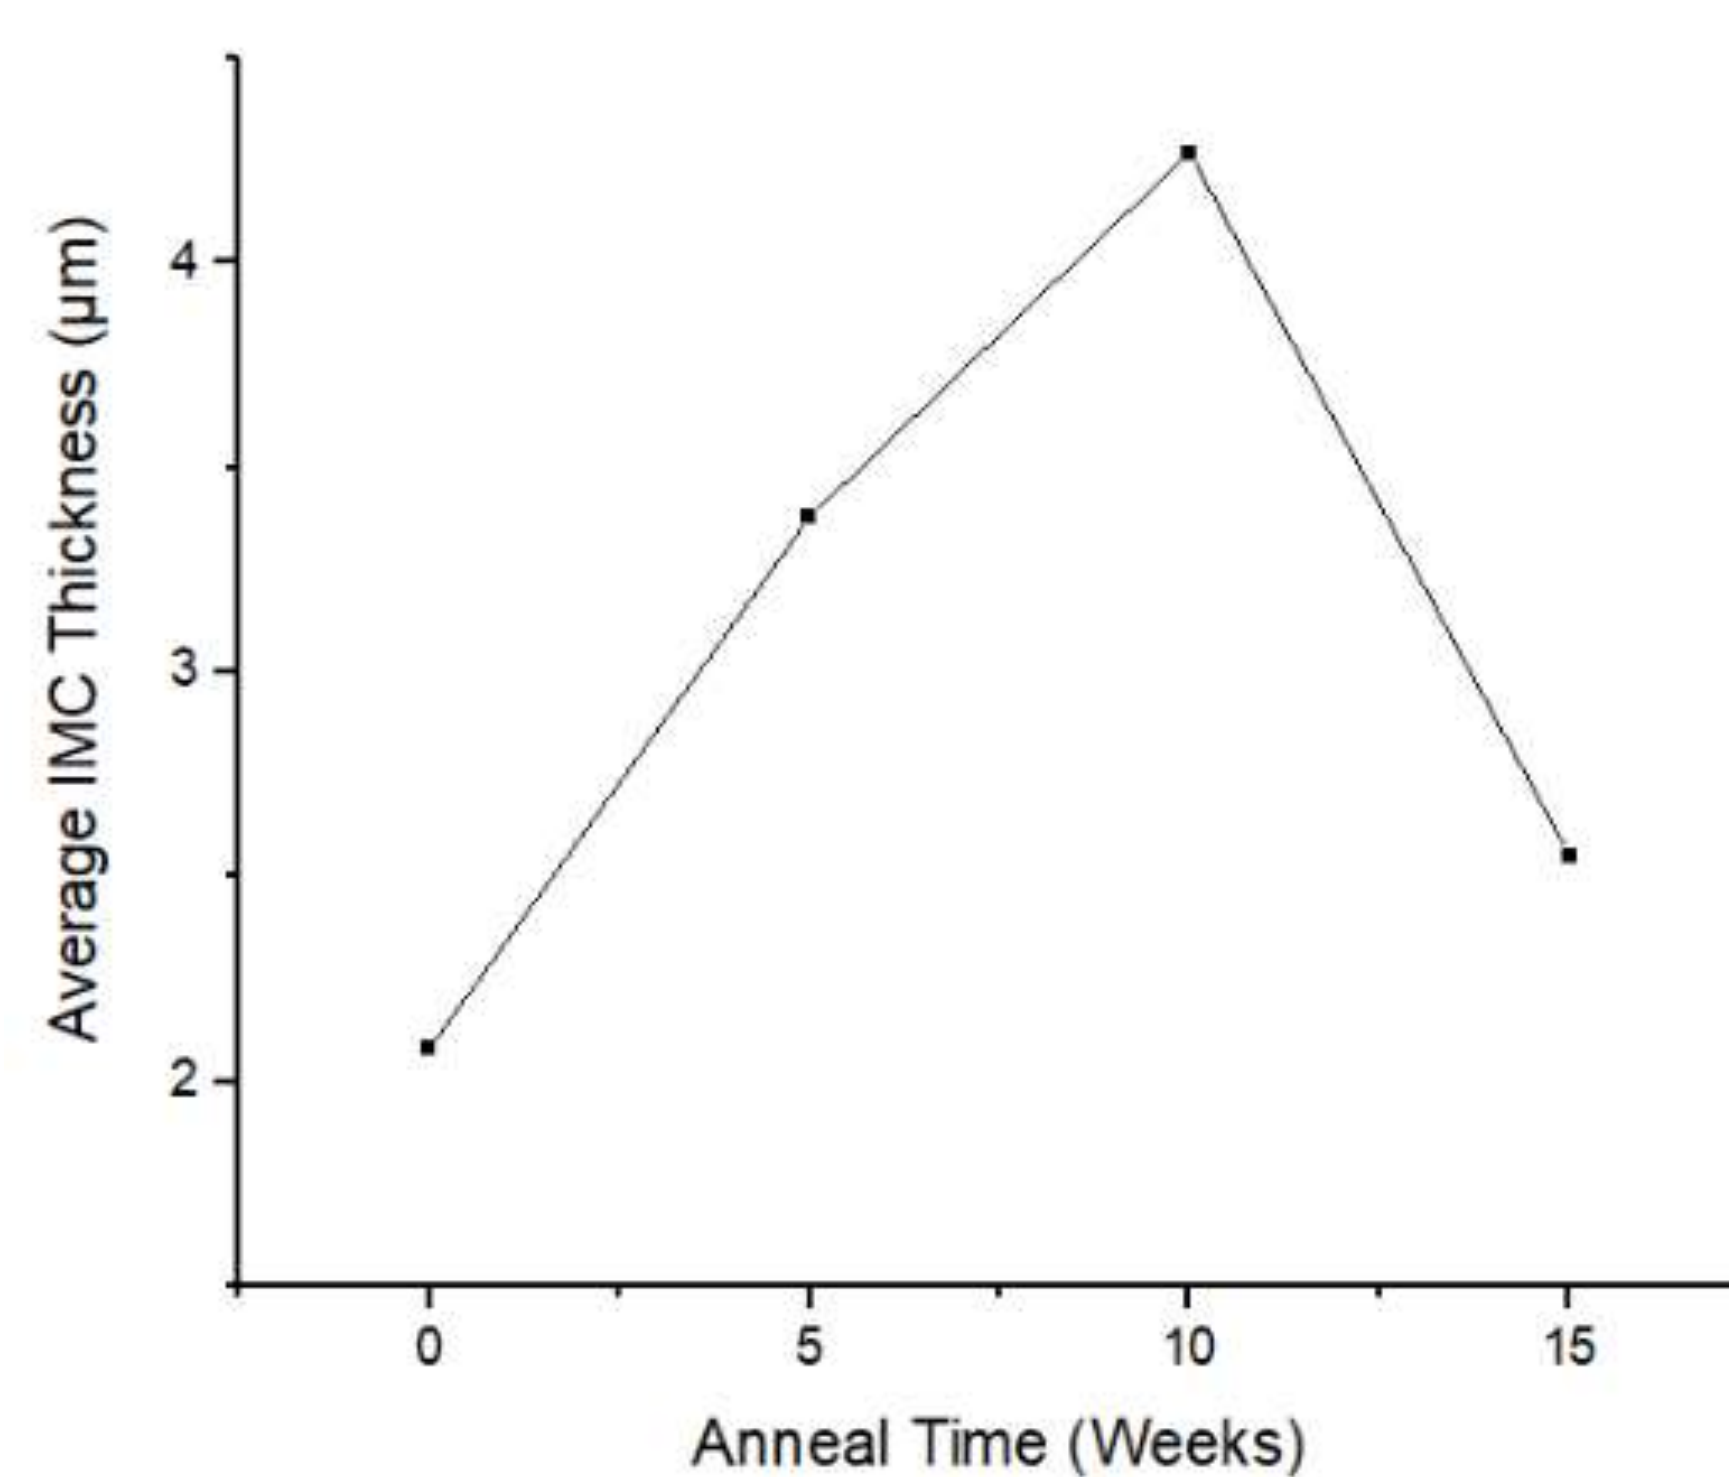
It was found that the electrically active area of each DRAM die consists of 4062 interconnects. The thickness of each interconnect is made of 5  $\mu m$  of SAC solder, and 2  $\mu m$  of the intermetallic phase  $Ni_3Sn_4$ . The area of the interconnect is 314  $\mu m^2$ , the  $Ni_3Sn_4$  resistivity is 28.5  $\mu\Omega \cdot cm$ , and the SAC resistivity is 12.3  $\mu\Omega \cdot cm$ . Using the simple series and parallel resistor equations, and assuming that all of the interconnects are active at once, a total IMC growth of just 1  $\mu m$  would lead to a 20% increase in overall component resistance. After averaging the IMC thicknesses from all annealed samples, Figure 4 was generated to show thickness over time. At 125°C, it takes just 5 weeks to reach the criteria for failure.

Figure 4: Graph of average IMC thickness at 5, 10, and 15 week anneal at 125°C

Figure 4 shows an increase in IMC growth from 0 to 10 weeks which is an expected trend as the intermetallic faces undergo transient diffusion during aging. After just 5 weeks of aging, the IMC grew enough to increase resistance of the chip by 20%, which is an industry benchmark for reliability failure. The drop in IMC growth in the 15-week aged sample is irregular. This anomalous data is due to differing GPU architecture that went unnoticed in the early stages of the experiment. While the 0 to 10 week interconnects appeared as in Figure 1 and 3, the week 15 interconnects appeared as in Figure 2. That is, the 15 week sample contained a large copper bond pad at the top of the interconnect instead of a thinner nickel pad. Although this was not desirable for creating a consistent trend, it could still be something useful to take note of. For example, this result means that using copper as the bonding surface could reduce the amount of IMC growth, thereby increasing the performance of the chip.
