Directed Energy Deposition of IN 718 for Turbine Blade Repair

Blade tips in gas turbine engines wear during use, decreasing the engine efficiency and increasing cost and fuel consumption. Our goal is to investigate the repair process for these blades using directed energy deposition (DED). For the repair, we test IN718 with 0, 1, and 3% ceramic reinforcement with high power and low power DED parameters. We characterize the process using optical microscopy, hardness measurements, tensile testing, and wear testing. We do not see differences in microstructure at different reinforcements, but we find evidence that 3% ceramic reinforced material is harder and stronger than 0 and 1% reinforced material.

This work is sponsored by Rolls-Royce, Indianapolis, IN

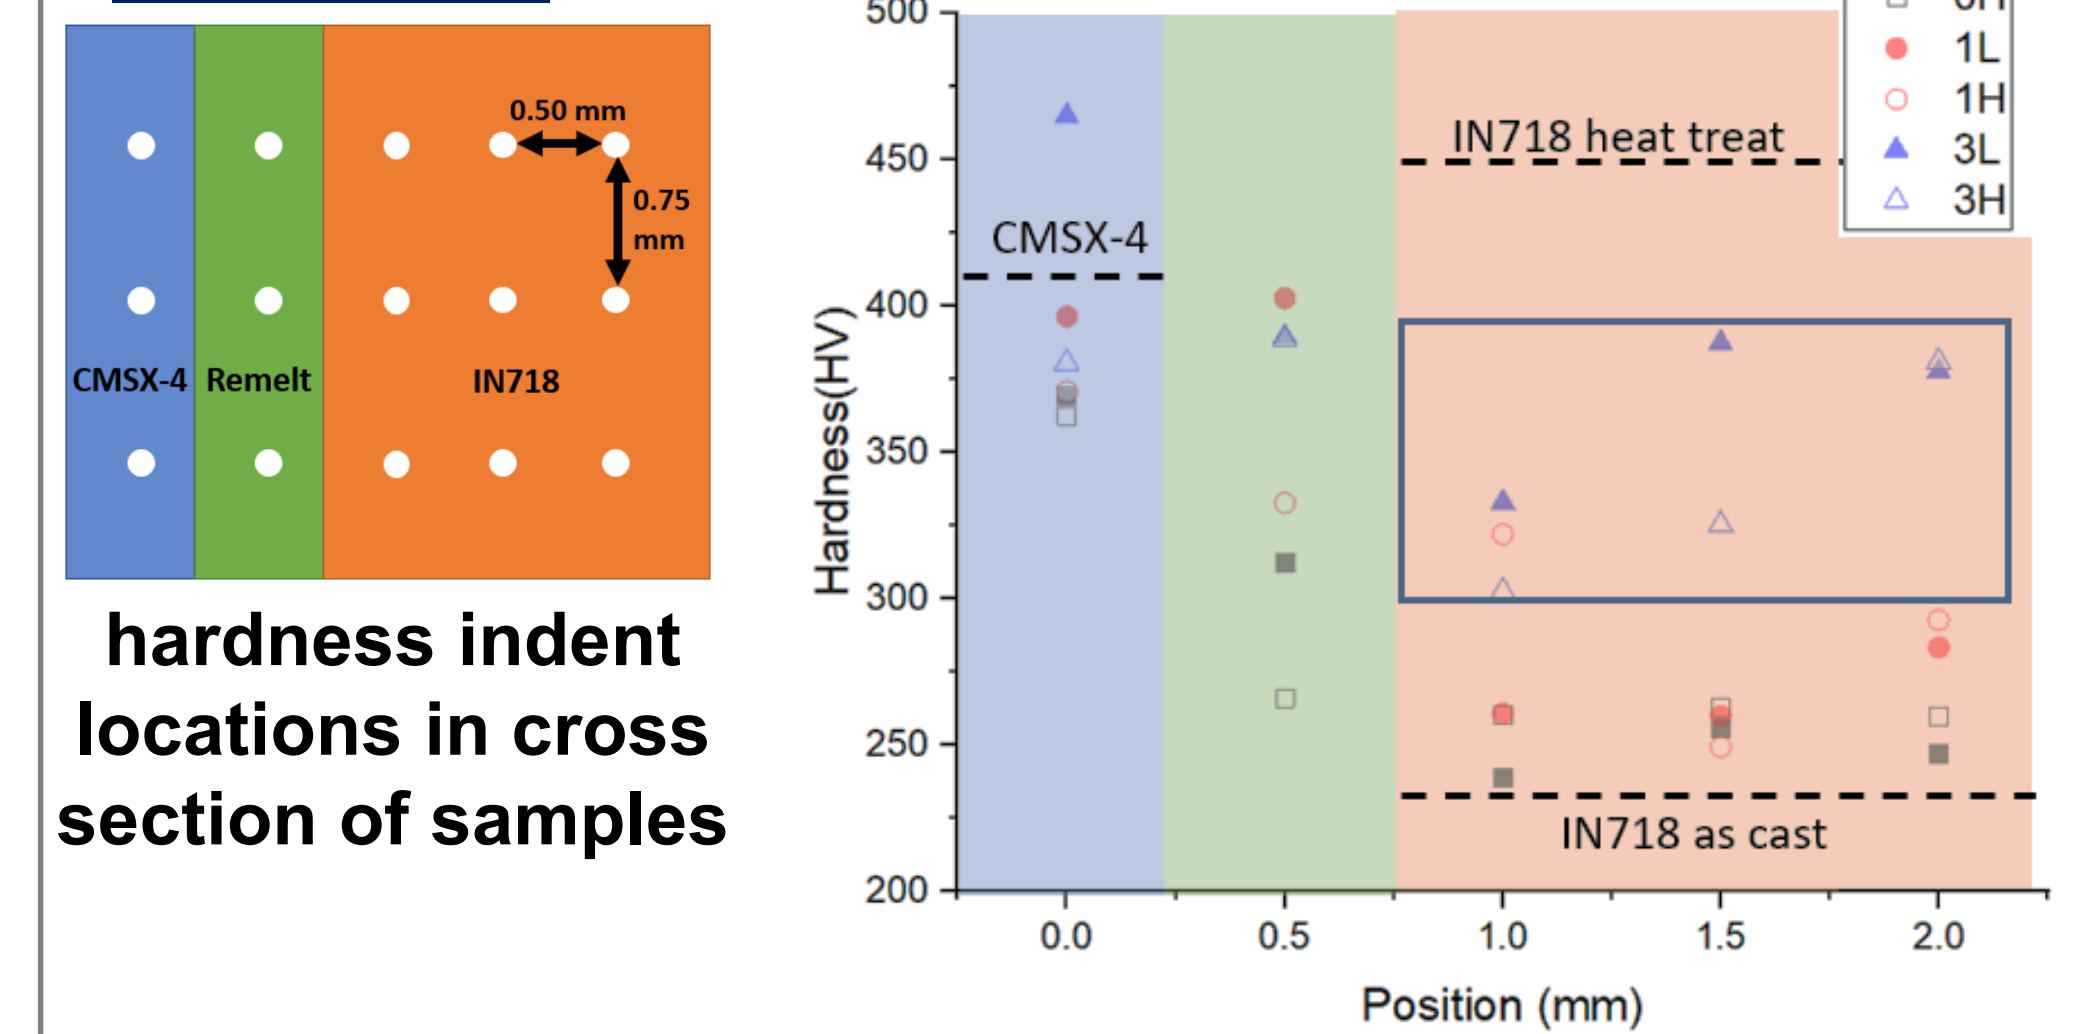
hardness indent locations in cross section of samples

- Hardness of CMSX-4 is lower than handbook value²
- 3% reinforcement** samples had higher hardness
- Samples printed at **low power** generally had higher hardness than high-power samples
