The absence of specified acceptance criteria for evaluating commercial off-the-shelf circuit card assemblies (CCAs) leads to a vital absence of quality control in the otherwise robust production of embedded systems technologies. To address the needs of our stakeholders, NSWC Crane and Purdue University's School of Materials Engineering, our goal is to establish comprehensive acceptance criteria integrating industry standards and proprietary visual and microscopic inspection techniques. This aims to integrate a consistent and reliable identification of viable commercial off-the-shelf circuit card assemblies into the production pipeline, crucial for ensuring reliability and performance.

This work is sponsored by Naval Surface Warfare Center, Crane, IN

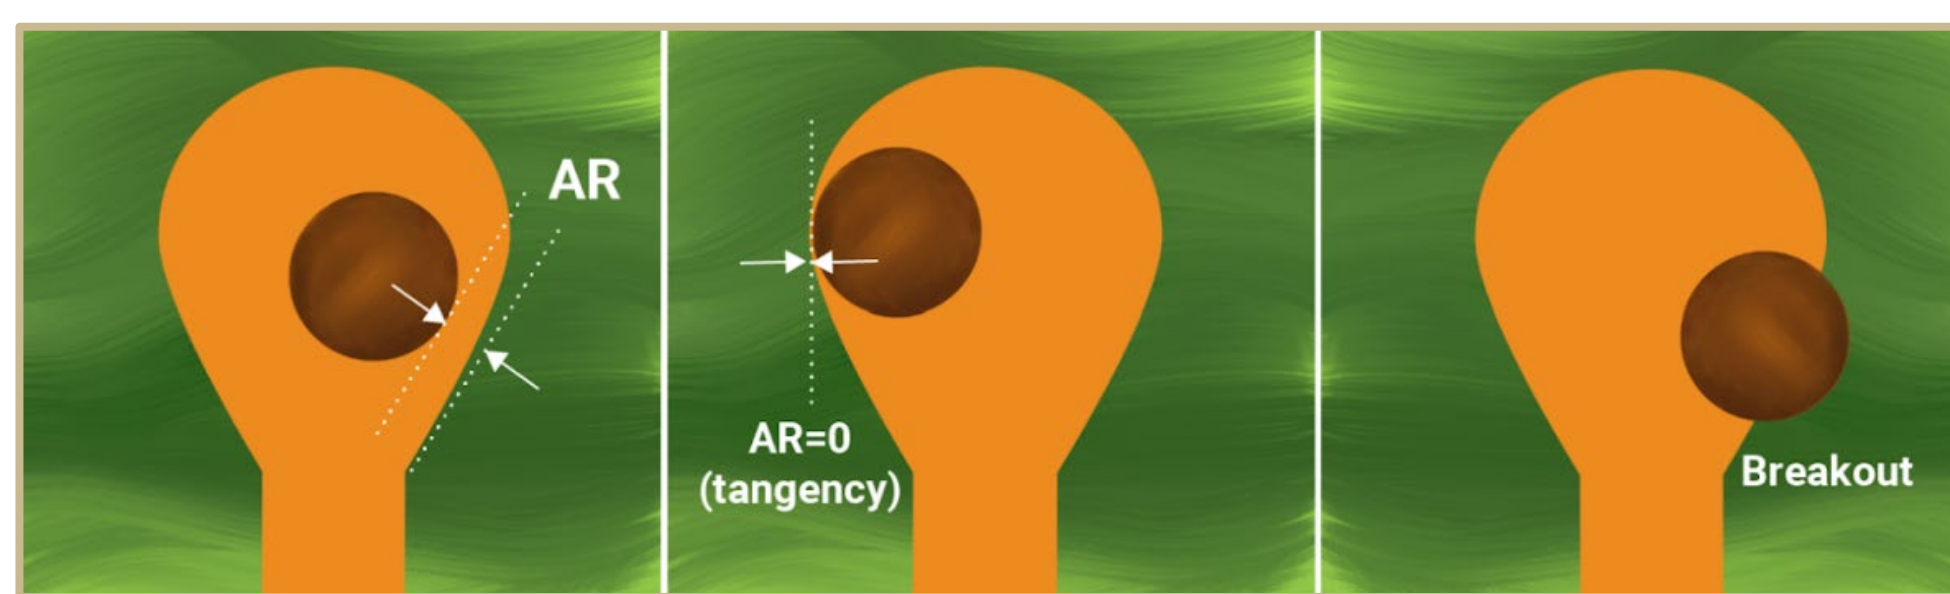
### Inadequate Annular Ring<sup>1</sup>

- Due to lack of tool calibration or mechanical and thermal warping
- Leads to poor electrical connection or misalignment of components

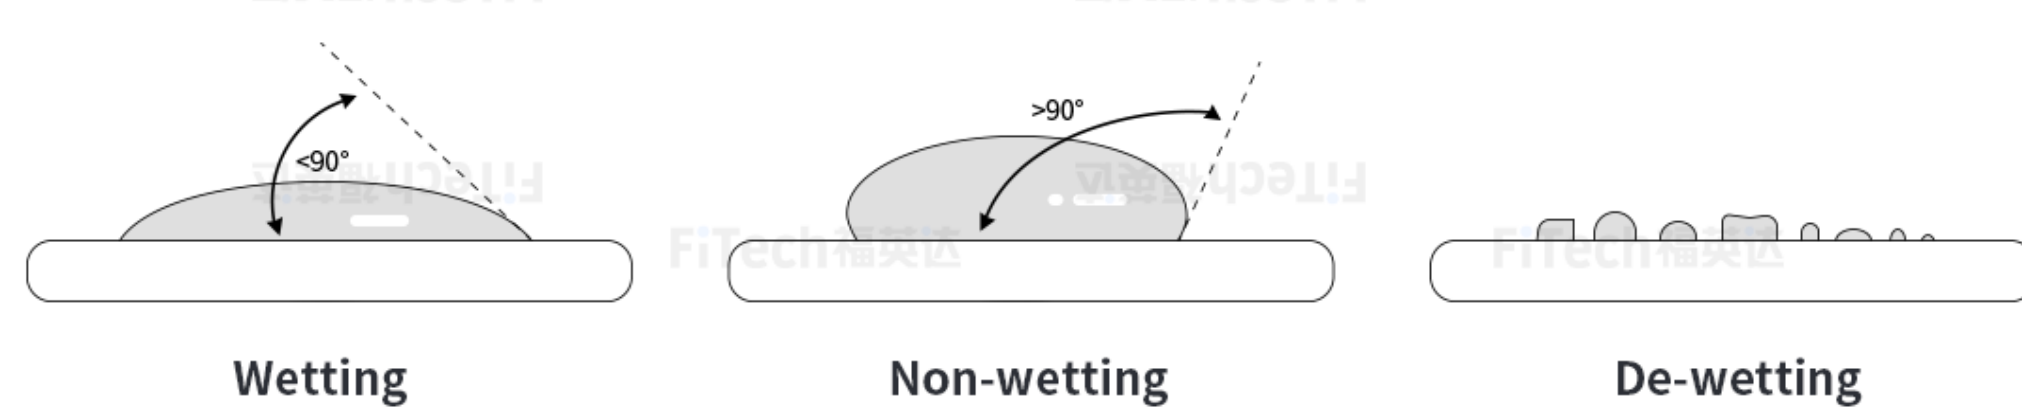
### Solder Adherence Issues<sup>2</sup>

- Solder doesn't properly adhere to the board or lead
- Caused by contaminants on pad, insufficient soaking time or inadequate heating during solder reflow, or poor surface finish

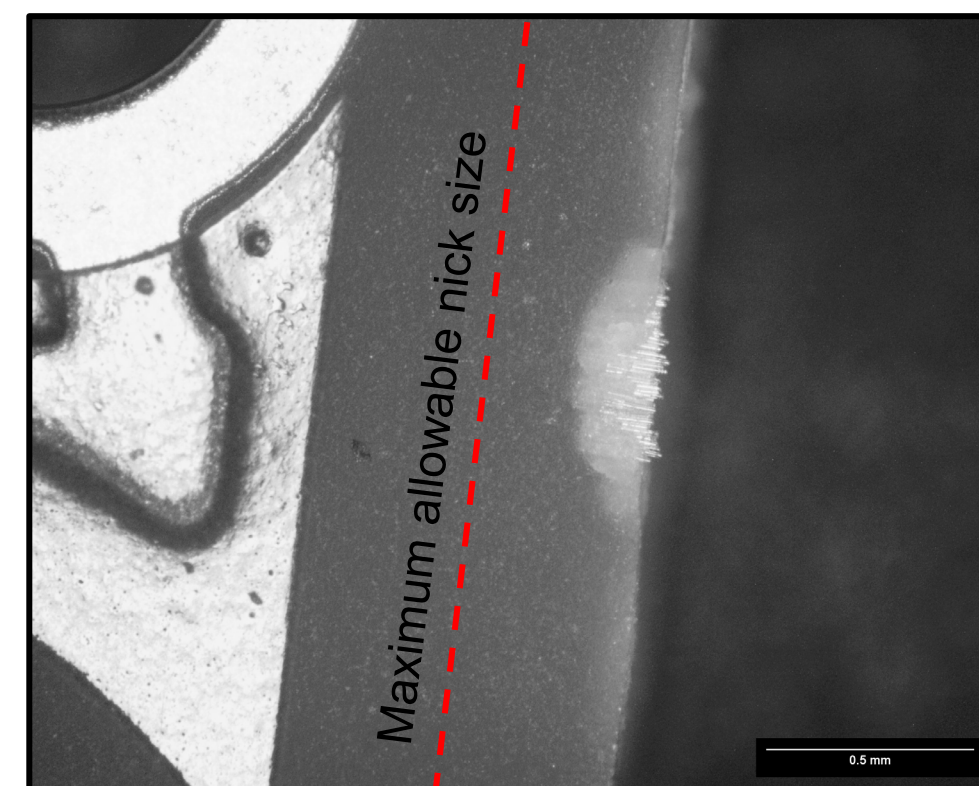
#### Nicks

Repetitive nicks were discovered along the edges likely originating from the separation of the boards. These are permissible if they do not extend beyond 50% of the distance to the nearest conductor or exceed 2.5 mm. This occurrence **conforms** to IPC standards<sup>3</sup>.

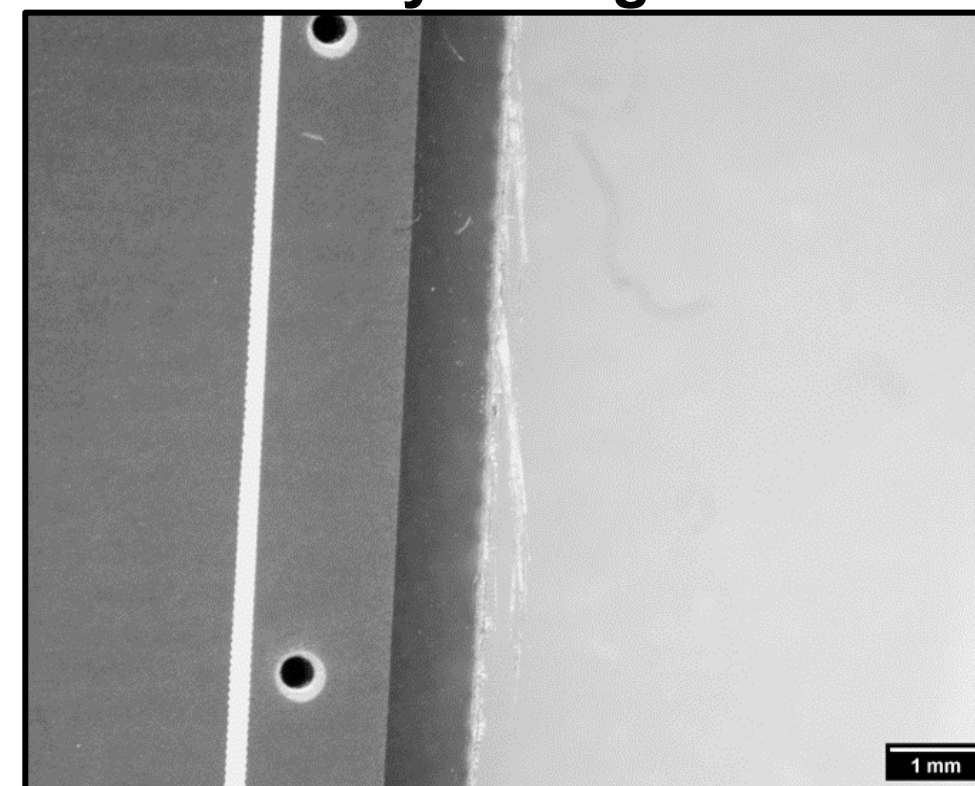
#### Frayed Edges

The rough edges likely stem from the cutting of the board to size. Edges should be smooth without any burrs; however, rough edges are acceptable given any loose burrs do not impede fit or functionality. Therefore, this instance of fraying **conforms** to IPC standards<sup>3</sup>.

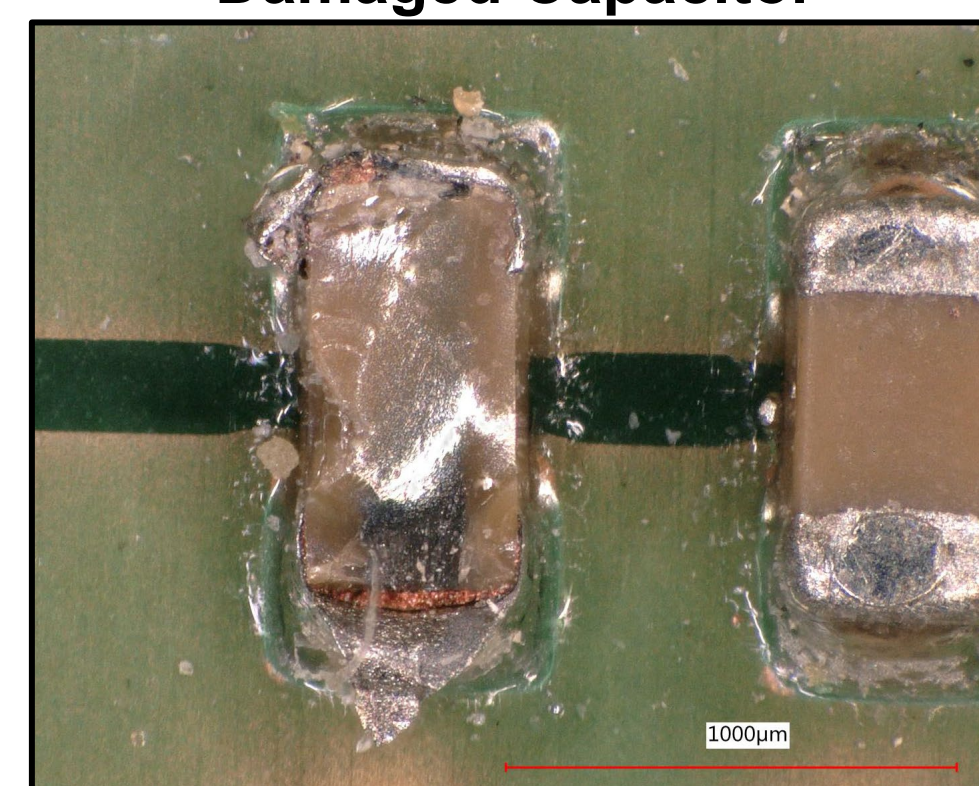
#### Damaged Capacitor

This capacitor likely suffered an impact. Due to the shearing of the conformal coating, this likely occurred during handling rather than fabrication. The damage could affect the component's functionality and would **not conform** to IPC standards<sup>3</sup>.

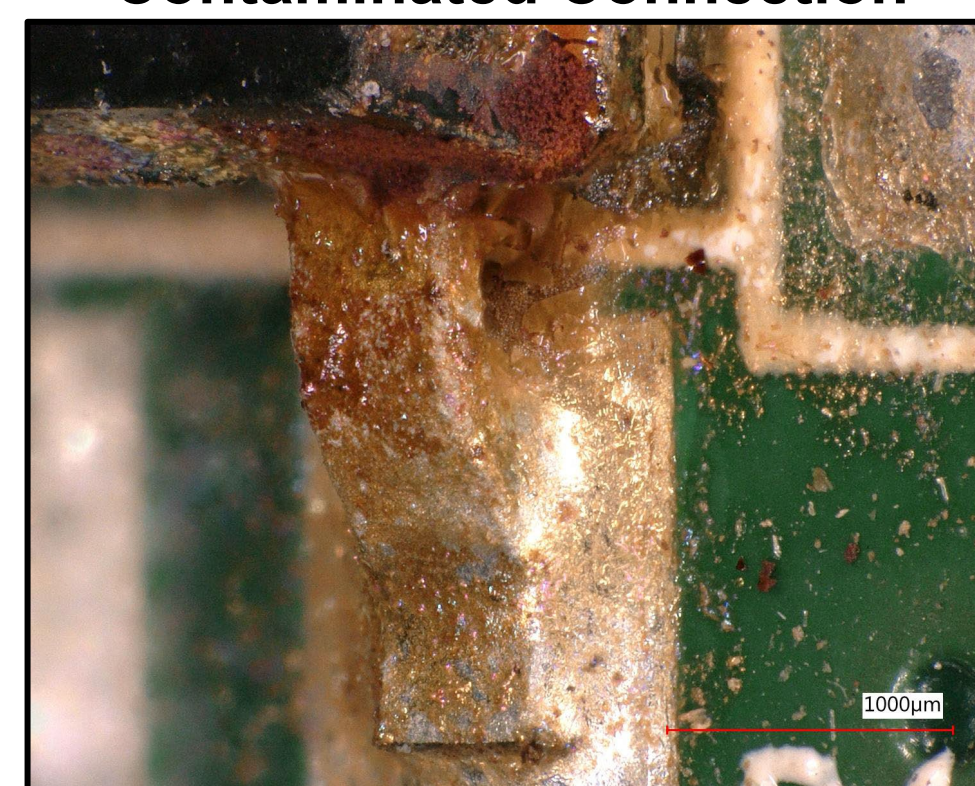
#### Contaminated Connection

Contamination threatens device functionality. From visual inspection, this solder joint is likely to be **nonconforming**. The degree of nonconformance could be quantified by measuring the ionic conductivity of the contaminants<sup>4</sup>.

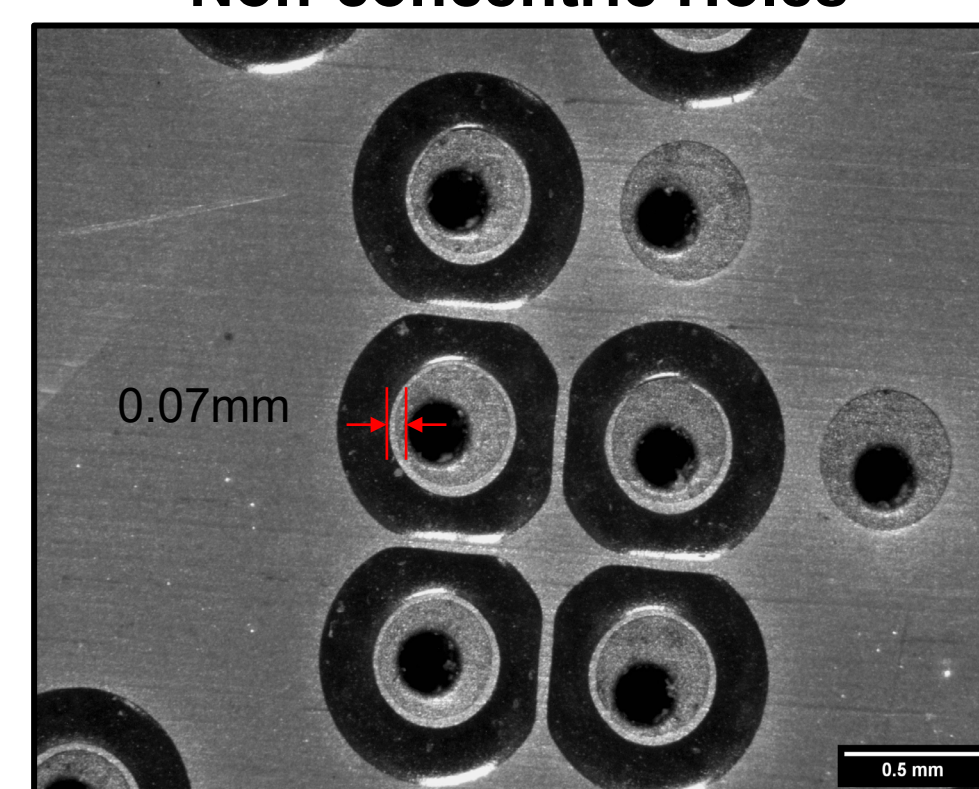
#### Non-concentric Holes

Non-centered holes are a byproduct of the alignment variability during manufacturing. Such occurrences are deemed acceptable given the annular ring a minimum of 0.050mm. These holes **conform** to IPC standards<sup>3</sup>.

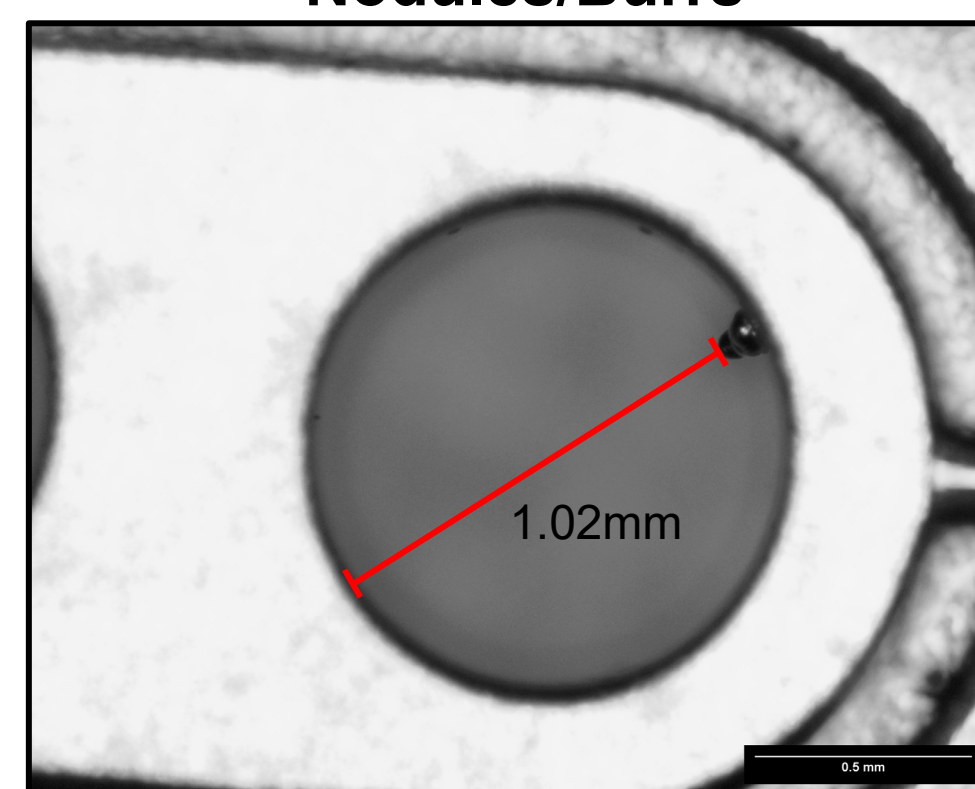
#### Nodules/Burrs

For plated through holes, the target condition is no nodules or burrs. The presence of nodules in this case still **conforms** to IPC standards<sup>3</sup>, as the minimum finished hole diameter is still met.

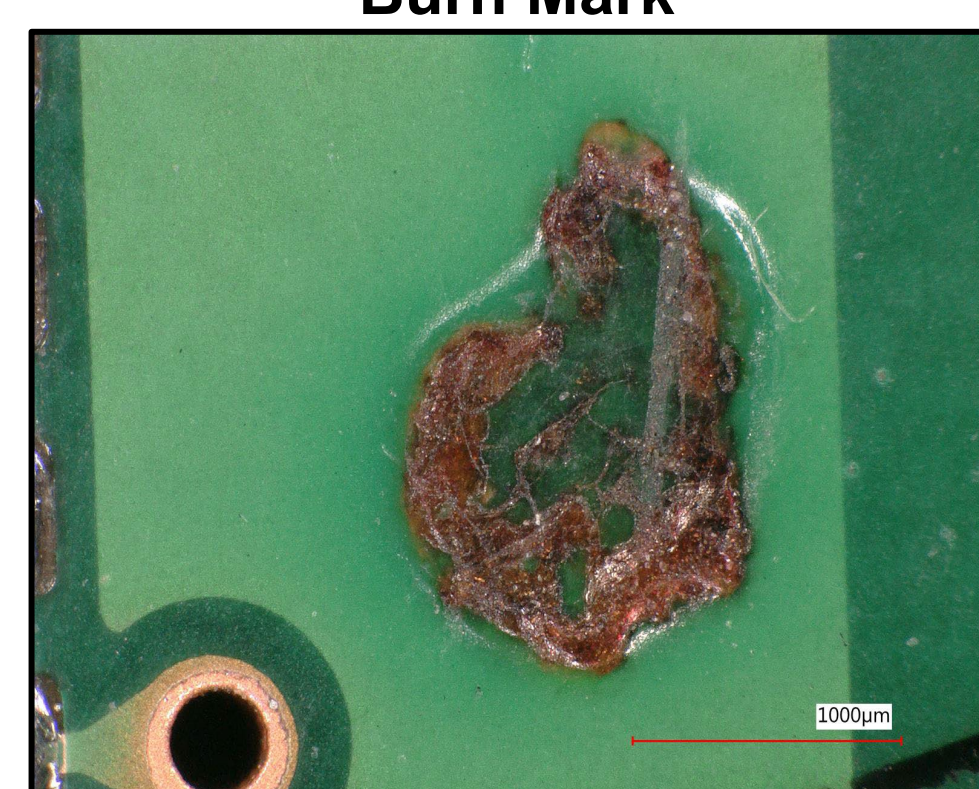
#### Burn Mark

This burn was likely caused by a soldering iron during a manual touchup in fabrication. XRF analysis revealed elevated levels of copper, indicative of the erosion of the solder mask, thereby exposing the underlying plane. However, as no adjacent conductive patterns have been exposed, this defect is permissible, and **conforms** to IPC standards<sup>3</sup>.

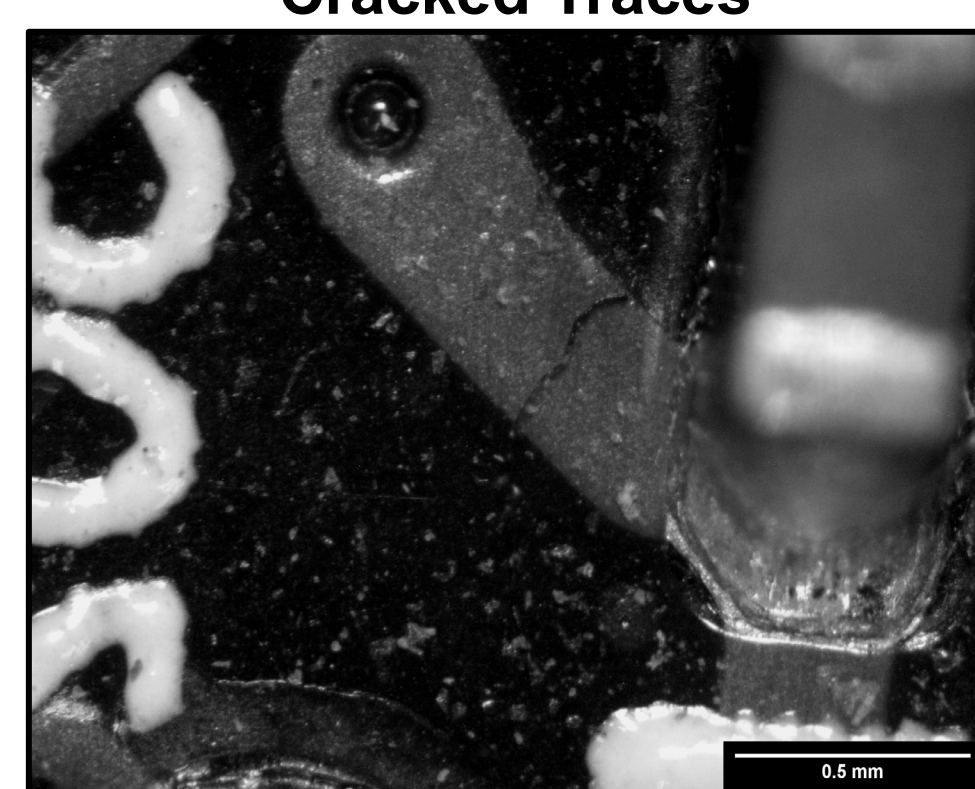
#### Cracked Traces

The presence of this crack is **nonconforming** to IPC standards<sup>3</sup> as it severs a trace, disrupting the flow of electrical signals along the intended path. This crack was likely a result of mechanical stress during assembly or handling. Inadequate curing or adhesion could also leave the board susceptible to these kinds of cracks.

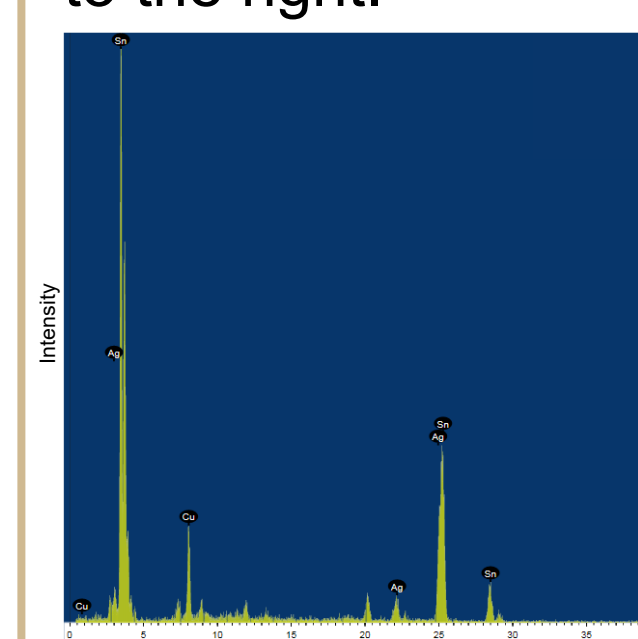
XRF spectra from GPU solder joint

Similarly, XRF can be utilized for elemental analysis, including for solder joints. When used on the GPU, XRF exhibited high amounts of tin, small amounts of silver and copper, and no lead content. This can be useful in identifying solder type, likely SAC305 in this case, but it can also be used to identify impurities. EDS and XRF are both used in circuit card analysis given their differences in sensitivity and penetration depth.

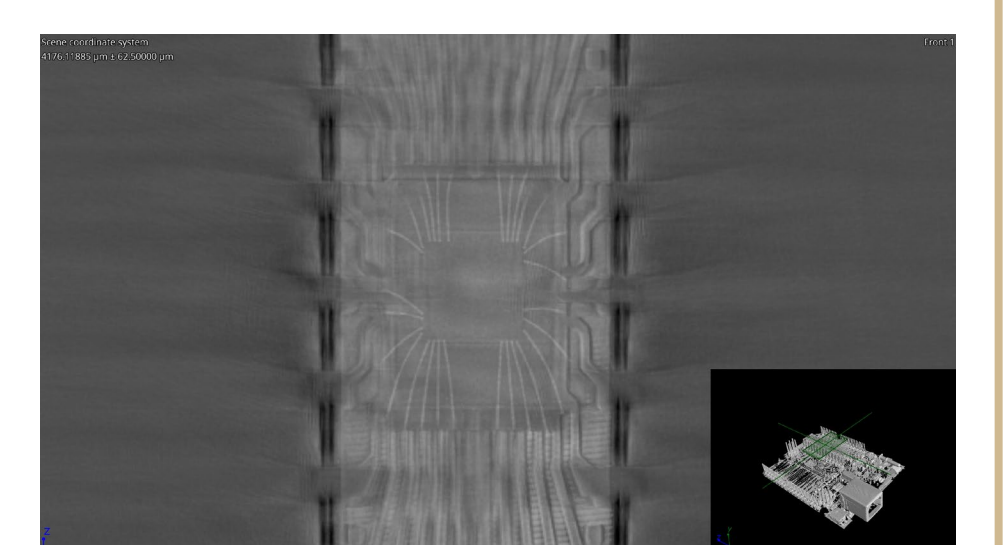
CT X-Ray serves as a non-destructive testing method offering insights beyond optical inspection. It enables the isolation of conductive pathways by filtering out non-conductive material, facilitating examination inside component packaging. As illustrated by the cross-sectioned Arduino board to the top right, X-Ray CT allows inspection of the internal wiring of components like the microcontroller IC. While the Arduino exhibited no failures, X-Ray CT is invaluable for detecting internal failures such as the crack visible in the component to the bottom right, which went undetected through optical inspection despite the board's malfunction.

CT Scan of an Arduino Uno R3 circuit board

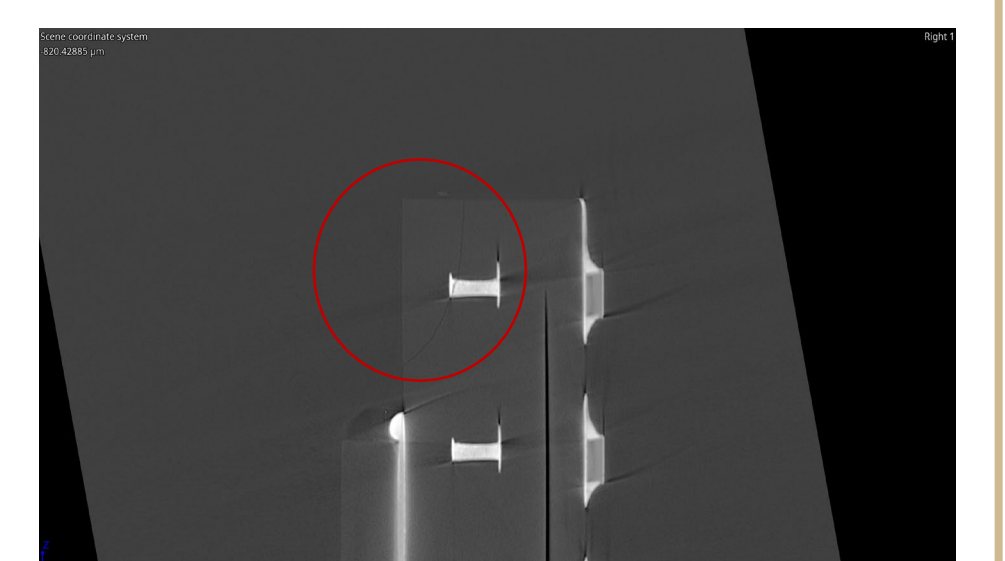
Example of an internal fracture found through CT X-ray
