Intergranular corrosion on Hastelloy

Chemical Engineering R&D (CERD) - Environmental & Process Safety Engineering (EPSE)

Merck & Co., Inc., Rahway, NJ, USA

Corrosion was observed in one of our processes when outsourced at a CMO.

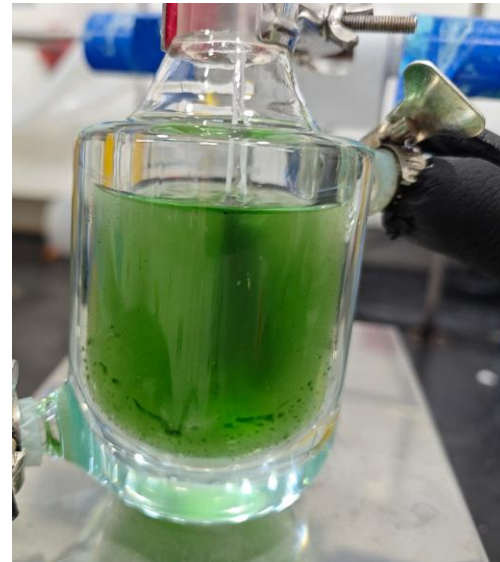
Hastelloy (Alloy) C-22 vs 2M HCl (aq) in Acetonitrile

**Cr: 1847ppm
Mn: 28ppm
Fe: 151ppm
V: <20ppm
W: 29ppm
Co: 27ppm
Ni: 6092ppm
Mo: 502ppm**

- Discoloration of the solution
- Elevated metals
- Roughening of the coupon

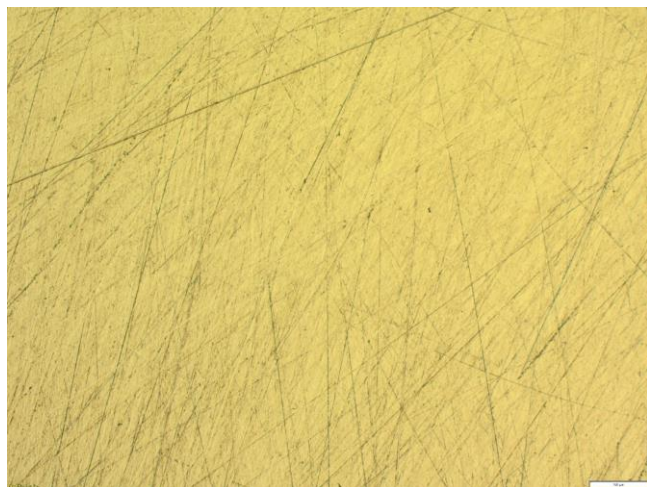
Pure MeCN, 5x
No corrosion observed on coupon
Solution did not discolor

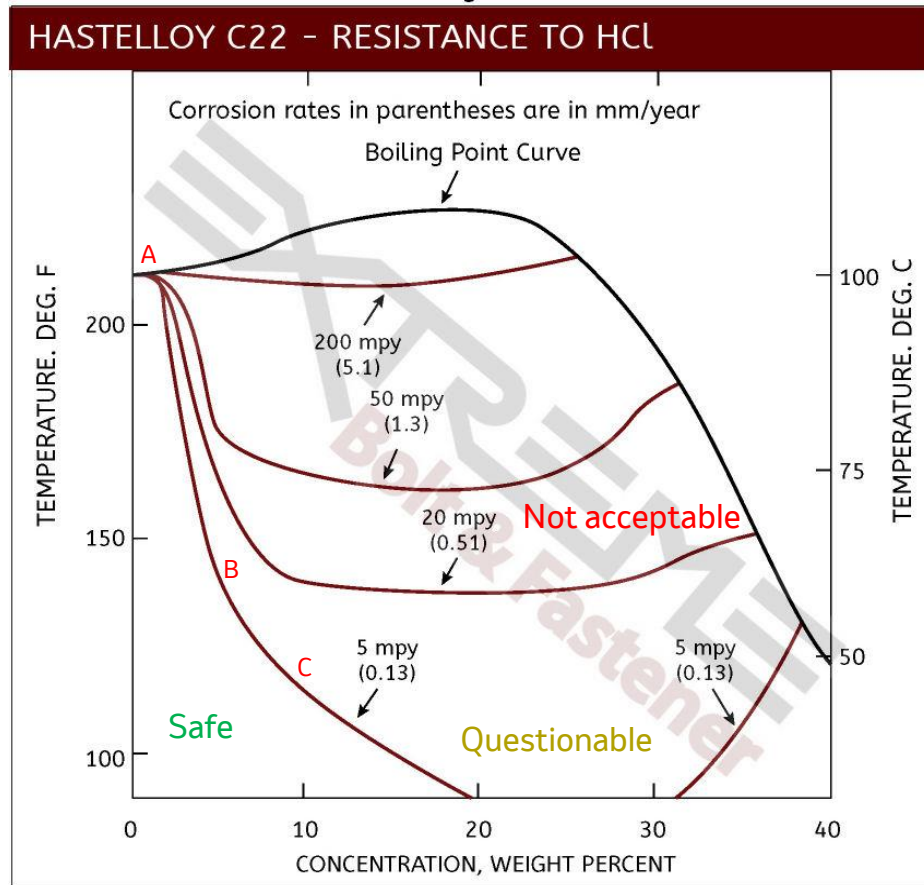
- At 25C, HC-22 is resistant to HCl (aq) up to 20wt%
- Corrosion rate < 5 mpy (Safe)
 - 1 wt% at 100C (Point A)
 - 5 wt% at 60 C (Point B)
 - 10wt% at 45-50C (Point C)
- Safe region = Excellent Corrosion Resistance
 - Low/acceptable corrosion rate
 - Low metal loss
 - Low risk and Low safety implication
 - Tolerable wear and tear

Corrosion rate calculated based on mass loss over time
1 mpy (mils/year) = 0.001 in/year

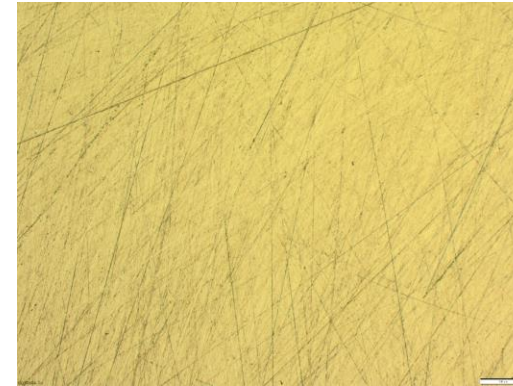
Pure MeCN, 5x
No corrosion

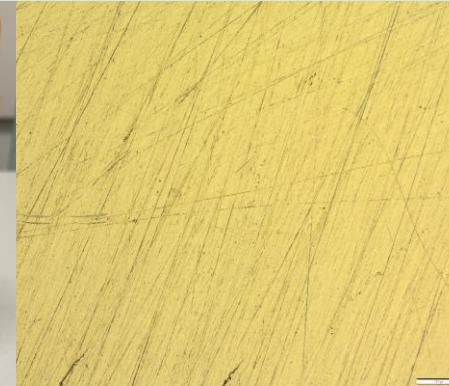
1:1 v/v, 10x ; No corrosion

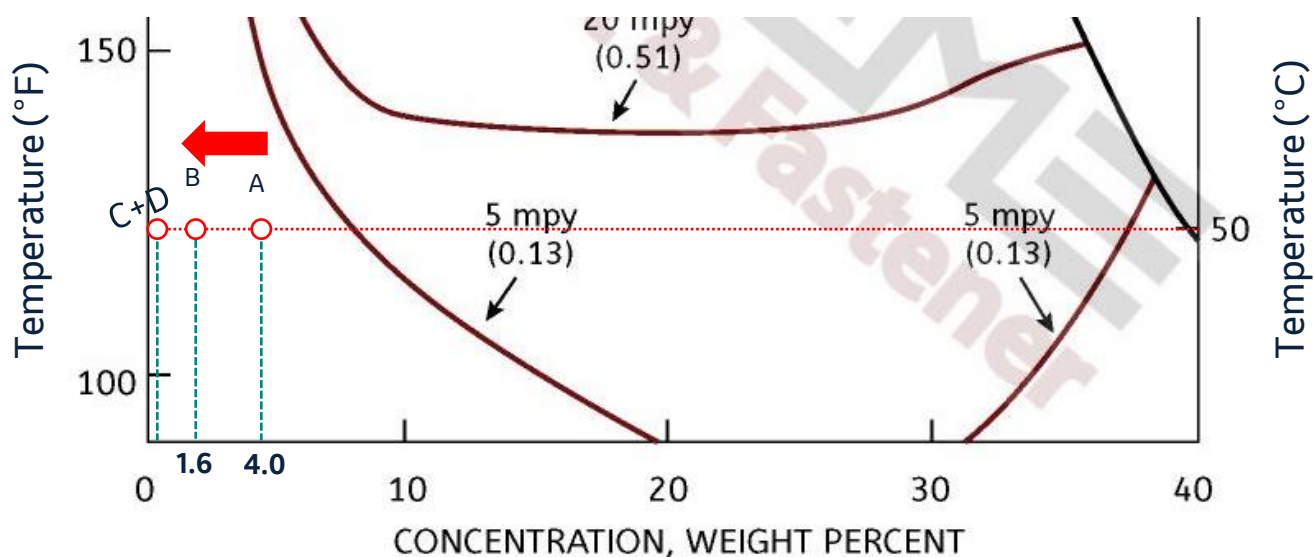
- Corrosivity of HCl increases with reduction in 2M HCl (aq) vs MeCN
- HC-22 most severely attacked at 20:1 v/v MeCN/2M HCl (aq)

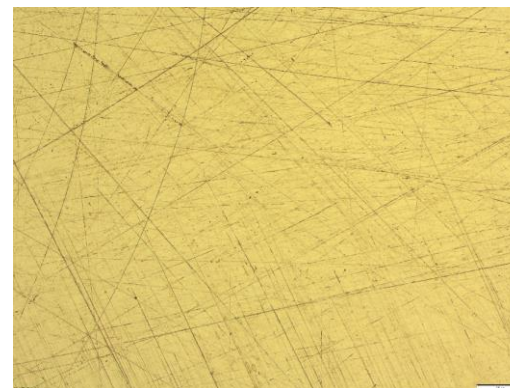
25C, 5x; No corrosion

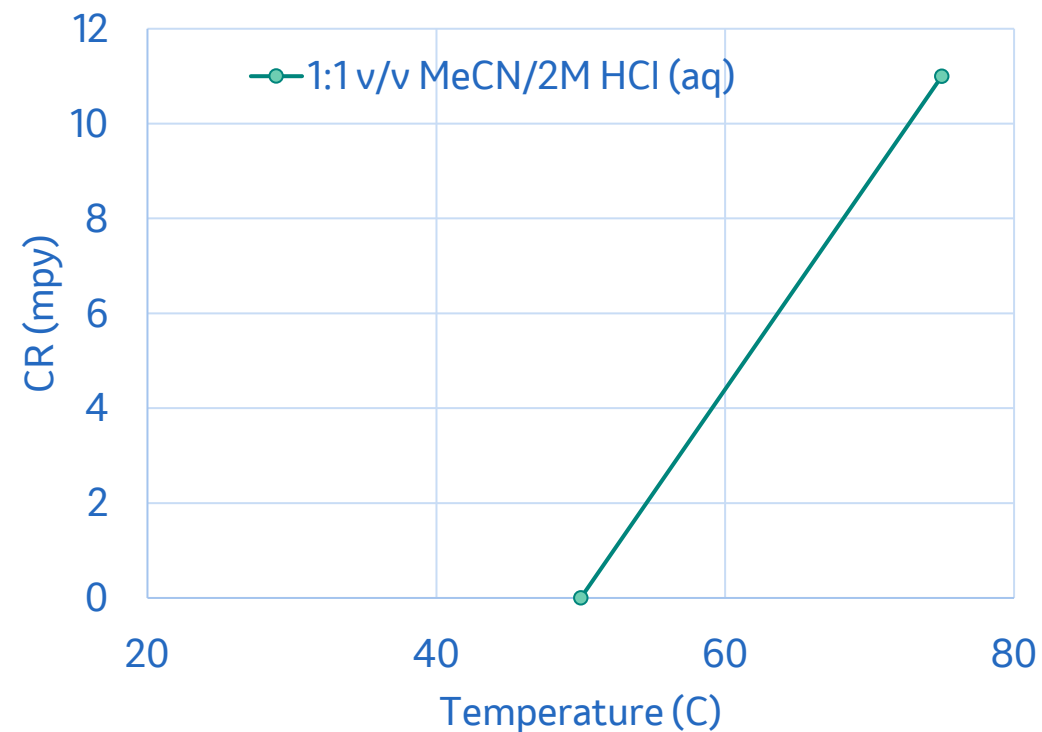
- Increase in temperature increased the corrosivity of the system vs HC-22
- The increase in corrosion rate and corrosivity is expected (to some extent) for corrosive systems for increase in temperature
- However, intergranular corrosion was not expected.
- Mechanistically, the HCl is attacking the metallic grains differently than that in a pure aqueous HCl system

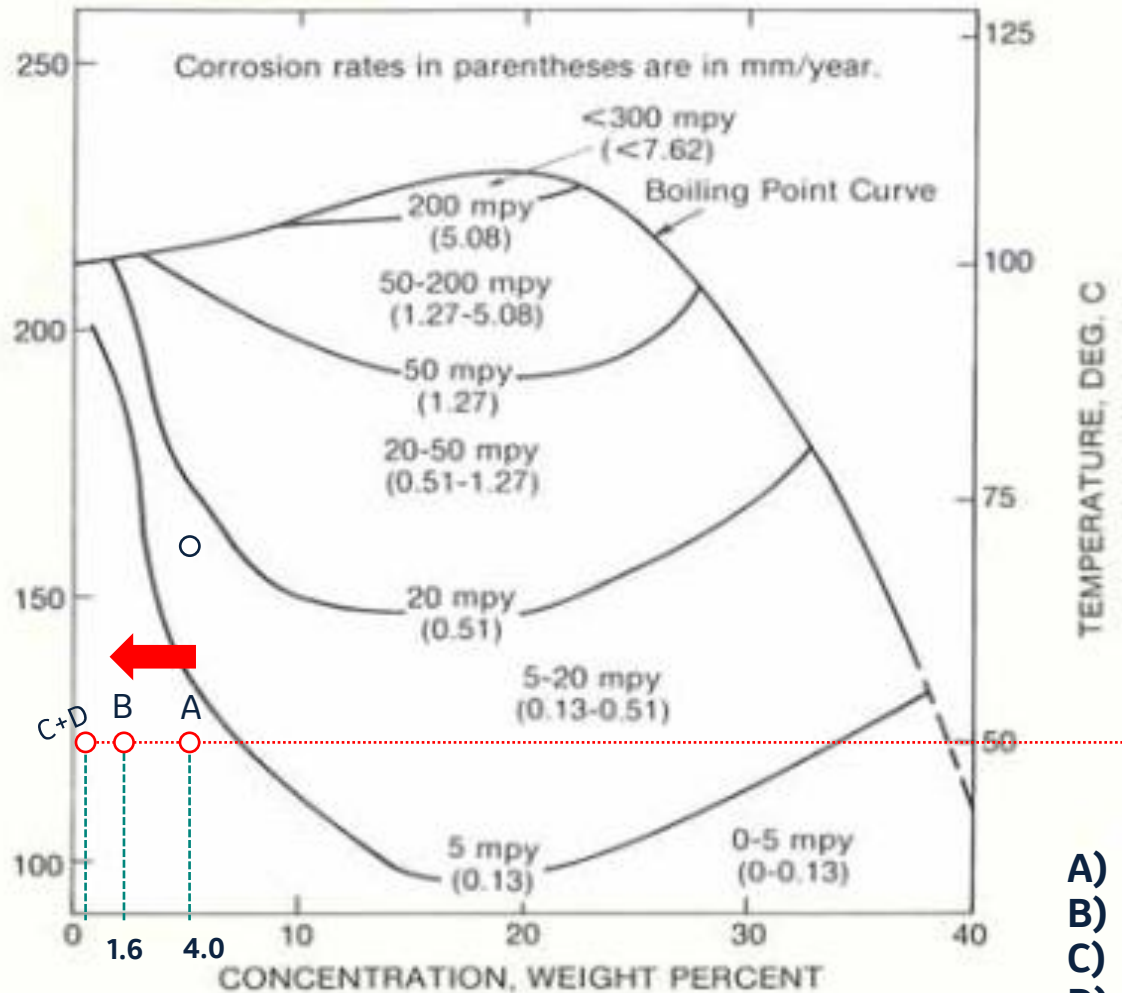
HASTELLOY® Alloy C-276 Resistance to Hydrochloric Acid

- A) 4.0 wt% HCl
- B) 1.6 wt% HCl
- C) 0.9 wt% HCl
- D) 0.4 wt% HCl

C276 is generally known for having better corrosion resistance than C-22 in reducing environment such as HCl.

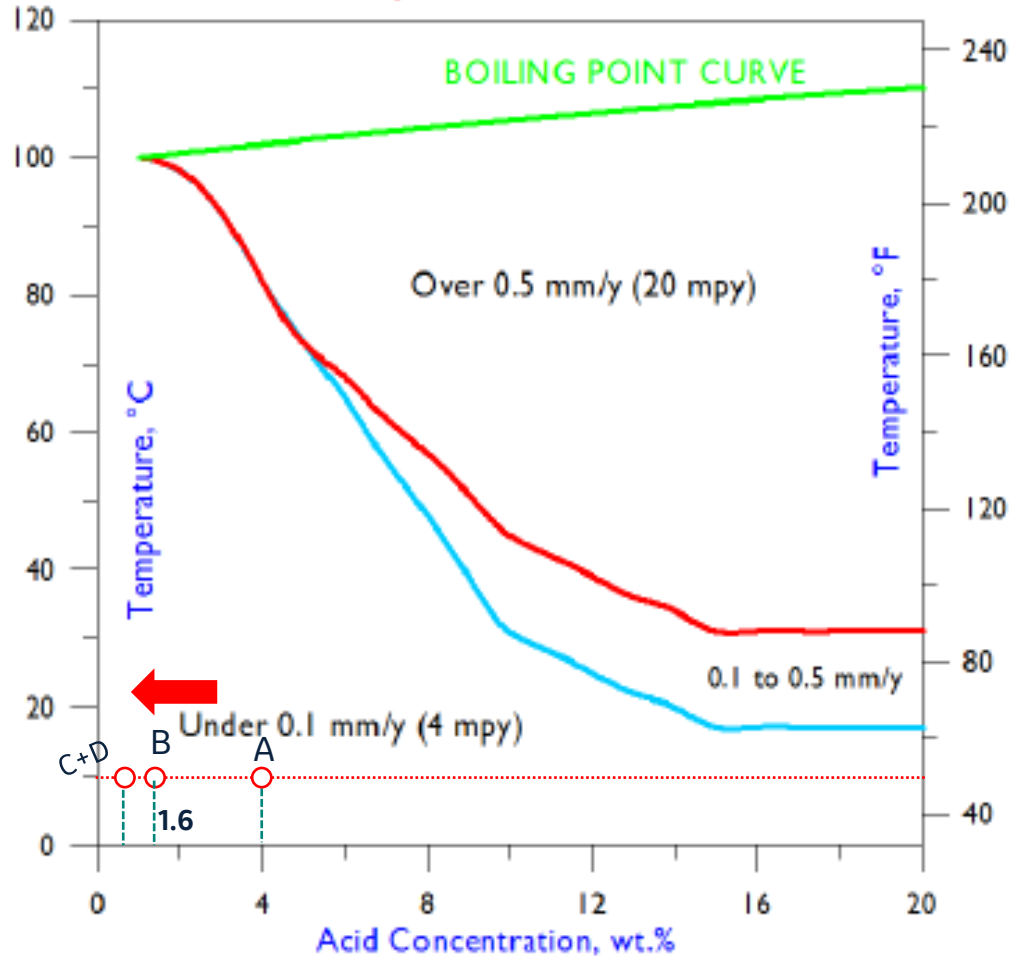
Iso-Corrosion Diagram for ULTIMET Alloy in Hydrochloric Acid

Excellent resistance to corrosion vs HCl comparable to C-22 and C-276

- A) 4.0 wt% HCl
- B) 1.6 wt% HCl
- C) 0.9 wt% HCl
- D) 0.4 wt% HCl

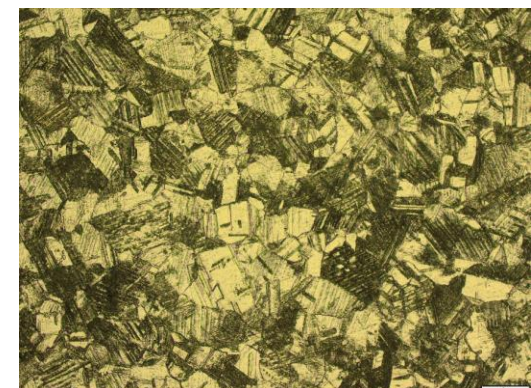
Ultimet 6B, 10x; Intergranular

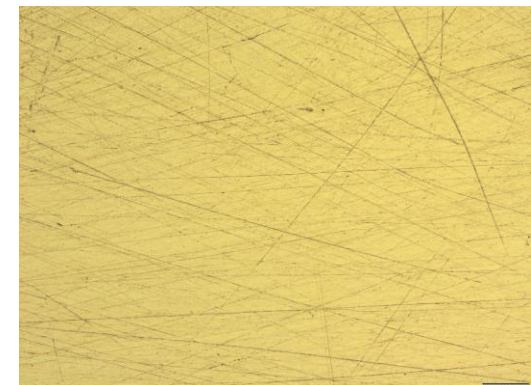
TEA, 5x; **No Corrosion**

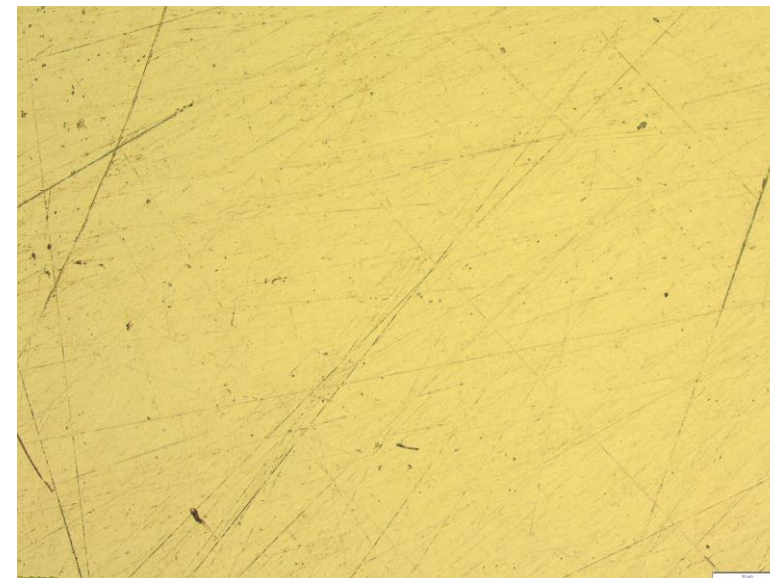
Removing green
aqueous layer

9:1 v/v MeCN to 2M HCl (aq)
7 Days at 50C
HC-22, No corrosion

Preventative measures include **elimination**, **substitution**, & **process modification**!
