**Research Report**  
**(Corrosion under insulation-Latest inspection techniques)**

CHE 597-Professor Ray Mentzer  
4th November 2021

Joseph Humes  
Kai-Che Shen  
CHE 597 Group 3

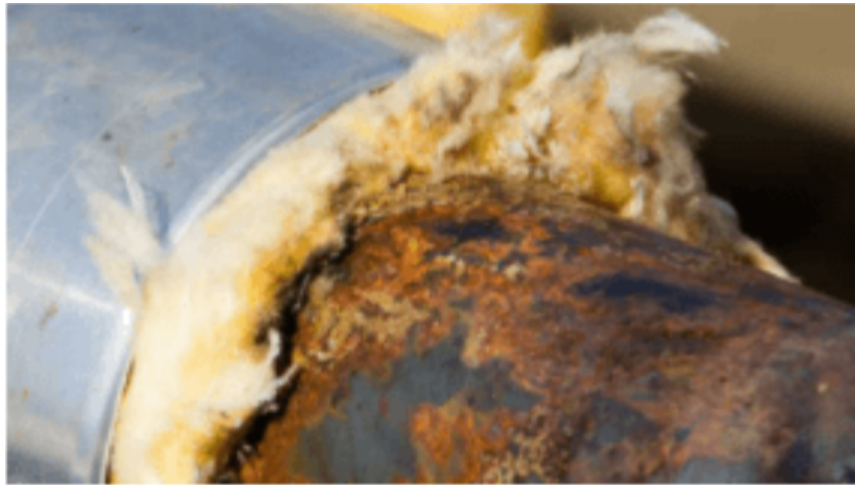
Normally, piping is made of stainless steel, which is mostly chemically inert.<sup>5</sup> However, the condensed water can dissolve any salts present, forming a saltwater solution, which is highly corrosive to stainless steel.<sup>5</sup> This corrosion can be seen in figure 2.

**Figure 2.** Corrosion under the insulation of a pipe. Note the relative lack of corrosion on the exterior metal cladding compared to the inner pipe.<sup>2</sup>

| <b>Figure 2.</b> An example of corrosion occurring under the insulation of a pipe. | 7 |

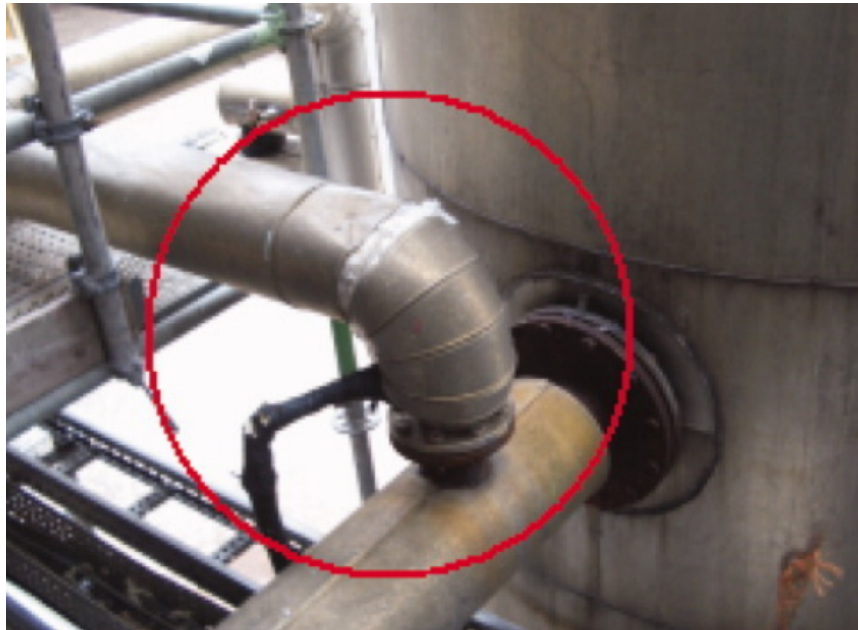
There are several cases that highlight the damage and danger of CUI.<sup>4</sup> In 2004, an ammonia leak occurred at one of Yara's ammonia production facilities. It was found that there was extensive damage due to corrosion in a four-inch elbow, as seen in figure 4.

**Figure 4.** The damage in the elbow is shown. More frequent inspections could have caught this before it turned into a serious incident.<sup>4</sup>

The pipe was insulated, but the quality of insulation and steel cladding used was below the standard, which allowed water to enter.<sup>4</sup> Furthermore, infrequent inspections failed to see the damage present, which subsequently led to the leak.<sup>4</sup> Analysis of the incident found that the process conditions were optimal for CUI to occur, with operating temperature swings regularly between  $-5^{\circ}\text{C}$  and  $120^{\circ}\text{C}$ .<sup>4</sup> The combination of a lack of integrity in the insulation/coating and process conditions led to a corrosion problem that ultimately was responsible for a massive ammonia leak. Following this incident, the Yara plant updated its inspection program and commenced a plant-wide analysis of the piping for potential missed conditions that could lead to CUI.<sup>4</sup>

| <b>Figure 4.</b> Damaged insulation from poor exterior cladding is shown. | 9 |

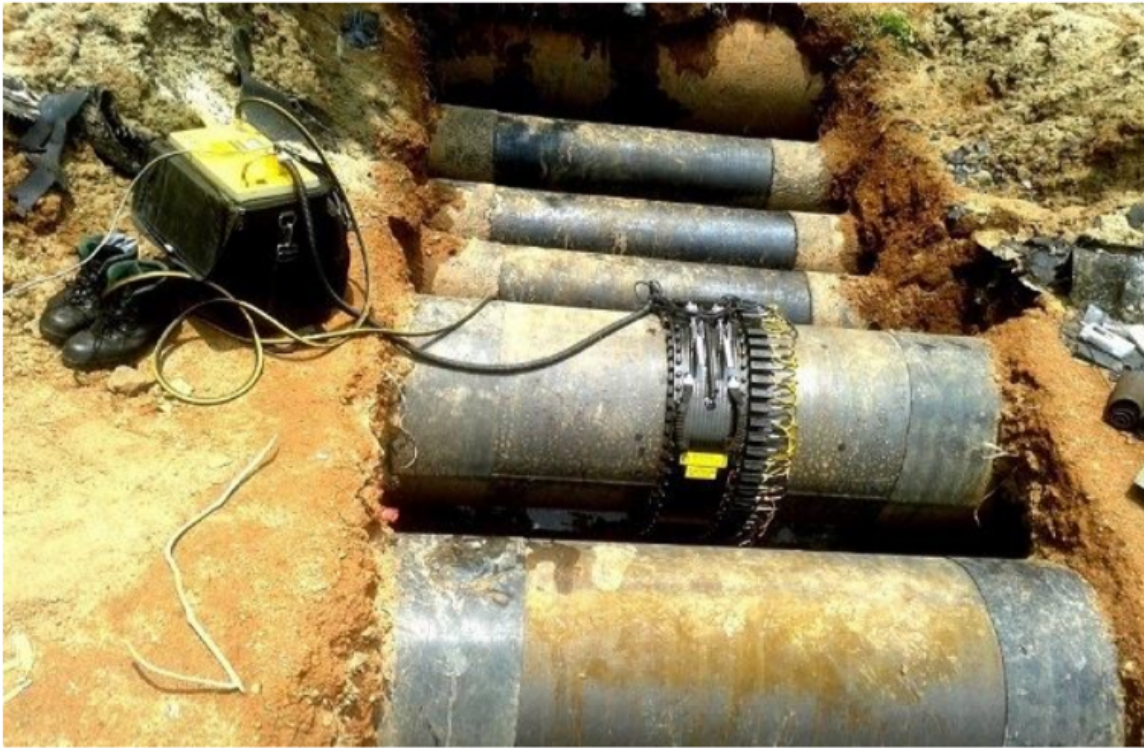
This inspection works with the measurement of how long it receives a reflected sound pulse from the sample.<sup>1</sup> Initially, one sound pulse will be spread from an ultrasonic

transducer, travel through the inner tested pipes, and finally will be reflected back to the detector. The data of thickness of pipes will be calculated and be shown on the screen. However, the drawback of this measurement is that it can be only applied to the small region, and operators need to calibrate it for different materials.<sup>1</sup> Figure 7 shows how a UT instrument can be applied to an insulated pipe.

**Figure 7.** Applying long range ultrasonic testing to observe the situation of pipes.<sup>11</sup>

| <b>Figure 7.</b> A photograph detailing how ultrasonic testing is performed on piping. | 12 |

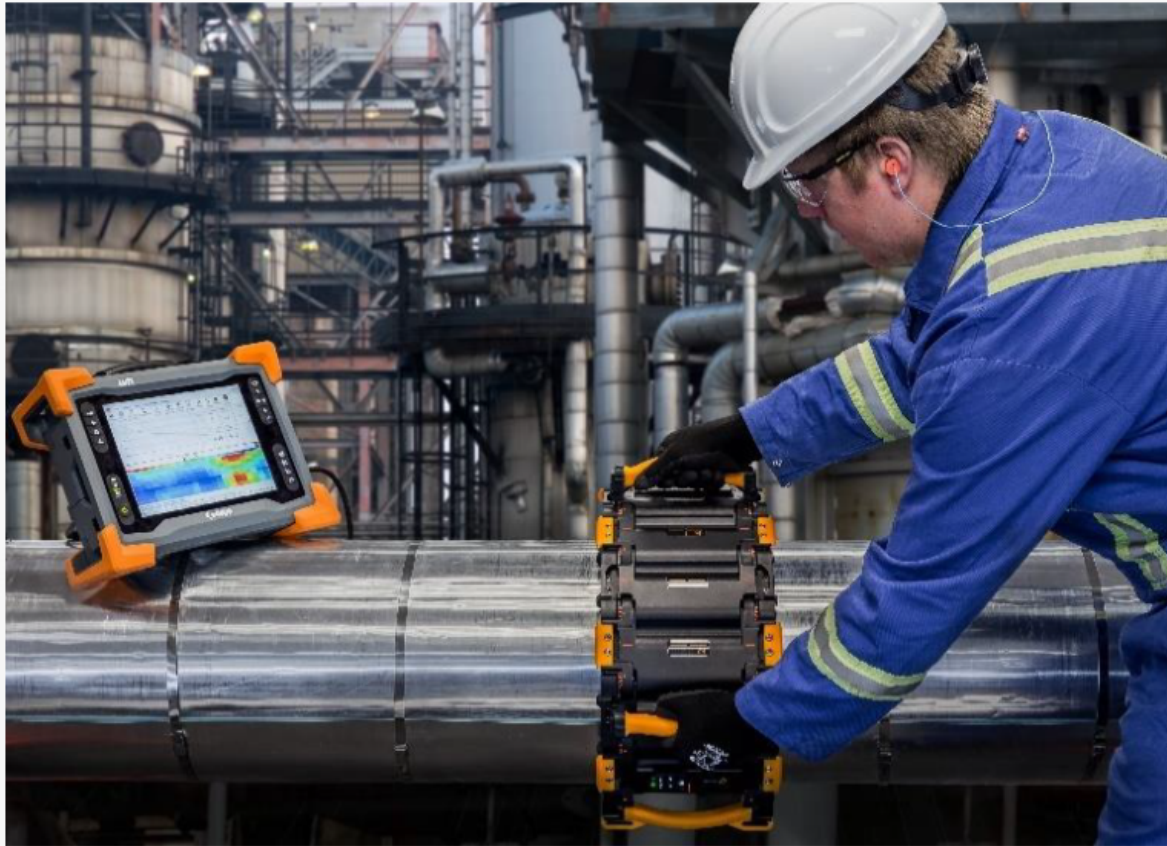
This technique utilizes electromagnetic waves to detect the average thickness of pipes.<sup>1,12</sup> There's no requirement that the probe has to contact the sample, and it can track the rate of reduction of induced current and convert it to the data of thickness of the object. Although the measurement is accurate, the data cannot reflect the area of corrosion because it only provides the information of average thickness.<sup>1</sup> Furthermore, this inspection is also limited to carbon steel and low-alloy steel construction.<sup>1</sup> Figure 8 shows the relative ease at which a pulsed eddy current instrument can be deployed on a pipe.

**Figure 8.** How pulsed eddy current technique is used in the plant.<sup>12</sup>

| <b>Figure 8.</b> A photograph showing how pulsed eddy current is used on insulated piping. | 13 |

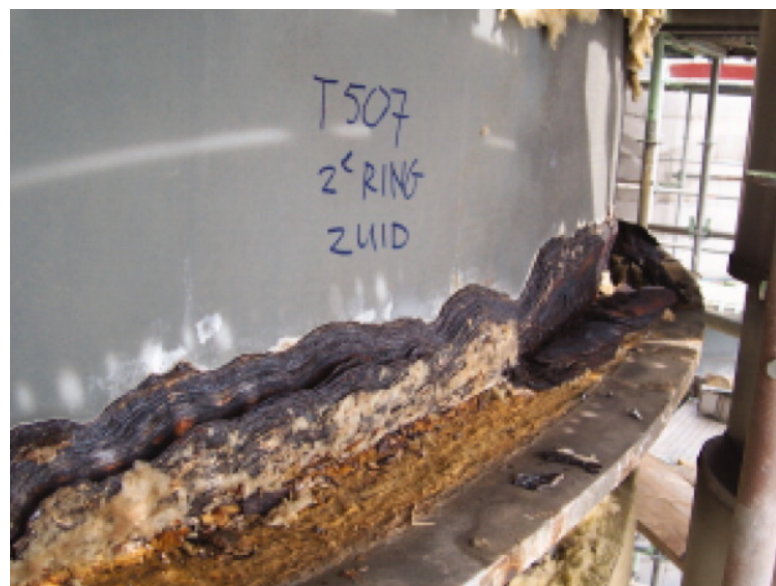
The exterior coating of the pipe or vessel can have drastic impacts as to the severity of the corrosion. Figure 10 demonstrates the damage caused by corrosion on an uncoated metal surface.

**Figure 10.** Damage due to uncoated metal can be seen. Such damage can be prevented by applying anti-resistant sprays to metals before their service life begins.<sup>4</sup>

| <b>Figure 10.</b> Damage caused by corrosion on a vessel without a protective coating. | 15 |
