RESEARCH REPORT

**WHAT HAS THE INDUSTRY EXPERIENCE BEEN WITH AMMONIA
MANUFACTURING PLANTS? WHAT IS THEIR TRACK RECORD FOR
HAVING SERIOUS PROCESS SAFETY INCIDENTS? WHAT ROOT
CAUSES HAVE TYPICALLY LED TO THEM?**

Research done by TEAM 2G

Professional Master's in Chemical Engineering

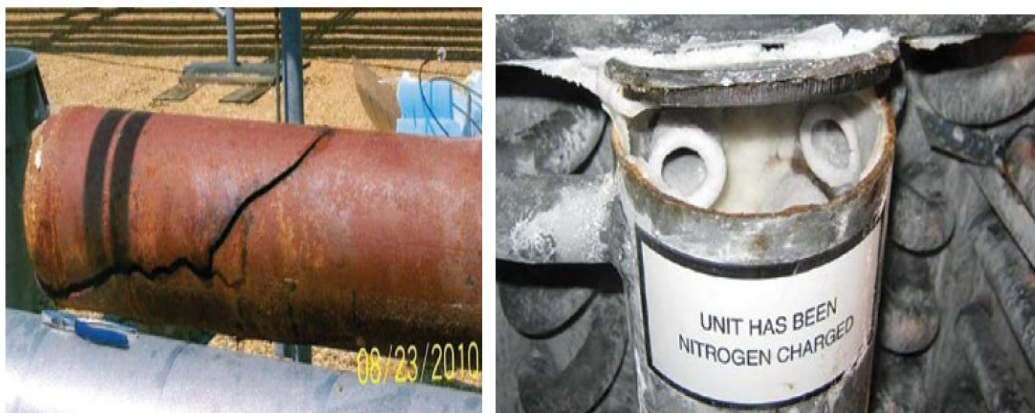
On 23rd August 2010, a catastrophically failure of a 12-inch suction pipe on roof lead to a release of more than 32000 pounds of anhydrous ammonia in Millard Refrigerated Services in Theodore, Alabama. Additionally, the pressure developed due to hydraulic shock ruptured the evaporator coil inside the facility (Figure 1) [4].

Figure 1. Ruptured low temperature suction line (left), Evaporator coil weld failure (right) [4]

Hydraulic shock is an abnormal condition that results in sharp pressure ride which causes catastrophic failure of pipes, valves and other components. In refrigeration systems, the combination of high-pressure hot gas and cold liquid ammonia can result in hydraulic shock.

Before the incident, the facility experienced a loss of power that lasted more than 7 hours. While attempting to troubleshoot equipment issue after the system regained power, the operator manually cleared an alarm in the system. This resulted in interruption of a defrost cycle in progress for a blast freezer evaporator. The evaporator switched directly from defrost mode into refrigeration mode without bleeding hot gas from evaporator coil. The bleed phase is necessary to prevent rapid reduction of pressure. Because of manual intervention by operator and reset of control system, the control system did not recognize that the blast furnace evaporator contained high pressure hot gas. This allowed the low temperature liquid and hot gas to mix in the same pipe, causing the hot gas void to collapse as it rapidly condensed to liquid. This created pressure shock and ruptured the piping and evaporator coil.

- For refrigeration system design, avoid grouping multiple evaporators to a single set of control valves. The equipment control systems should be password protected so that only trained and authorized personnel can manually override the system.
- In event of ammonia release, activate the emergency shut down system to de-energize pumps, compressors and valves instead of attempting to isolate leaking equipment while the refrigeration system is running.
- Defrost control systems should be equipped with interlocks to have low temperature feed and isolate hot gas in a hot gas defrost cycle in case of power outage or any other deviation. The system should automatically depressurize or bleed the coils upon restart before opening the suction valve at the evaporator.

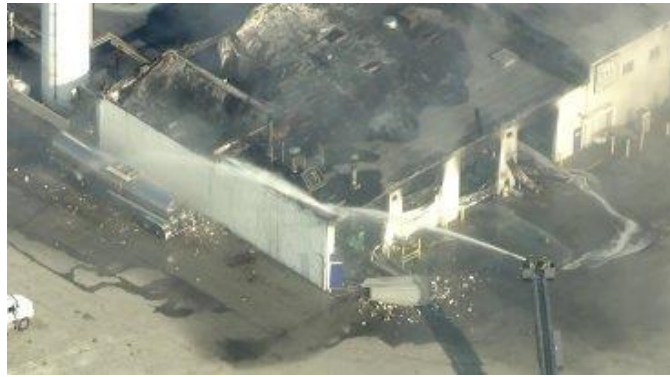
On July 7, 2017, a faulty quarter inch valve caused an ammonia leak at Grecian Delight food processing plant in Elk Grove Village which led to an explosion. Ammonia under 150 psi pressure leaked into an 80 x 40-foot room with 20-foot ceiling [7]. Something sparked the ignition of ammonia leading into a blast which ruptured the aluminum facade on the building (Figure 2). Around 100 employees were working onsite during the incident and were evacuated, and two people were hospitalized [8].

Figure 2. Damaged building due to explosion [9]

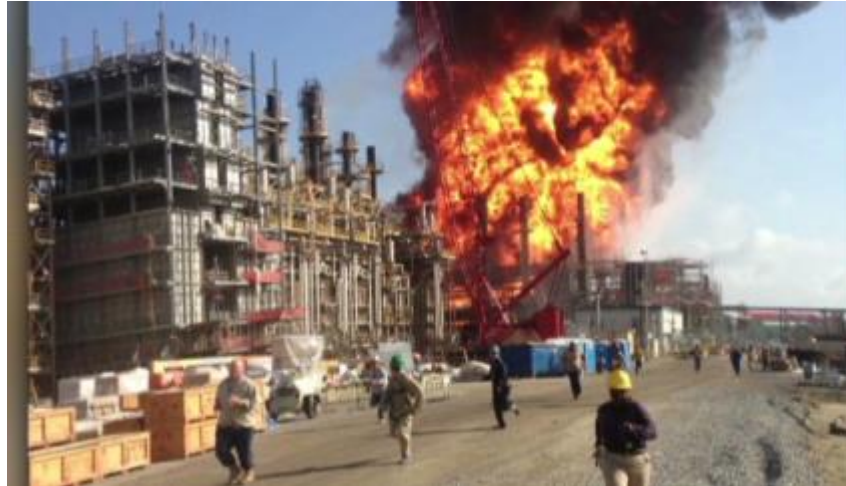
On June 14, 2013, an accident happened at an ammonia plant located at Donaldsonville, Louisiana owned by CF Industries. The plant has ammonia production capacity of 8 million metric tons per year with other urea and urea ammonium nitrate facilities [10]. The accident involved fire and explosion (Figure 3) in one of the four ammonia production units, resulting in one fatality and injuring at least ten people. The fire was brought down in under half an hour and the plant was immediately shutdown [11]. Upon investigation it was found that the unit was shut down for maintenance and the workers were pumping nitrogen into a storage vessel. The accident occurred when they pumped too much nitrogen causing the vessel to rupture [12]. The root cause for this accident can be said to be human error or lack of preventive safeguards. The accident could have been avoided if the vessel was equipped with a safety relief device and a pressure sensor. At this facility, the last accident of such severity occurred in 2000 in the ammonia unit, which killed three people in a fire and explosion [13].

Figure 3. Fire and explosion at the facility [14]

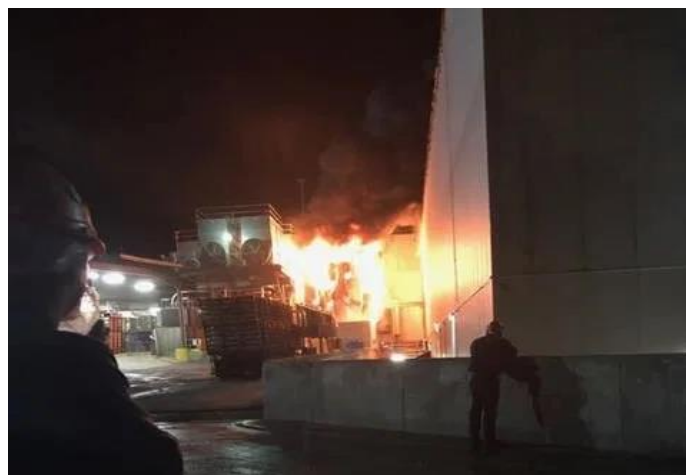
On August 16, 2011, ammonia leak at the Pilgrim's Pride Plant in Guntersville, caused fire and explosion (Figure 4) [15]. The fire was out within 45 minutes and there were no reported fatalities but the explosion damaged the plant. The plant uses anhydrous ammonia for processing chicken and refrigeration [16]. Emergency services were called immediately and as a safety precaution, nearby residents and employees had been evacuated. This company is a good example of a having a great safety culture and adequate emergency response training. Though, installing preventive safeguards like air monitoring devices can prevent large releases and serious consequences and the leak can be contained in time.

Figure 4. The fire caused by the leak [15]

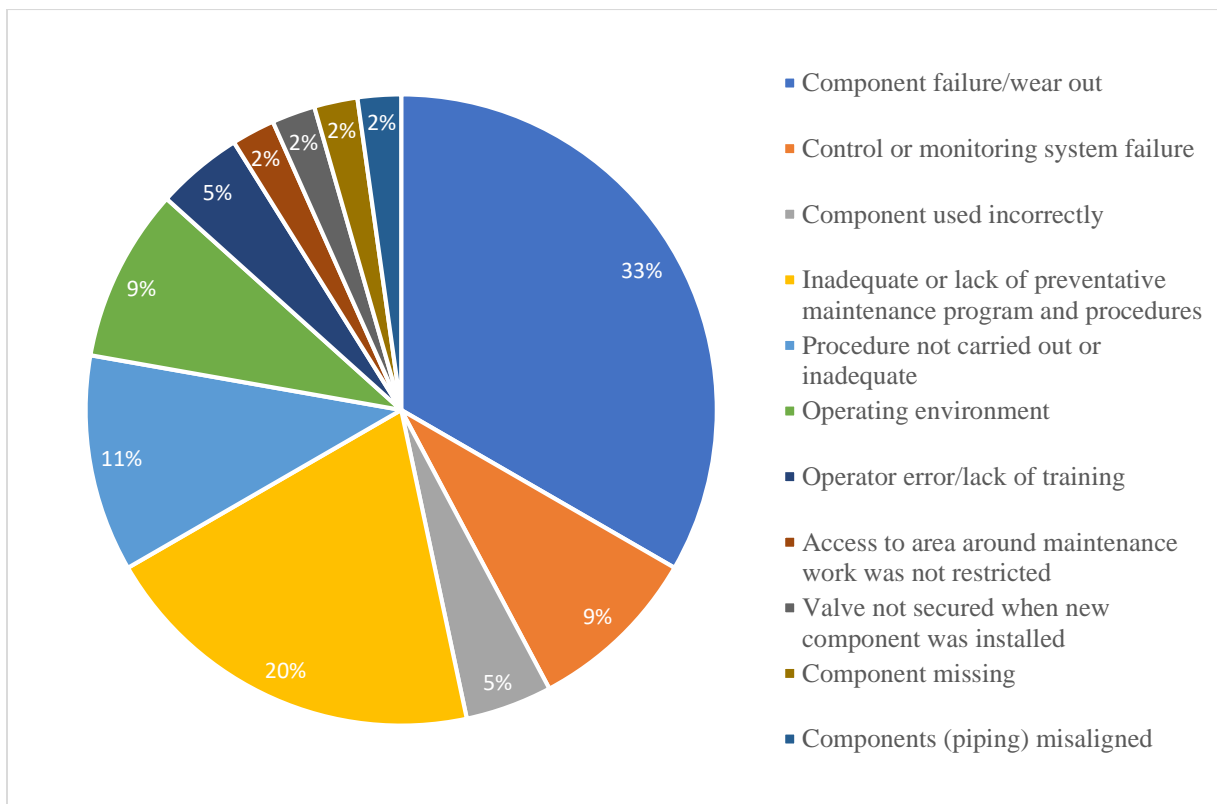
Figure 5. Causes of ammonia related accidents [22]

- Valve plugging or valve malfunction
- Defects in shaft seal, pipe flanges and valve stems
- Pipe failure due to corrosion, mechanical damage or vibration
- Tank material failure
