Geologic History and Resulting Unstable Slopes in the Cuyahoga River Valley

BBC&M ENGINEERING, INC.

Geologic History – Cuyahoga River Valley

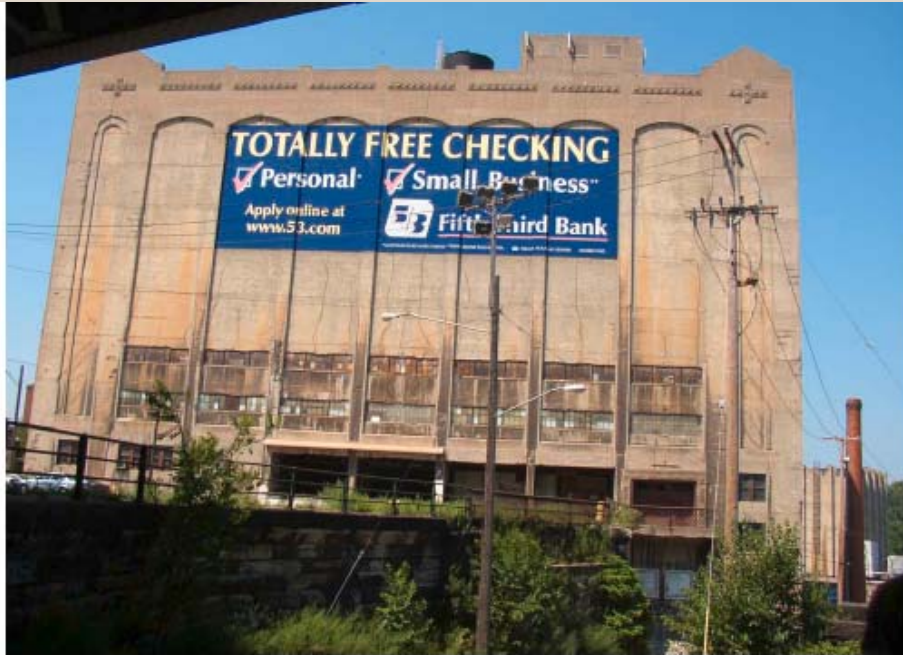
Plate 46: Warehouse (cold storage) west of I-90 on University Avenue, point 9. Photo is looking at the east wall of the warehouse

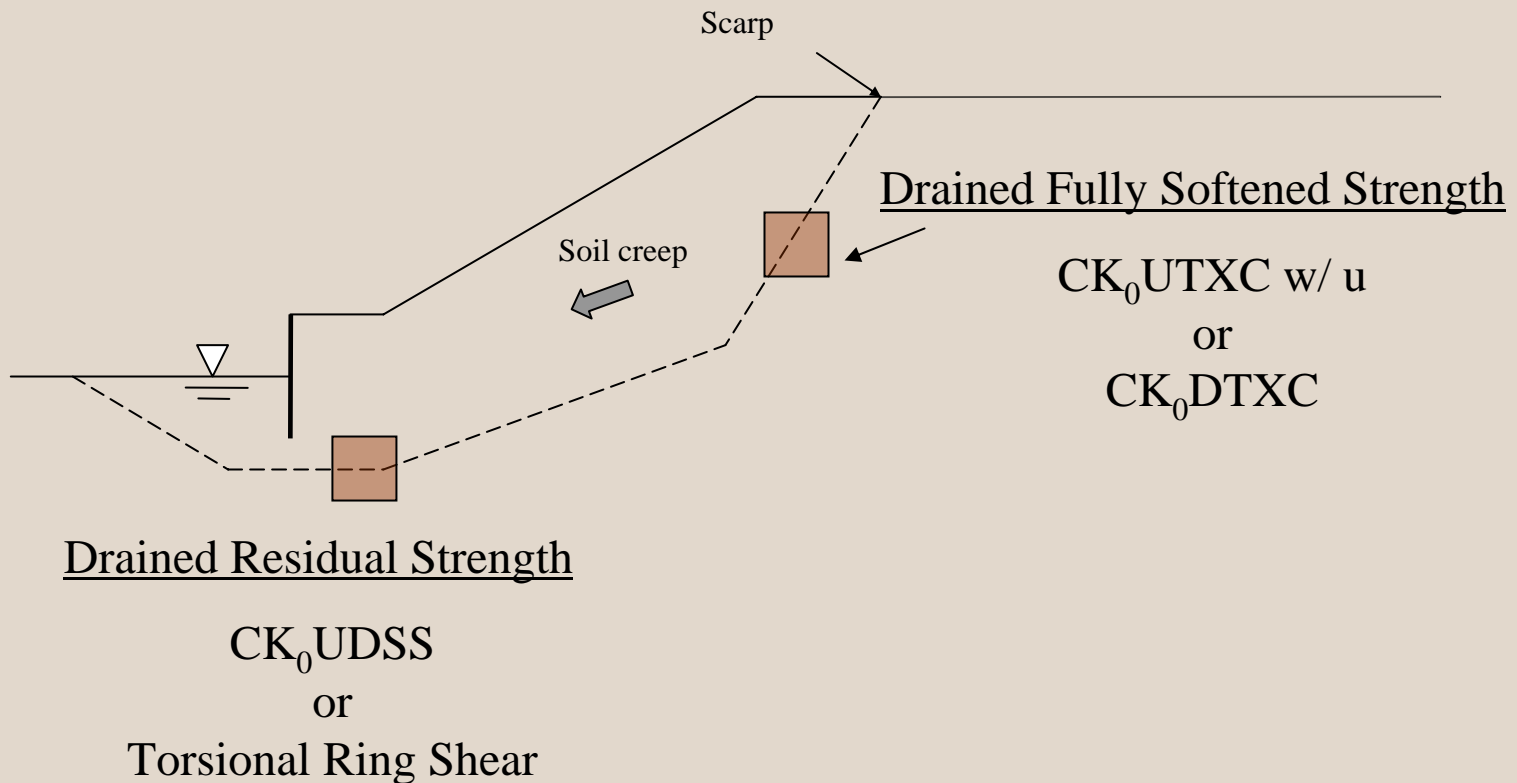
Slope Model for Creeping Slope in Clay
