“Emergency Geotechnical Investigations of Failed Highway Embankments Resulting From Ohio River Lock Damage”

Richard L. Williams, Ph.D., P.E.

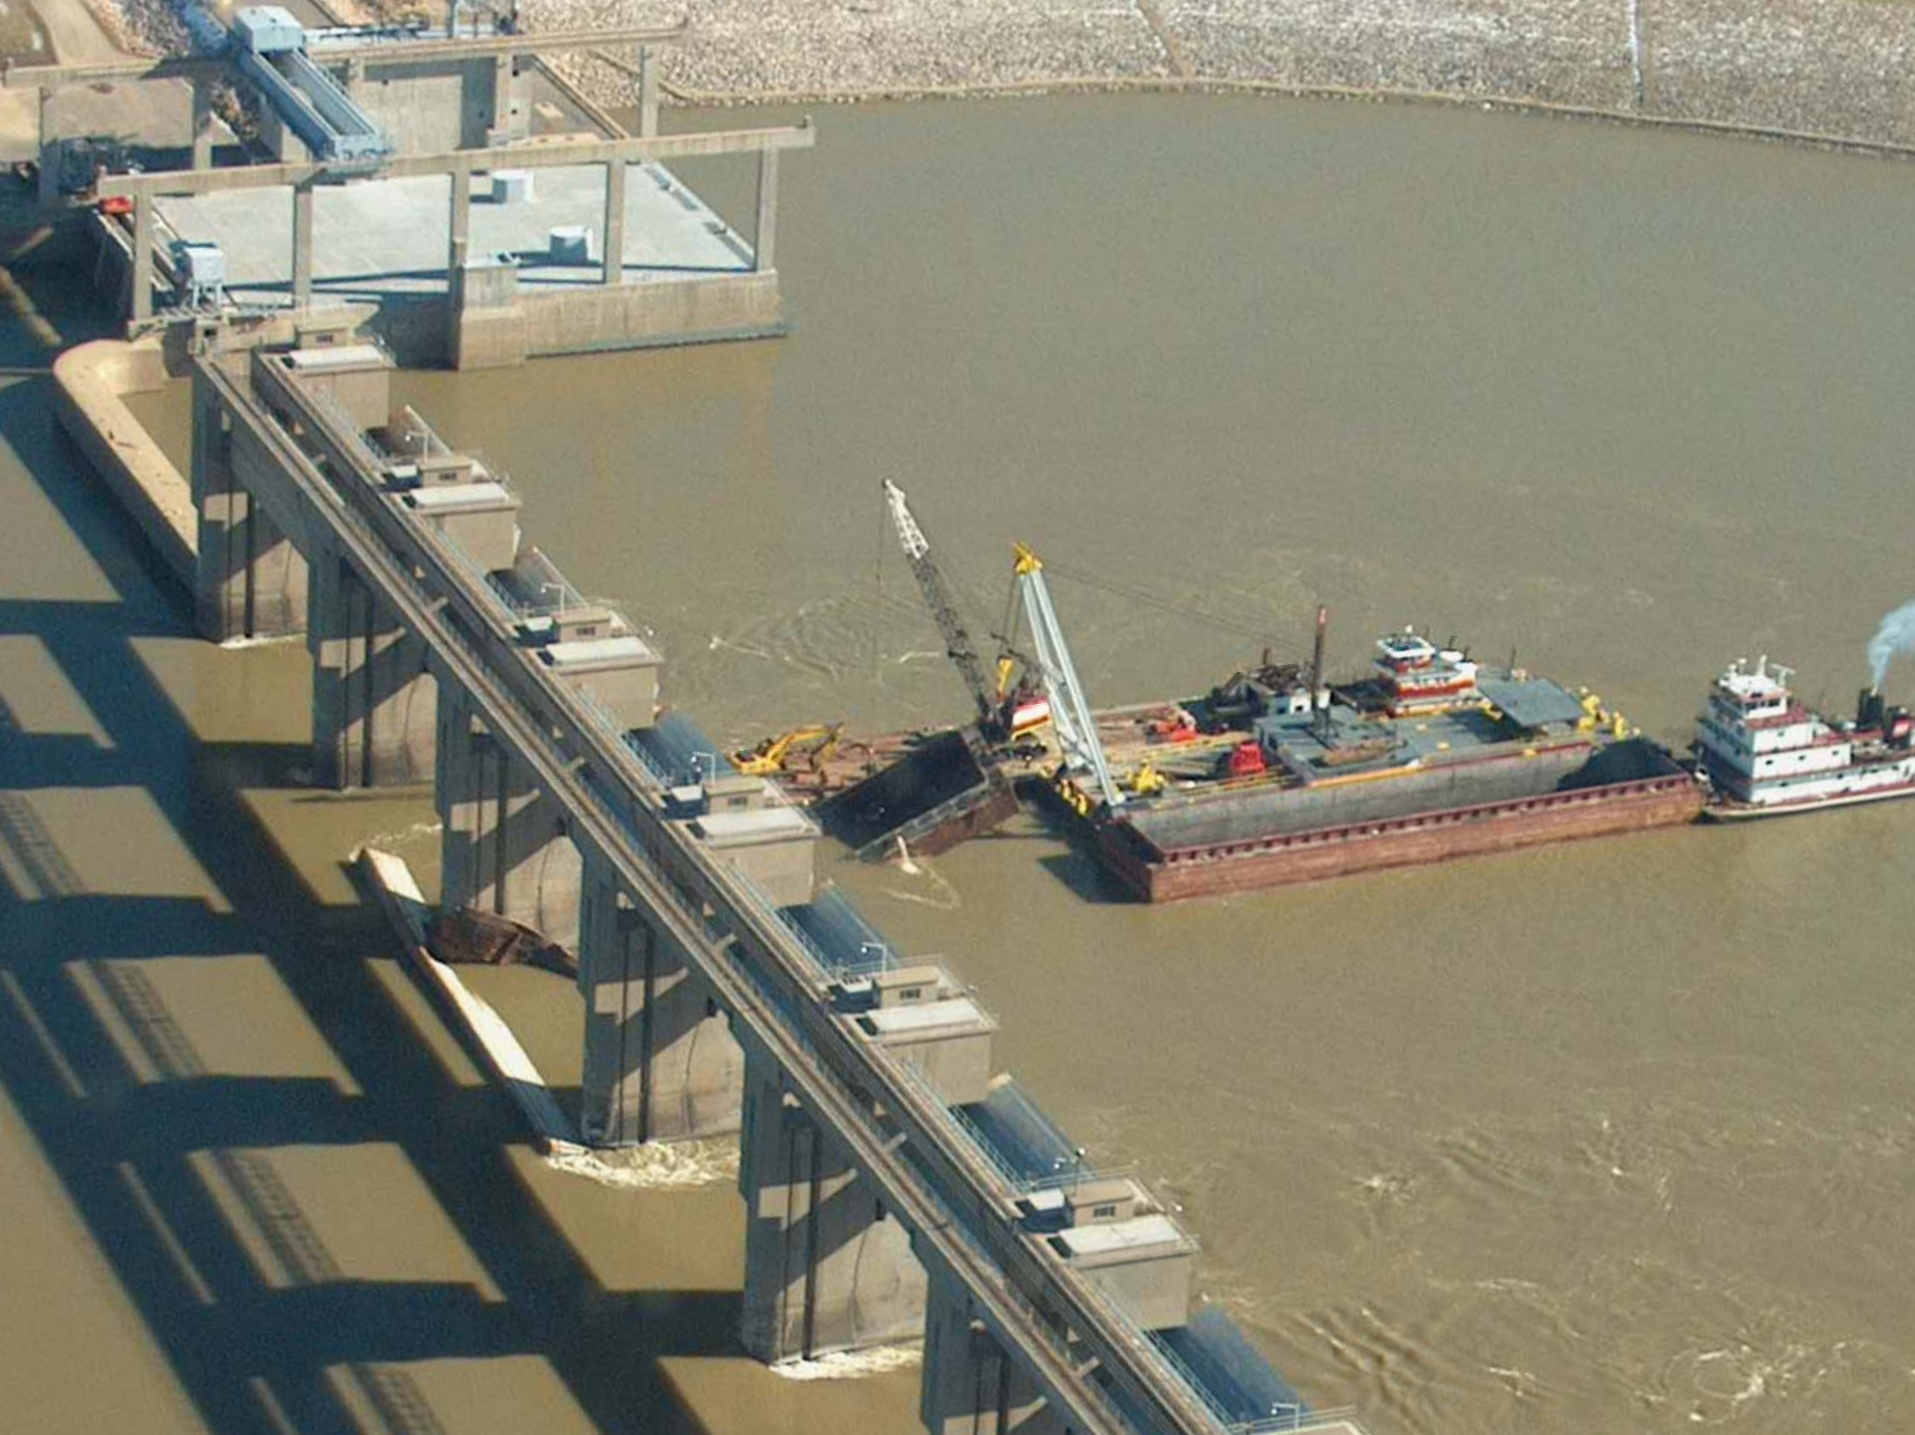
BELLEVILLE LOCK & DAM

18FEB05 14:00:55

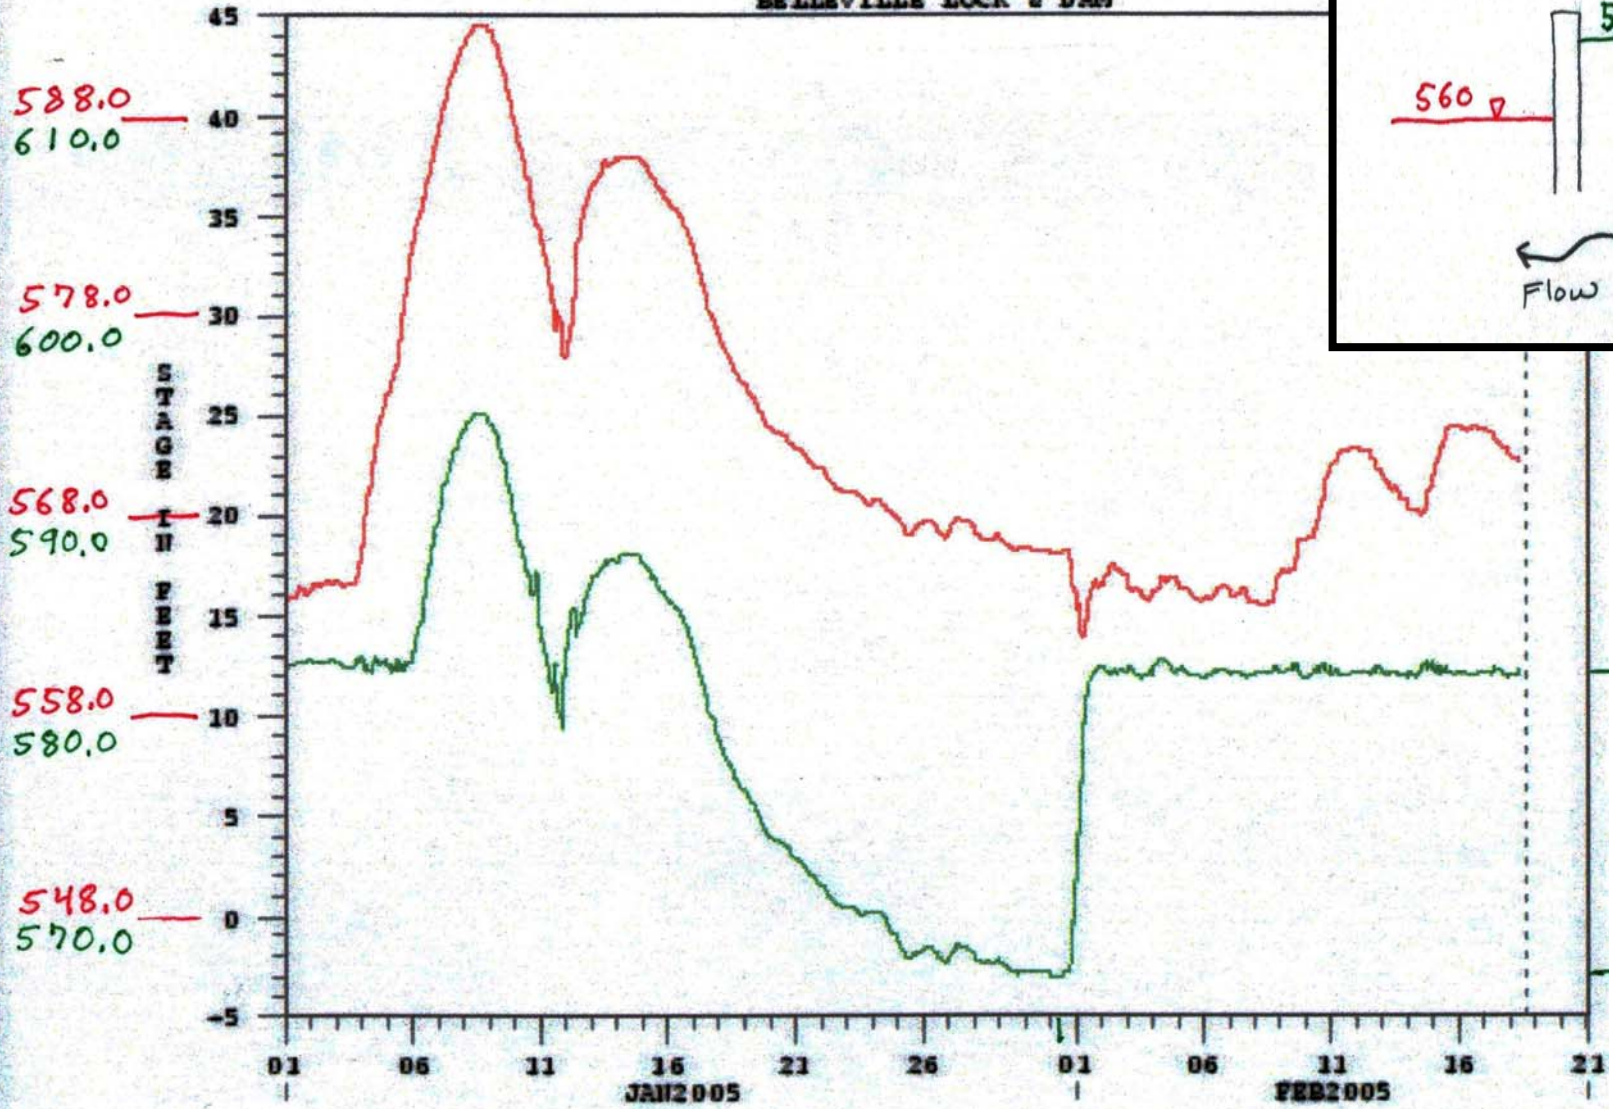
— STAGE_LOWER OBS (Lower Gage)
— STAGE_UPPER OBS (Upper Gage)

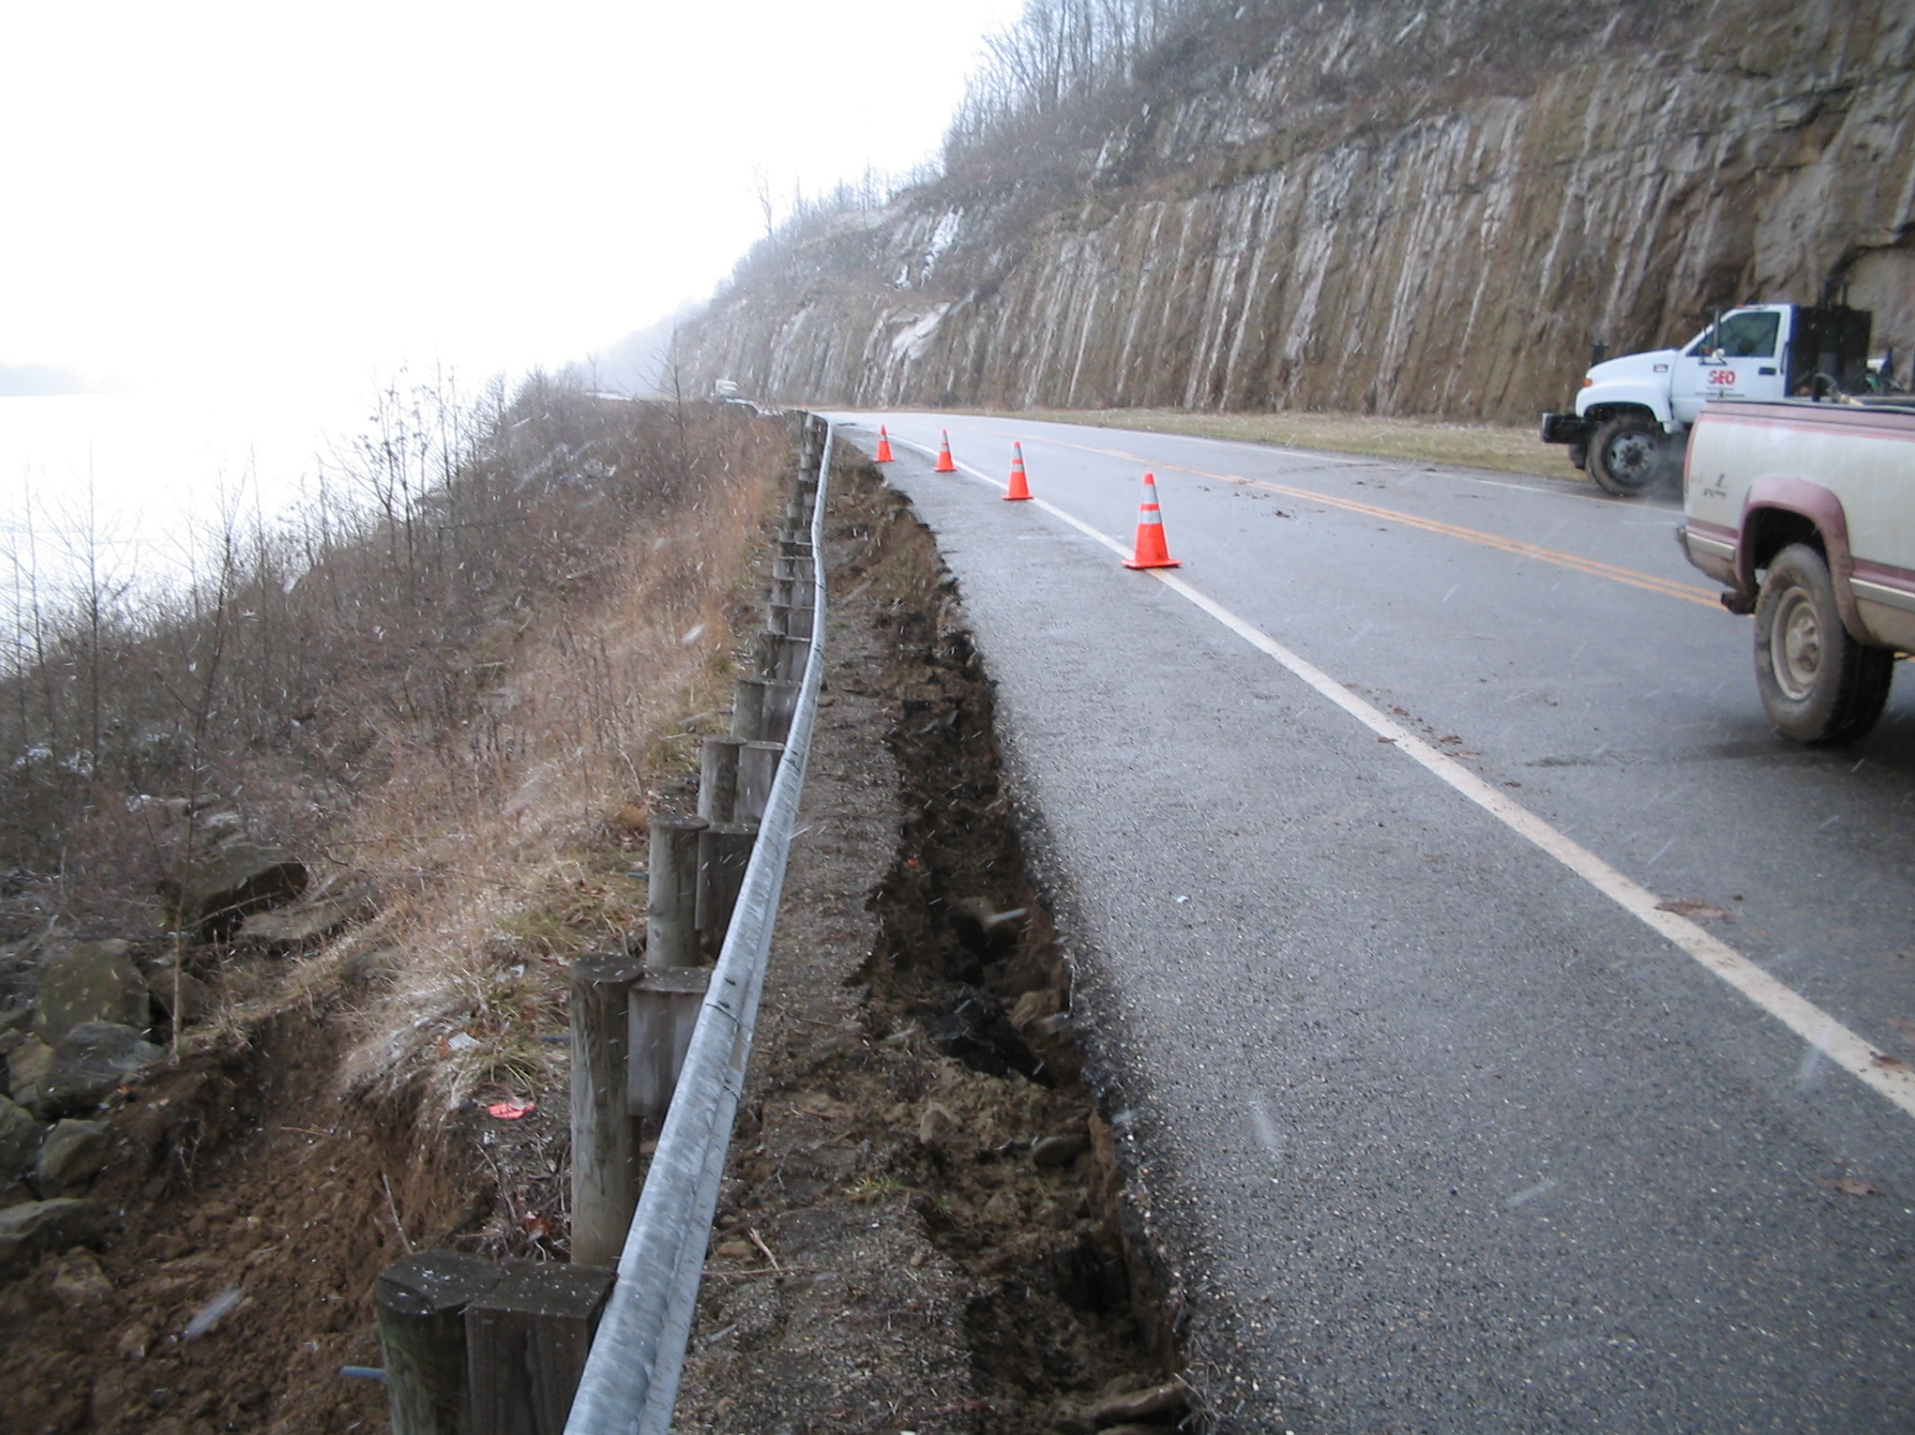
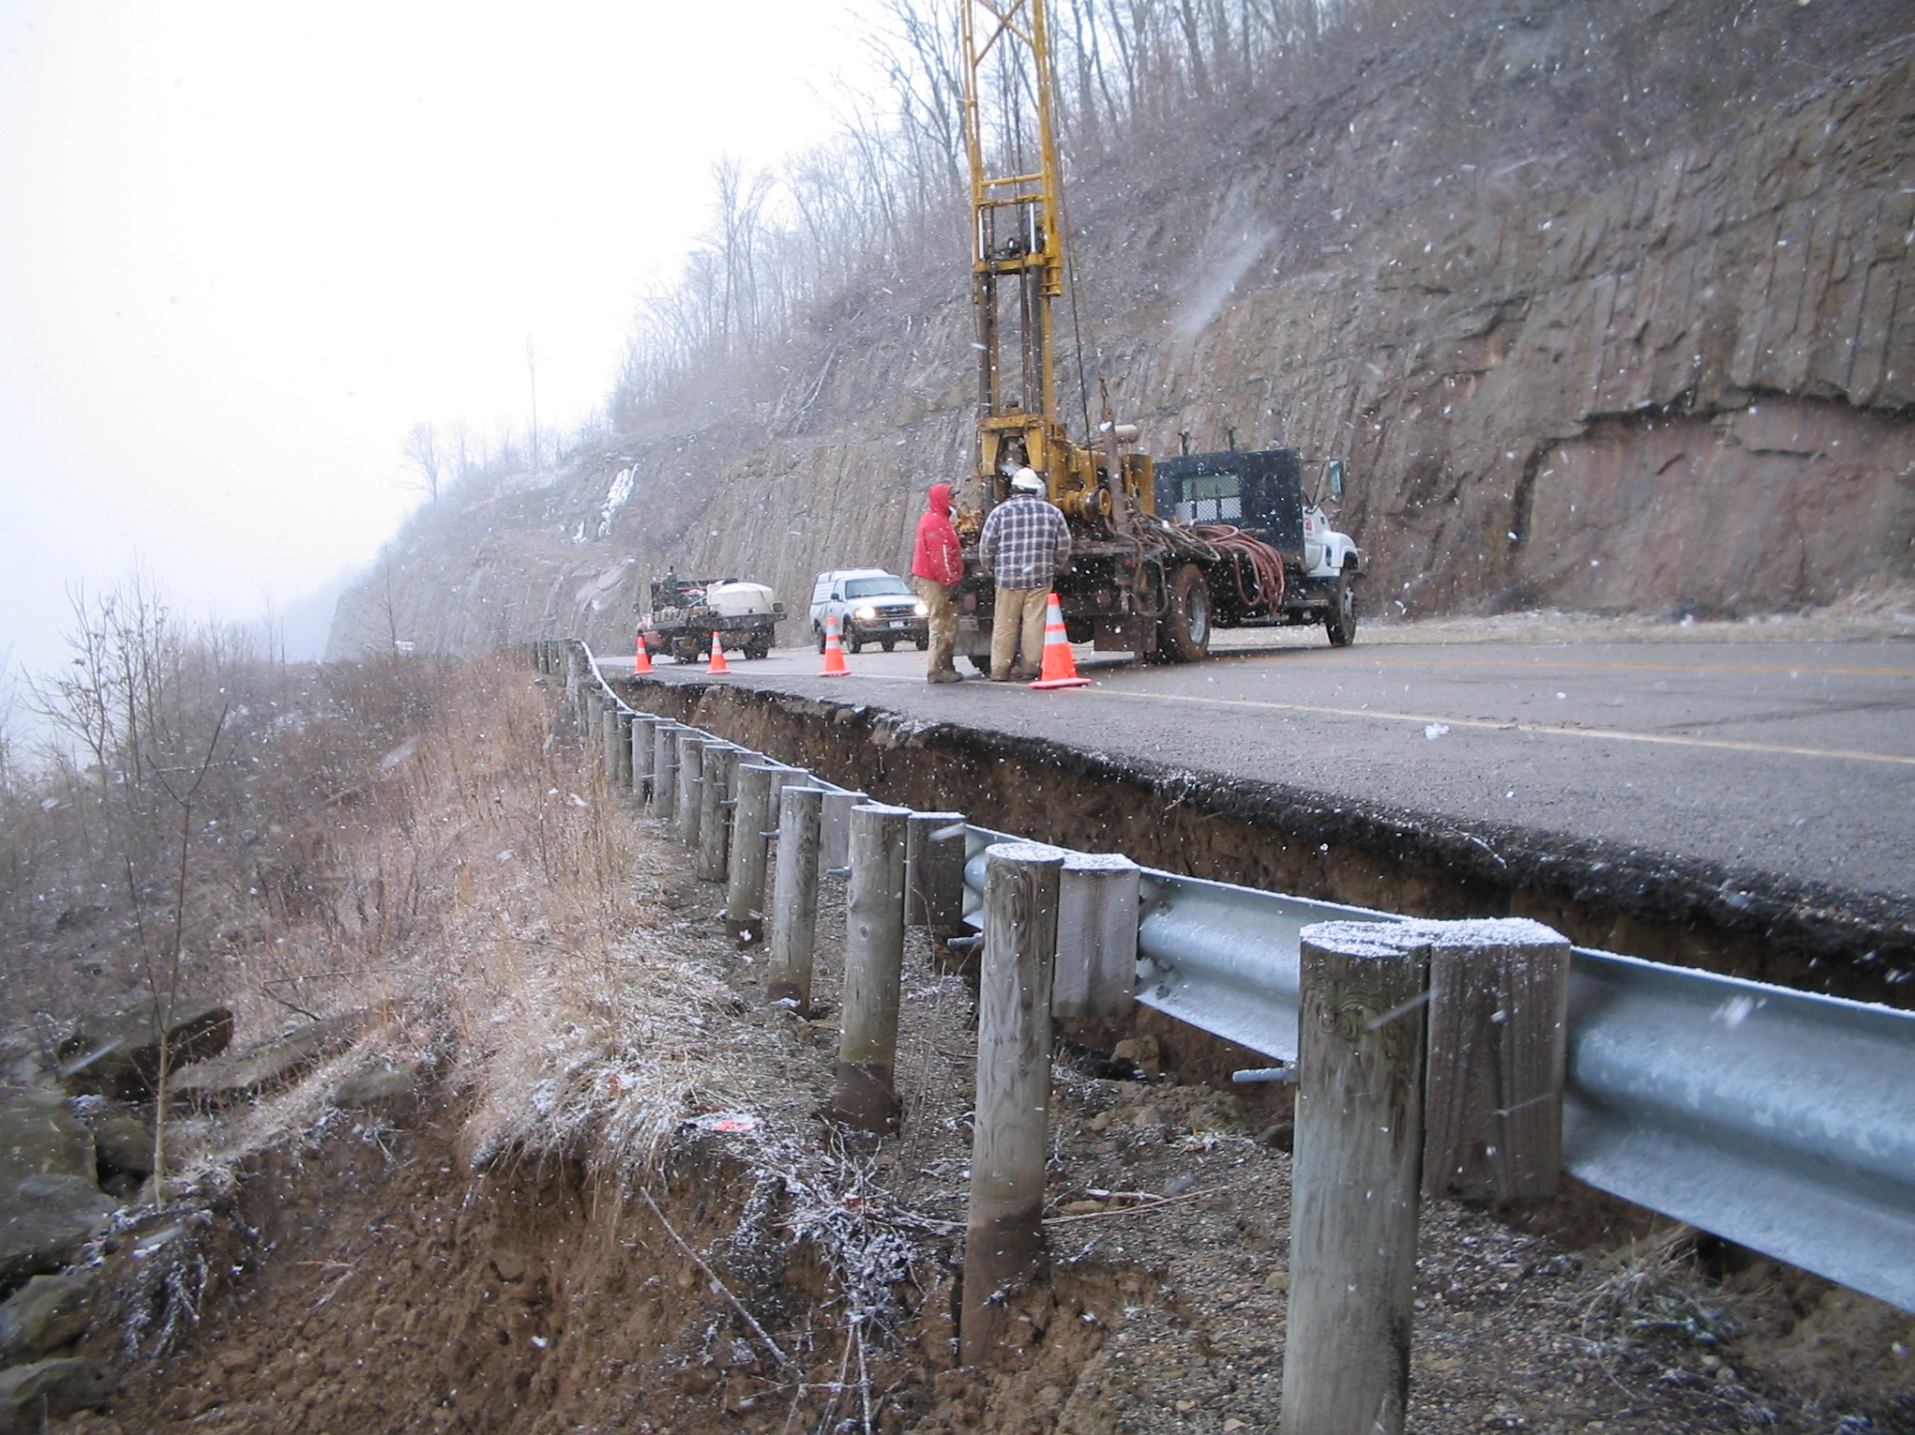
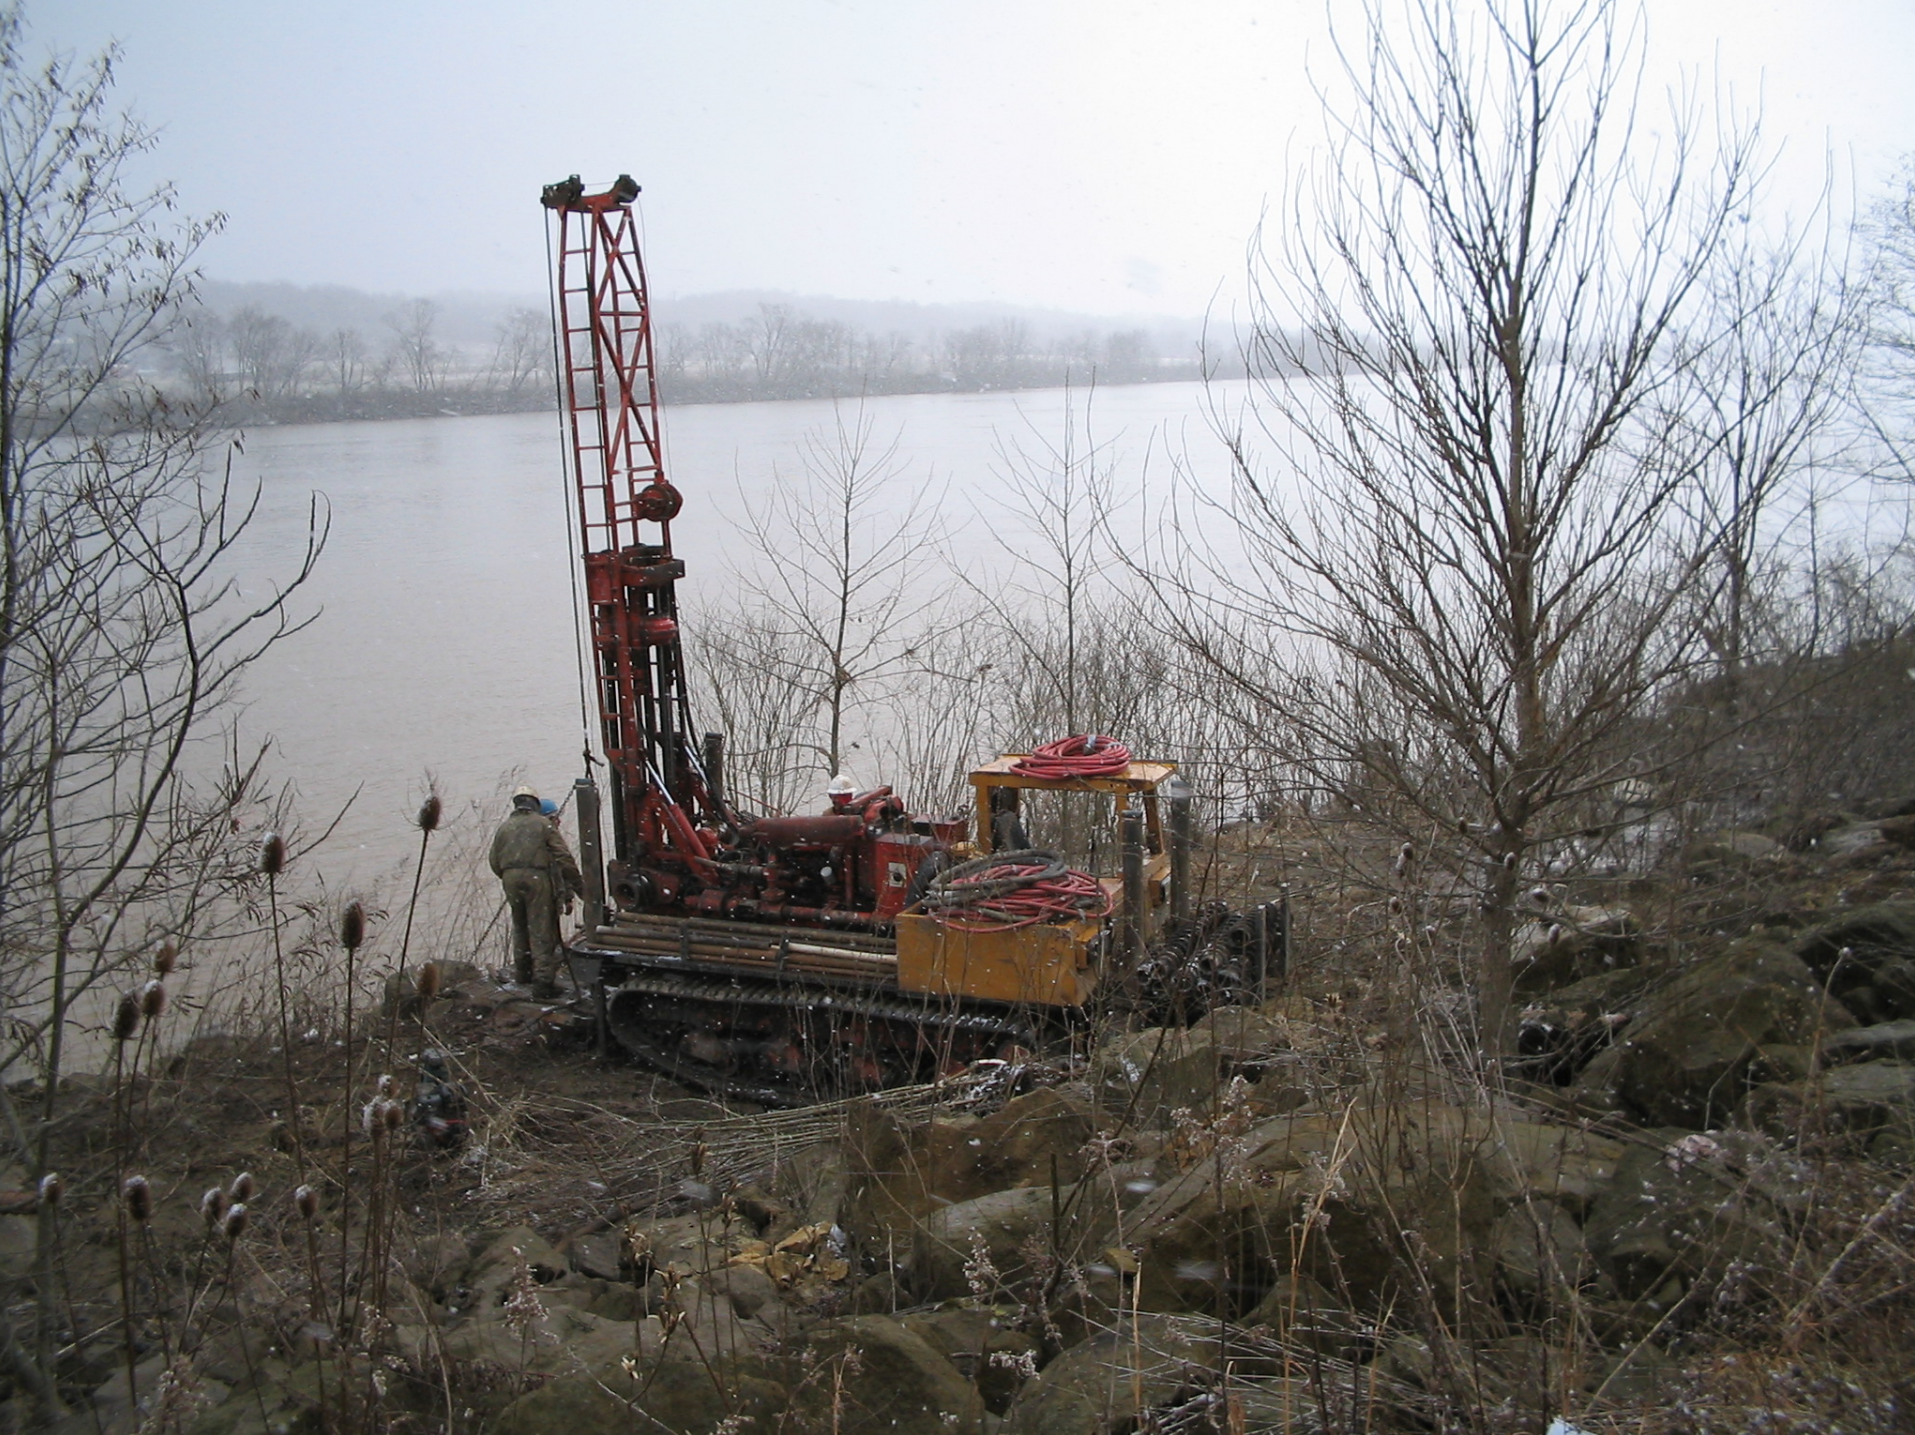
MEG-124 EXISTING STA-32+50 NORMAL POOL

GSTABL7 v.2 FSmin=1.48
 Safety Factors Are Calculated By The Simplified Janbu Method

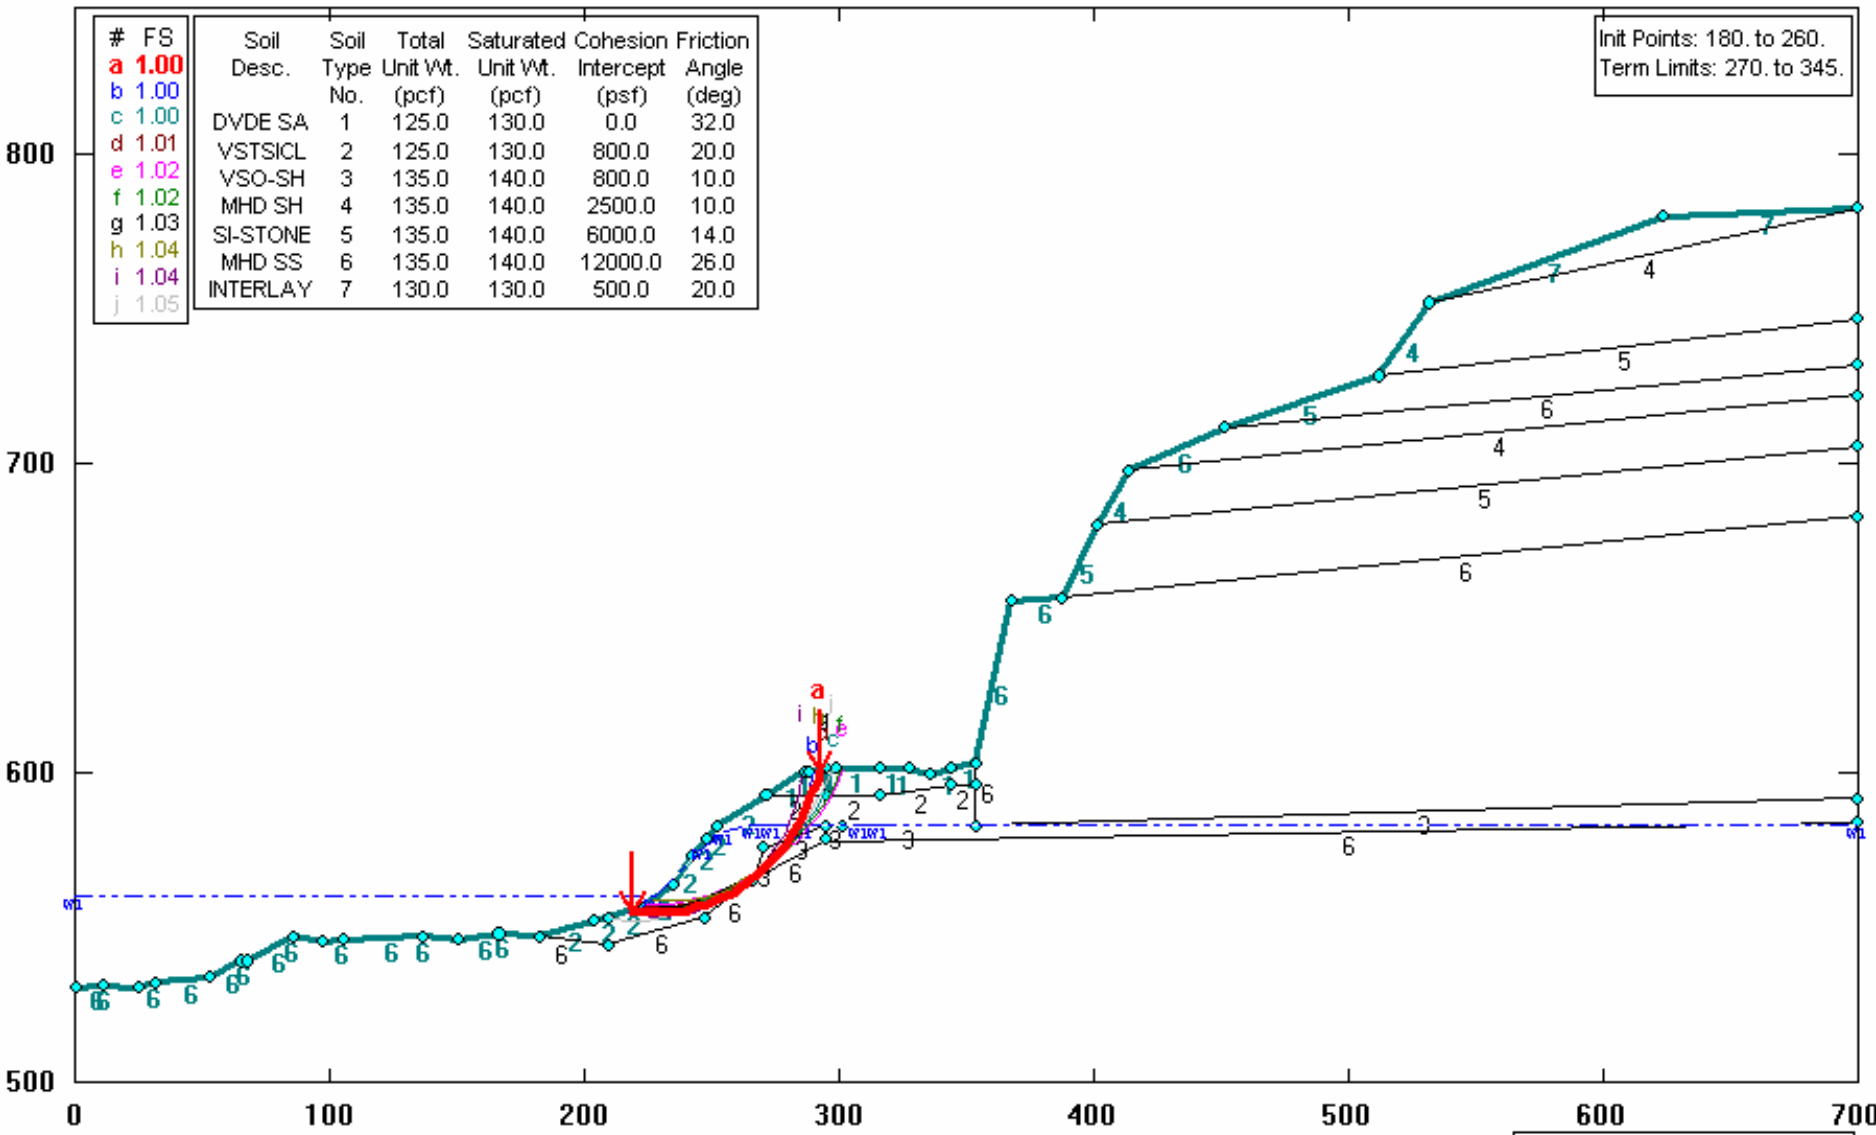
MEG-124 EXISTING-STA 32+50 RAPID DRAWDOWN

#	FS	Soil Desc.	Soil Type No.	Total Unit Wt. (pcf)	Saturated Unit Wt. (pcf)	Cohesion Intercept (psf)	Friction Angle (deg)
a	1.00						
b	1.00						
c	1.00						
d	1.01	DVDE SA	1	125.0	130.0	0.0	32.0
e	1.02	VSTSICL	2	125.0	130.0	800.0	20.0
f	1.02	VSO-SH	3	135.0	140.0	800.0	10.0
g	1.03	MHD SH	4	135.0	140.0	2500.0	10.0
h	1.04	SI-STONE	5	135.0	140.0	6000.0	14.0
i	1.04	MHD SS	6	135.0	140.0	12000.0	26.0
j	1.05	INTERLAY	7	130.0	130.0	500.0	20.0

GSTABL7 v.2 FSmin=1.00
Safety Factors Are Calculated By The Simplified Janbu Method for the case of phi=0

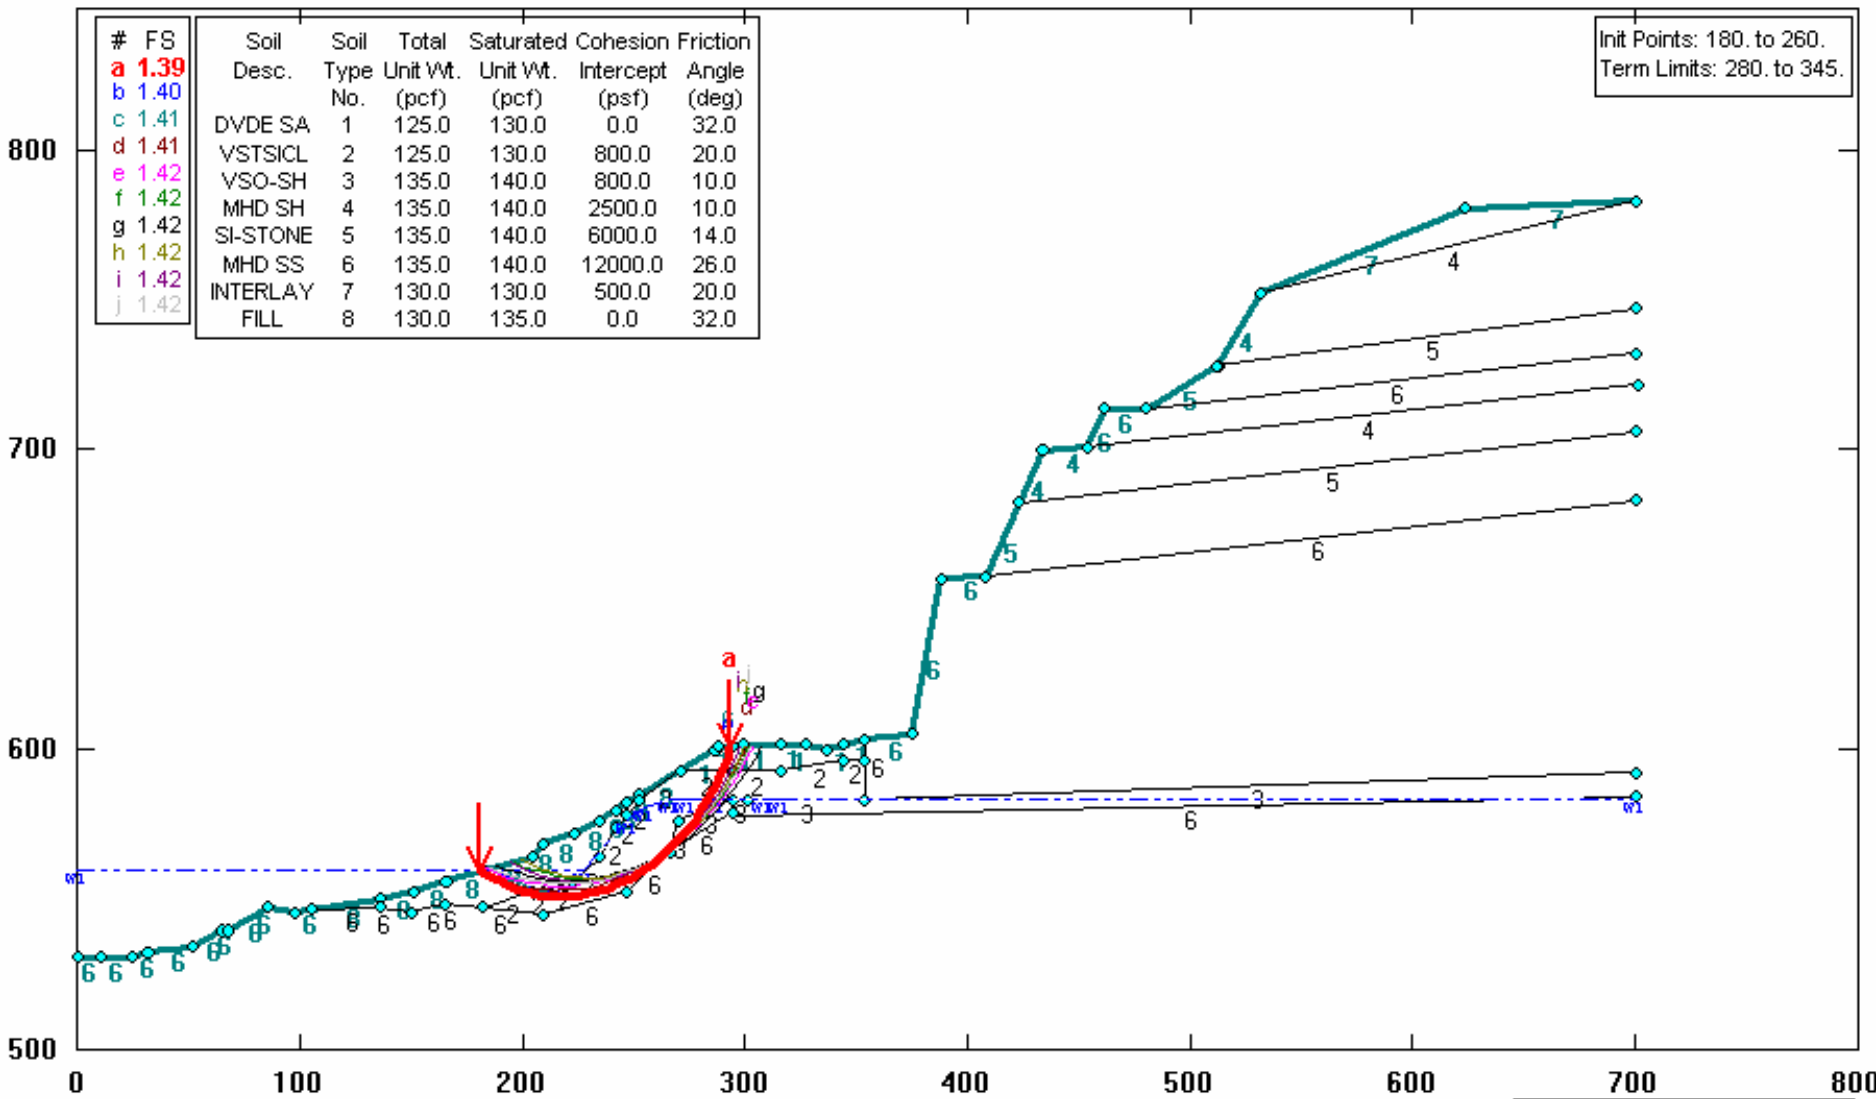
MEG-124 PROPOSED CUT AND FILL -STA 32+50: RAPID DRAWDOWN

GSTABL7 v.2 FSmin=1.39
 Safety Factors Are Calculated By The Simplified Janbu Method for the case of phi=0

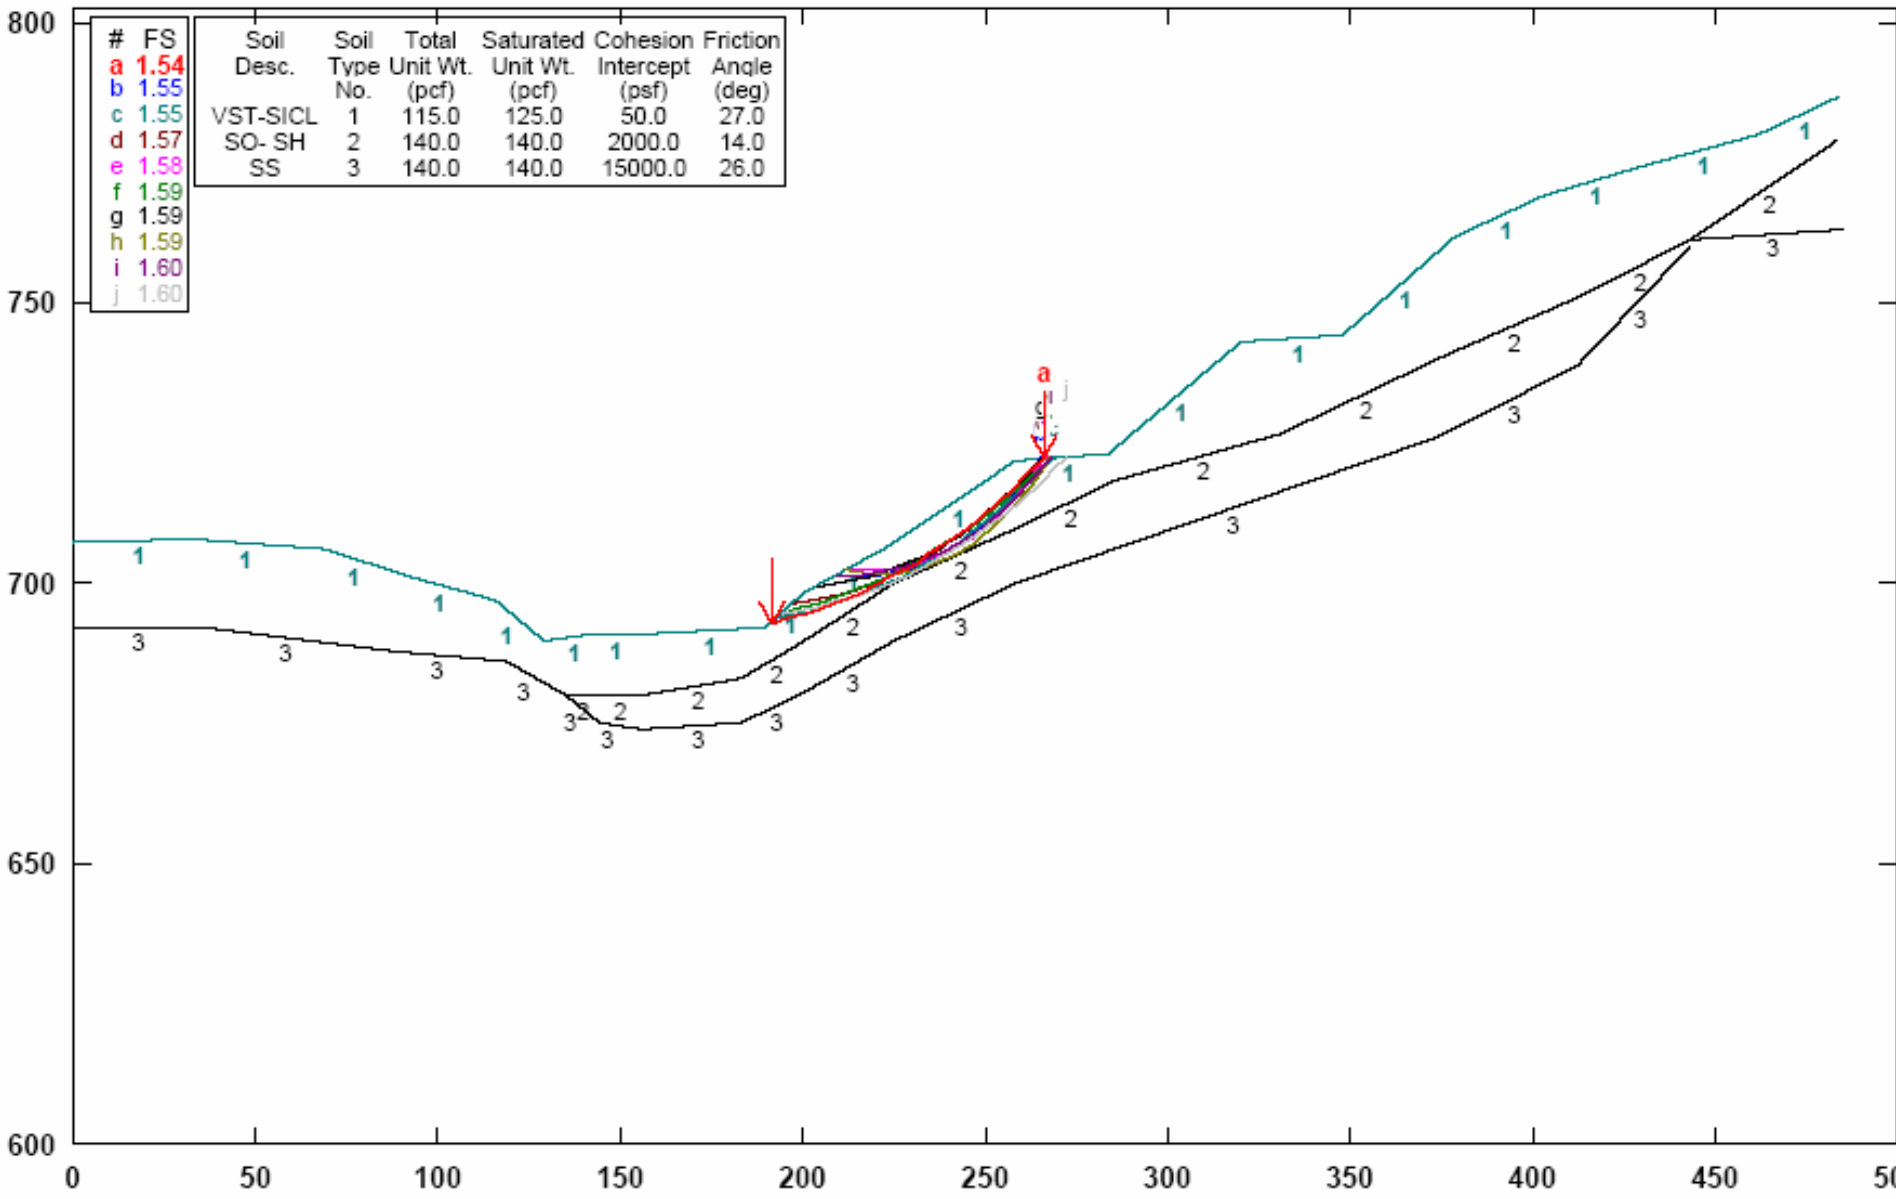
ATH 124 RELOCATION (CR 62 UPGRADE) STA 262+00 (Existing Slope)

GSTABL7 v.2 FSmin=1.54

Safety Factors Are Calculated By The Simplified Janbu Method

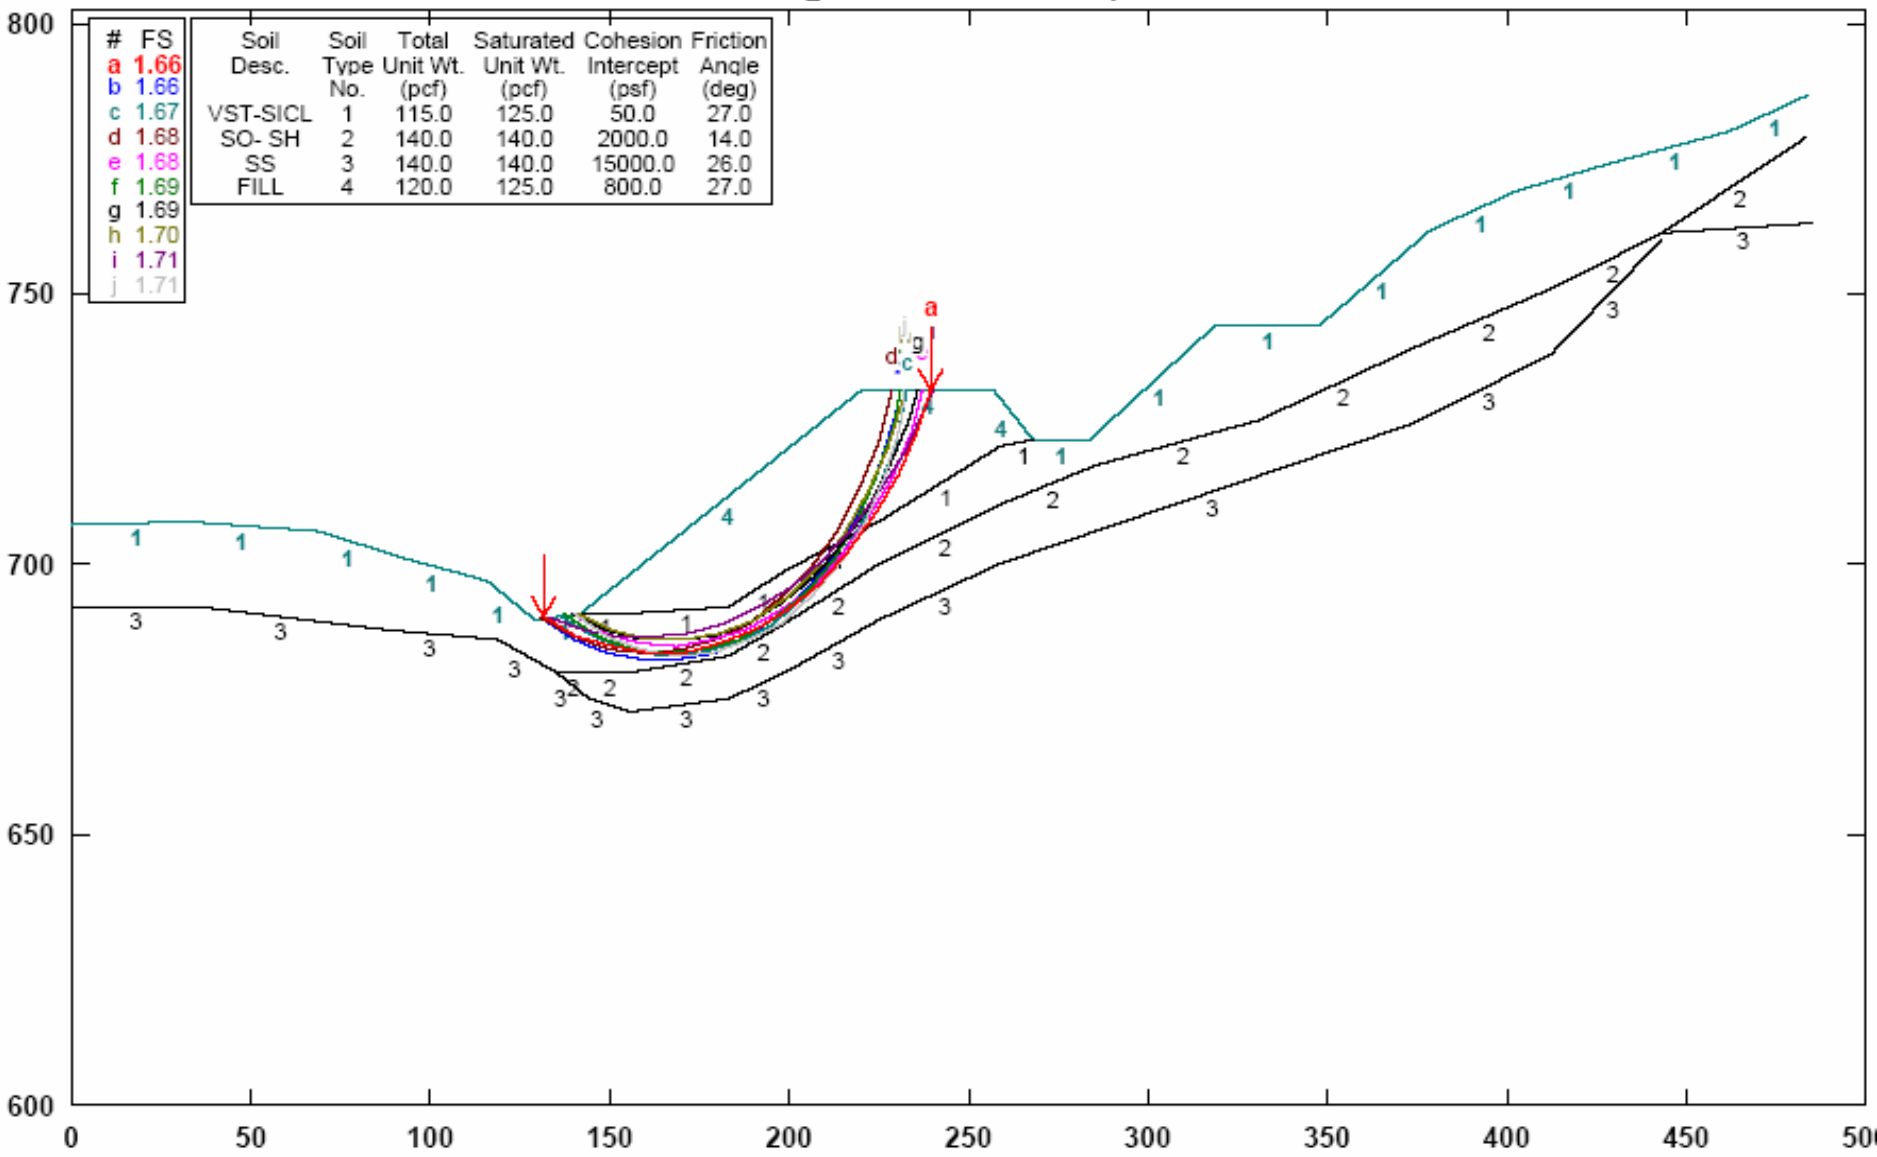
ATH 124 RELOCATION (CR 62 UPGRADE) STA 262+00 (LONG TERM)

GSTABL7 v.2 FSmin=1.66
 Safety Factors Are Calculated By The Simplified Janbu Method
