“Emergency Geotechnical Investigations of Failed Highway Embankments Resulting From Ohio River Lock Damage”

Richard L. Williams, Ph.D., P.E.

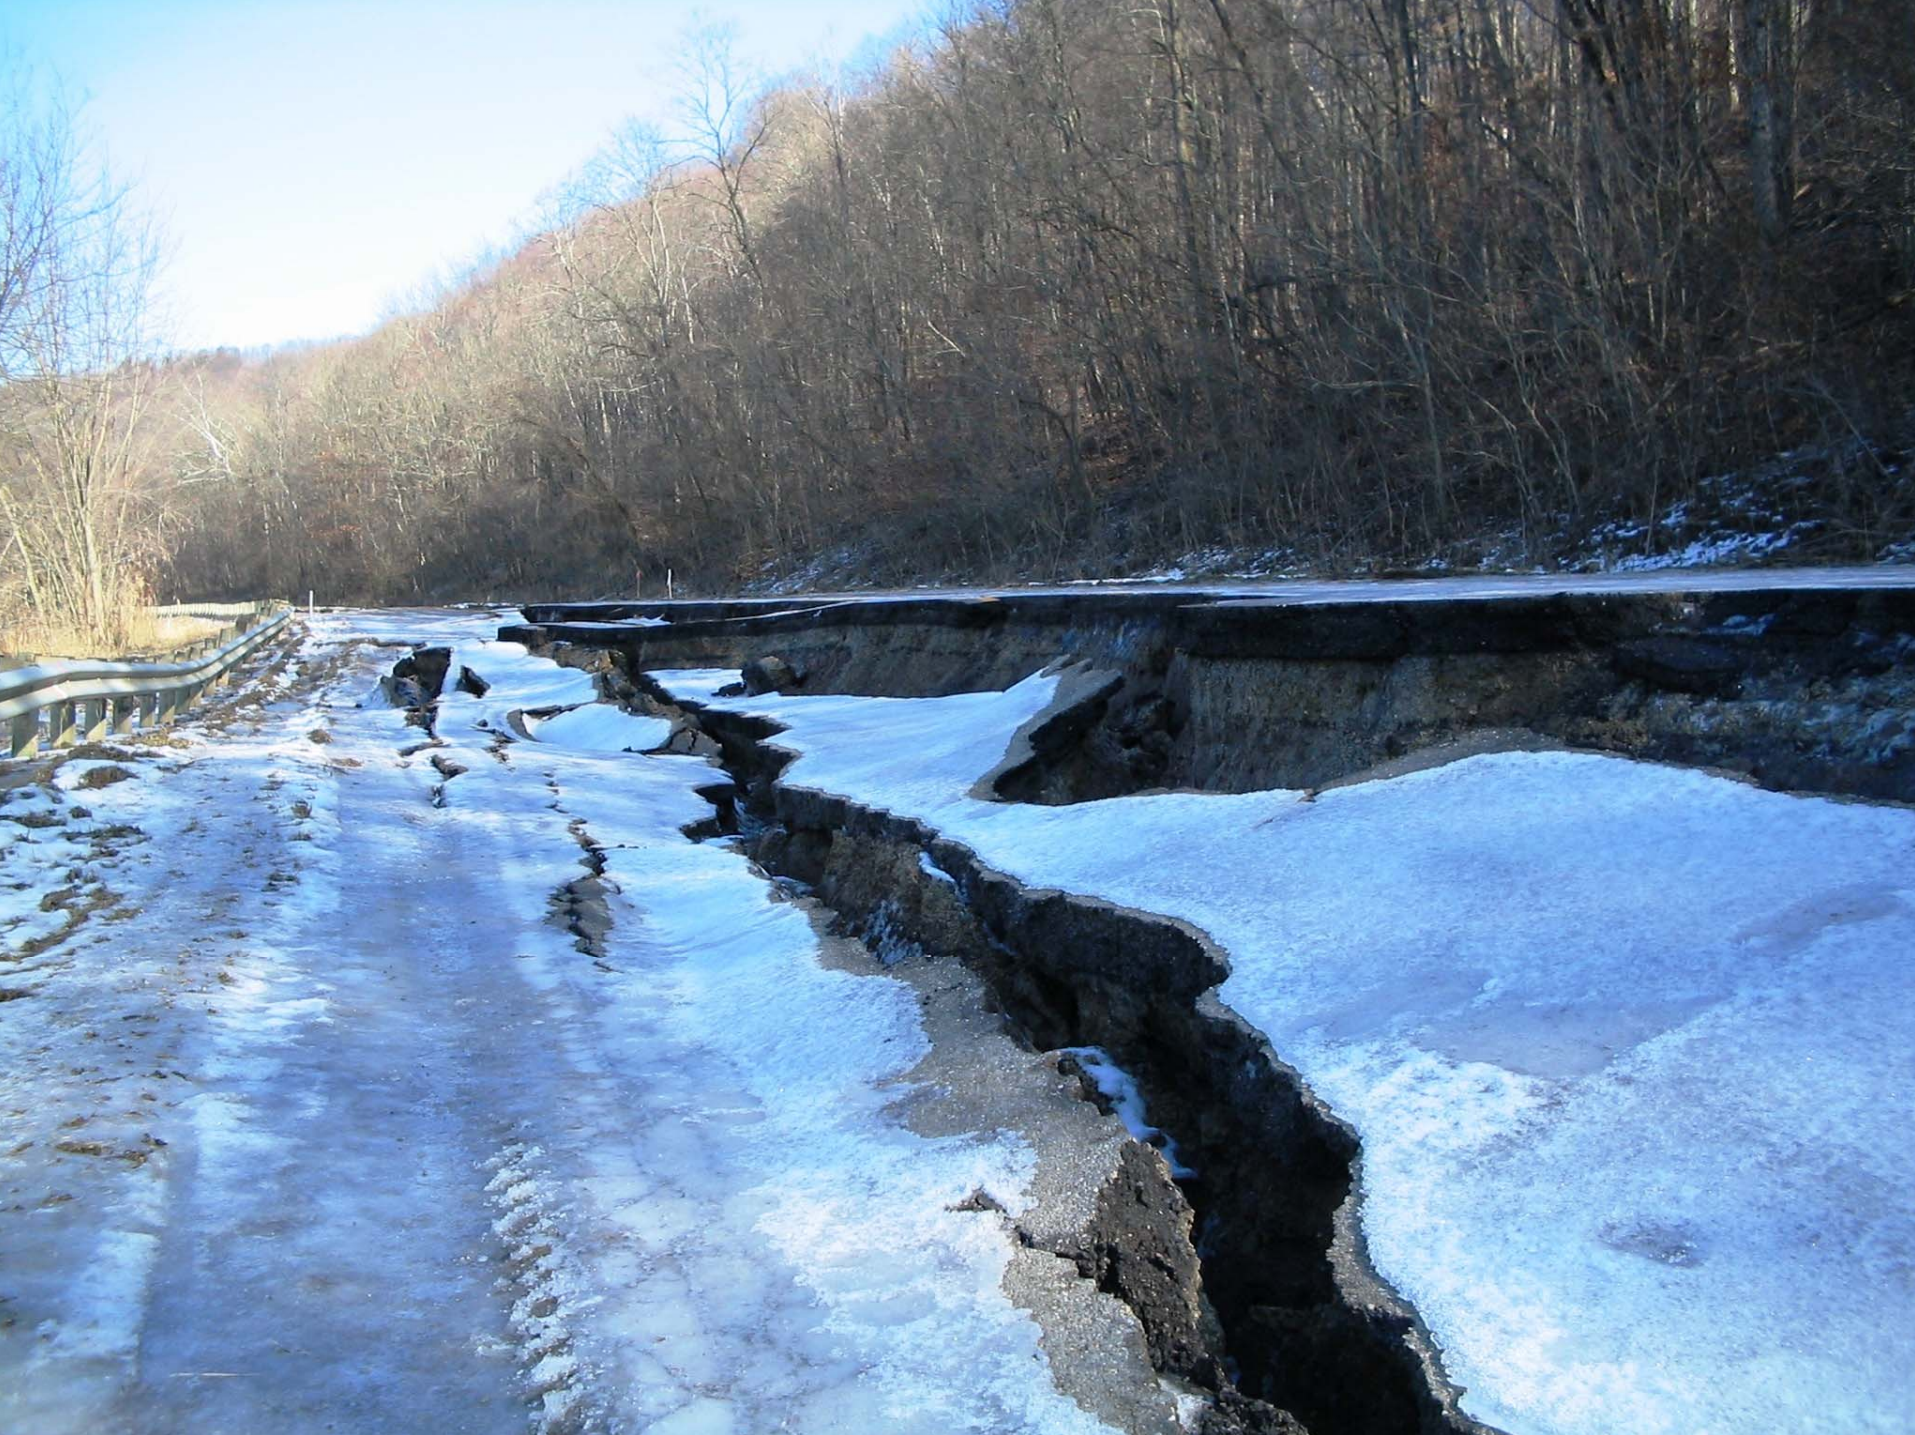
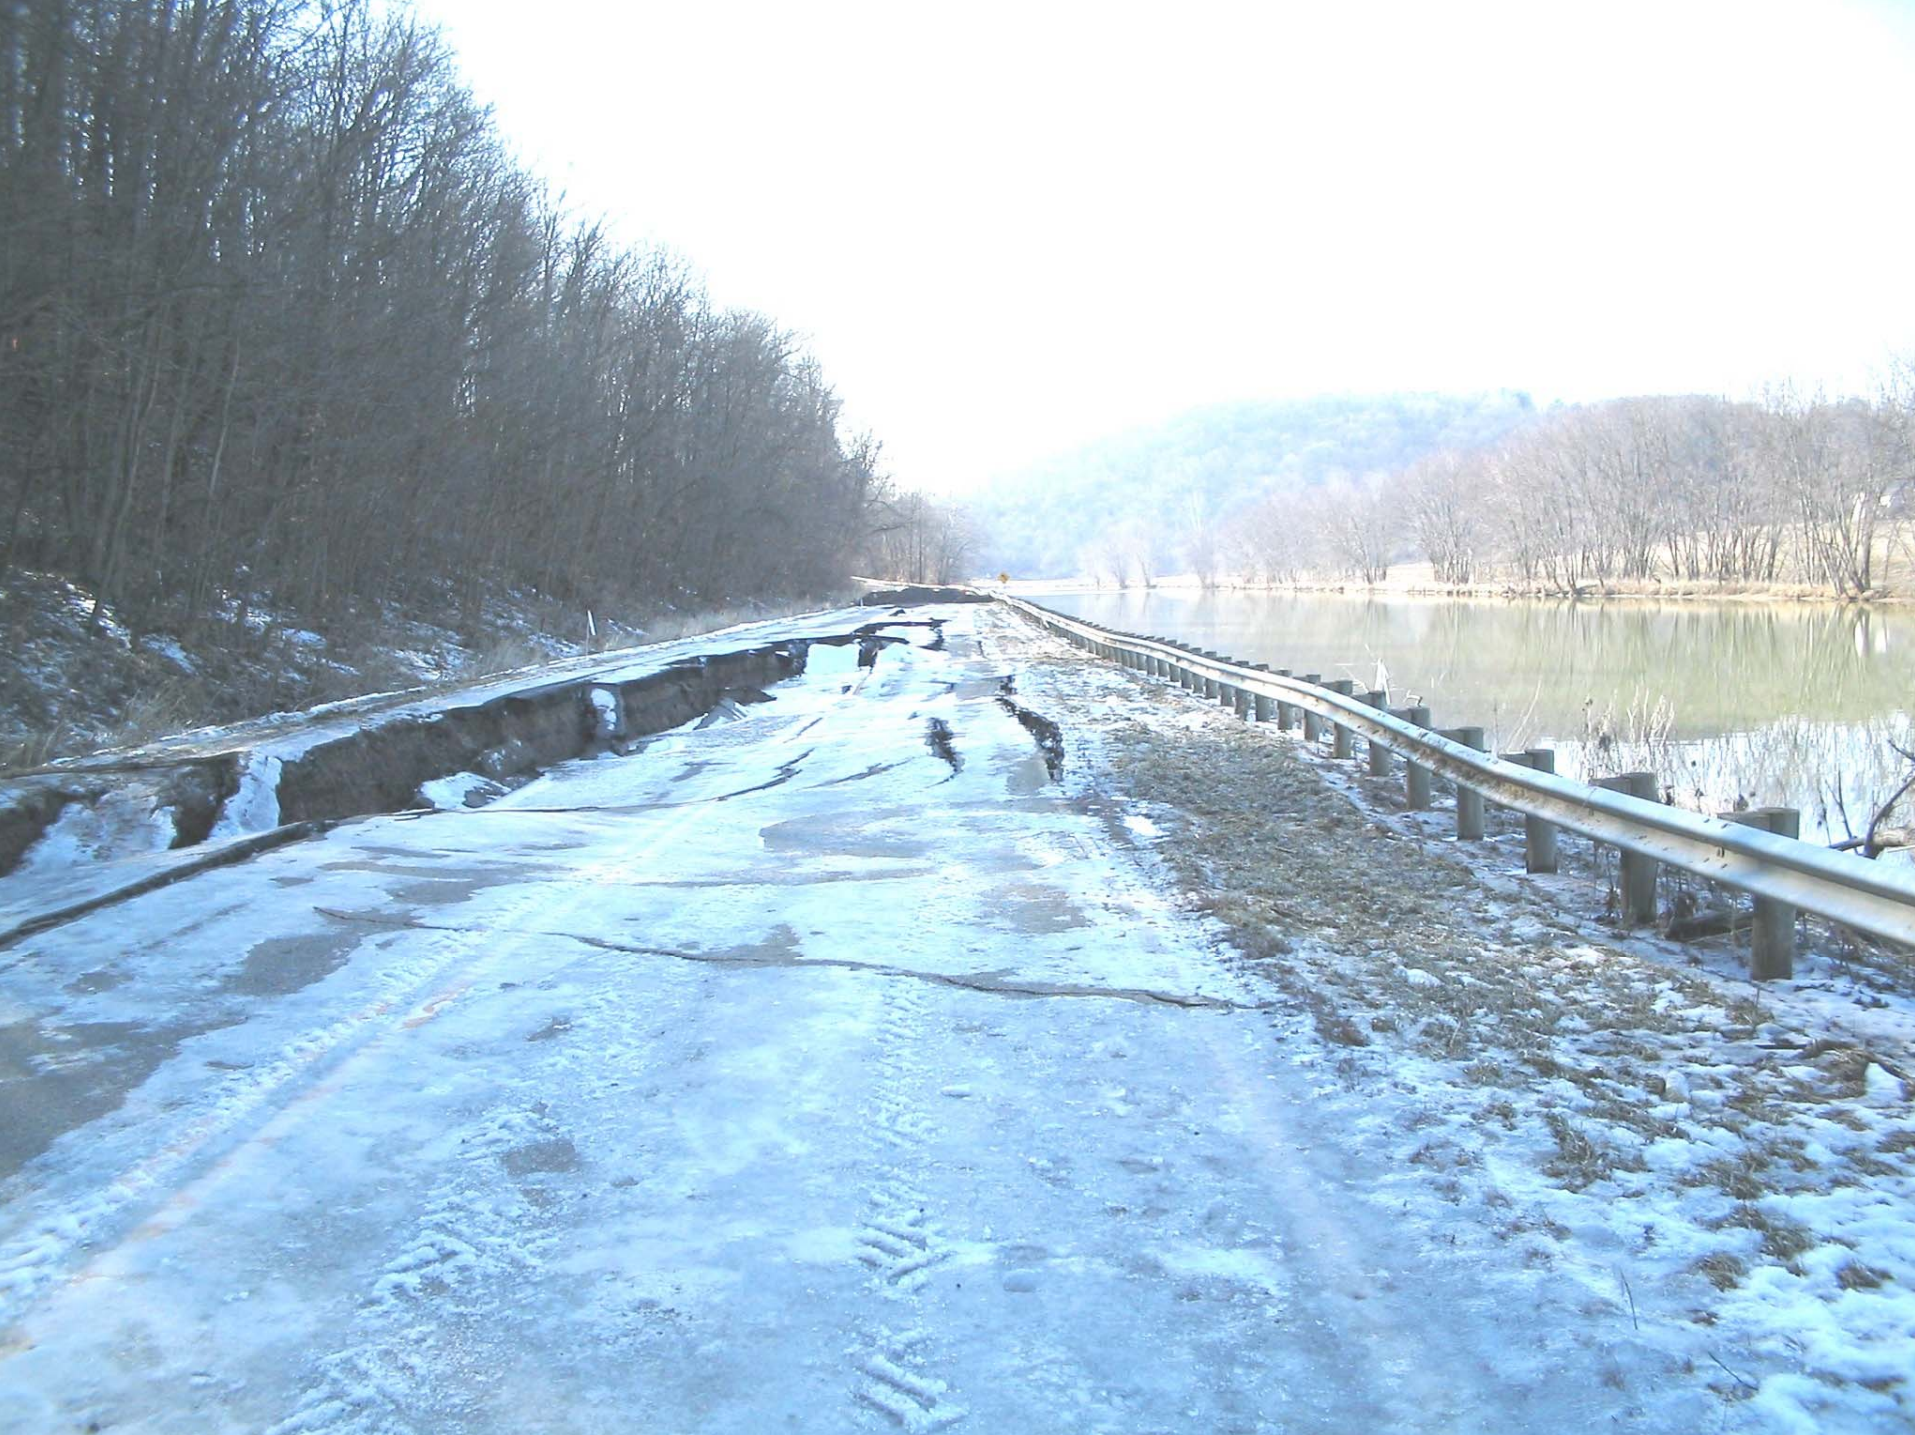
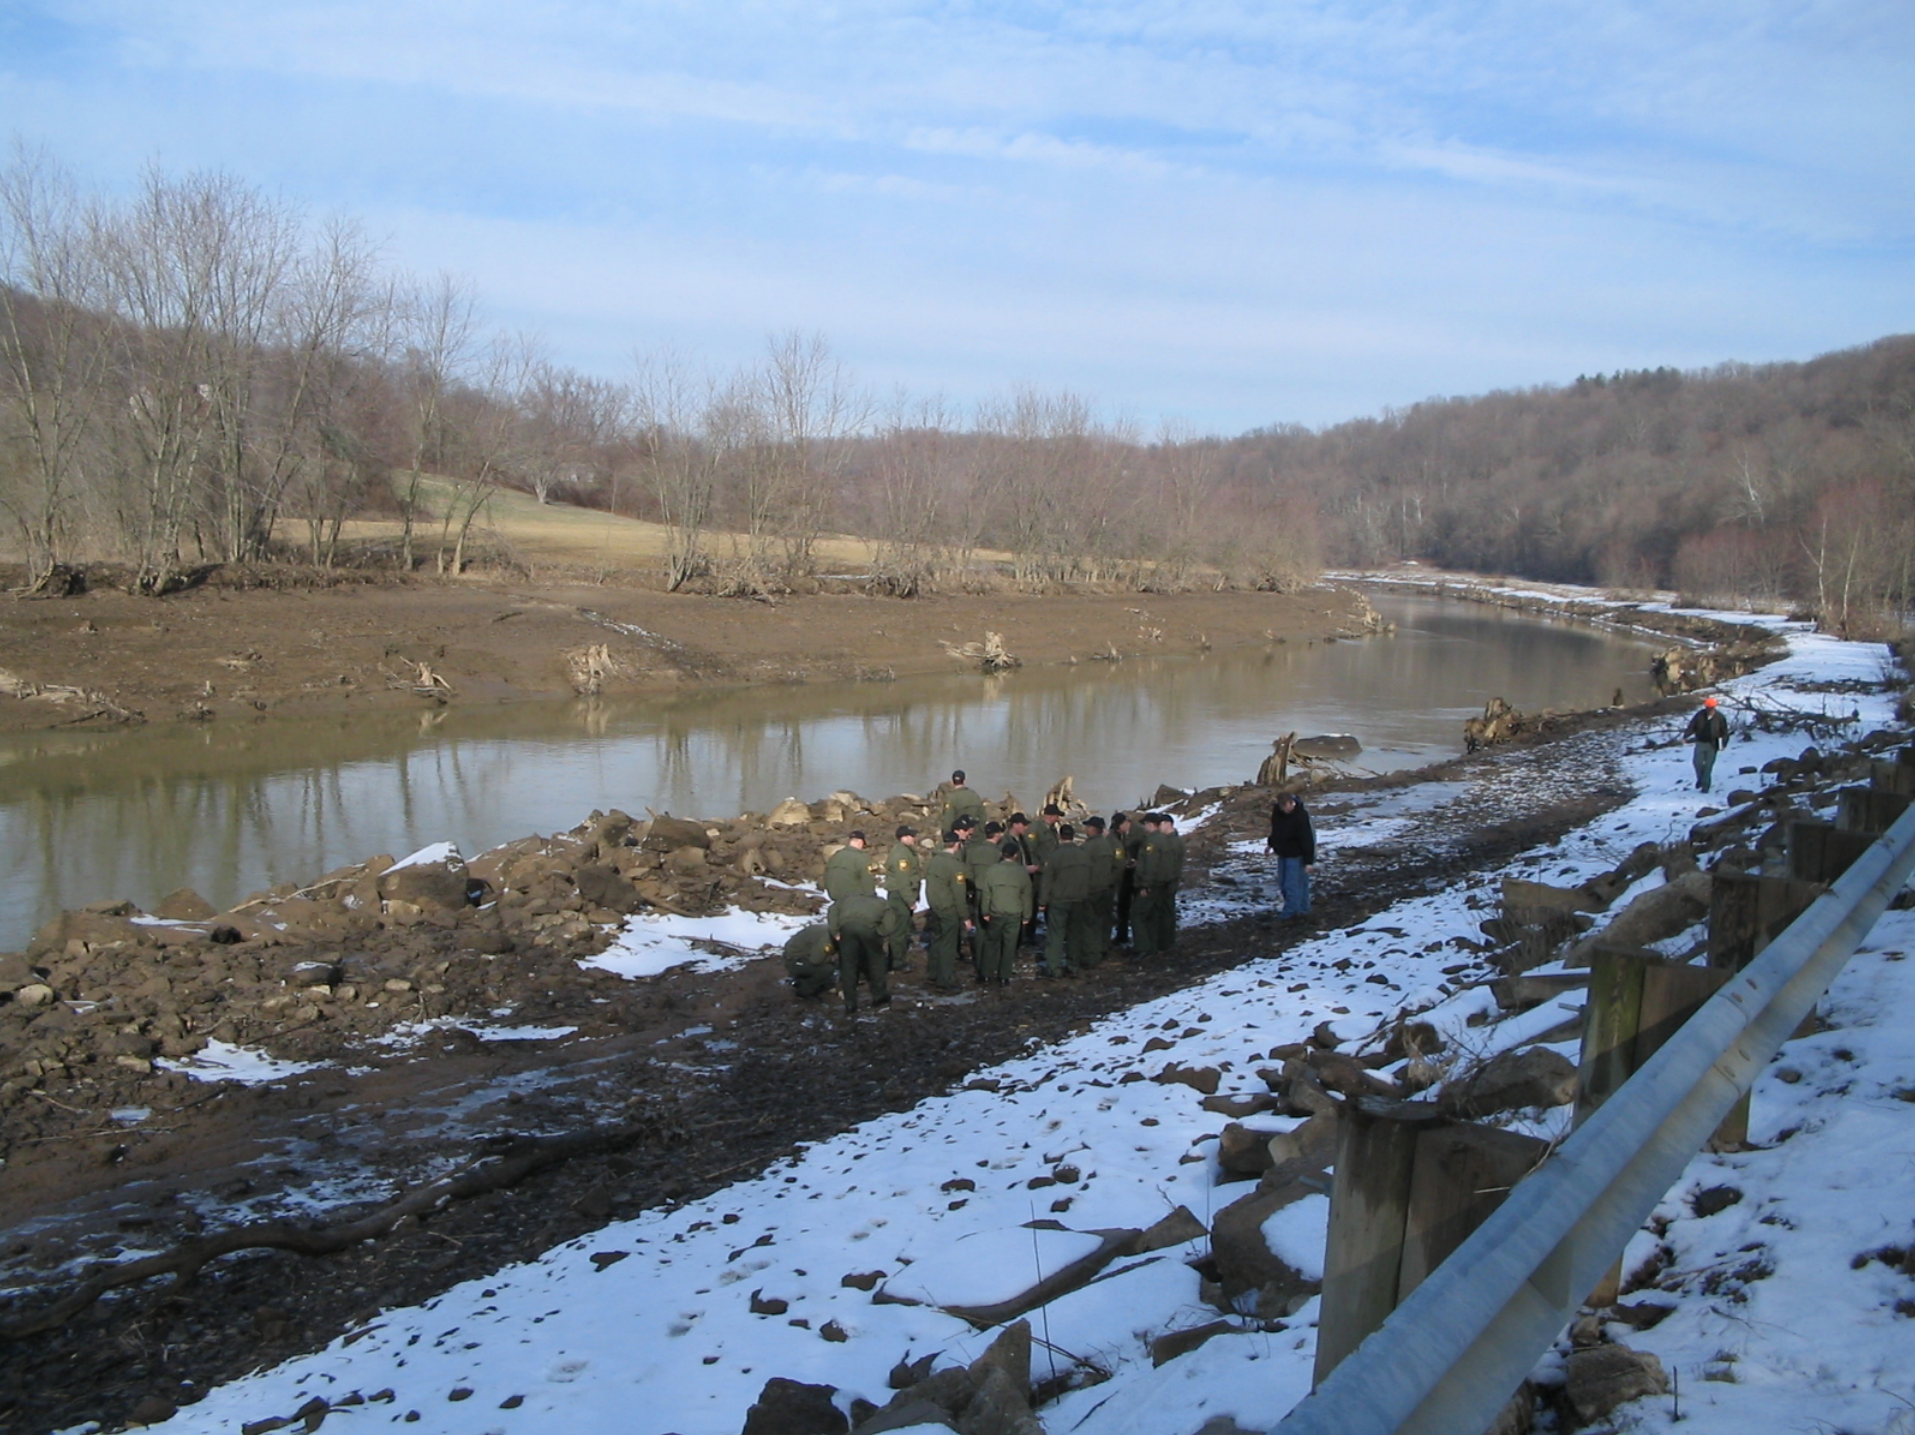
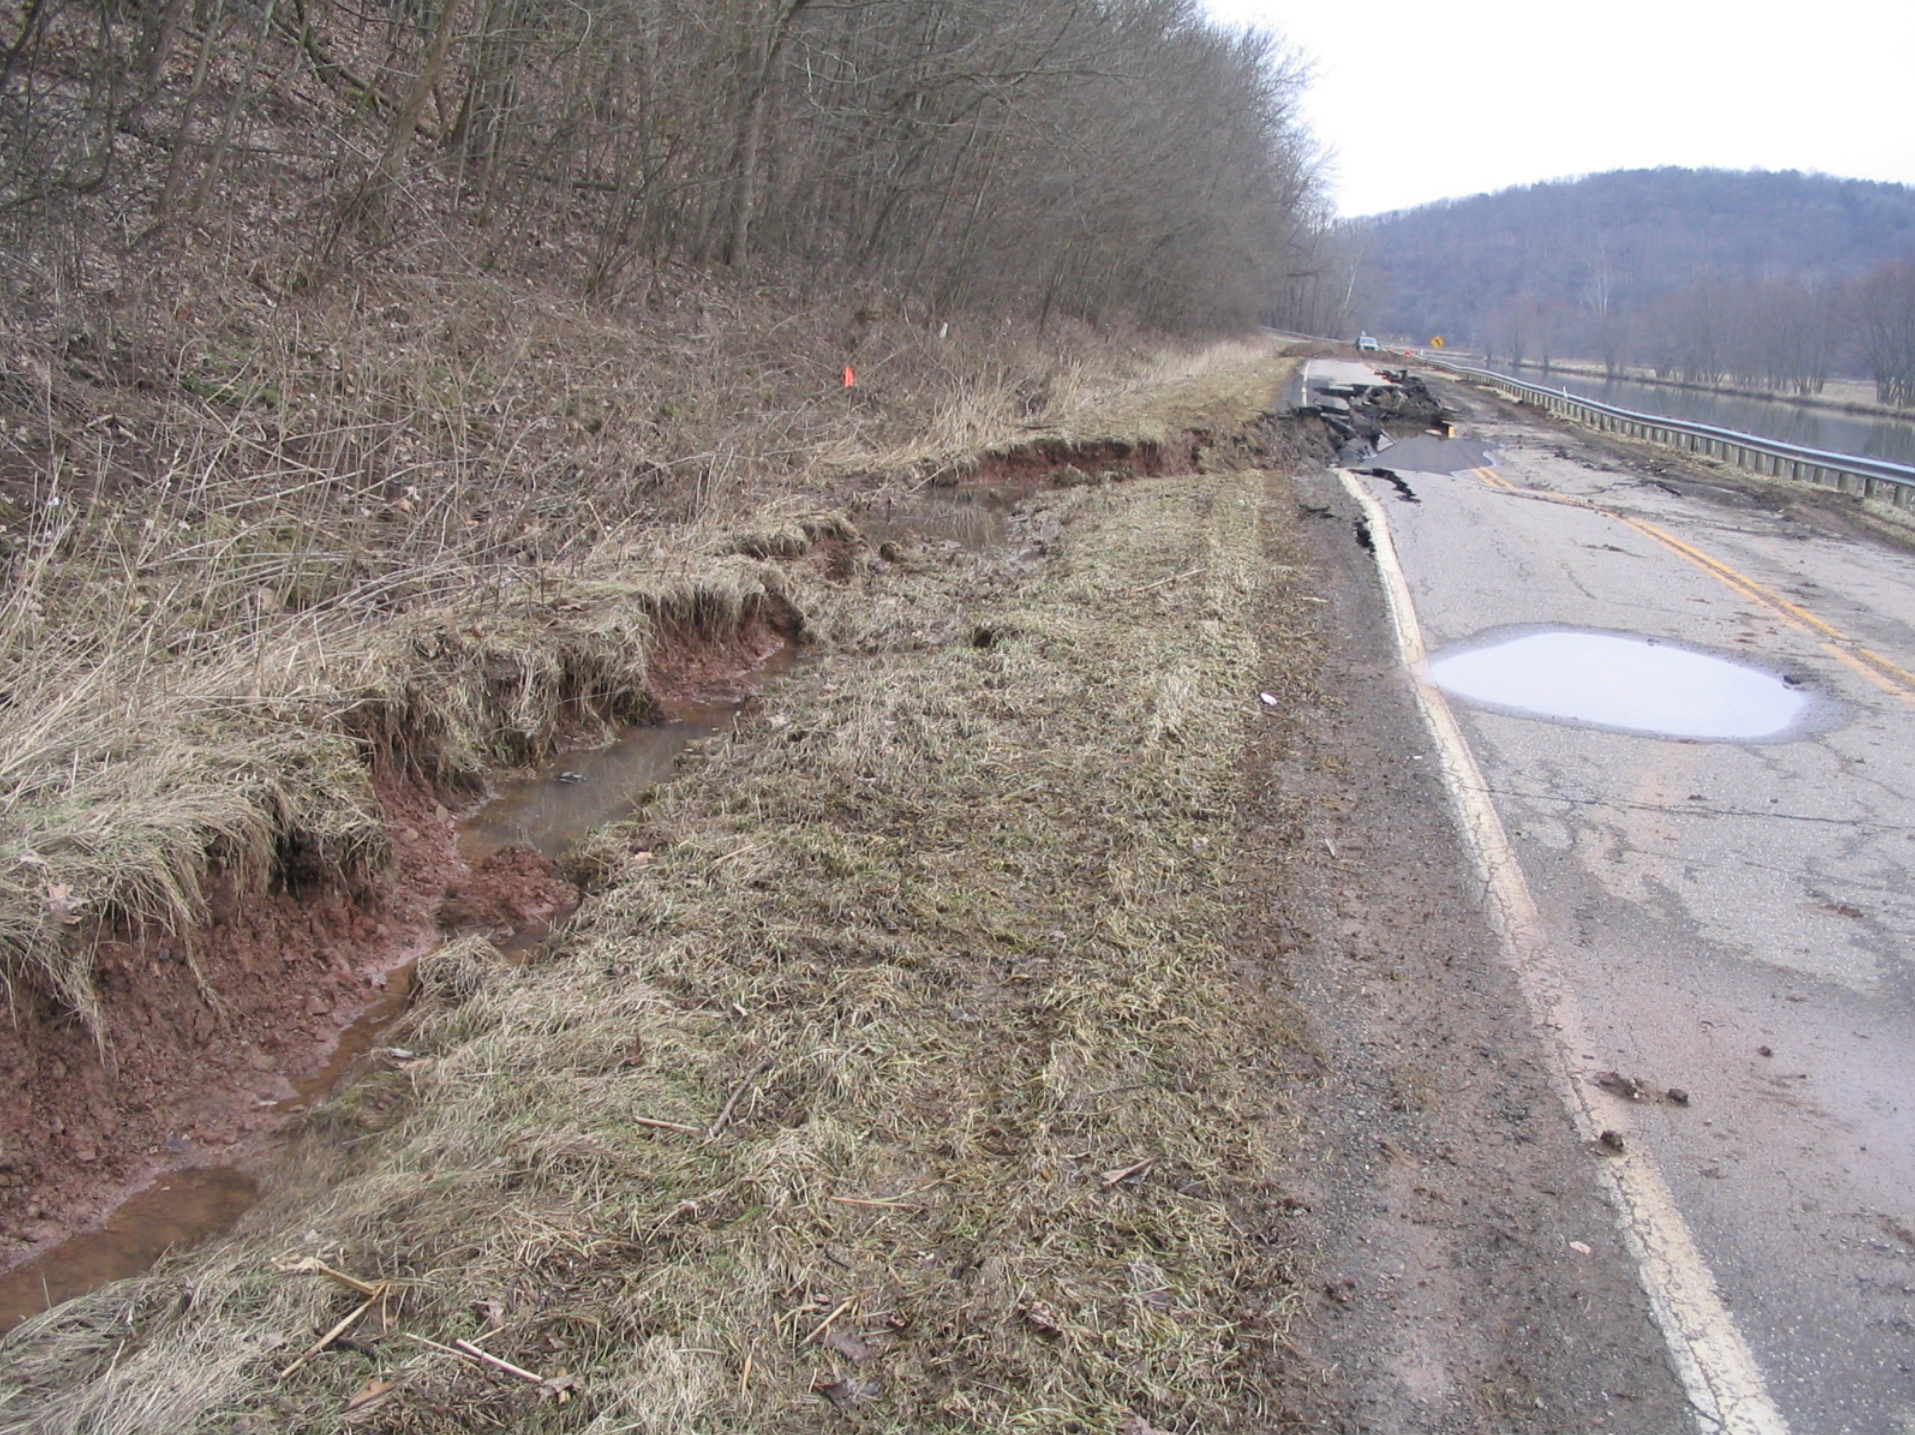
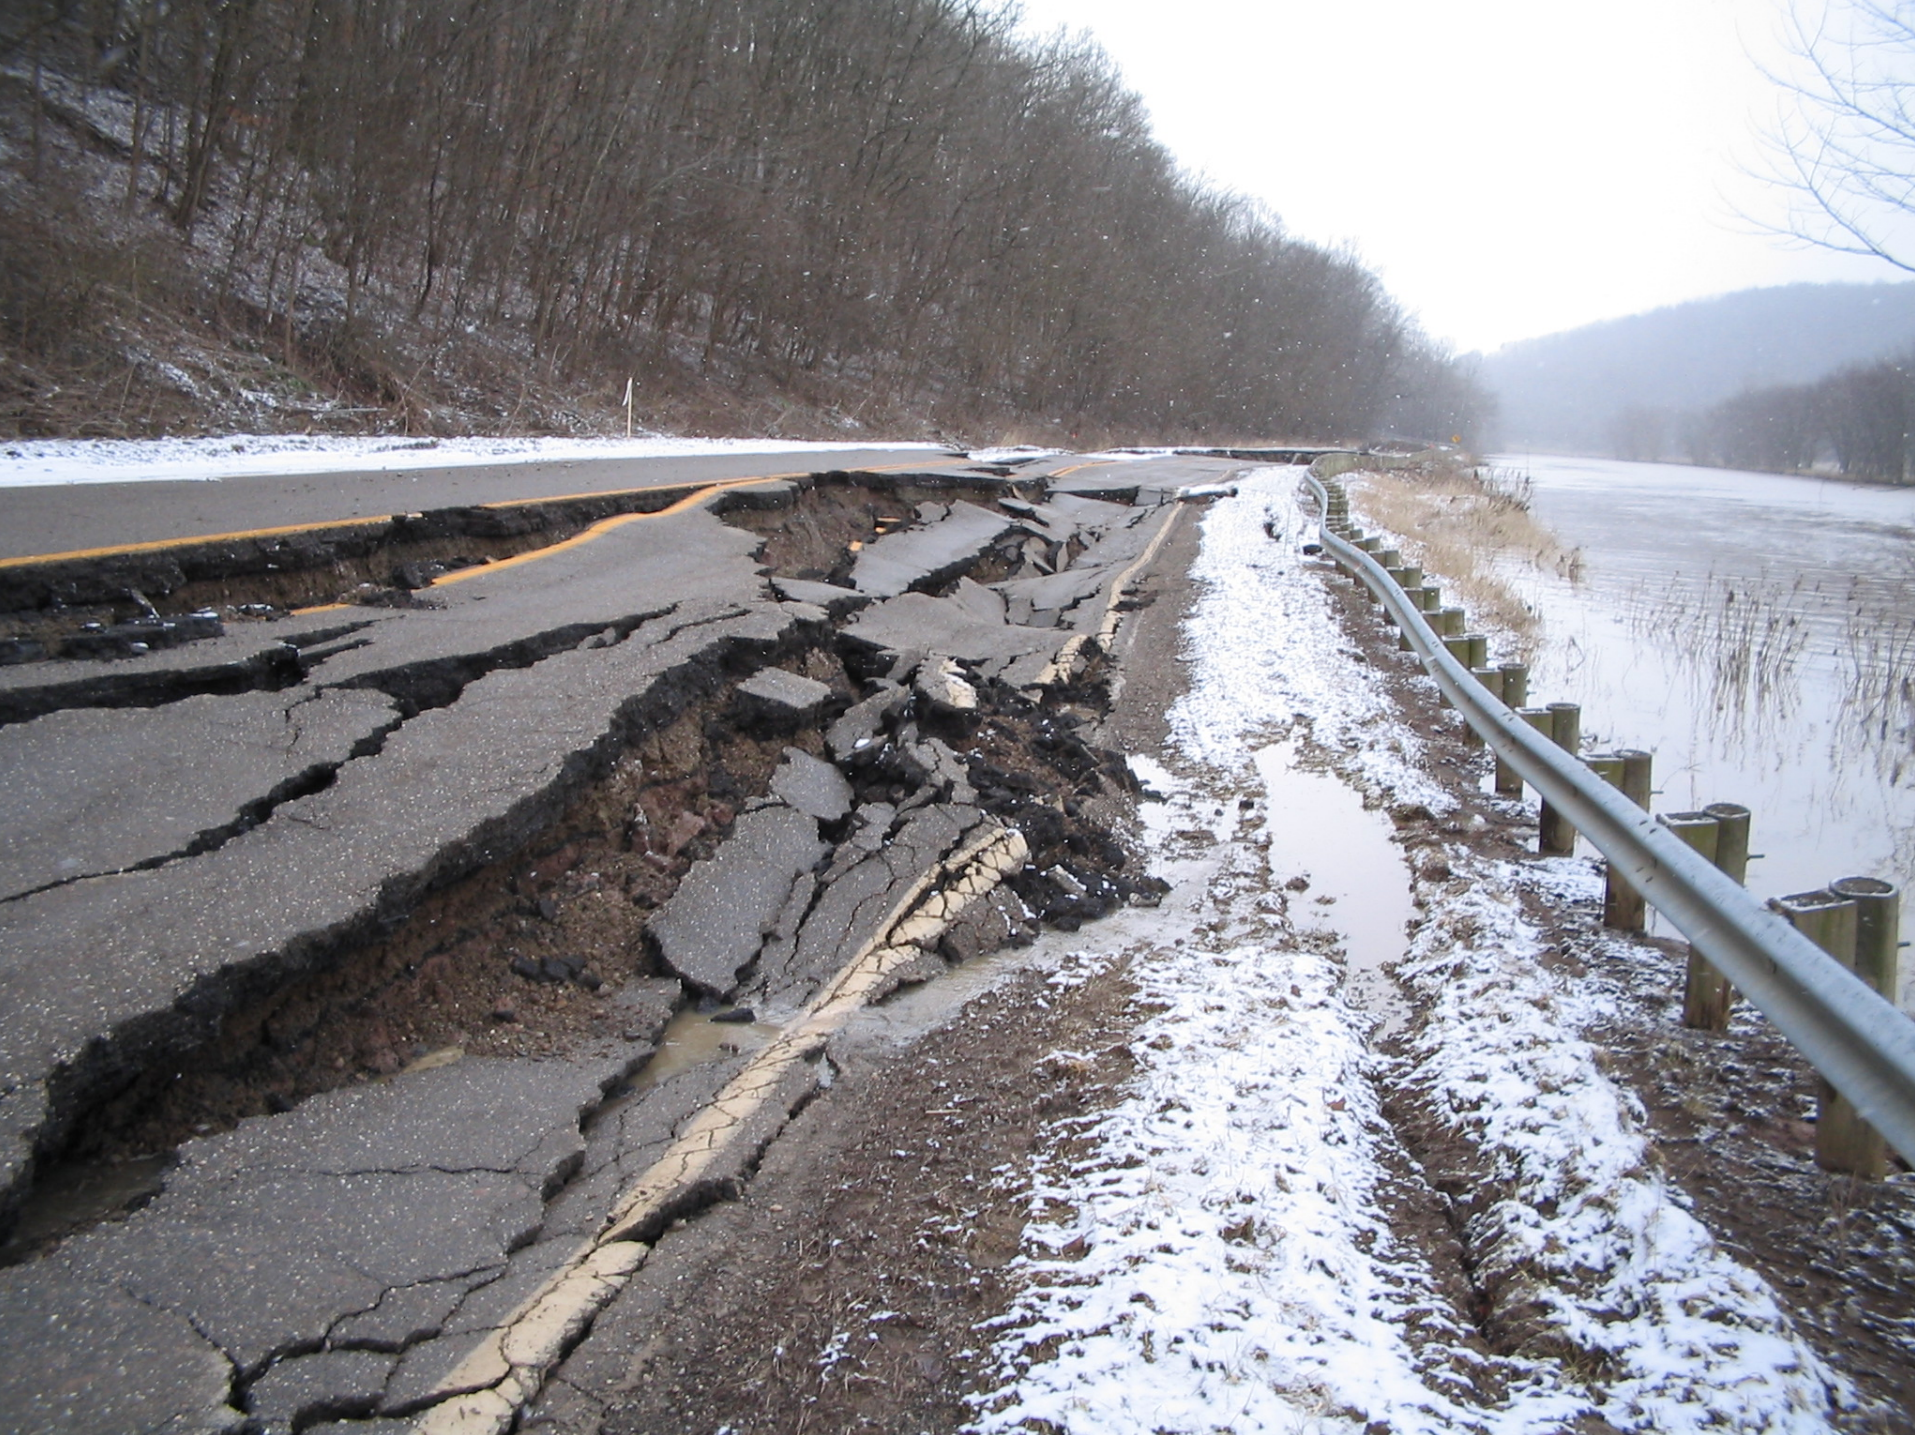
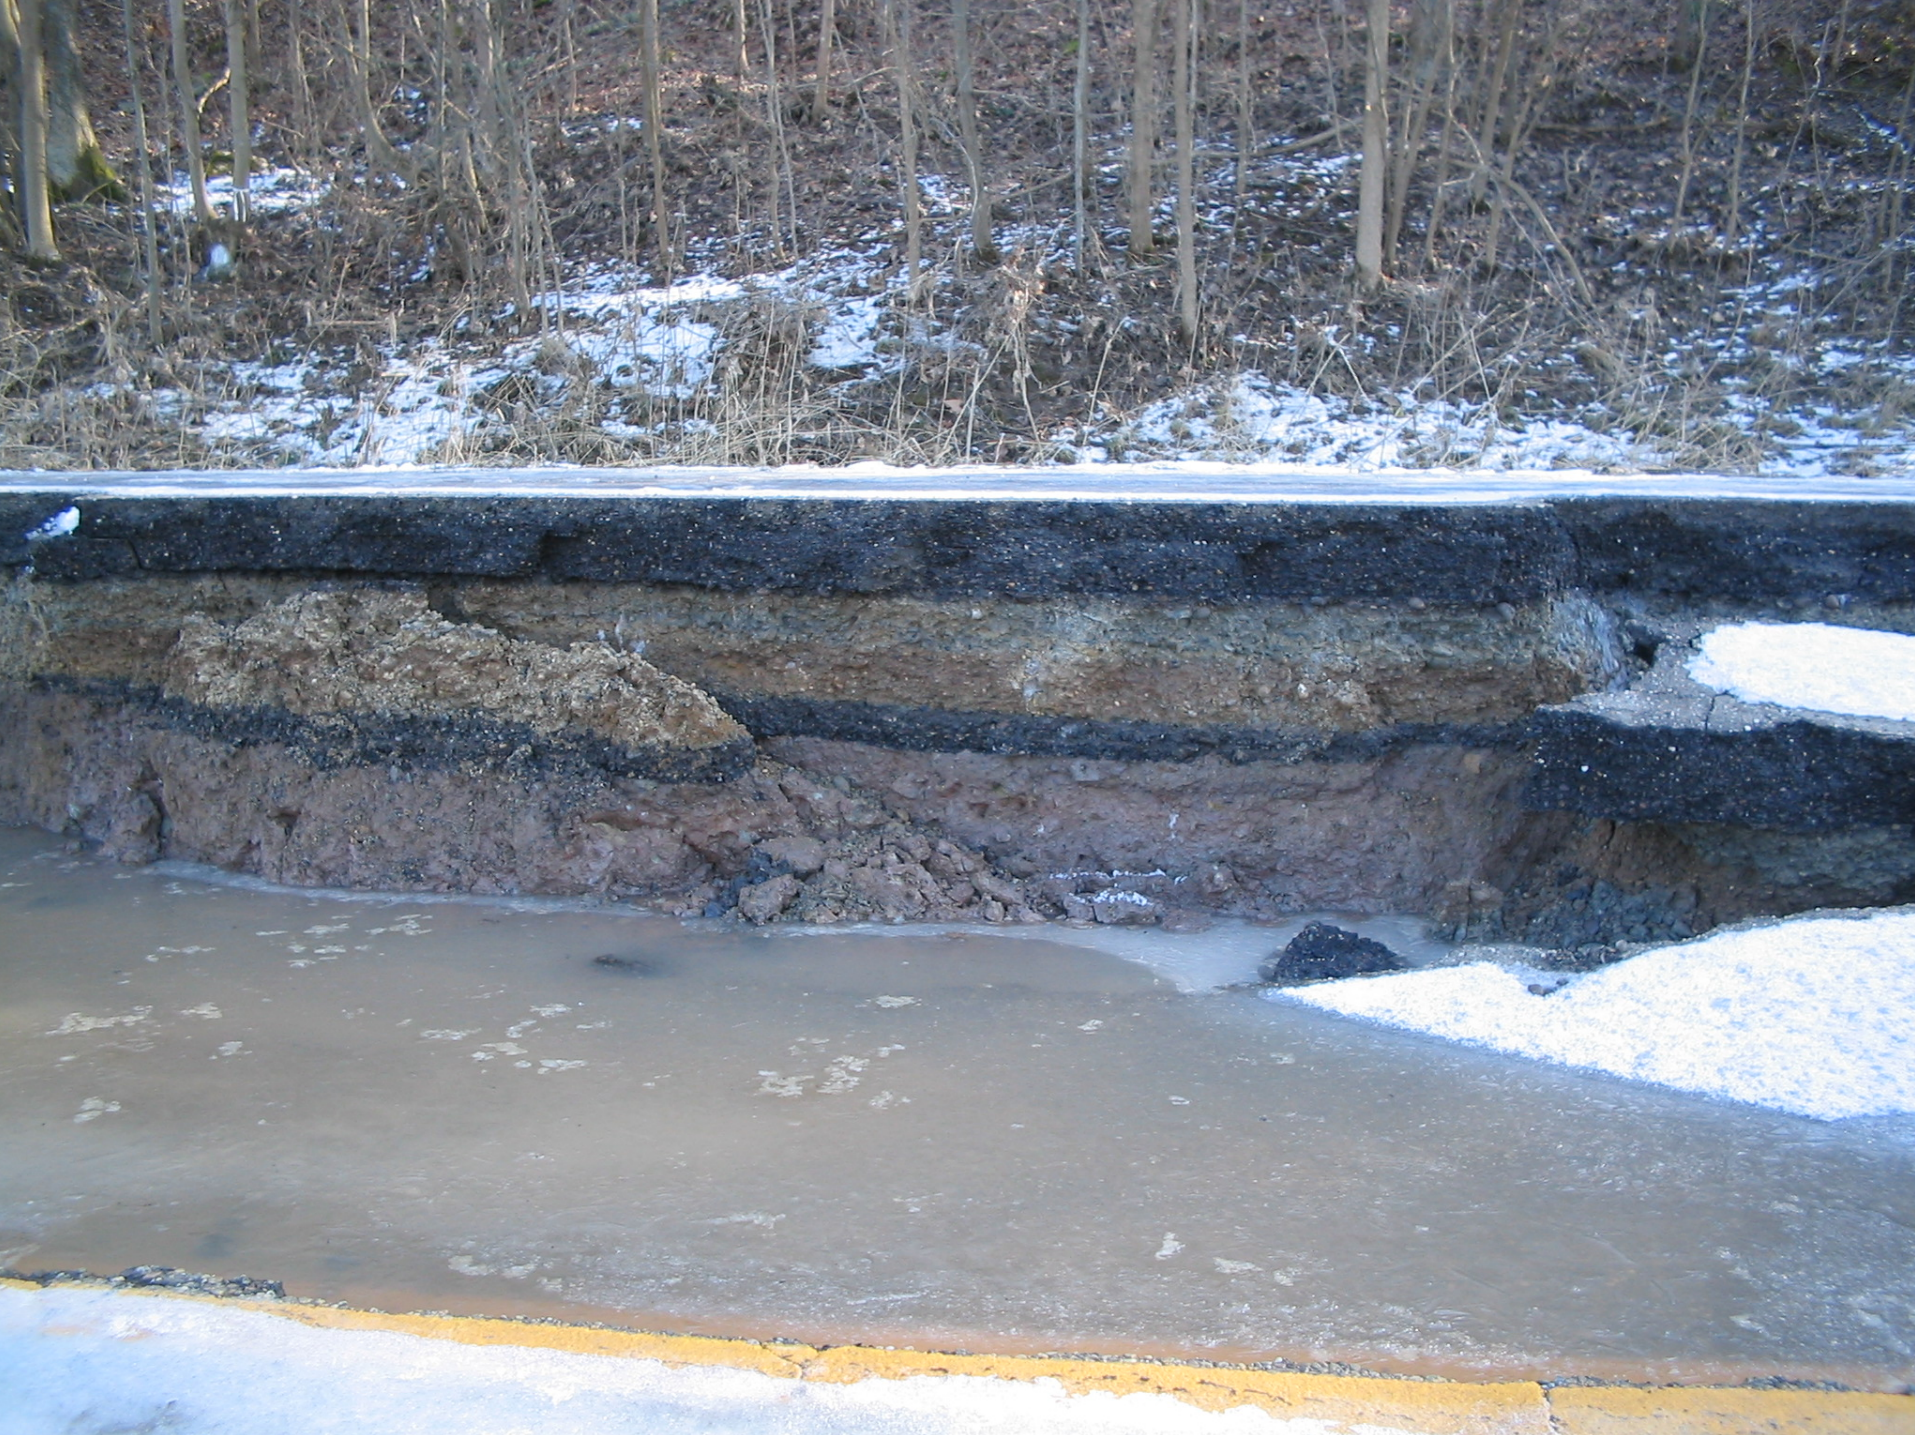
CONCEPTUAL SCHEMATIC SUBSURFACE SECTION	
ATH-144 SLOPE FAILURE ATHENS COUNTY, OHIO	
BBCM	
Columbus (614) 793-2226 Cleveland (216) 901-1000 Cincinnati (513) 771-8471 Dayton (937) 424-1011	
Project: OII-10250-201	Drawn By:
Drawing Date:	Approved By:
Revision Date:	Scale:

Match Line STA 3100

Match Line STA 2200

Match Line STA 1300

ASSUMED HIGH WATER LEVEL (EL. 599) BASED ON SURVEYED MUD AND WATER STAINING ON EXISTING SLOPE

MEDIUM-STIFF BROWN SILTY CLAY
LOOSE F-C SAND & GRAVEL

VERY-SOFT TO MEDIUM-STIFF BROWN SILTY CLAY
DENSE F-M & F-C SAND
LOOSE F-C SAND

VERY-LOOSE TO LOOSE GRAY FINE SAND

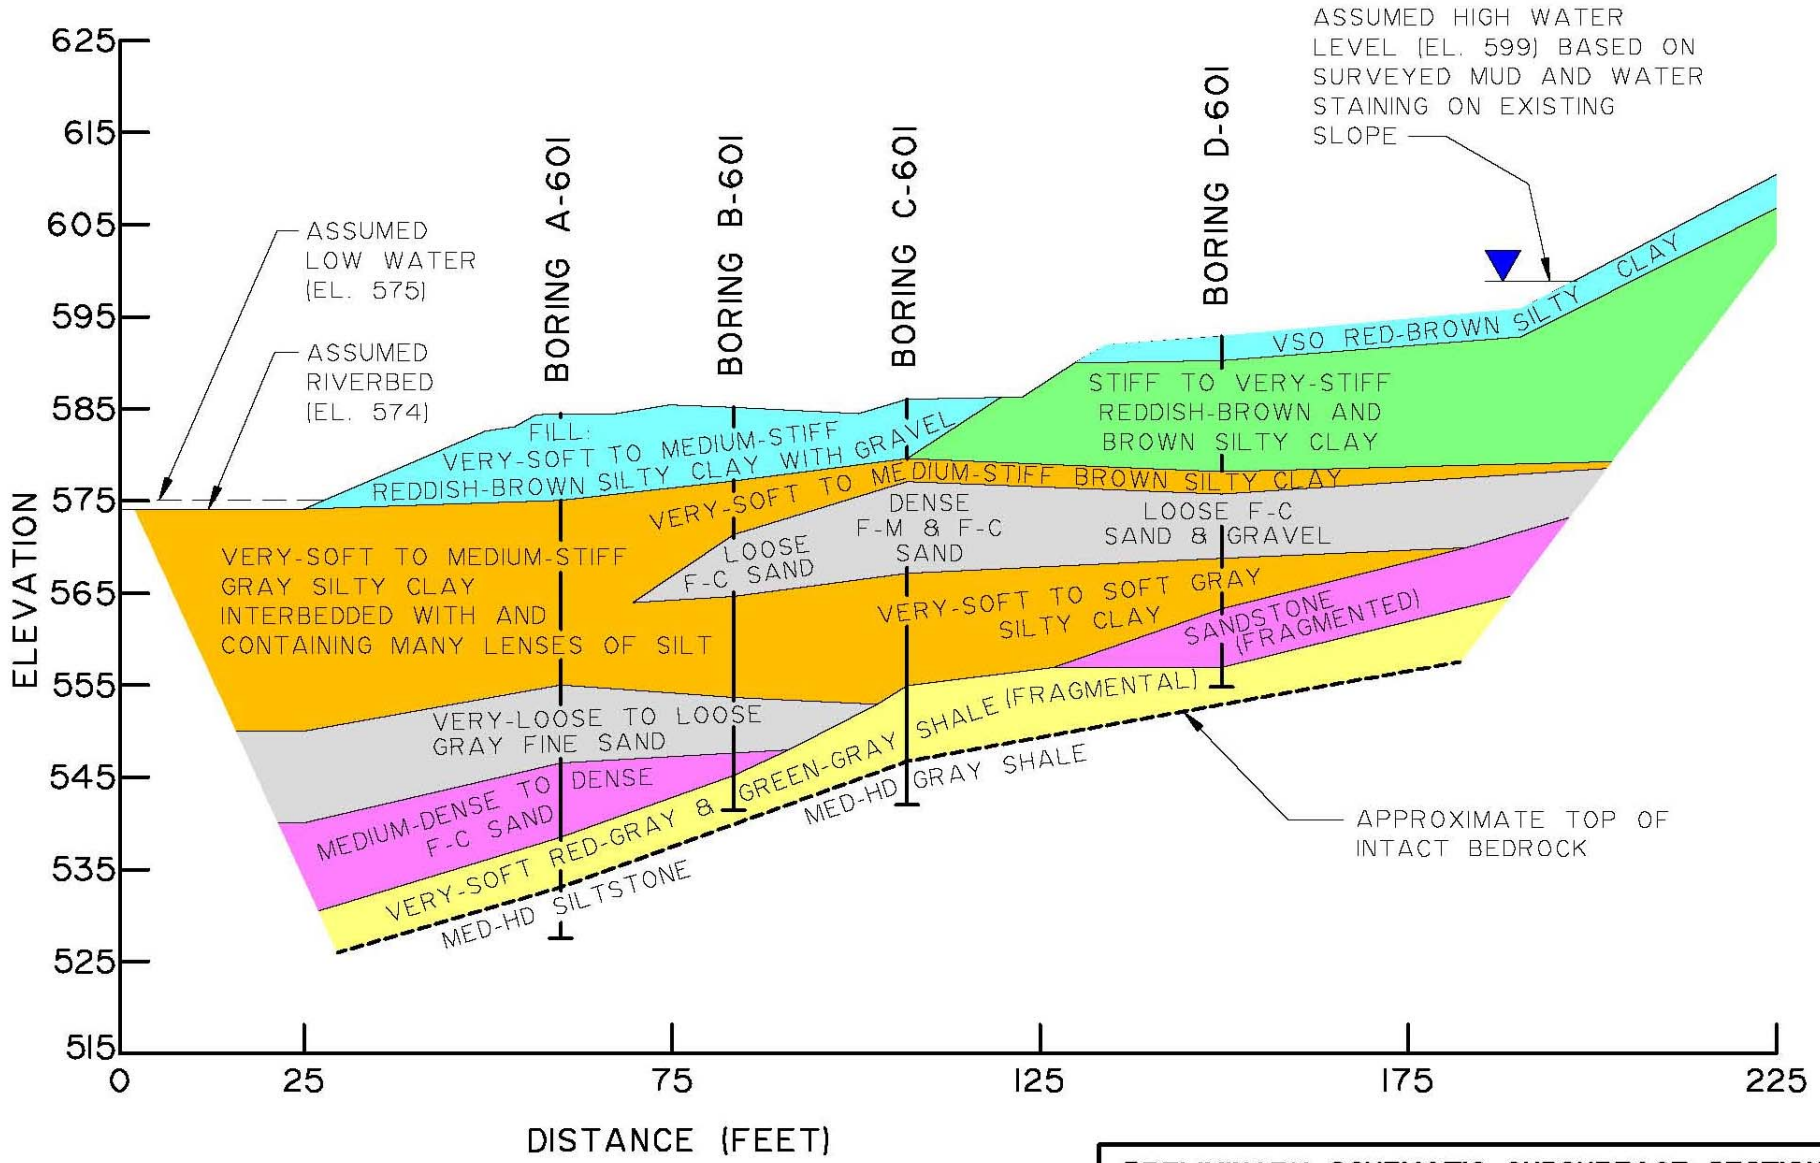
PRELIMINARY SCHEMATIC SUBSURFACE SECTION

ASSUMED LOW WATER (EL. 575)

ASSUMED RIVERBED (EL. 574)

VSO RED-BROWN SILTY CLAY
STIFF TO VERY-STIFF REDDISH-BROWN AND BROWN SILTY CLAY

FILL: VERY-SOFT TO MEDIUM-STIFF REDDISH-BROWN SILTY CLAY WITH GRAVEL

VERY-SOFT TO MEDIUM-STIFF GRAY SILTY CLAY INTERBEDDED WITH AND CONTAINING MANY LENSES OF SILT

VERY-SOFT TO SOFT GRAY SILTY CLAY

APPROXIMATE TOP OF INTACT BEDROCK

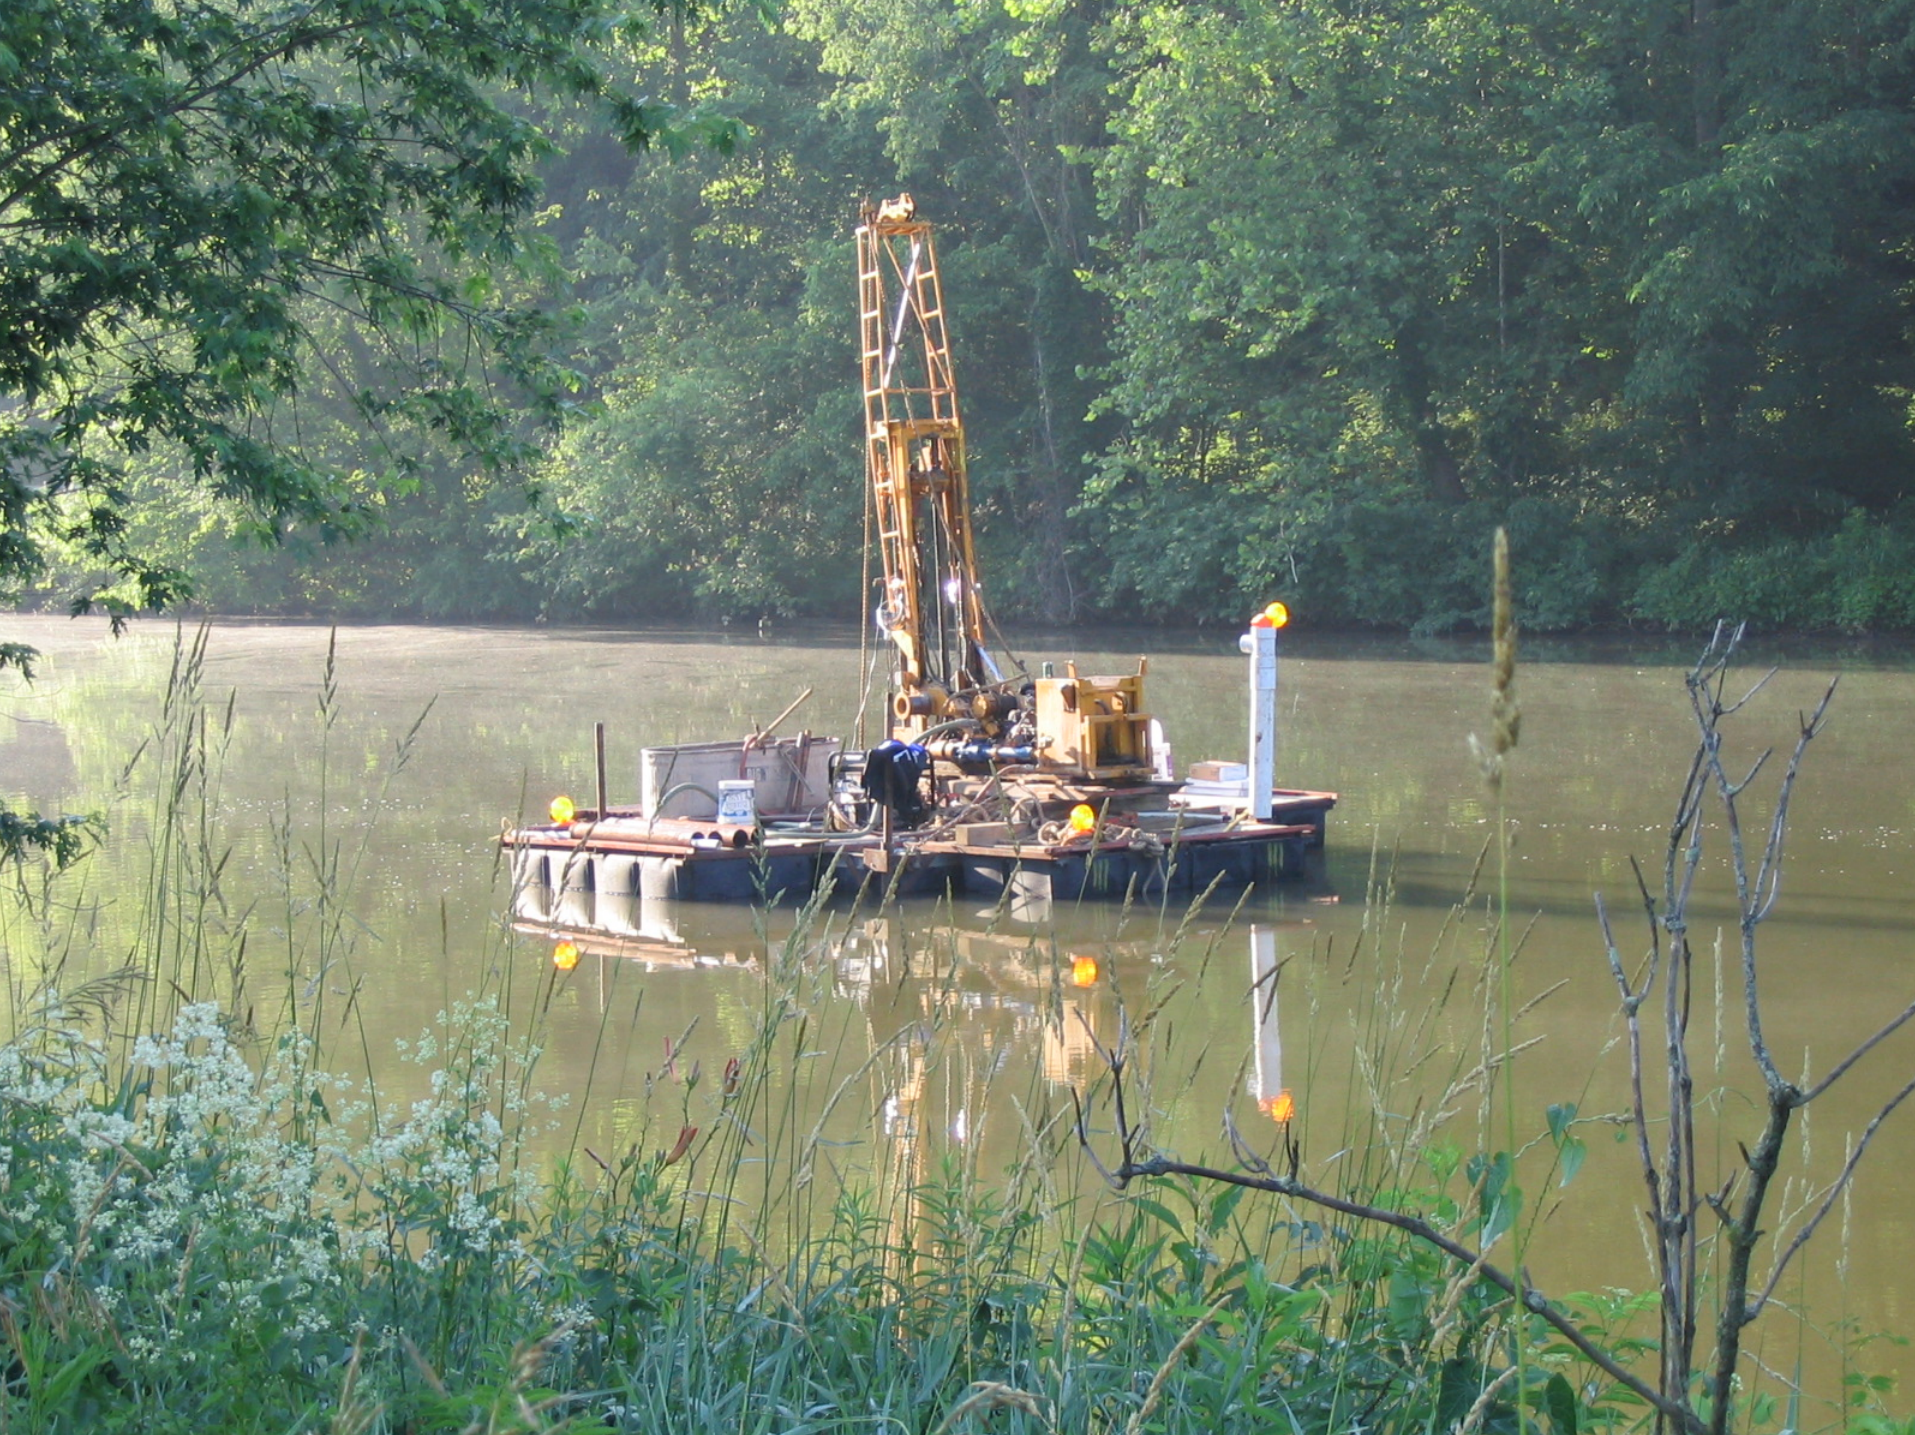
ATH-144-Realignment, Rear Abutment X-section STA 21, Long-term

Safety Factors Are Calculated By The Modified Bishop Method
