“Emergency Geotechnical Investigations of Failed Highway Embankments Resulting From Ohio River Lock Damage”

Richard L. Williams, Ph.D., P.E.

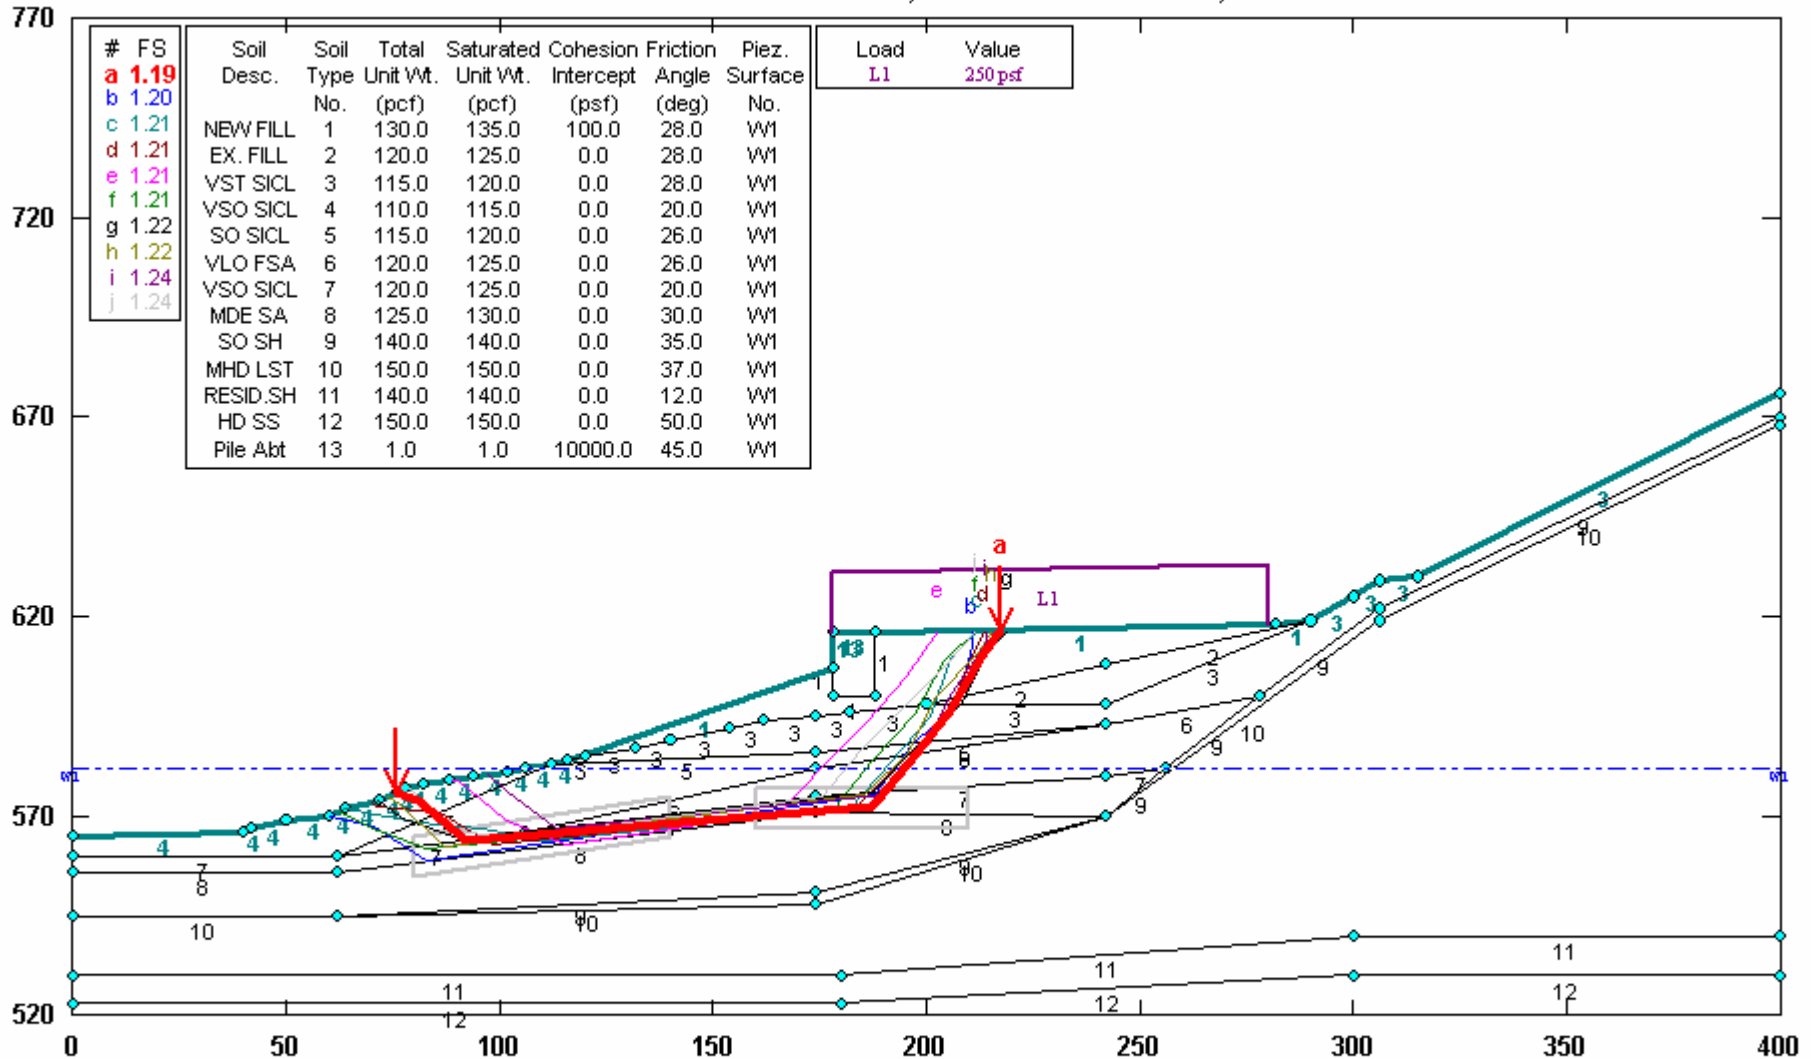
ATH-144-Realignment, Rear Abutment X-section STA 21, Long-term

GSTABL7 v.2 FSmin=1.19

Safety Factors Are Calculated By The Simplified Janbu Method

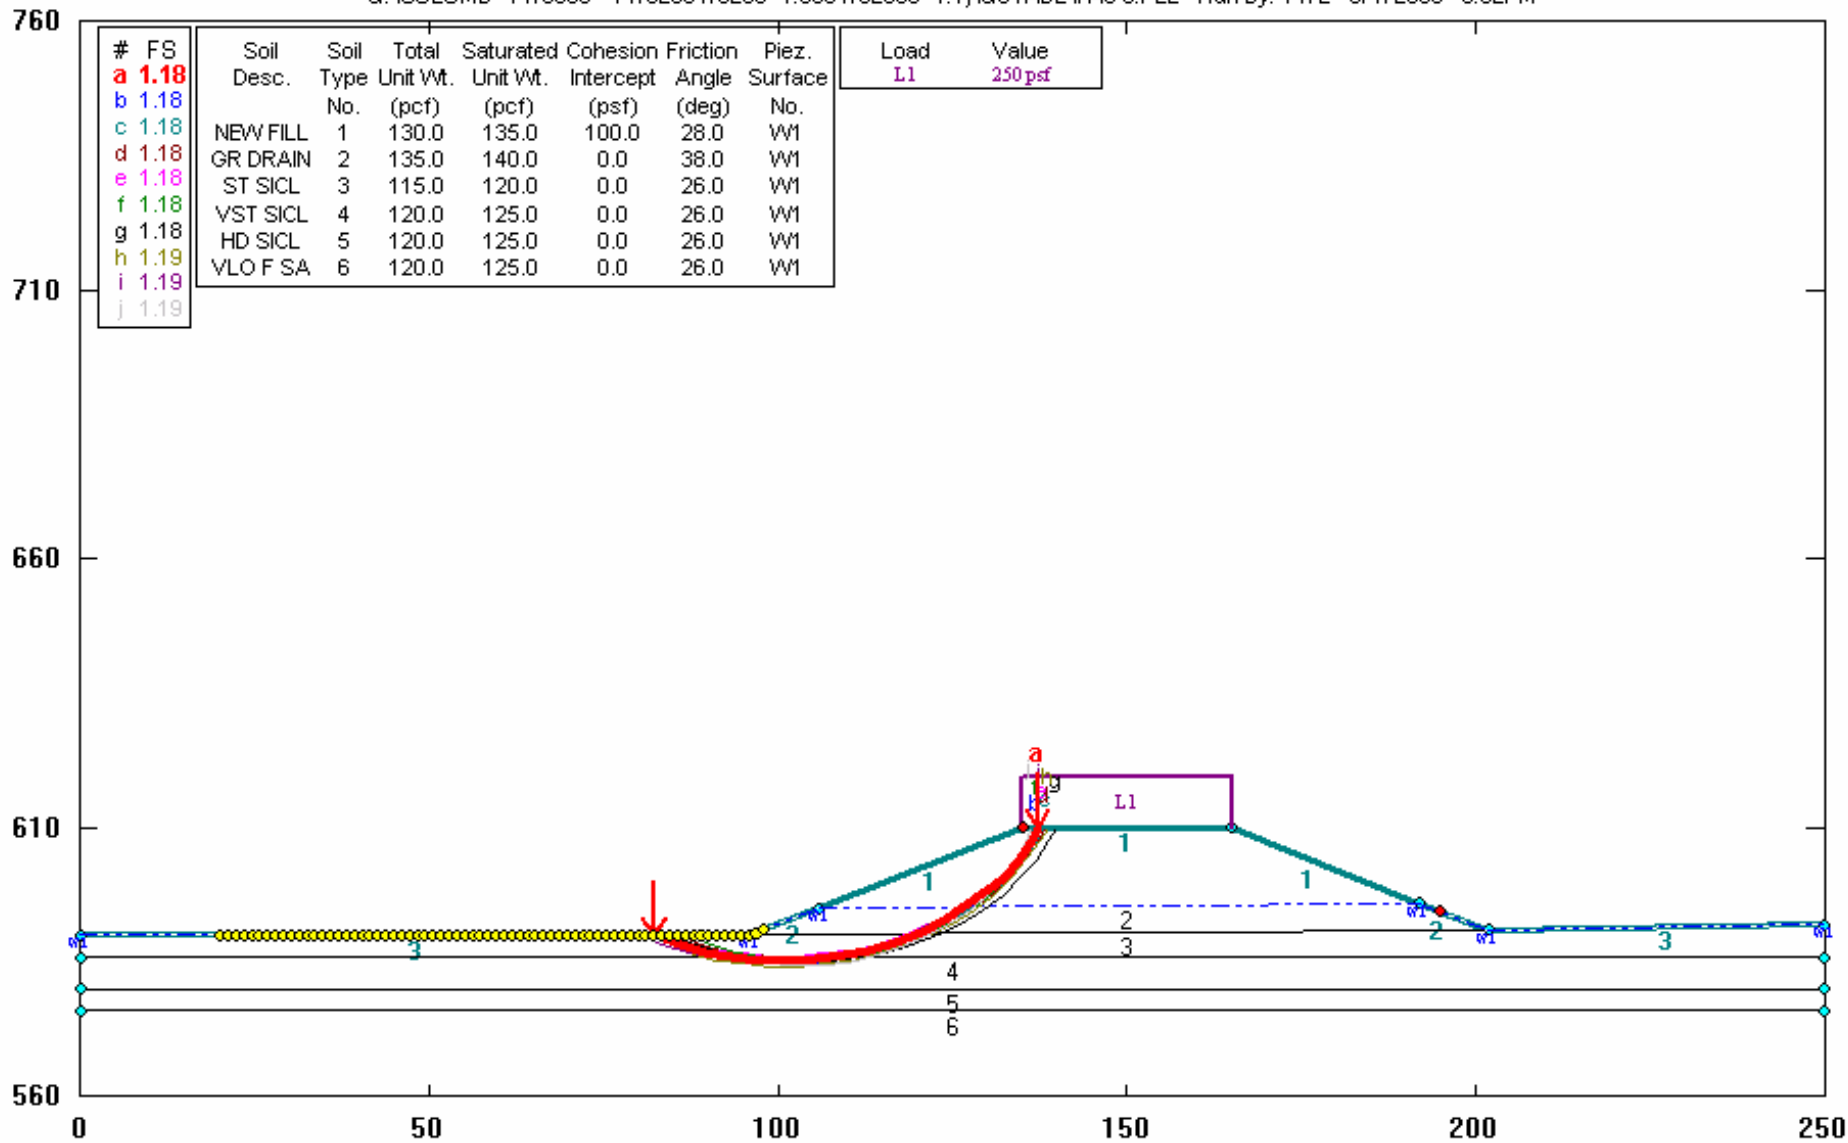
ATH-144-Realignment, Forward embankment, STA 28+35, w/drain layer, Rapid drawdown

GSTABL7 v.2 FSmin=1.18

Safety Factors Are Calculated By The Modified Bishop Method
