# *Bio-Stabilization Case Studies*

- Donald H. Gray  
Professor Emeritus
- Dept. of Civil and  
Envl. Engineering
- The University of  
Michigan

# Case Study No. 1 - Stream Bank *Stabilization*

# Case Study No. 2 - Slope Stabilization

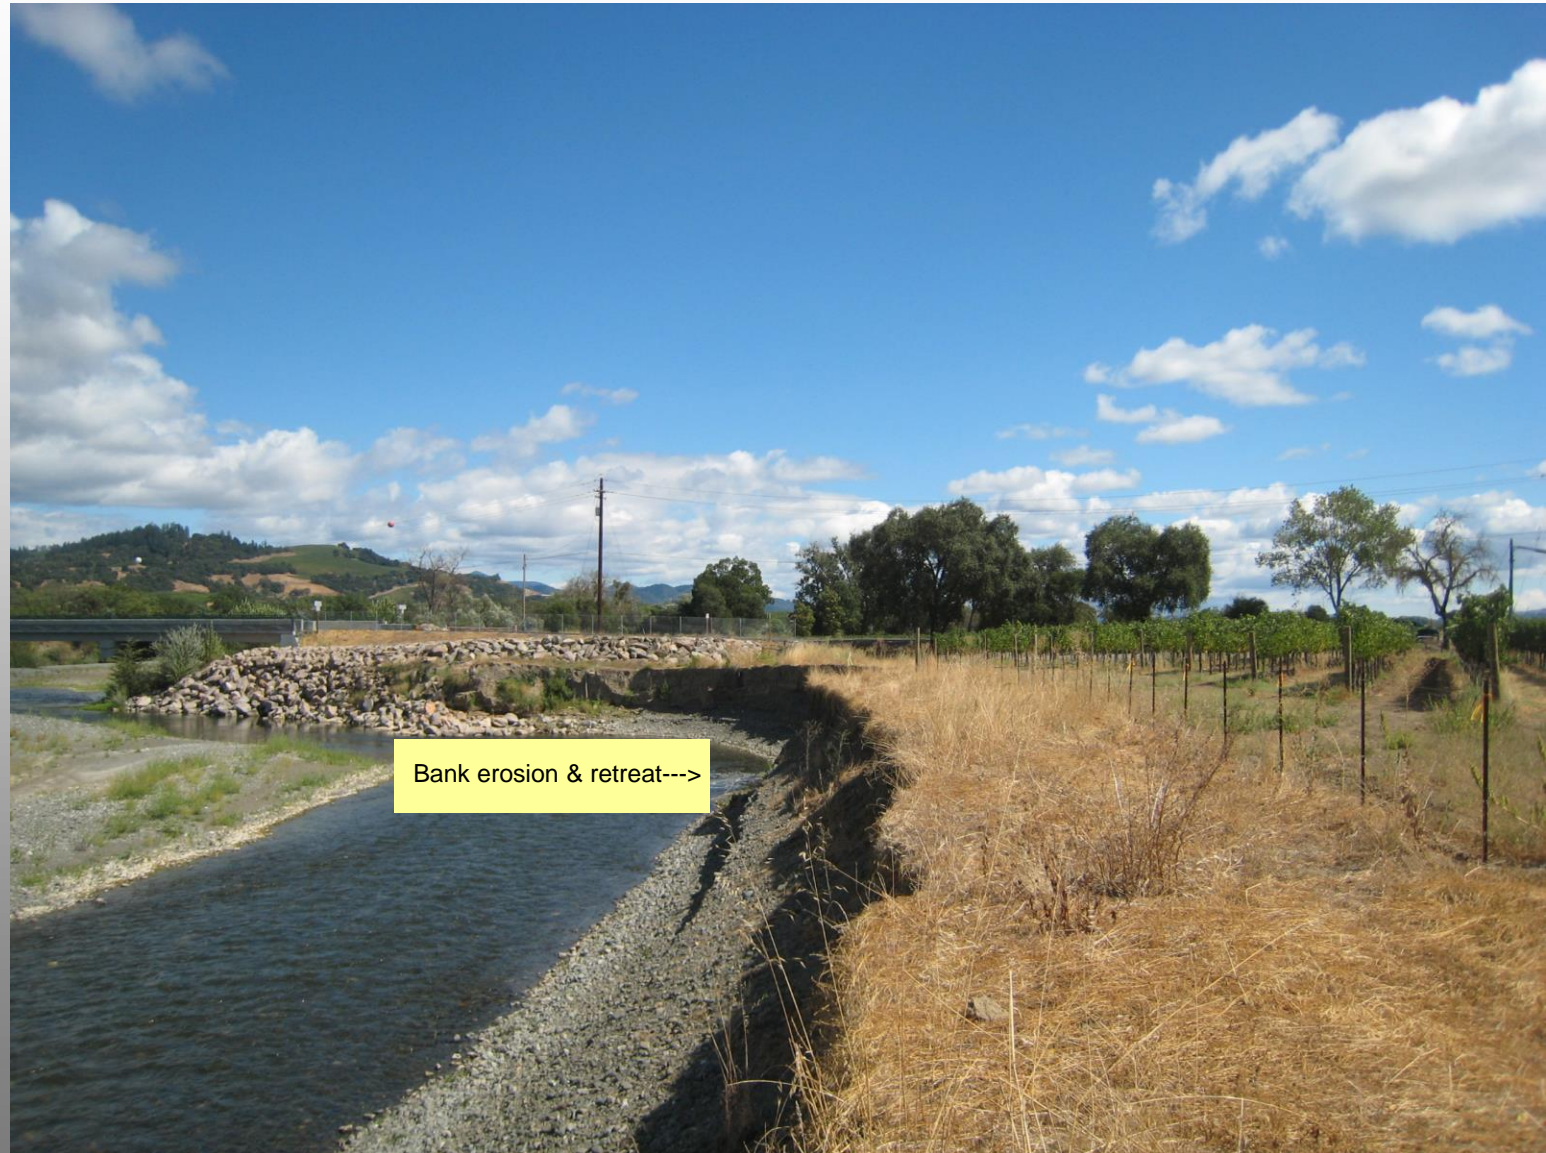
# Initial Site Conditions

Bank erosion & retreat-->

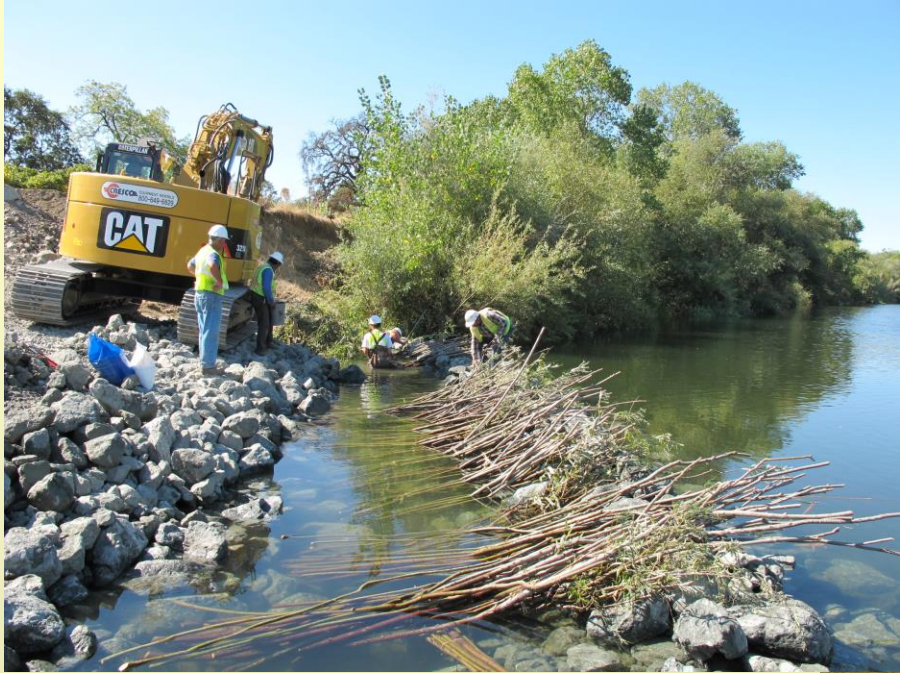
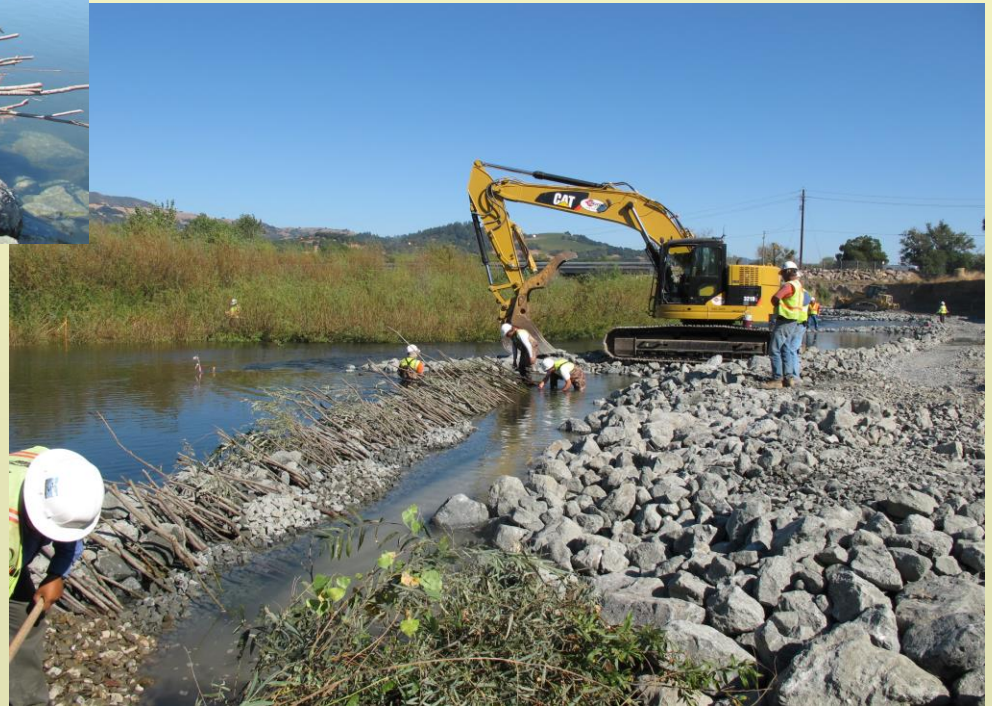
# *Live Siltation Construction*

Live cuttings were placed behind and leaning against a LSTP on edge of rock ramp

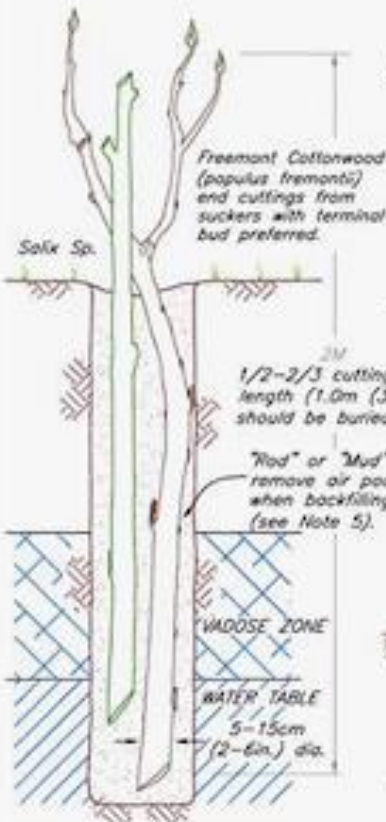
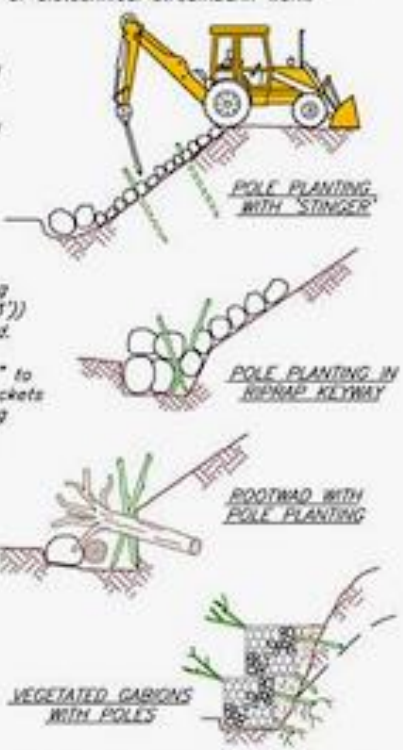
**WILLOW POSTS & POLES**

*Plant poles deeply during construction of biotechnical streambank work.*

*Freemant Cottonwood (populus fremontii) end cuttings from suckers with terminal bud preferred.*

*1/2-2/3 cutting length (1.0m (3')) should be buried.*

*"Rod" or "Mud" to remove air pockets when backfilling (see Note 5).*

1. Pole cuttings of willow or cottonwood are longer and have a larger diameter than branch cuttings or live stakes.
2. Larger diameter cuttings have a greater supply of stored energy (stored photosynthesis) than smaller diameter cuttings.
3. Pole cuttings are better suited for highly erodible areas and sites with fluctuating water levels.
4. The pole cuttings should extend through the vadose zone and into the permanent water table. At least 1/2 to 2/3 of the pole should be below the ground, at least 1.0 m (3 ft.), and long enough to emerge above adjacent vegetation.
5. "Muddying" - filling the hole with water and then soil to make a mud slurry can remove air pockets.

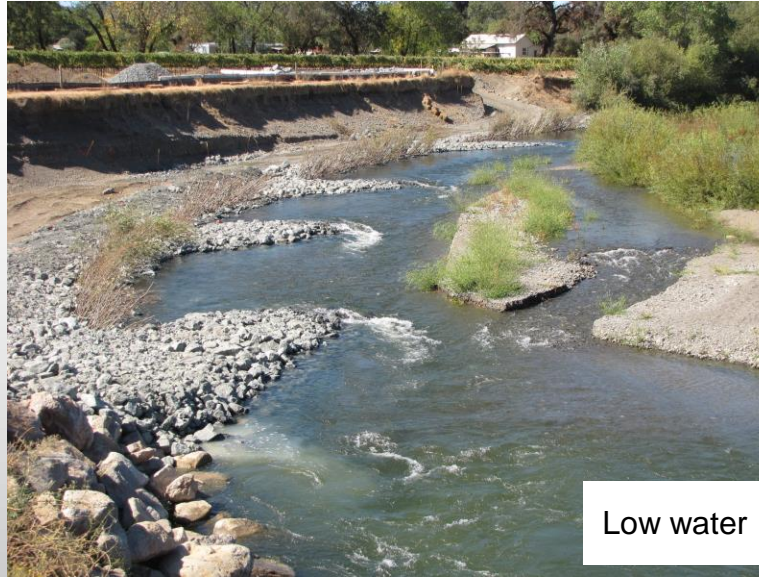
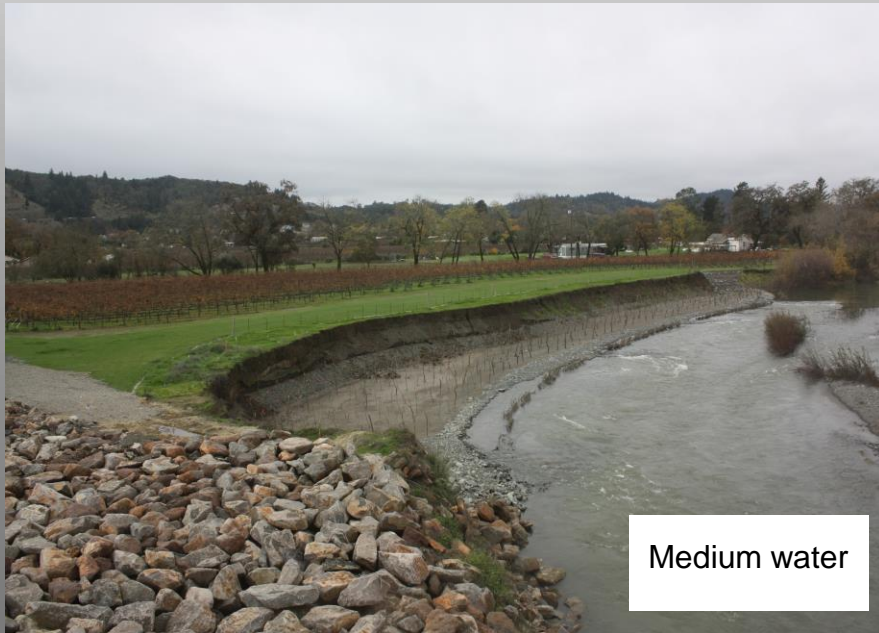
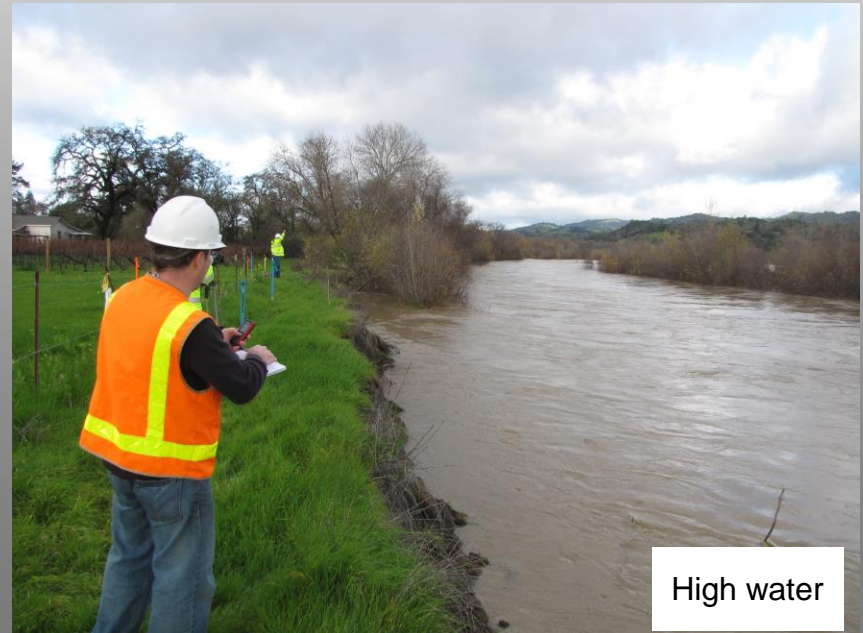
# *Thalweg Displacement*

Low water

Medium water

High water

- ❑ The rock vanes were redirected the high flow currents away from the actively eroding bank
- ❑ The project demonstrates that rock vanes can be effective in large, high energy rivers, where large rock armor has traditionally been used
- ❑ Willow cuttings used for live siltation and willow poles planted on the low flood terrace helped to slow stream velocities and promote sedimentation.
- ❑ After a relatively short learning curve, the techniques employed were very “buildable” and cost-effective.

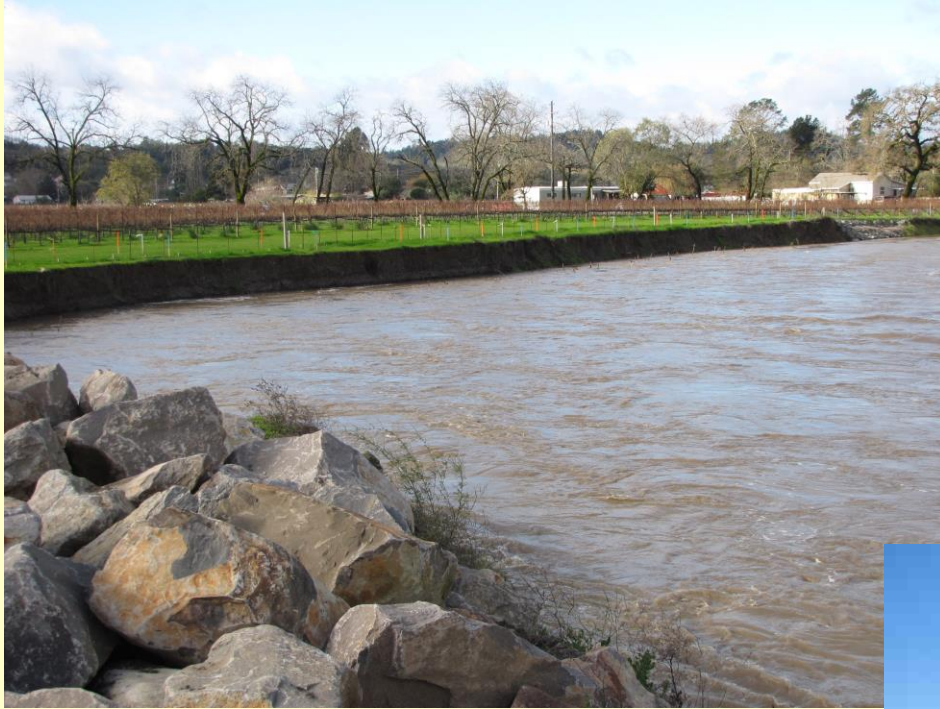
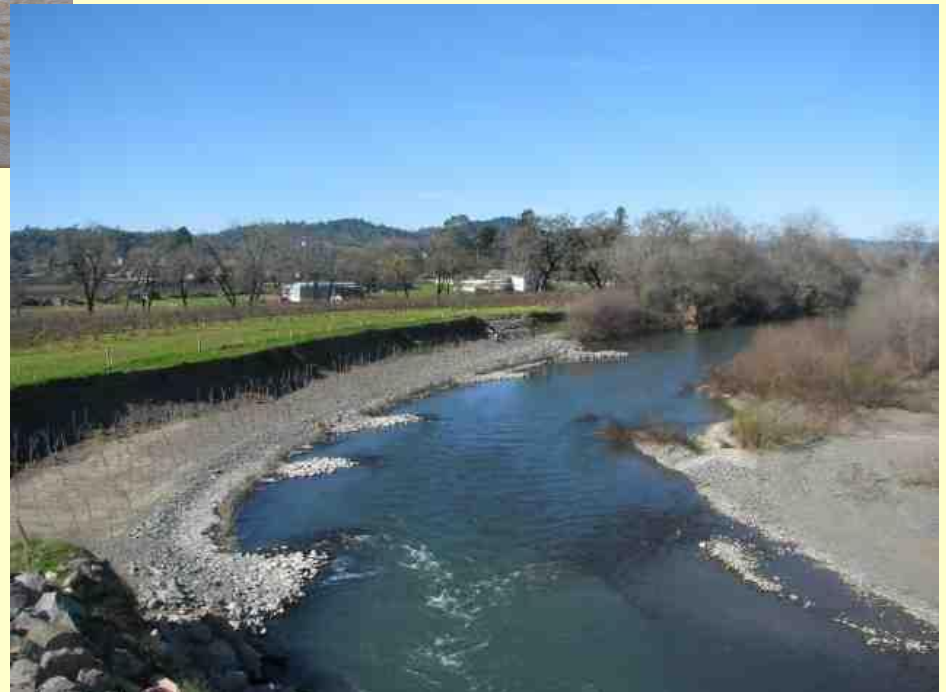
# *Storm (Flood) Response*

<---During Dec 2010 flood

After Winter----->  
2010/2011 Floods

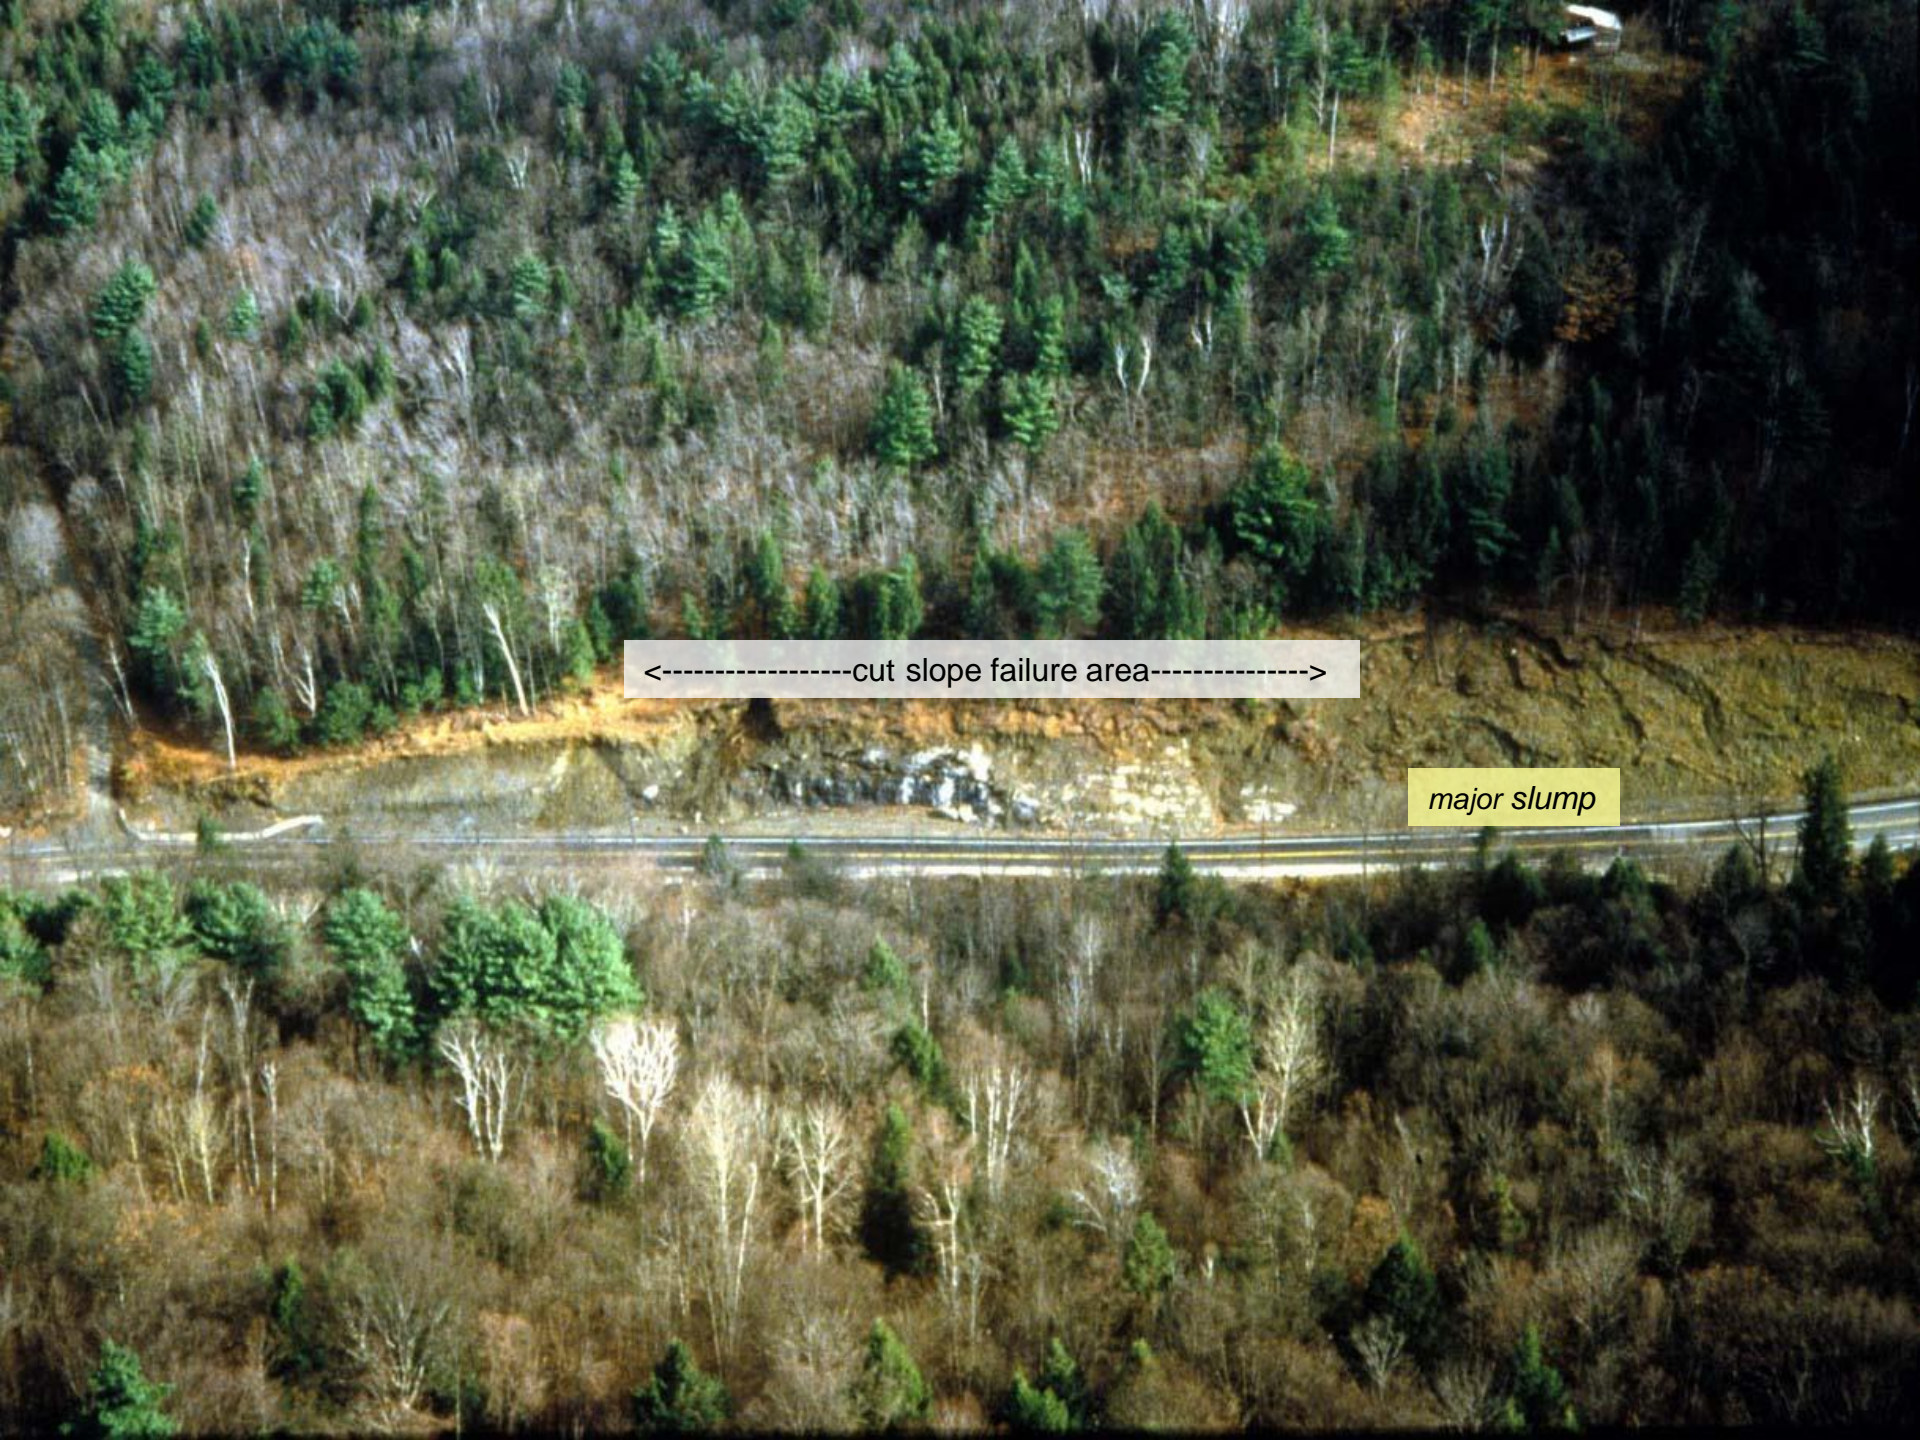
<-----cut slope failure area----->

*major slump*

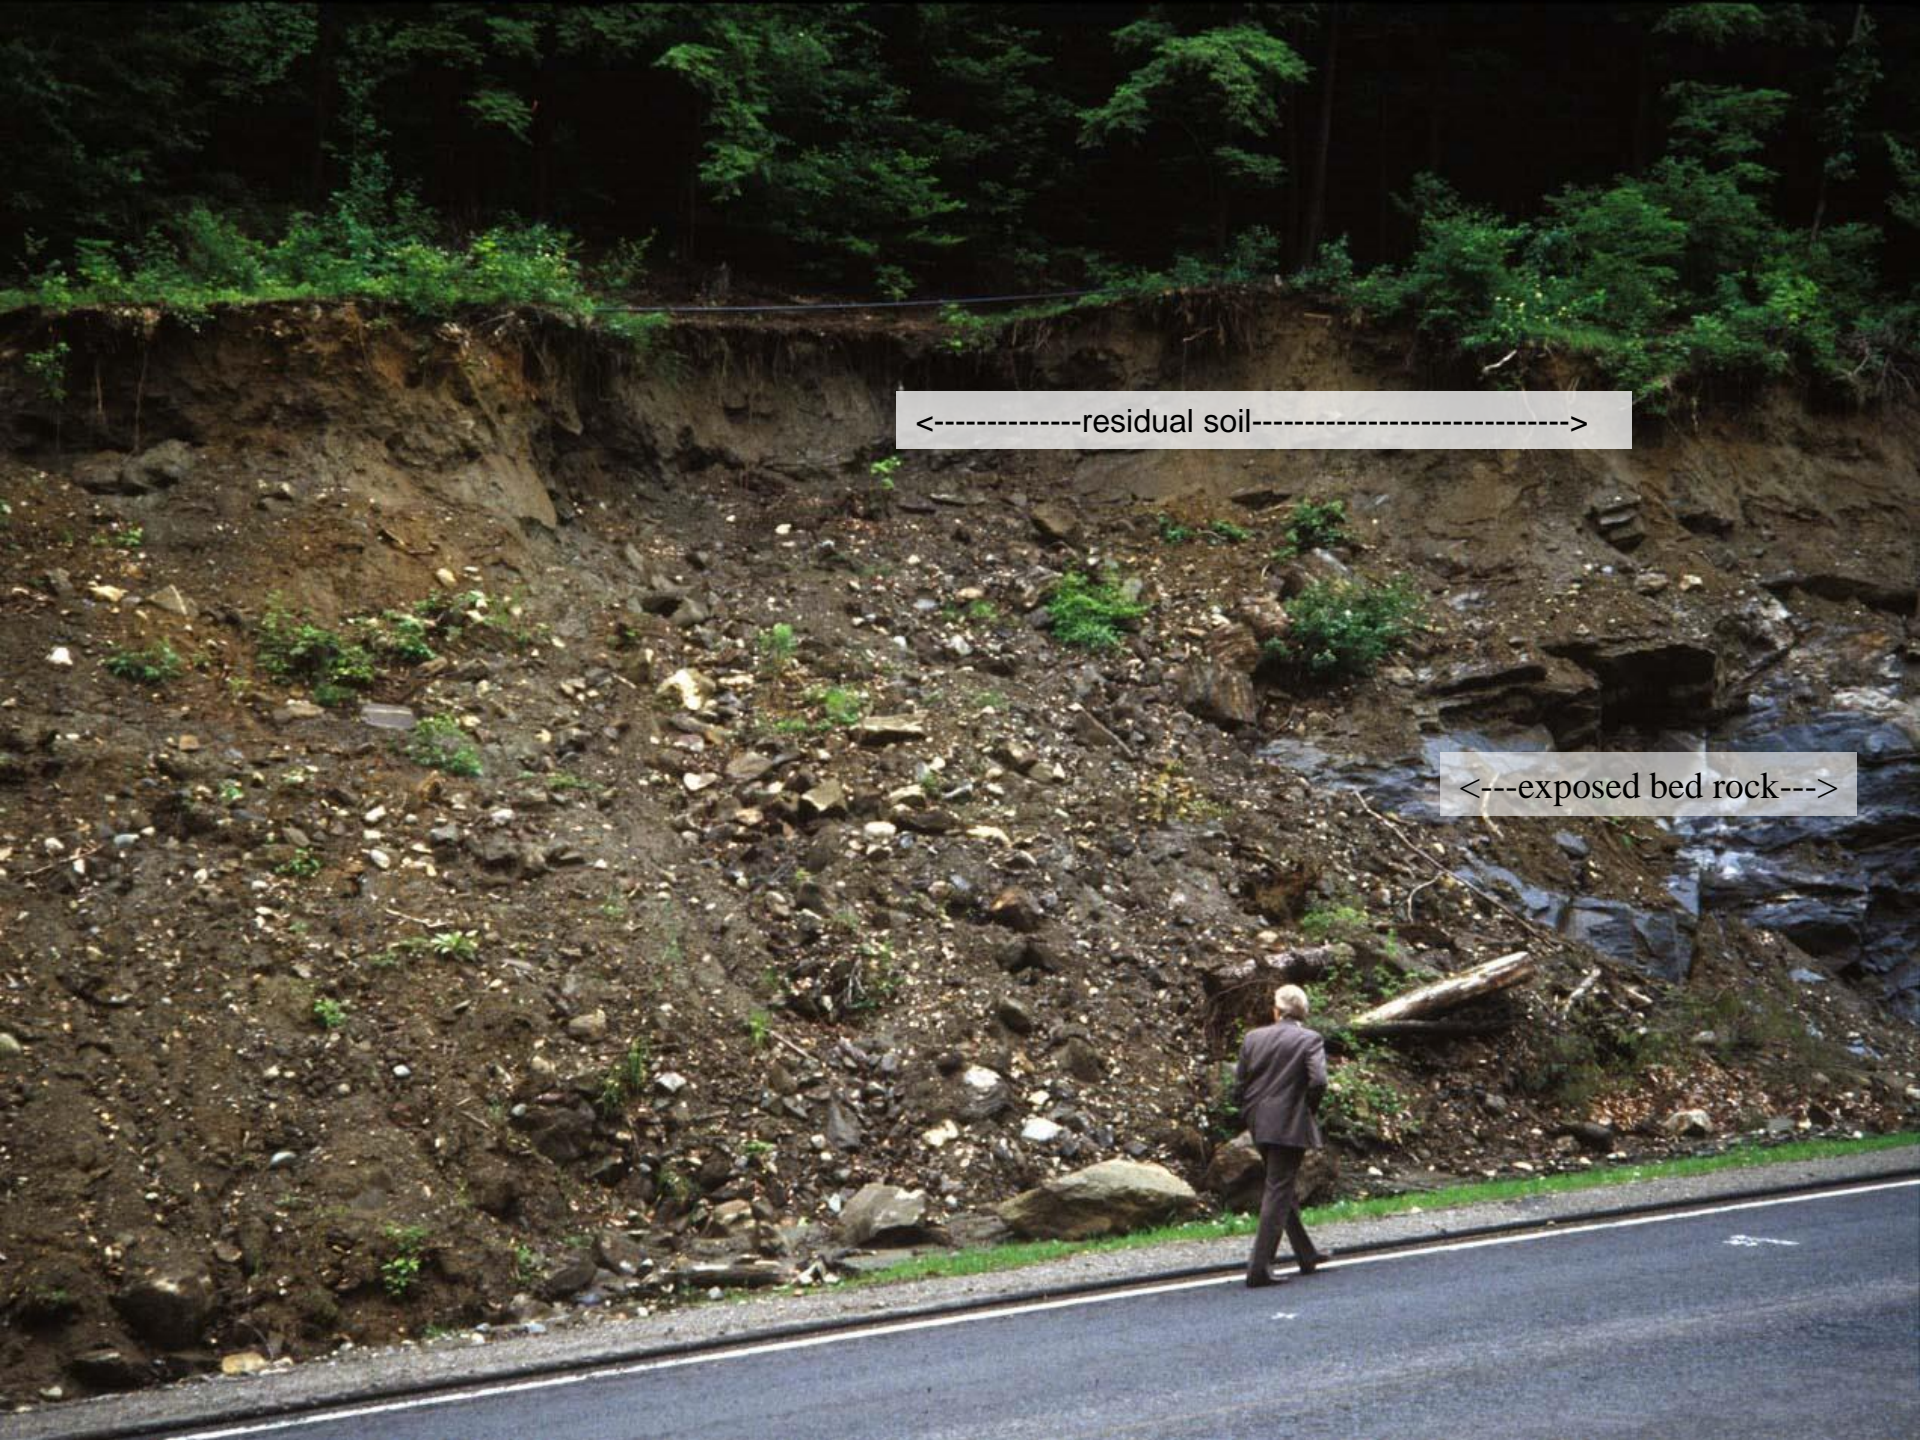
<-----residual soil----->

<---exposed bed rock--->

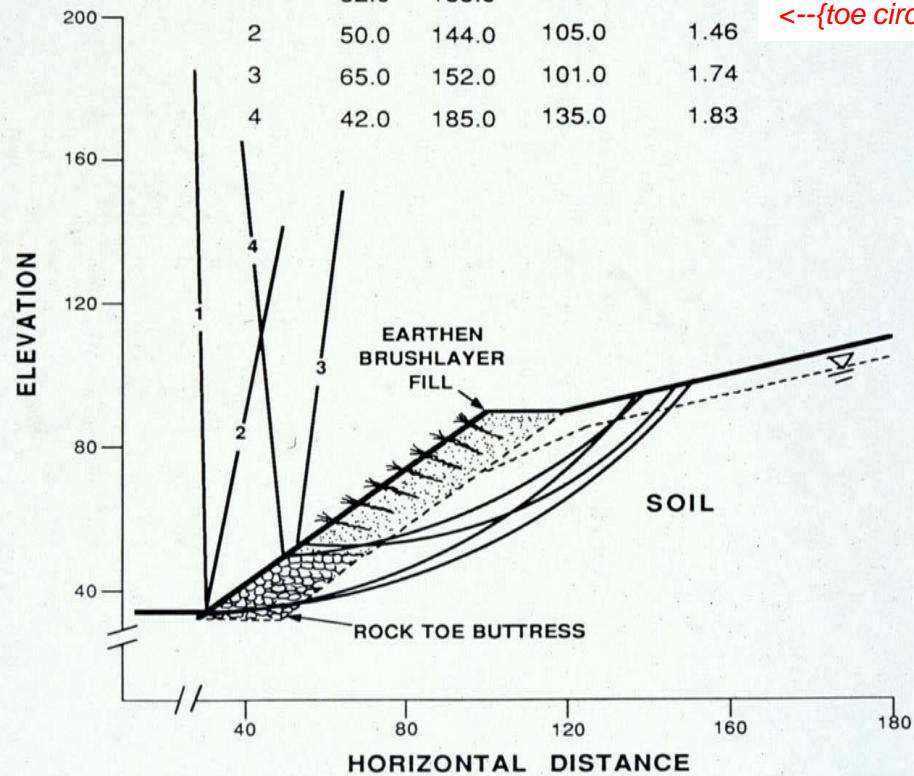
## Simplified Bishop Slope Stability Analysis

- Rock toe-buttress with brushlayer reinforced fill

PROJECT: SLOPE REPAIR WITH COMPOSITE ROCK TOE BUTTRESS AND EARTHEN BRUSHLAYER FILL

COMPLETE SLOPE CROSS SECTION

CIRCLE	X	Y	RADIUS	FS
1	32.0	185.0	145.0	1.50
2	50.0	144.0	105.0	1.46
3	65.0	152.0	101.0	1.74
4	42.0	185.0	135.0	1.83

1. Willows performed better than alder; pre-construction trials may be necessary to identify best performing plant material
2. Conventional geotechnical slope stability analyses can be adapted to evaluate the stability of biotechnical slope stability installations.
3. Conventional slope stabilization techniques, e.g., a rock-toe buttress, can be combined successfully with soil biostabilization techniques, e.g., live brushlayering.

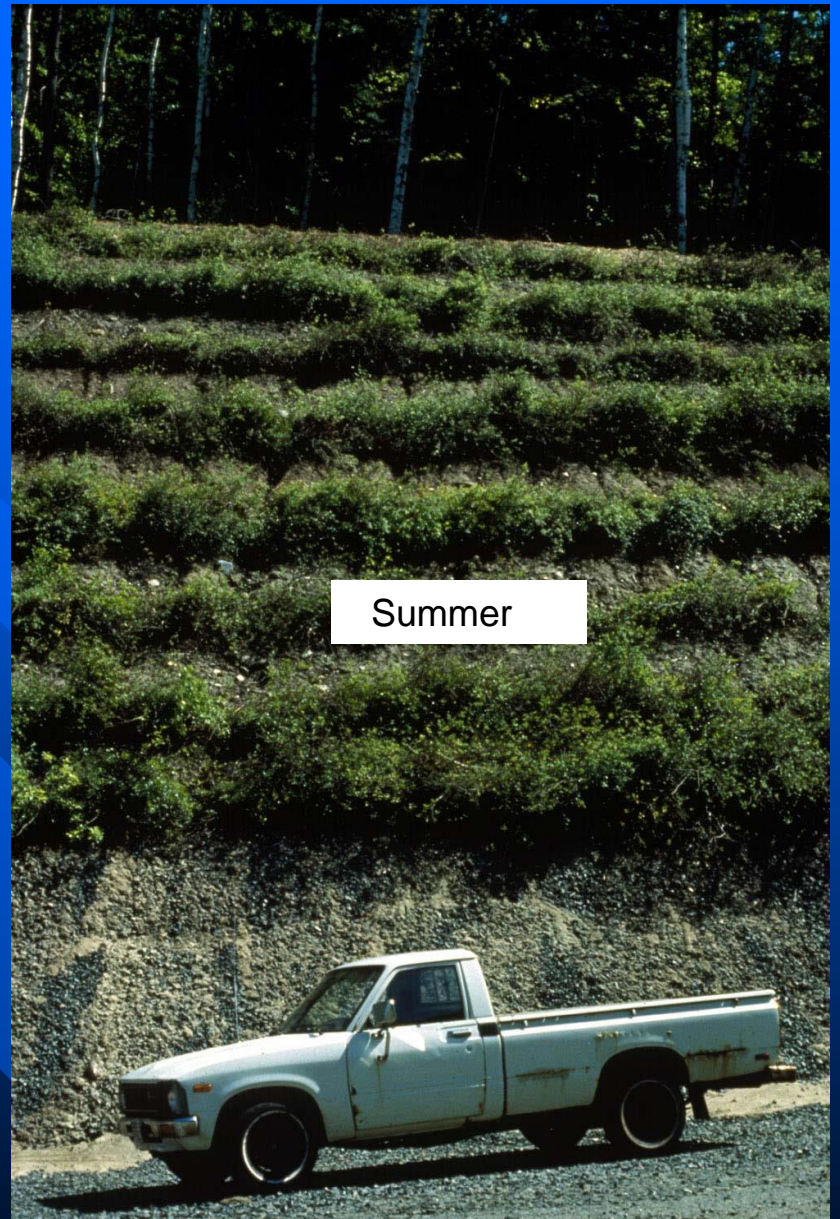
Summer

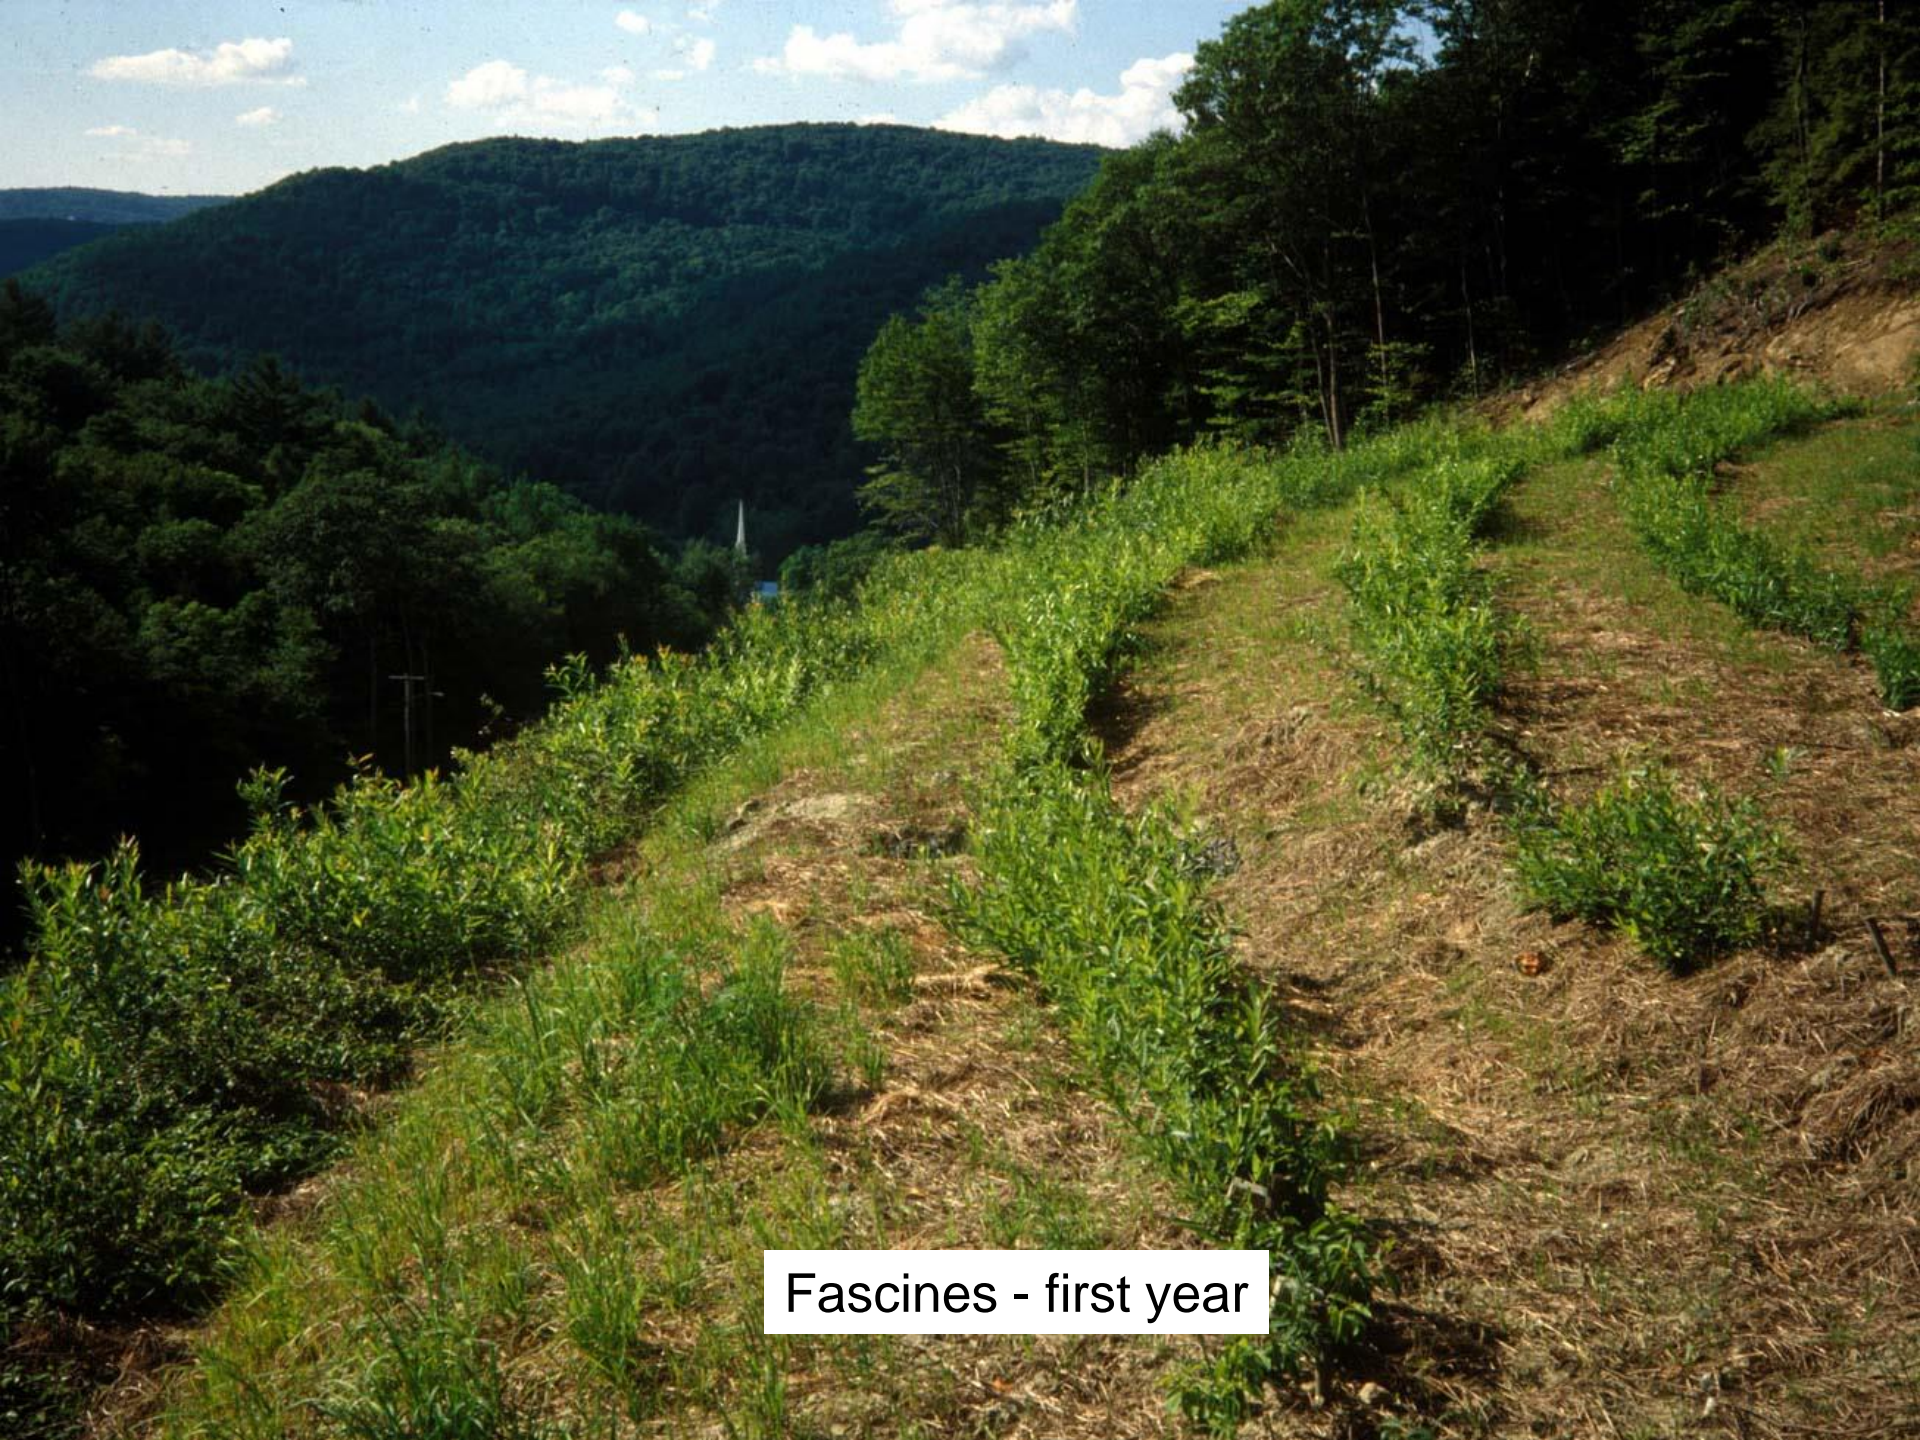
Fascines - first year

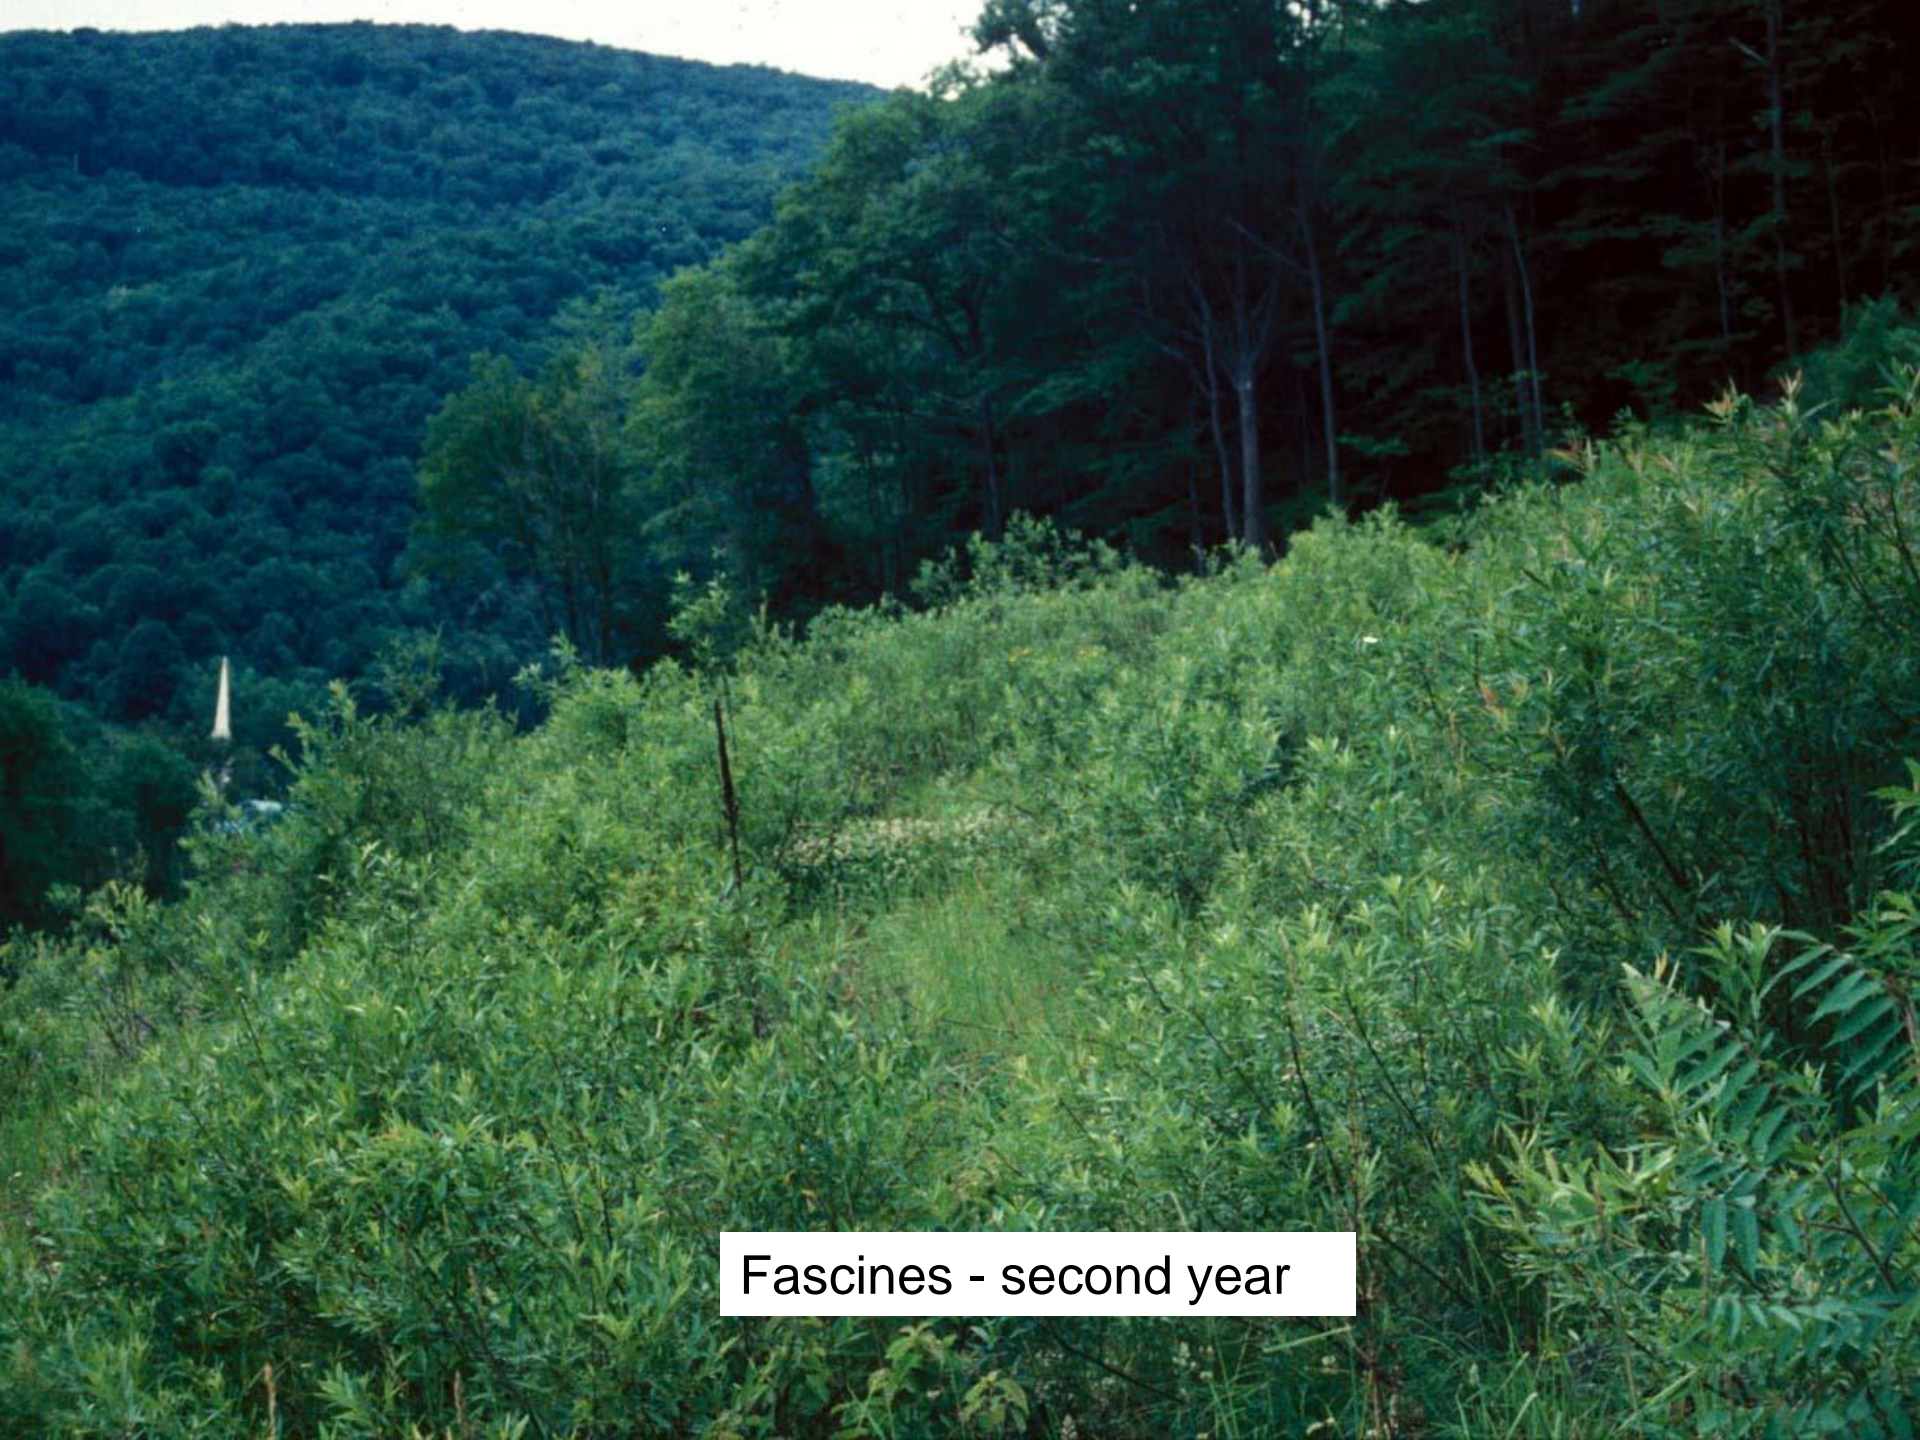
Fascines - second year
