Geosynthetics in Transportation Engineering: New Solutions to Old Problems

Robert D. Holtz, PhD, PE University of Washington, Seattle

Third G. A. Leonards Lecture Purdue University 16 May 05

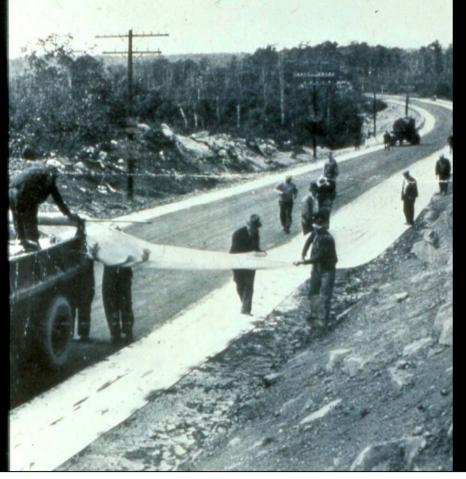
Surfacing soft shoulders with cloth-reinforced asphalt in Rhode Island. The cotton strips are being laid out to the toe of the slope to prevent erosion. OPEN-MESH FABRIC, eight threads to the inch, was used on Round Top road; this is a medium weave as practice varies from six to twelve threads per inch.

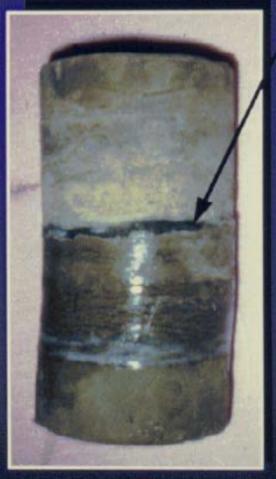
Frost Heave Requires:

Capillary Barrier

Freezing temperatures
 Frost-susceptible soil
 Water supply

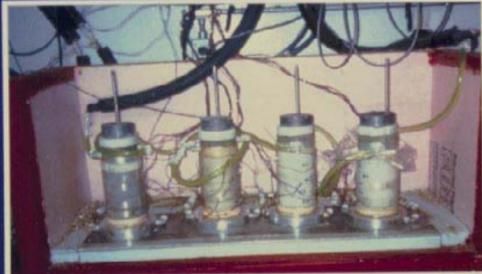
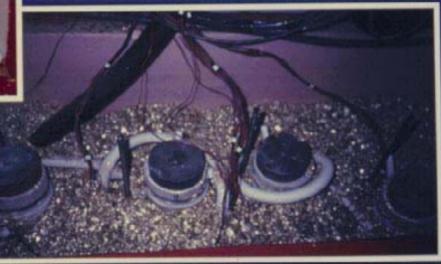
Freezing Tests

- 100 x 150 mm
- <25 mm water level
- Geosynthetic at 30 mm
- Bottom temp 0.7°C
- Top temp
 - 1.5 (low)
 - 3.0 (high)

- Moist geotextiles did not reduce frost heave
- Moist geocomposites reduced frost heave when soil was < 75% saturated
- Above two results were not product dependent
- Results did not depend on freezing rate
