Monitoring Drinking Water Chemical Quality Changes at a Residential Net- Zero Energy Building

Tolu Odimayomi, Maryam S. Esfandarani, Christian Ley, Jade Mitchell, Janice Beecher, Joan Rose, Juneseok Lee, Pouyan Nejadhashemi, Erin Dreelin, Tiong Gim Aw, Amisha Shah, Matt Syal, Gulshan Singh, Ryan Julien Kara Dean, Ian Kropp, and Andrew J. Whelton

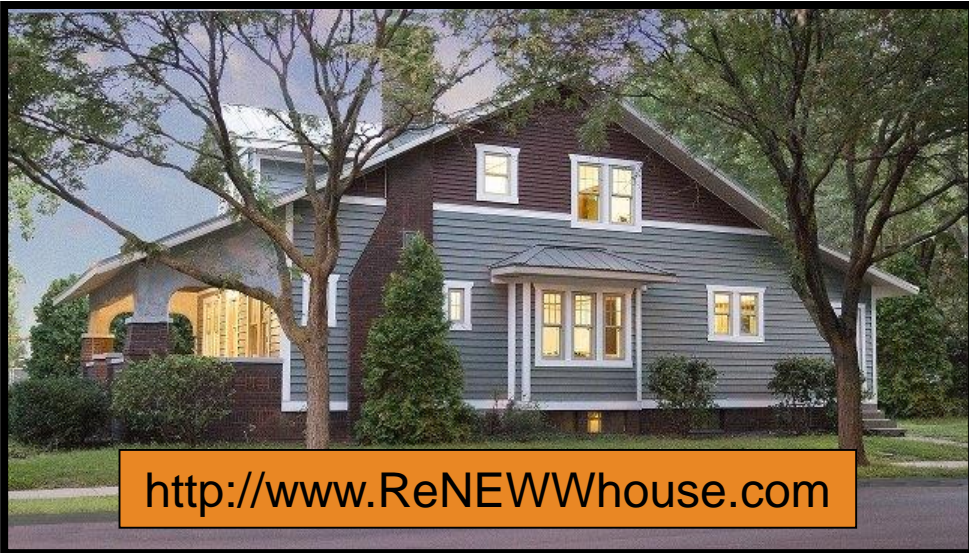
- Low flow fixtures
- Flow rate monitoring at each fixture
- Continuous water usage monitoring
- Four water heater tanks in series, three 108 gal and one 40 gal

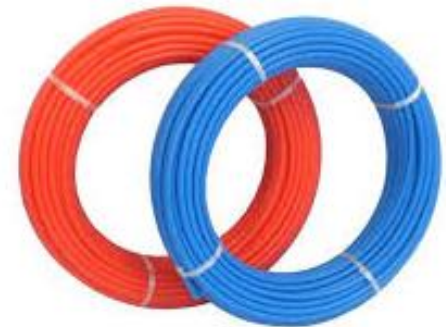
PEX-A

City water: Groundwater, treated with free chlorine residual and a corrosion inhibitor, PVC and Iron water mains

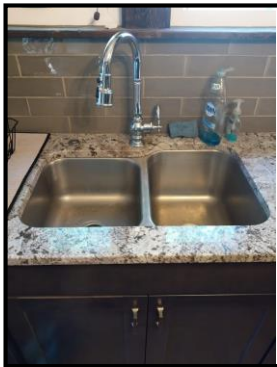
1KC & 1KH
1st Floor
Kitchen Cold
and Hot

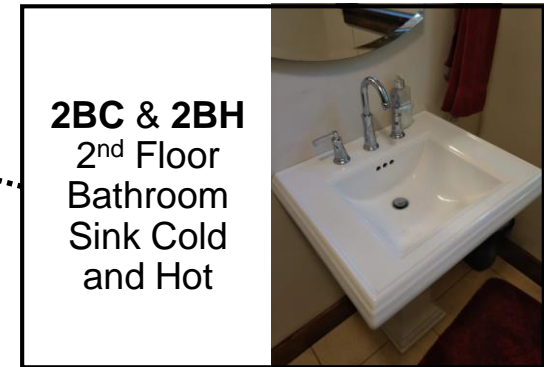
2BC & 2BH
2nd Floor
Bathroom
Sink Cold
and Hot

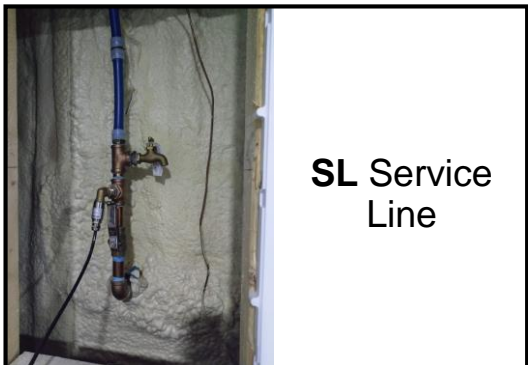
SL Service
Line

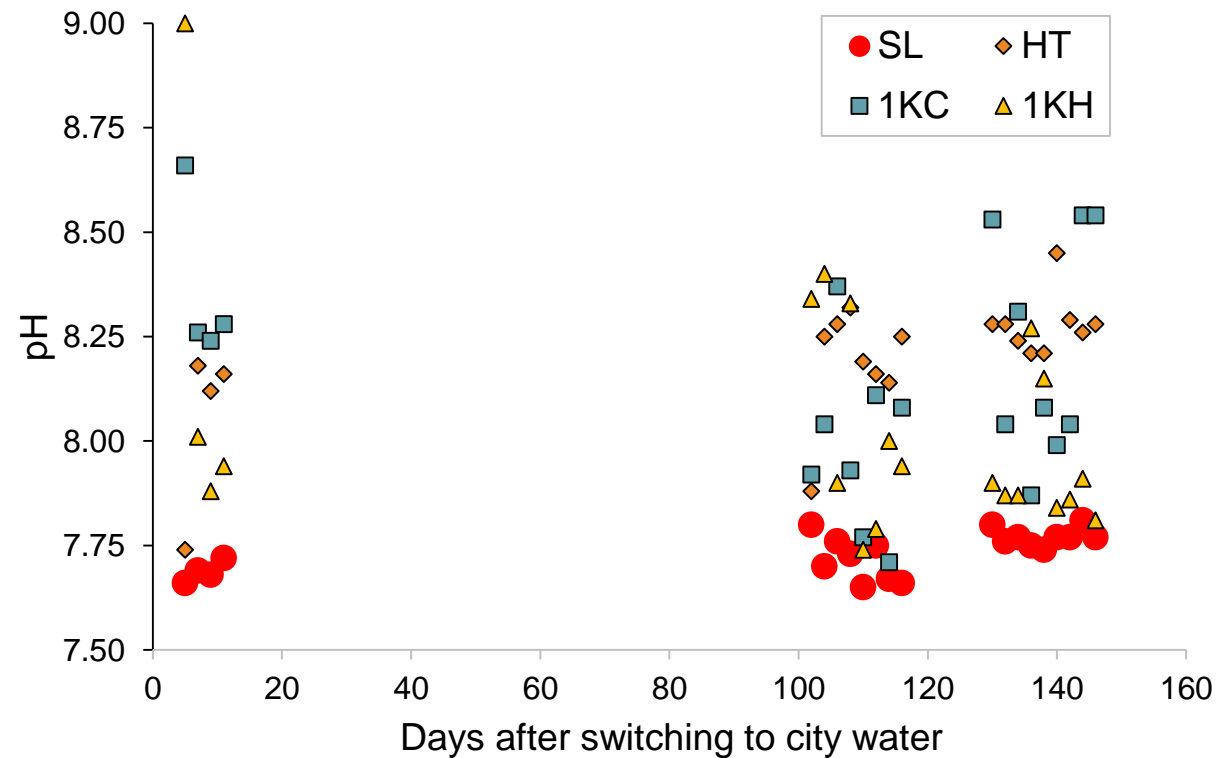
pH levels within the house
where **higher** compared to
city water

Little change was seen in
average pH across the
sampling periods

Water pH ranged from 7.6
to 9.0

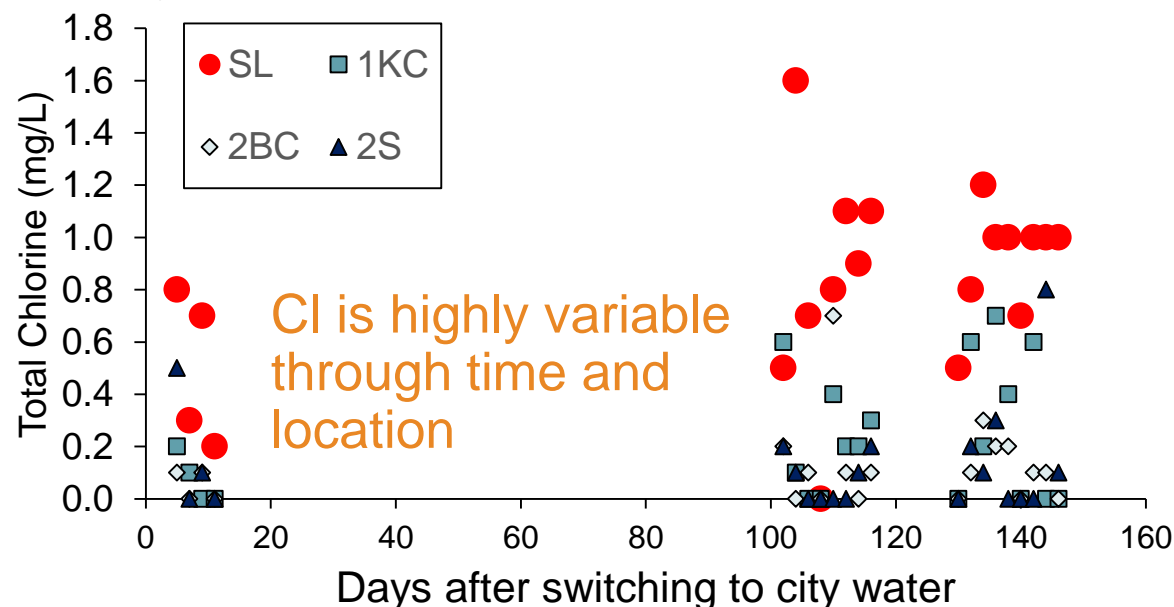
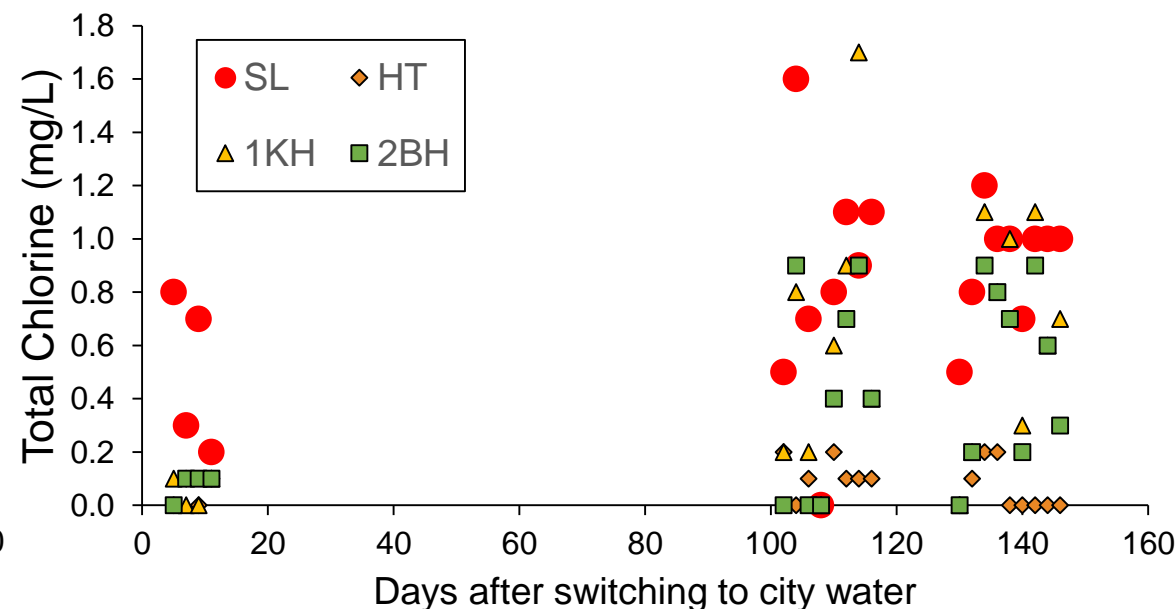
Total Chlorine

Chlorine residual is greatest at in the city water

Chlorine level ranged from 0.0 to 1.7 mg/L

Total chlorine is **undetectable** for over 60% of samples taken at the water heater and shower

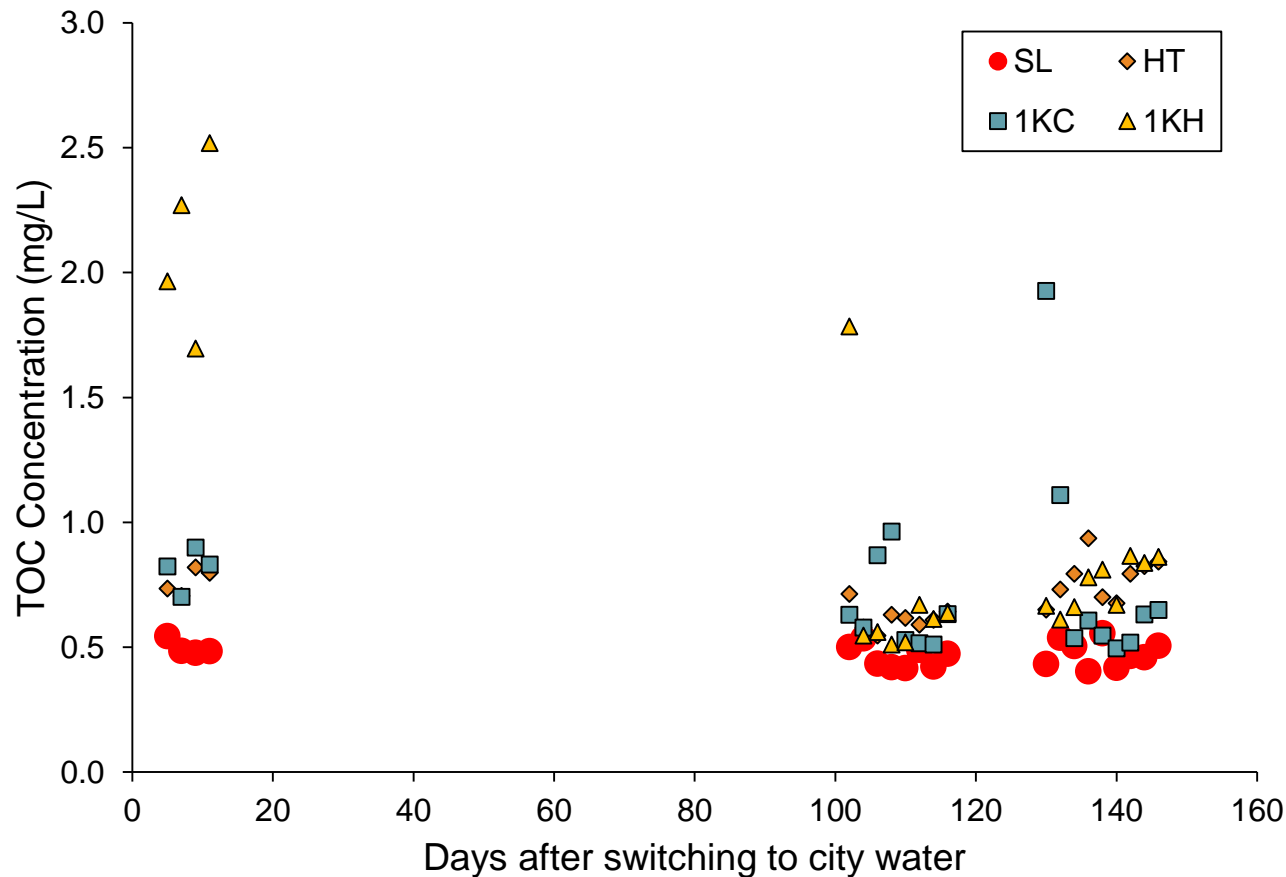
TOC & DOC

TOC is **stable** through time at each location for sampling periods 2 and 3

Above 80% of the organic total organic carbon was dissolved for sampling periods 1 and 2. During sampling period 3 this values dropped to 70% and above.

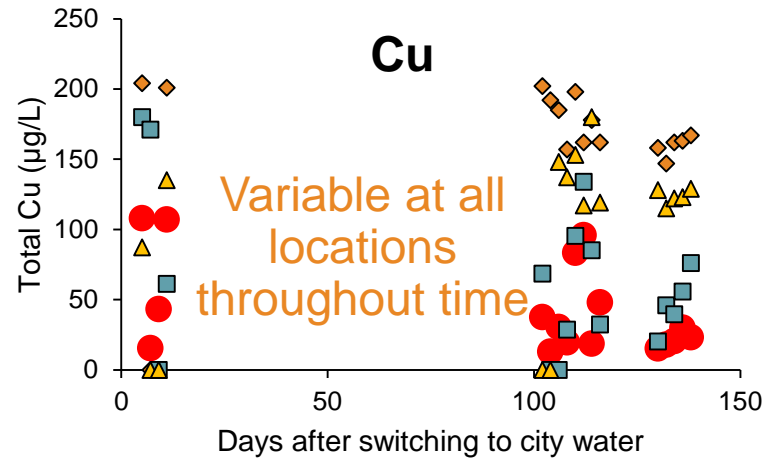
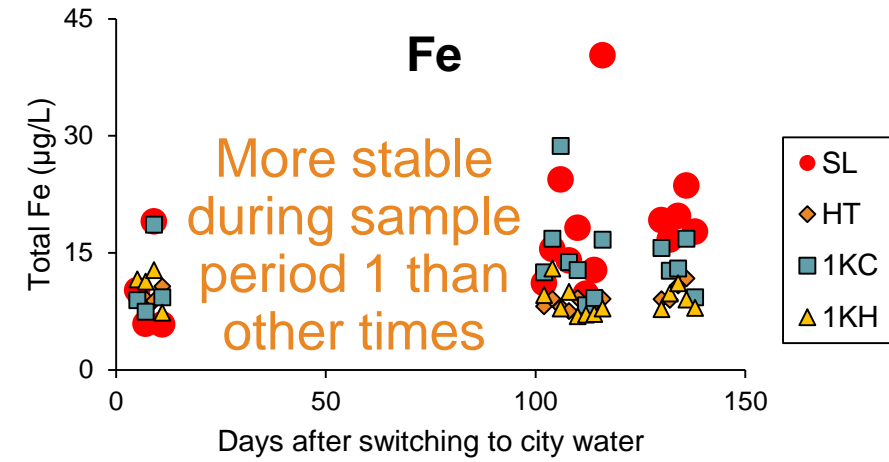
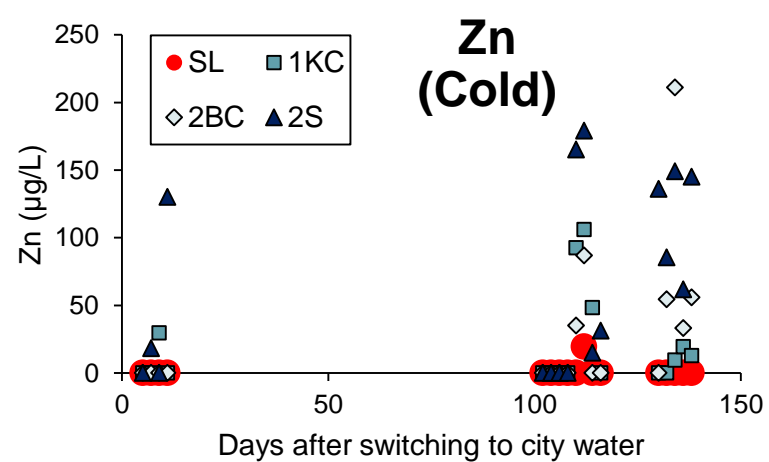
Total Metals

Cu	83.8%
Pb	67.7%
Fe	19.7%
Zn	9.9%

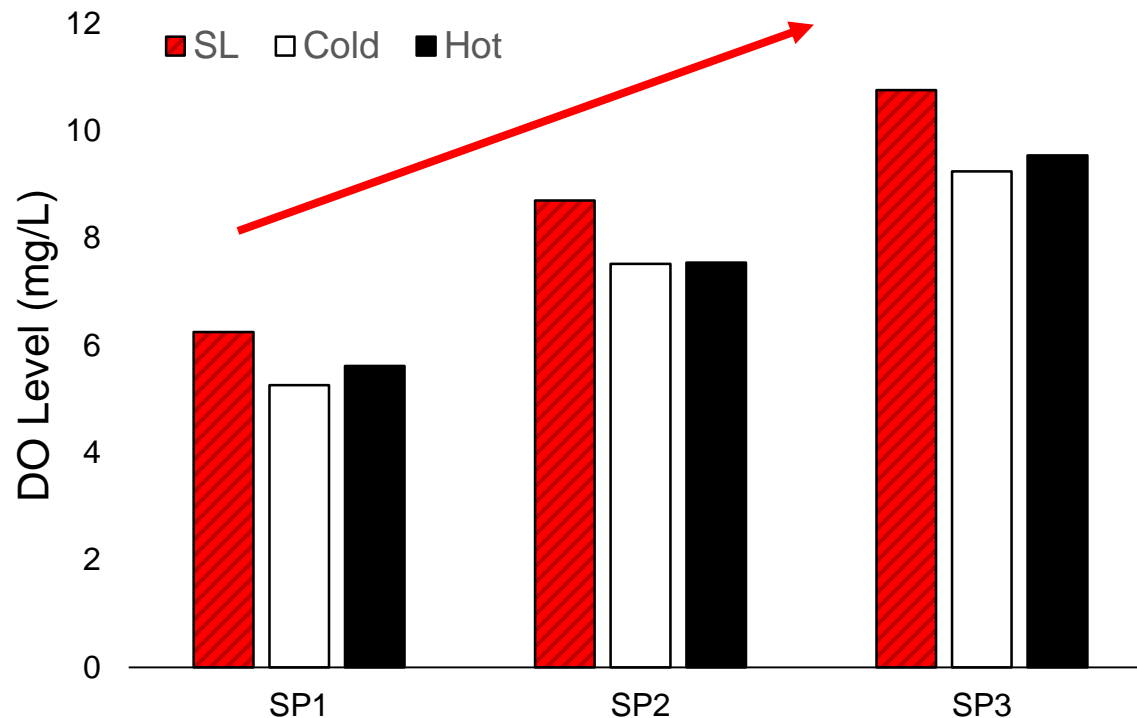
Dissolved Oxygen

DO levels within the house where **lower** compared to city water for the second and third sampling periods

DO level increases during each sampling period
