The Link between Fixture Water Use and Drinking Water Quality at a Net Zero Energy Residential Building

By: Maryam Salehi, Andrew Whelton, Mohammad Abouali,
Mian Wang, Zhi Zhou, Amir Pouyan Nejadhashemi,
Jade Mitchell, Stephen Caskey

*Lyles School of Civil Engineering, Division of Ecological and
Environmental Engineering & School of Mechanical Engineering
Purdue University*

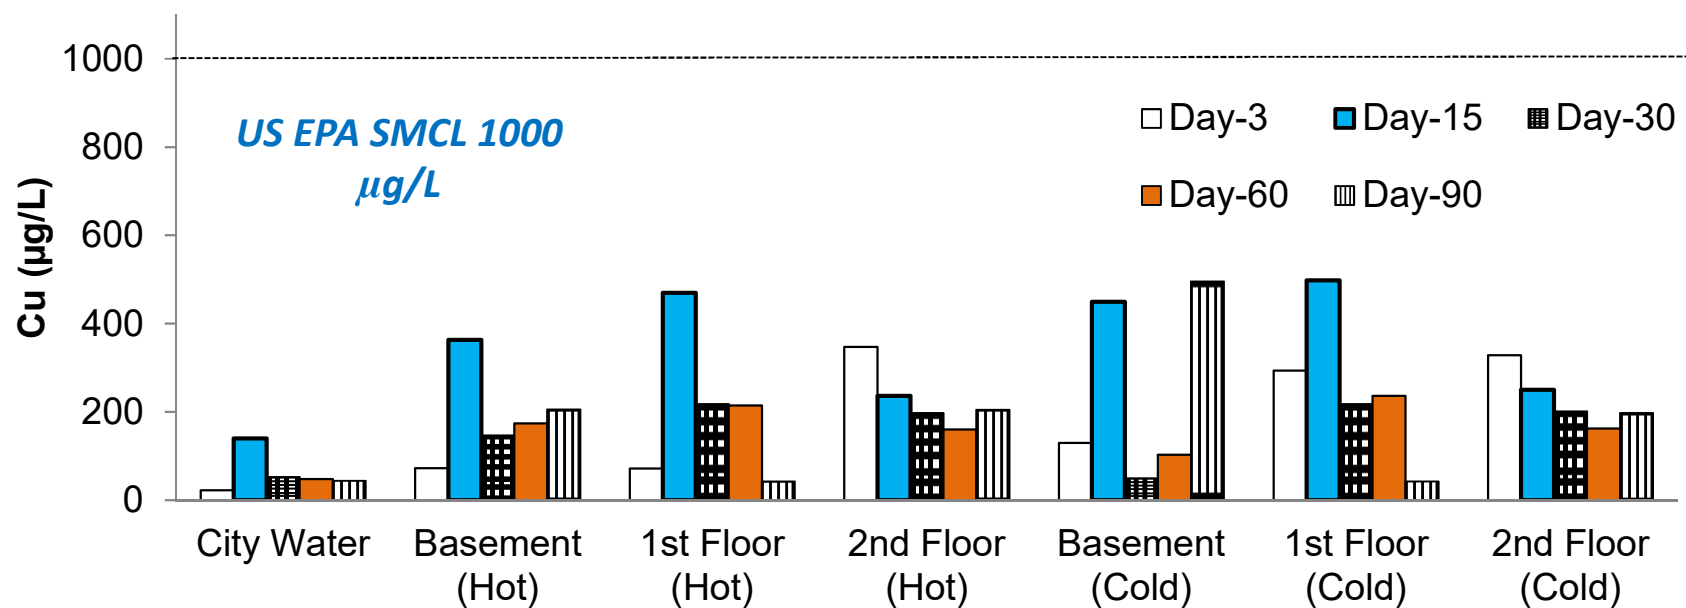
Several Heavy Metals with Health & Aesthetic Limits were Detected

The **basement fixture brass needle valve** may have caused maximum Zn (5.9 mg/L), Fe (4.1 mg/L), and Pb (23 µg/L) levels compared to other fixture water samples.
