Preliminary Results: Challenges and Solutions for Small Drinking Water Systems and Private Well Owners Impacted by the Marshall Fire

April 13, 2022

2214580 RAPID: Drinking Water System Contamination Response & Recovery Following the 2021 Colorado Fires

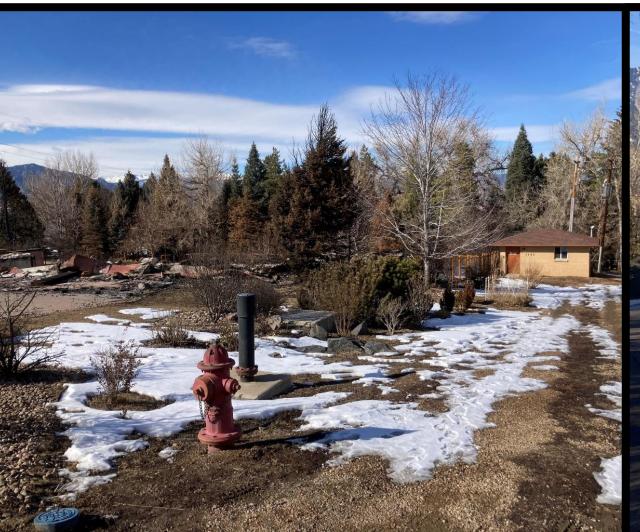
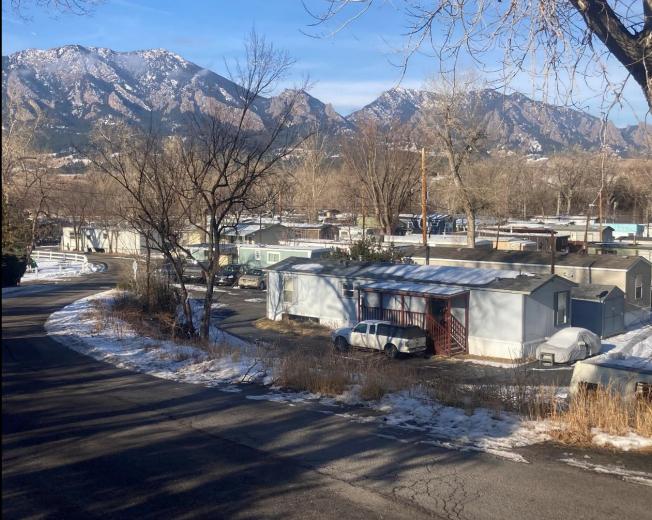
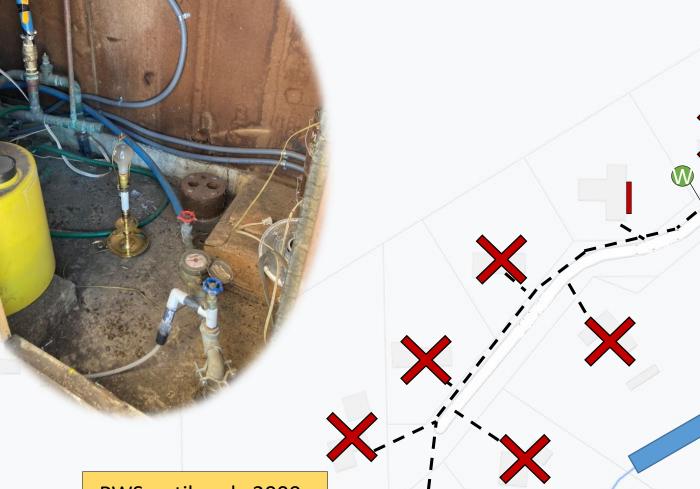
8 homes, not an HOA

1 well, 1 chlorinator, flow,
pressure monitoring
2 concrete cisterns

780 ft HDPE (3") water main
No hydrants

No water meters, no curb stops
1" HDPE service lines
160 ft max length

- Inoperable since Dec 30
- FEMA denied funding

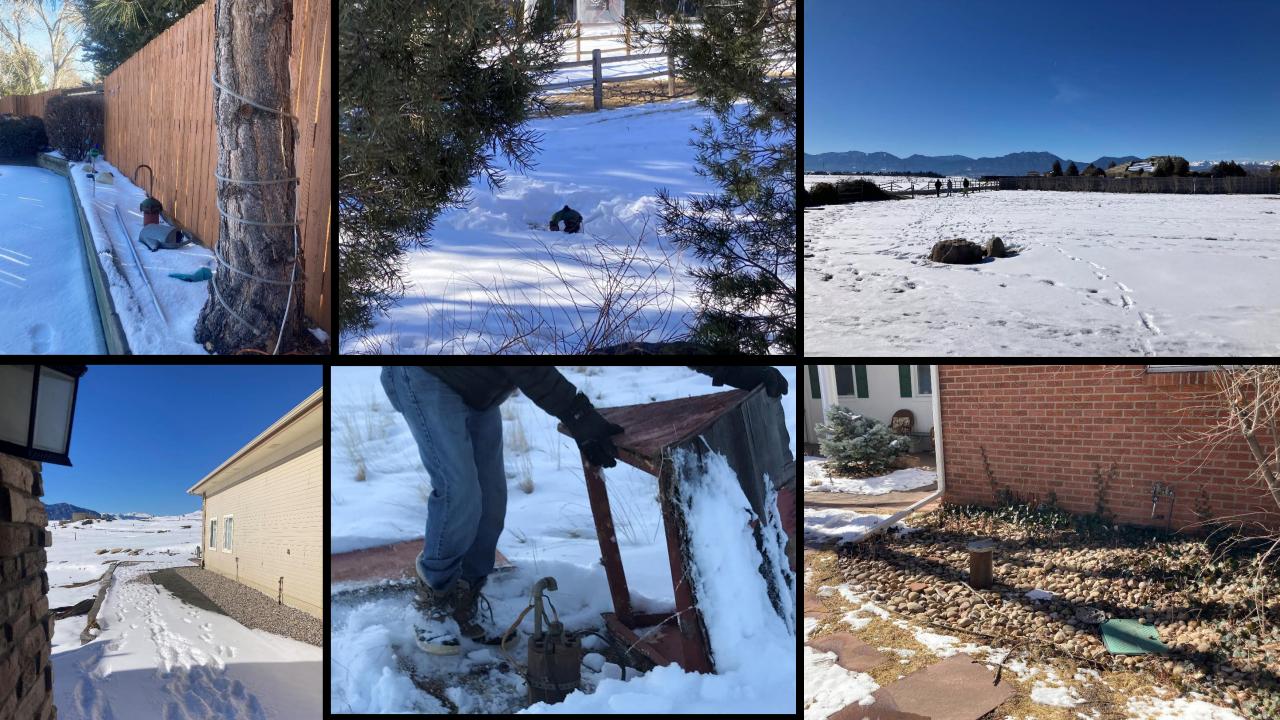
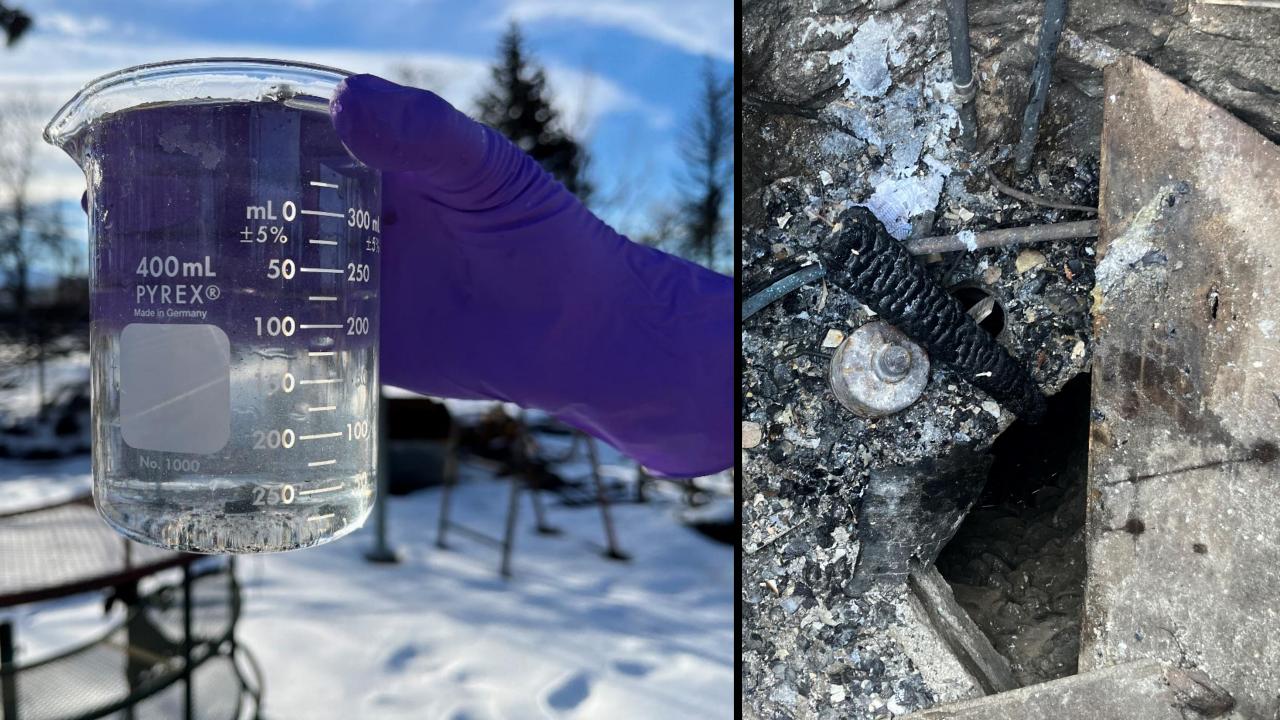
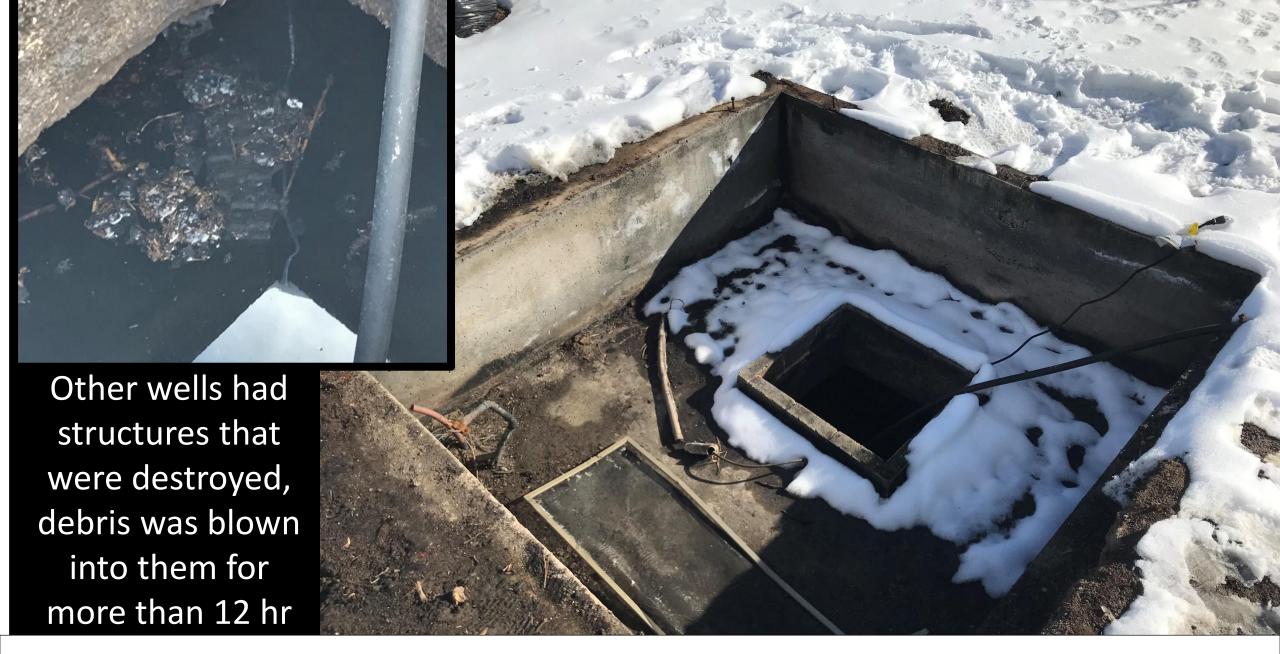
January 26 to 31, 2022 visits: 17 property contacts
Limitations discovered while onsite: Lack of power, sampling faucet, access, component condition
Complexity of in-home treatment was wide ranging

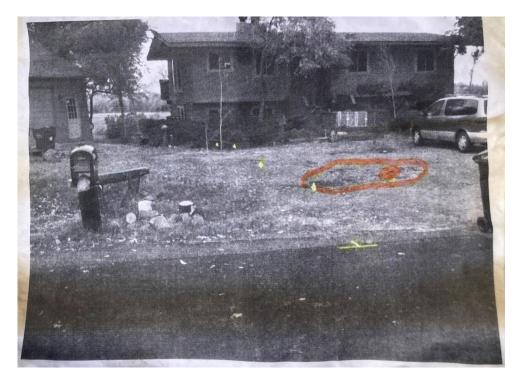
3.5 Months Post-wildfire

FEMA says they do not qualify for support CDHPE says their well is inactive and they were an HOA Depressurized since December 30, 2022 Unclear if there's mechanical damage or chemical contamination Waiting for debris removal before fixing the water system
