VOC Fate in Water Systems

Discussion to Support the Water Systems Task Force

11:30 AM EST (8:30 AM PST) March 4, 2019

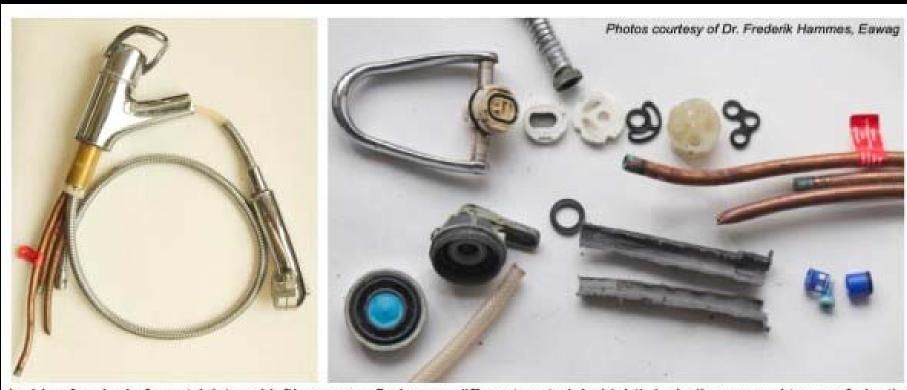
A single faucet can contain a variety of metal and plastic materials

Inside of a single faucet (pictured left), one can find many different materials (right), including several types of plastic.

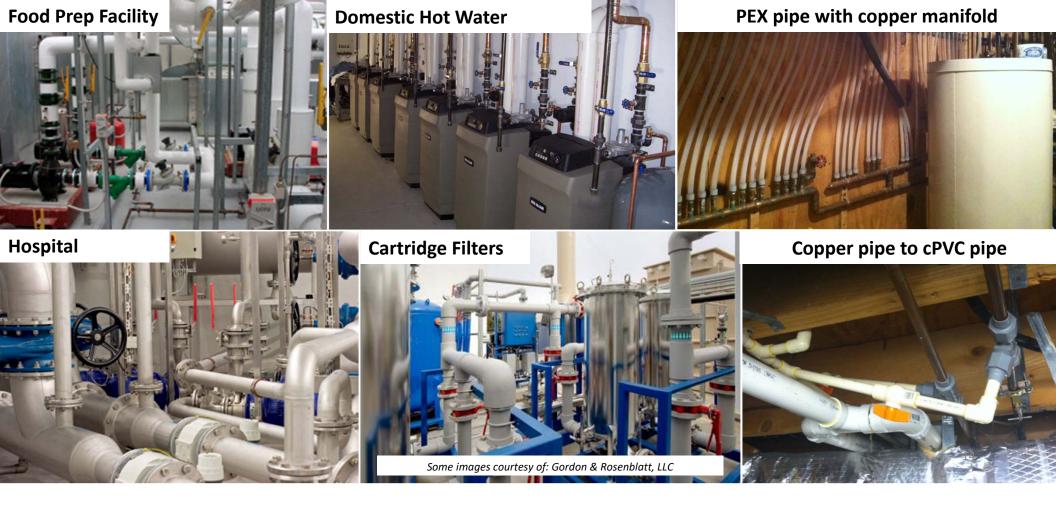
Premise plumbing is complex

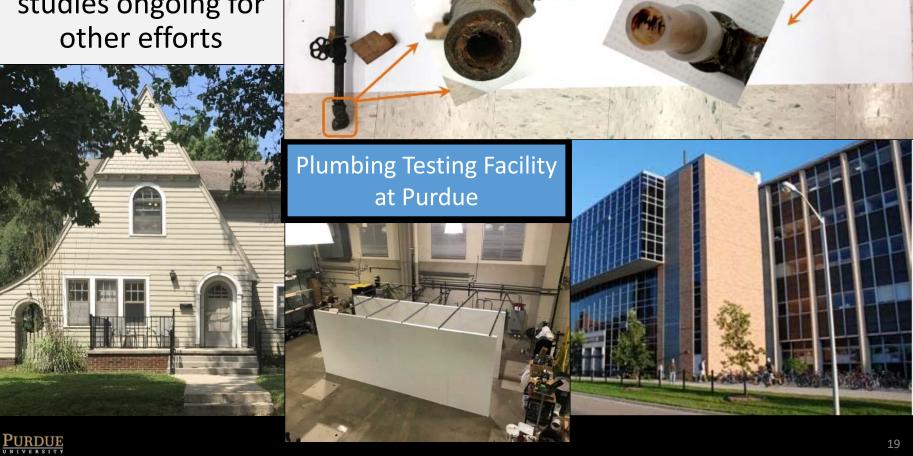
We have field- and pilot-scale plumbing studies ongoing for other efforts
