Community Update: Rapid Response to the Norfolk Southern Chemical Spill and Chemical Fires in East Palestine, Ohio

Paula Coelho, Andrew Whelton, Ph.D.,
and many more

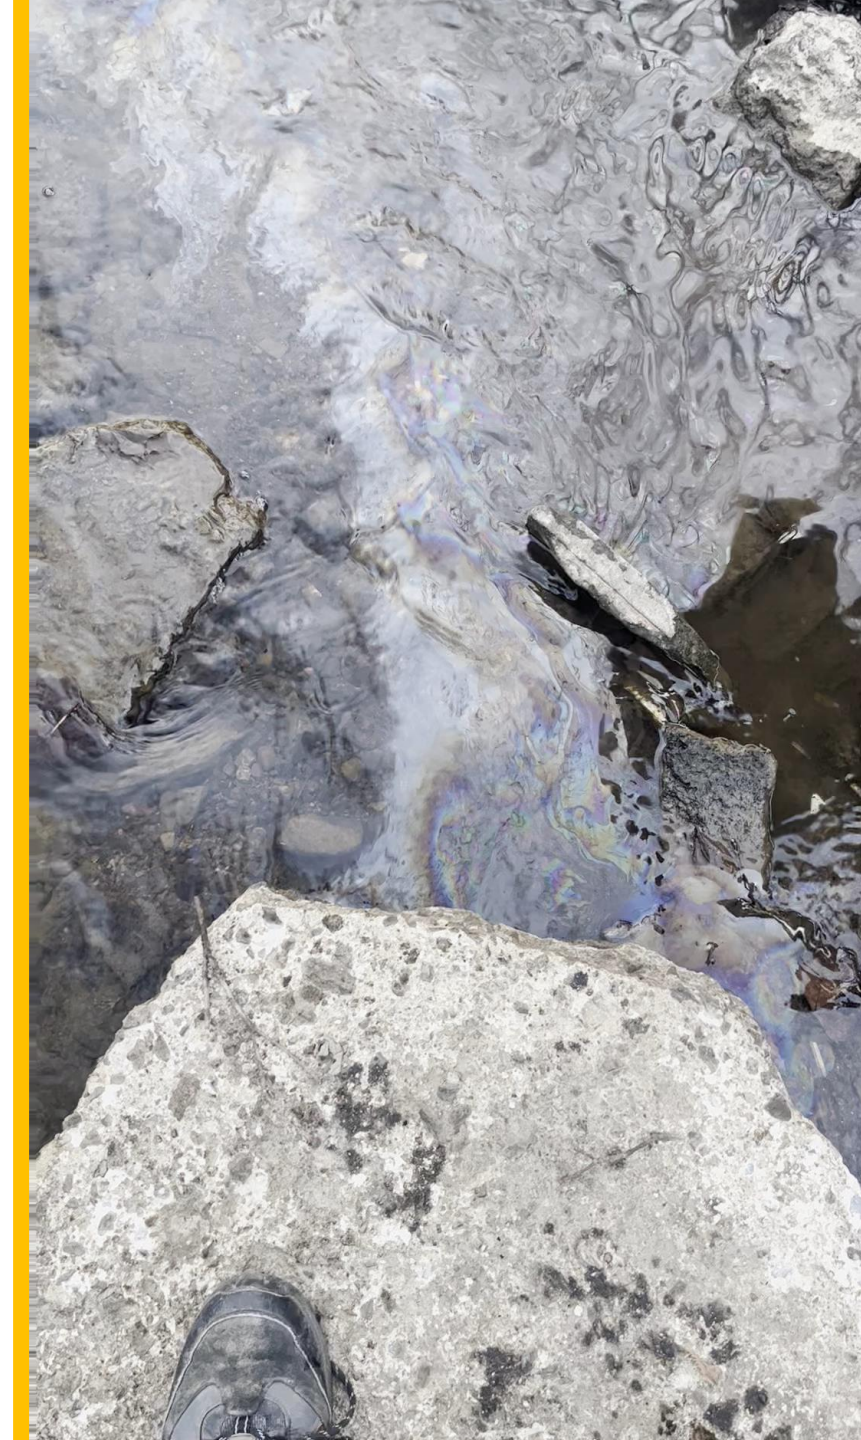
Free floating
chemicals
3 weeks
after the
spill

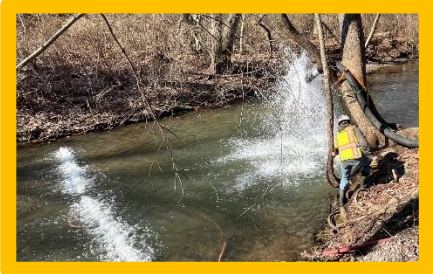
Aeration

USEPA and Norfolk Southern
were removing VOCs and SVOCs
from the creek water and
transferring them into the air

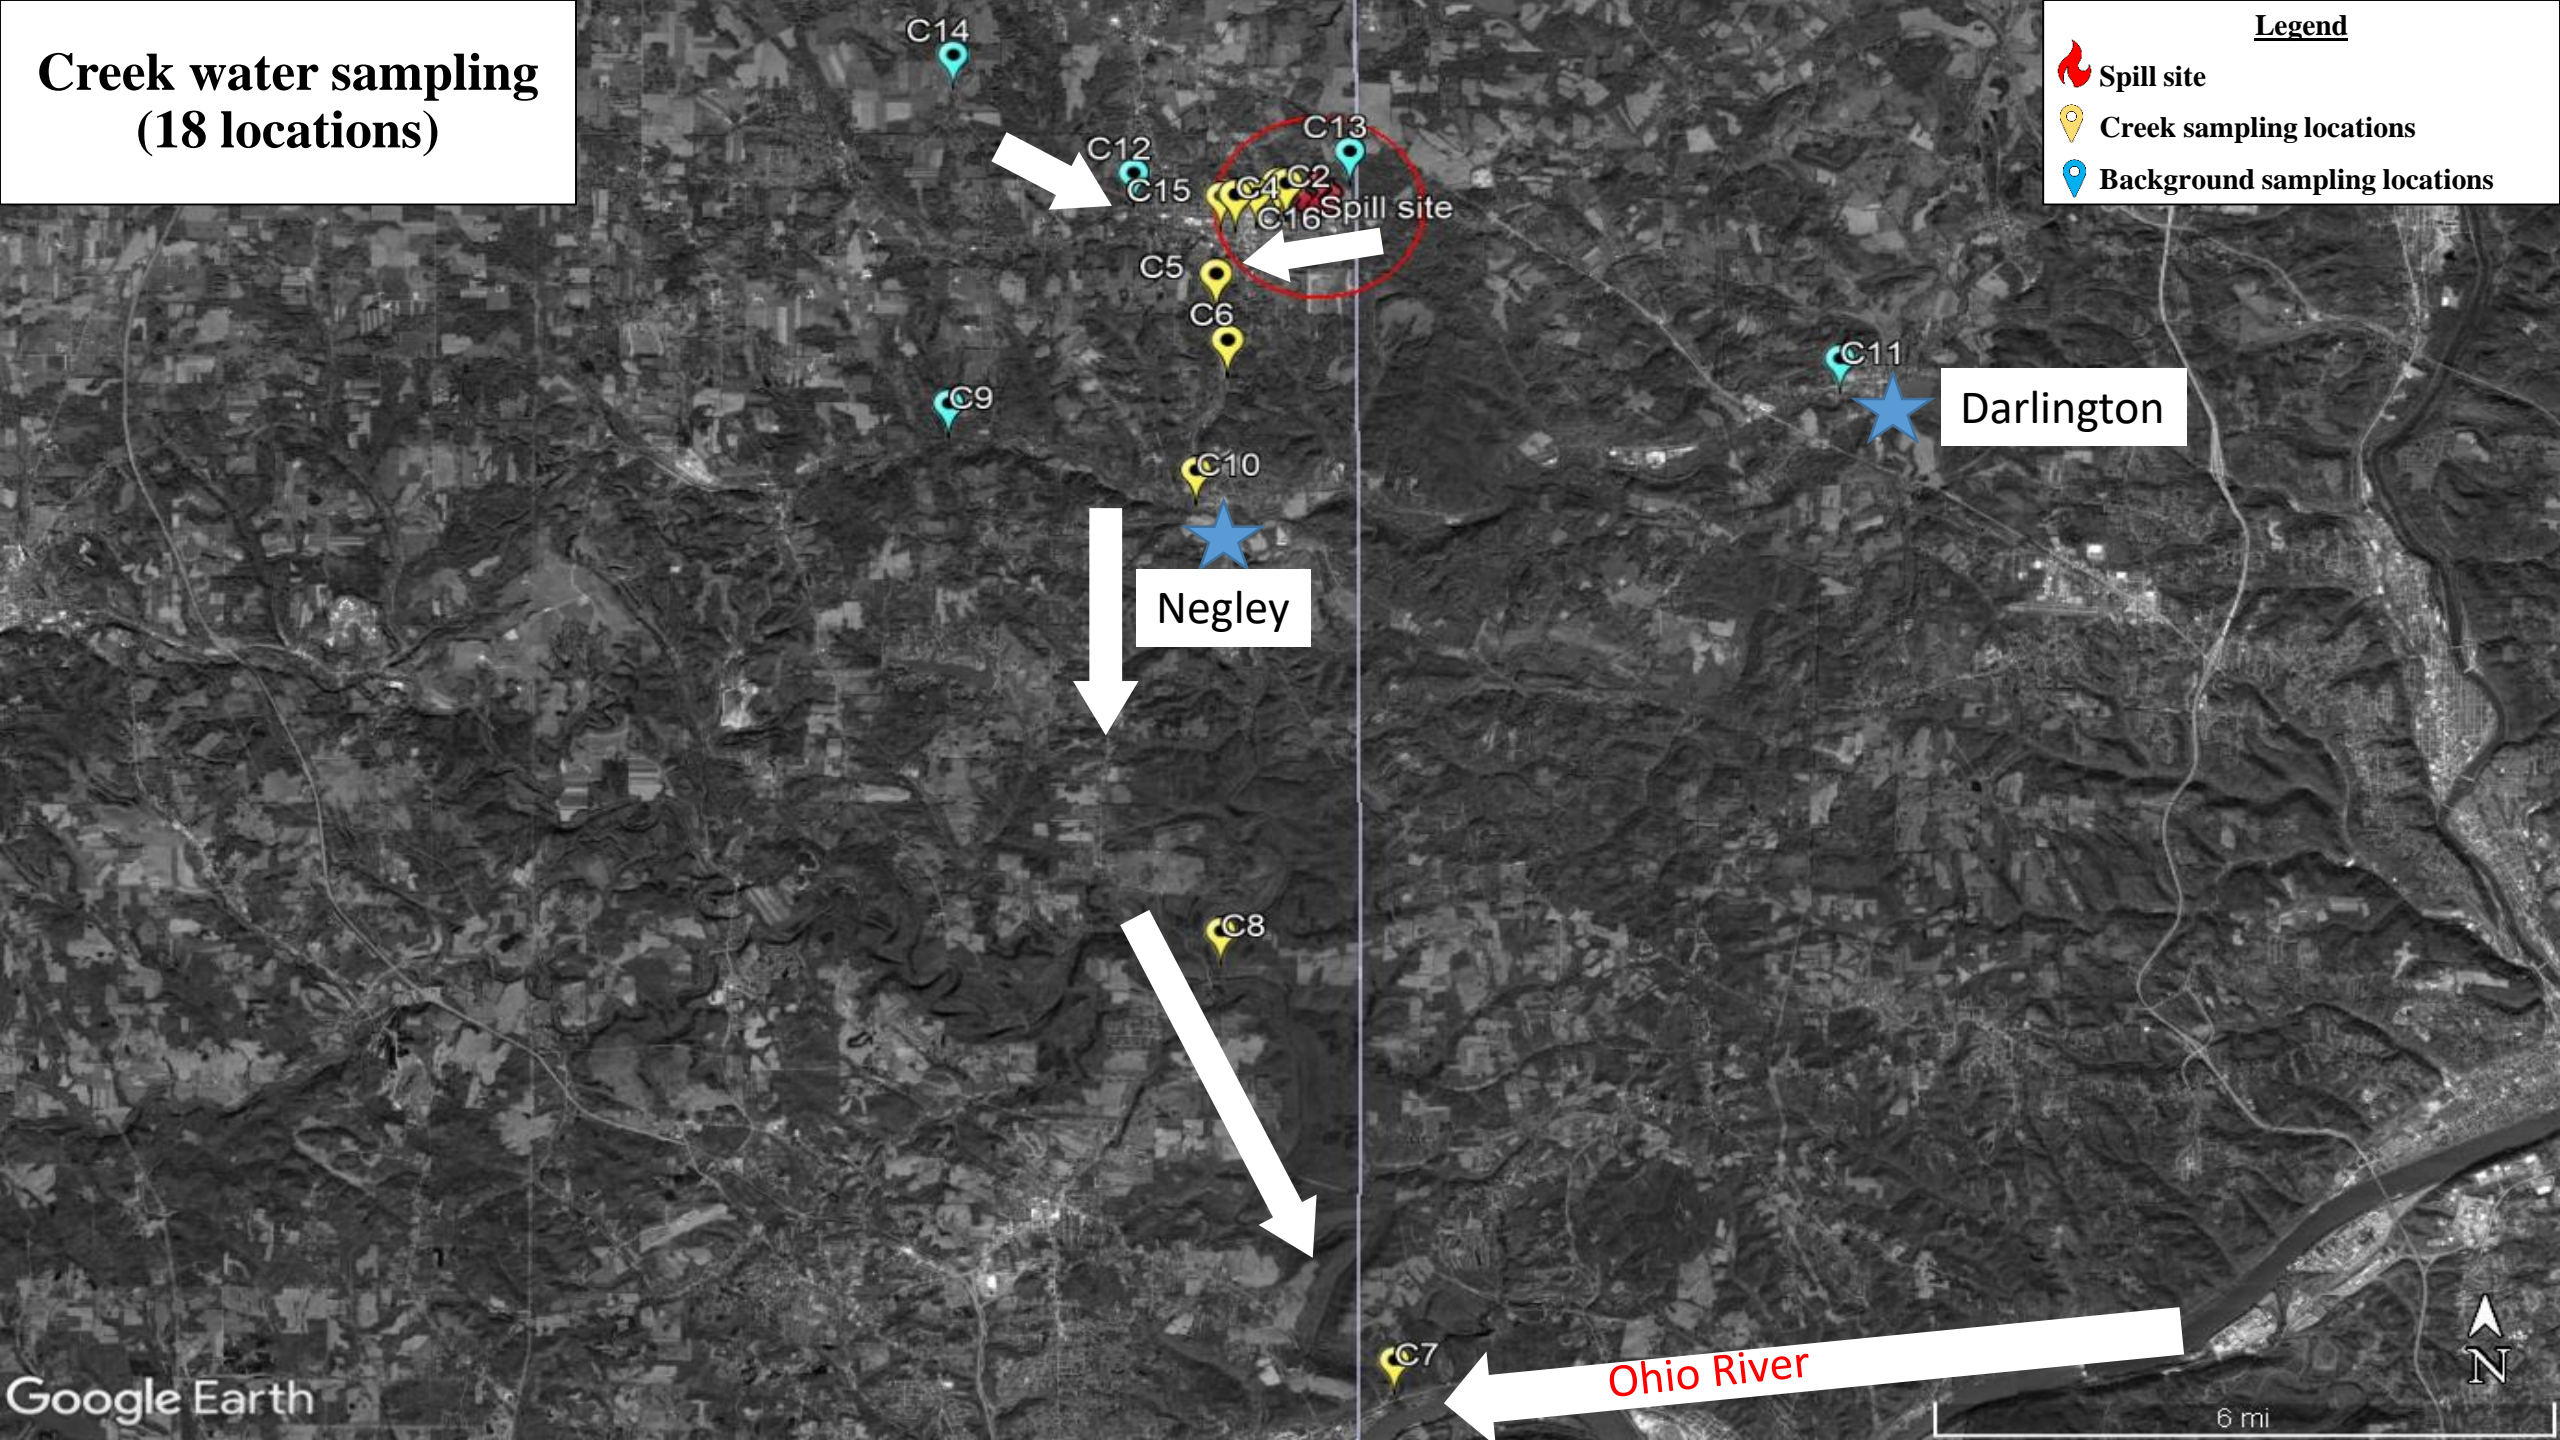
Creek water sampling
(18 locations)

Spill site

Creek sampling locations

Background sampling locations
