Building Water Safety: New Developments and Resources

Andrew J. Whelton, Ph.D.

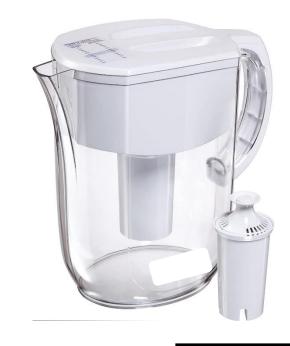
Should in-home POU water filtration devices be used to treat wildfire contaminated drinking water?

The devices are <u>NOT</u> designed for this.

The range of contamination must be known + testing.
