The Most Monitored Home in America: Plumbing for Innovation and Prosperity

November, 2018 Andrew J. Whelton, Ph.D.

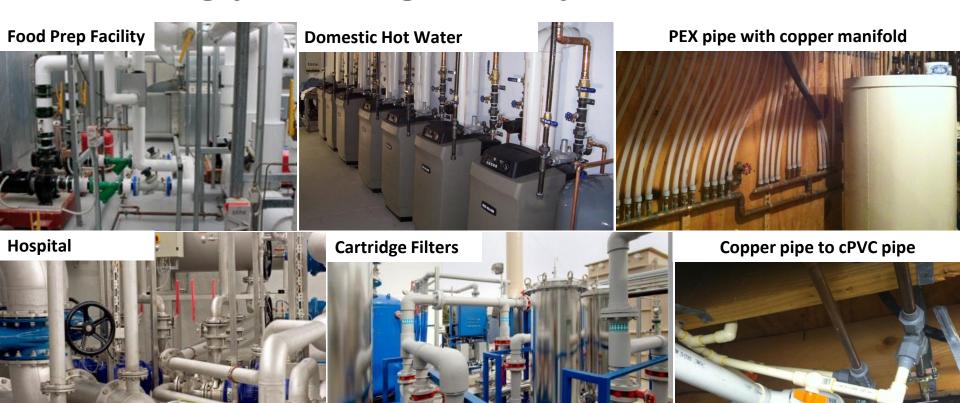
Building plumbing is complex

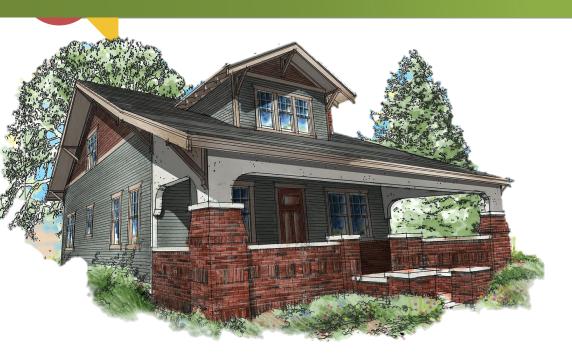
What is the Most Monitored Home in America?

Solar panels
Net-zero waste
Energy efficient appliances
Rainwater catchment
Greywater recycling
Online monitors throughout bldg

ReNEWW House = Retrofit Net Zero Energy, Water, and Waste

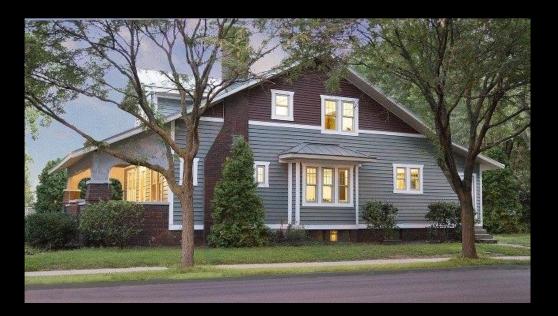
West Lafayette, Indiana
Less than 100 yards from lab
3 Bedroom, 1.5 baths
Water saving fixtures
Trunk-and-Branch design
PEX piping
Renovated in 2014

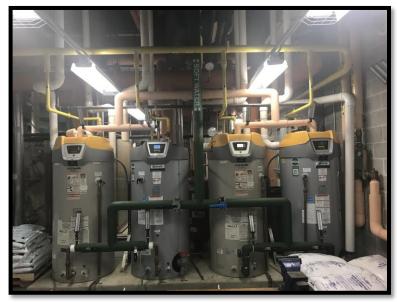
Copper drinking water action level was exceeded June 2018 to October 2018

- ✓ You cannot flush away this problem. It exists other places too.
 - Discarding first 250 mL of water did not consistently reduce copper levels
 - Flushing 1.5 Liters of water at each location (3-5 minutes) did not consistently reduce copper levels
 - Flushing can remove large volumes of stagnant water, but rebound likely
- ✓ POU devices likely needed and/or in-building treatment
- ✓ Additional water testing needed
