Some results and reflections:

Water quality during reduced occupancy due to COVID-19 and select intervention methods

Andrew J. Whelton, Ph.D.

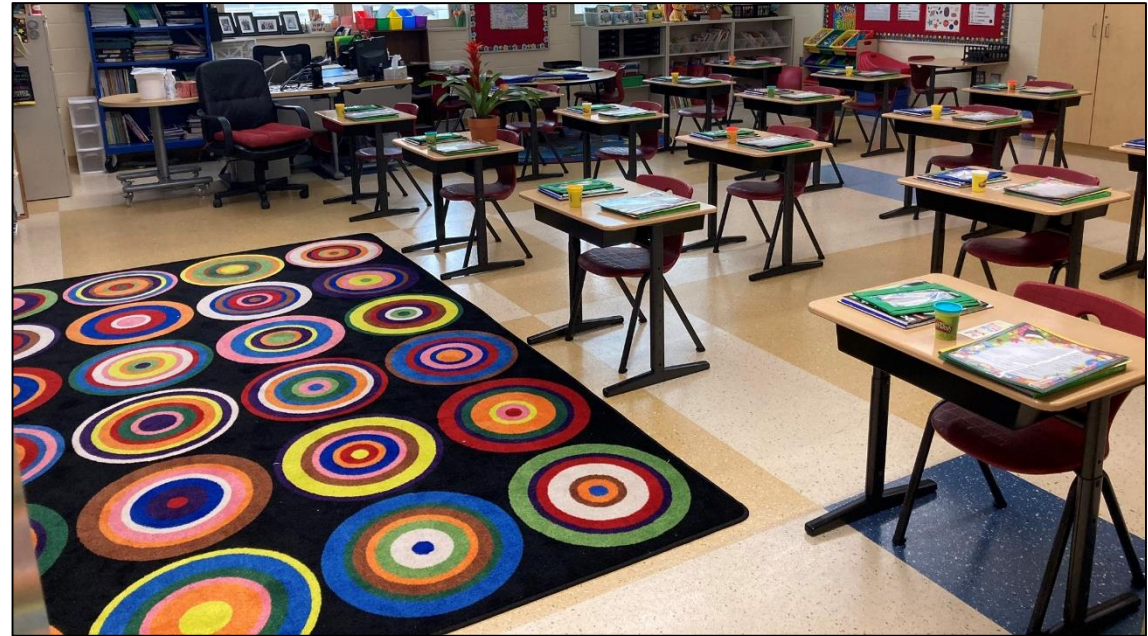
Some of our efforts involved testing building water systems in response to the pandemic

11 buildings across 4 studies

1. Elementary school, Indiana (Ra et al.)
2. Large residential building, Indiana (Angert et al., led by Proctor, Ph.D.)
3. Institutional buildings, Indiana (Ra et al.)
4. Elem/mid/high school, Ohio (Ley et al.)

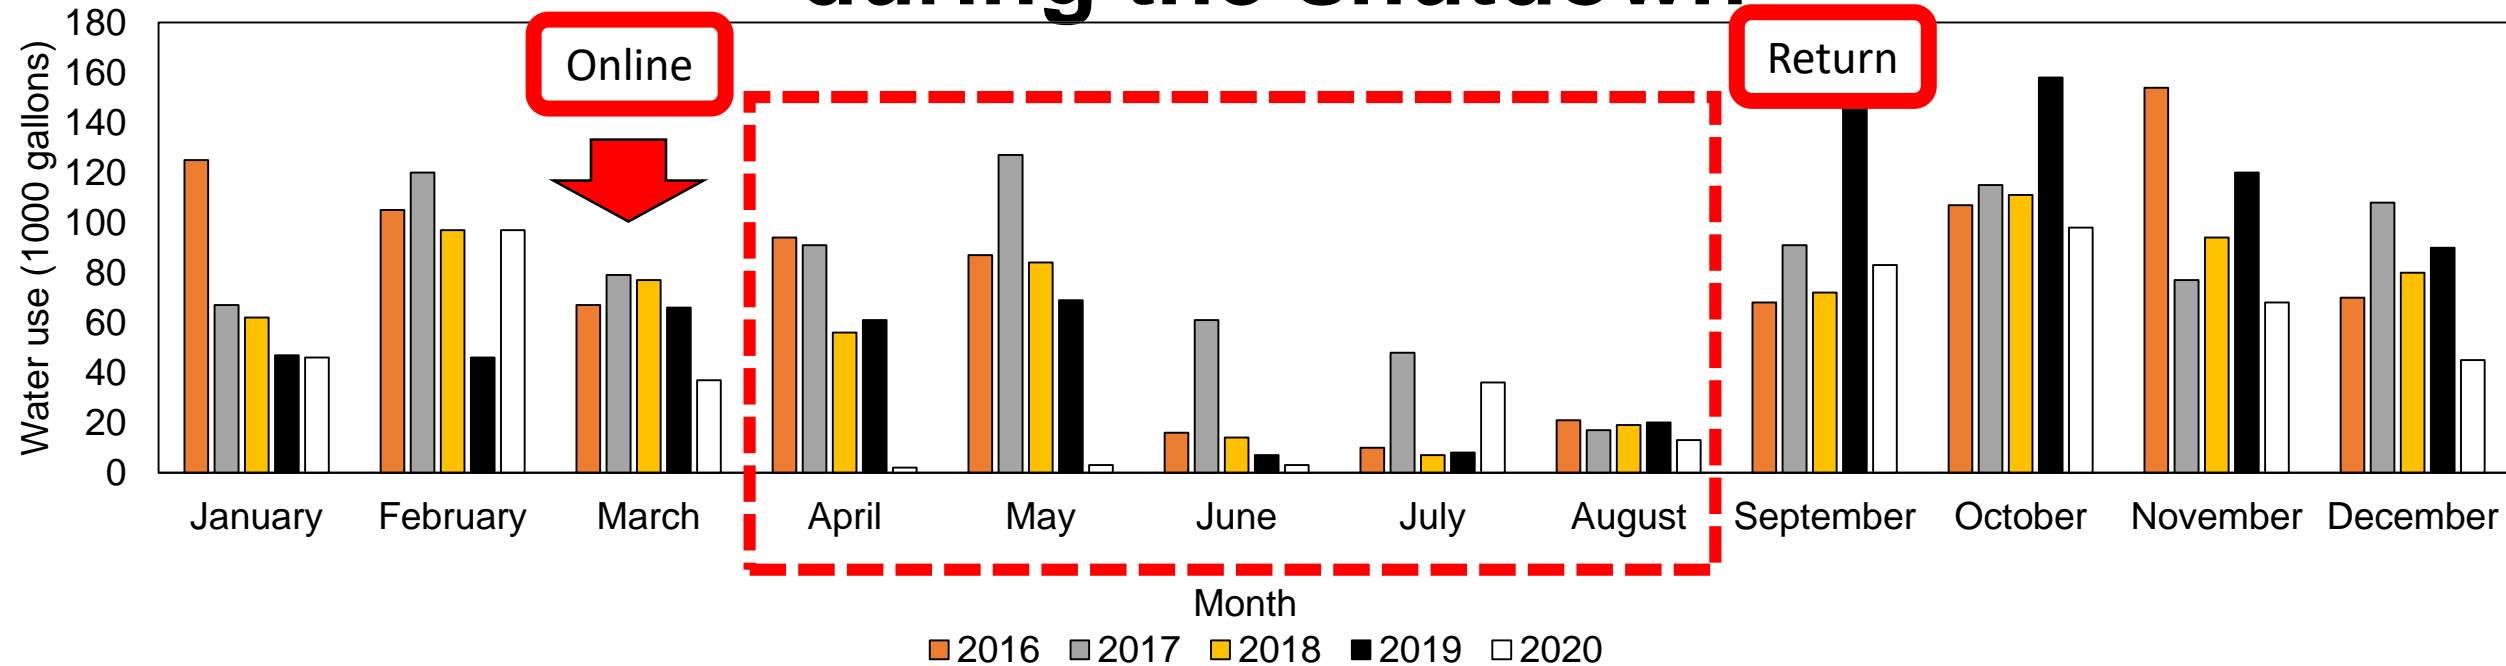
The school had a >95% reduction in water use during the shutdown

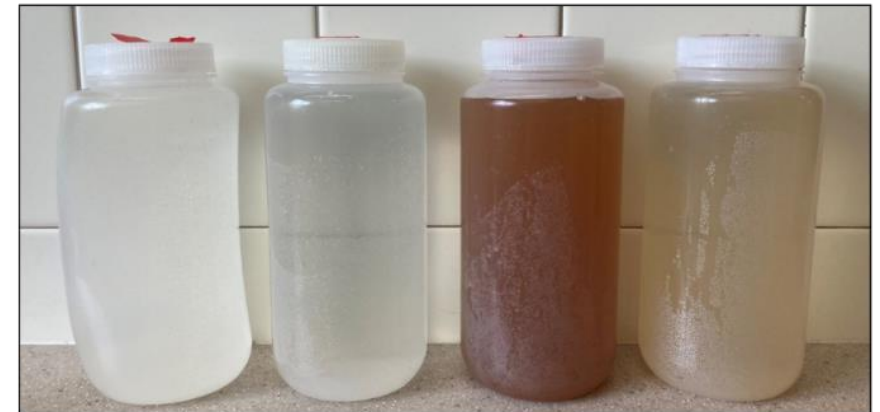
Hot water system had excessive corrosion.
Discolored water was observed

1,641 Fe	223 Fe	21,759 Fe	1,851 Fe
155 Zn	18 Zn	1,303 Zn	243 Zn
544 Cu	63 Cu	6,301 Cu	1,319 Cu
20 Pb	3 Pb	248 Pb	24 Pb
15 Al	3 Al	235 Al	129 Al

1st draw

10 min.

12 min.

20 min.

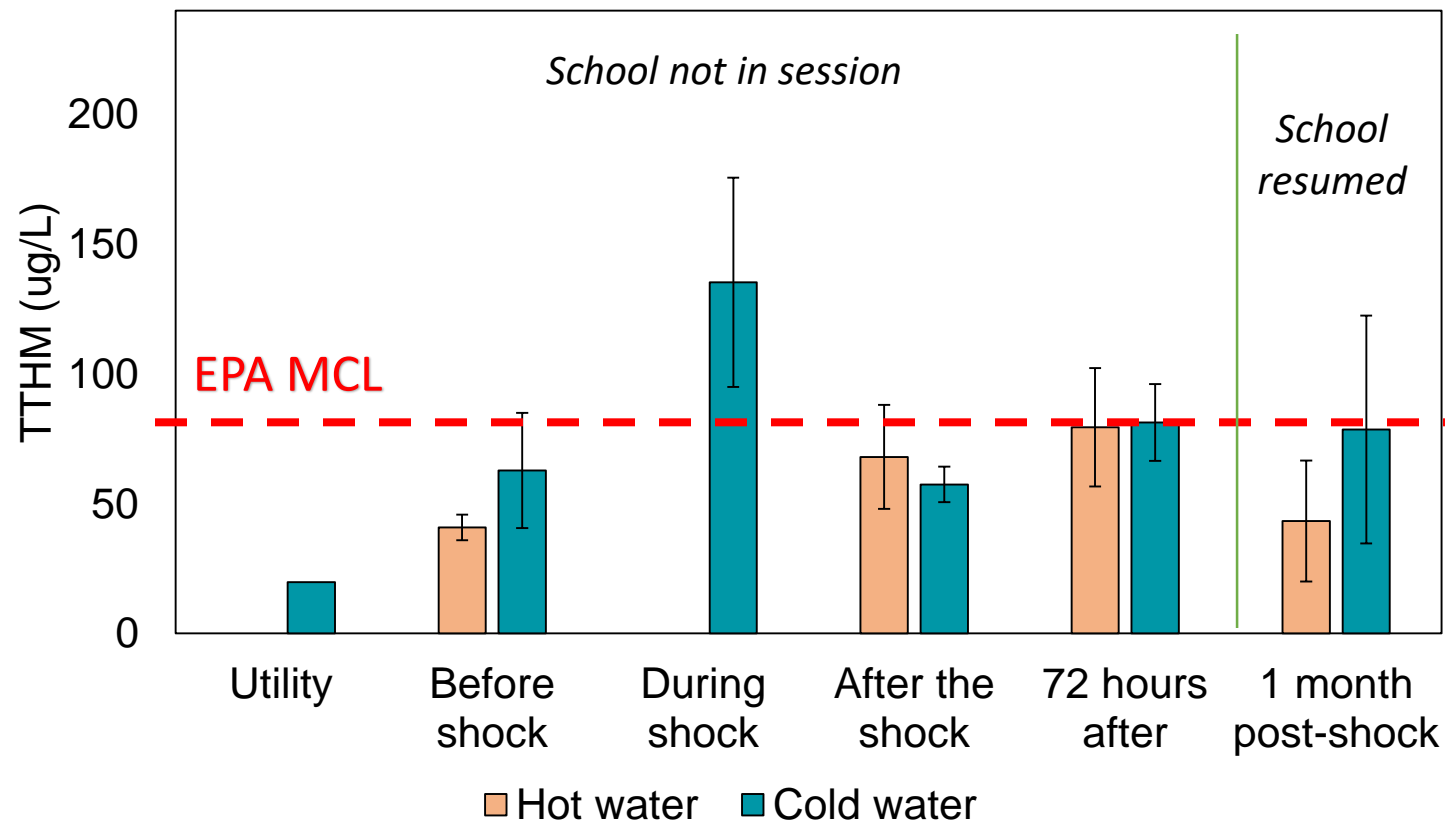
TTHM and copper levels were affected by the shock disinfection and flushing procedure

TTHM levels in plumbing >> water utility's distribution system

Highest TTHM levels: Shock chlorination (mean: 135.3 $\mu\text{g/L}$).

Highest number of exceedances: 72 hours after the shock + flushing, 7 / 15 samples

Some samples had copper levels exceed 1.3 mg/L post-shock, while lead was unaffected.

Hypochlorite shock disinfection levels varied 160-340 mg/L+
