The Relationship Between Drinking Water Quality in a Single Family Home and the Service Line

The Link between Fixture Water Use and Drinking Water Quality at a Net Zero Energy Residential Building

Case study: Fixture water use and drinking water quality in a new residential green building

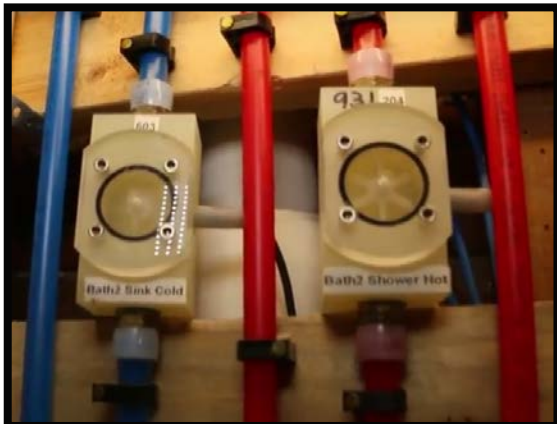
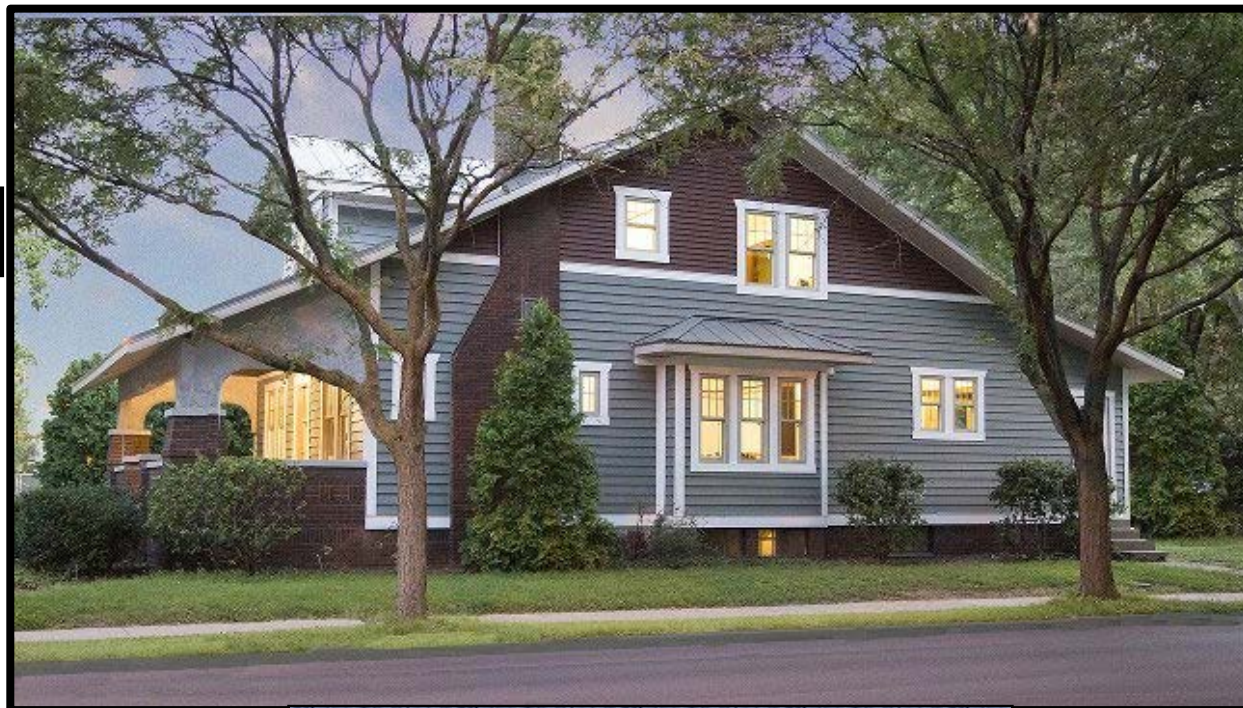
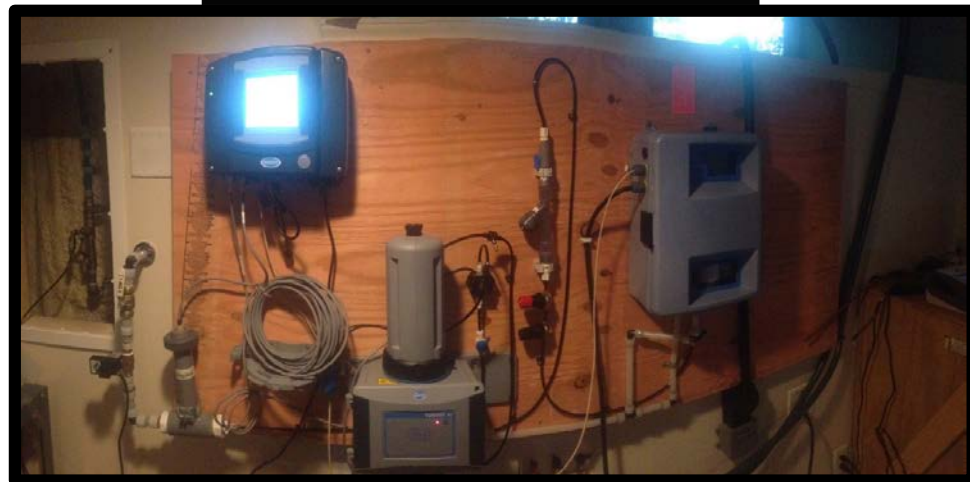
Online Flow and Temperature
Monitoring at All Fixtures

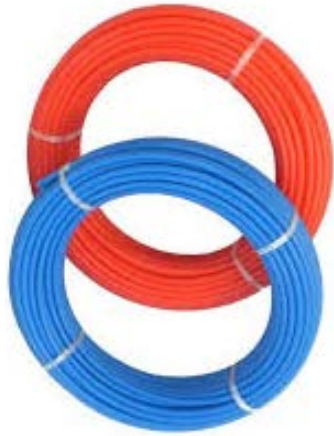
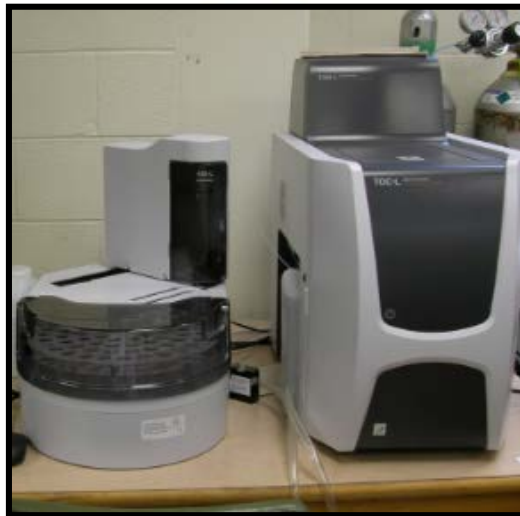
Bench Scale Study: pH and temperature influenced organic release

Water pH and Exposure Time		Total Organic Carbon (TOC) Concentration (mg/L)			
		PEX-a Pipe		PEX-b Pipe	
		23°C	50°C	23°C	50°C
pH 7	Day 3	13.09	41.29	16.66	58.92
	Day 15	3.33	5.71	0.89	12.88
	Day 30	5.07	3.44	1.08	10.77
	Sum	21.49	50.44	18.63	82.57
pH 10	Day 3	-	77.69	-	39.95
	Day 15	-	5.64	-	7.26
	Day 30	-	1.55	-	5.25
	Sum	-	84.88	-	52.46

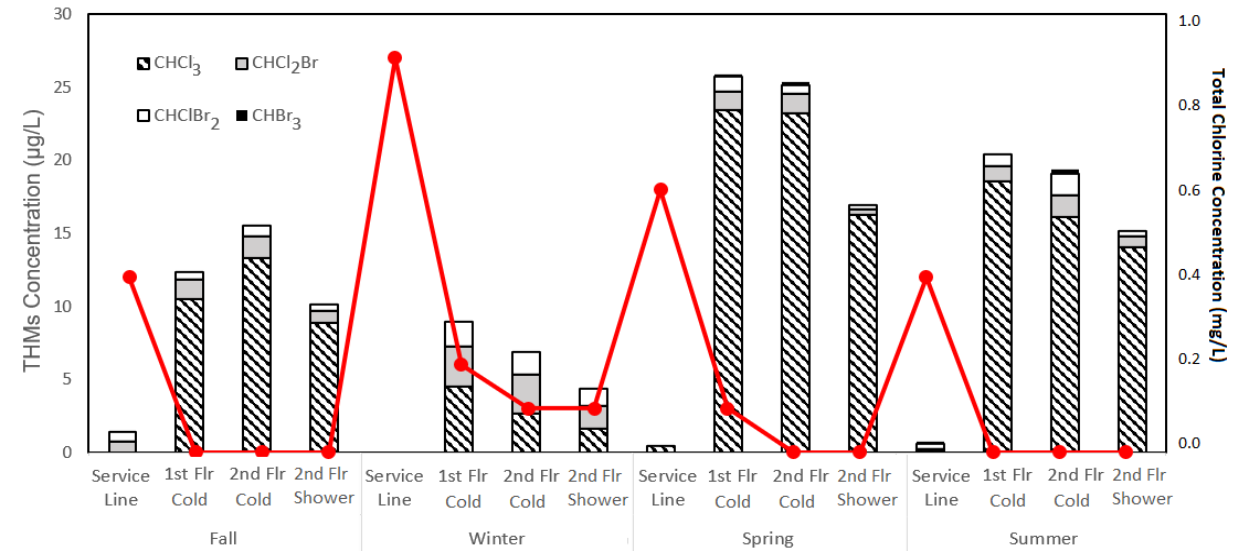
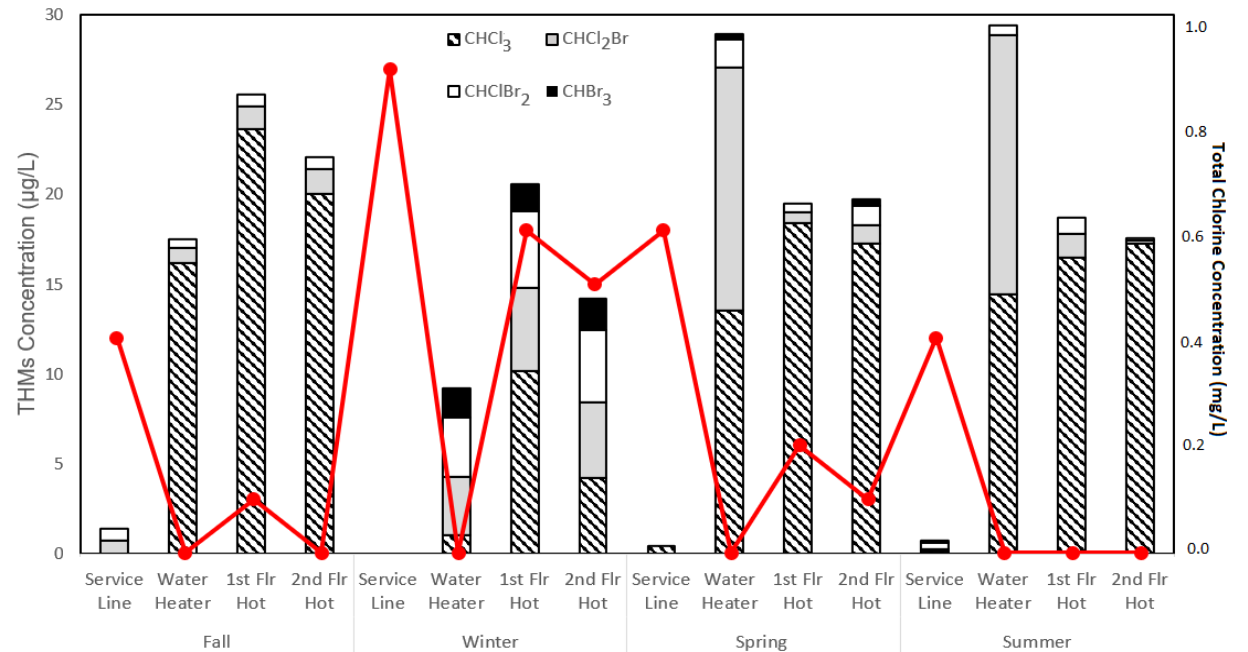
Disinfectant residual levels decreased through the building while TTHM concentrations increased.

For more than 85% of the sampling trips, disinfectant residual was not detected at the water heater, the 2nd floor cold, and 2nd floor shower fixture.

A significant negative correlation between Temp & disinfectant residual at all fixtures except the water heater and 2nd Flr shower
